## Compliance Assessment Report CAR\_NRW0043777

**Permit being assessed:** BJ0078801

For: GOLDEN GROVE WWTW LLANDEILO CARMS, held by DWR CYMRU CYFYNGEDIG

**Type of assessment carried out:** Site Inspection, Reason: Routine.

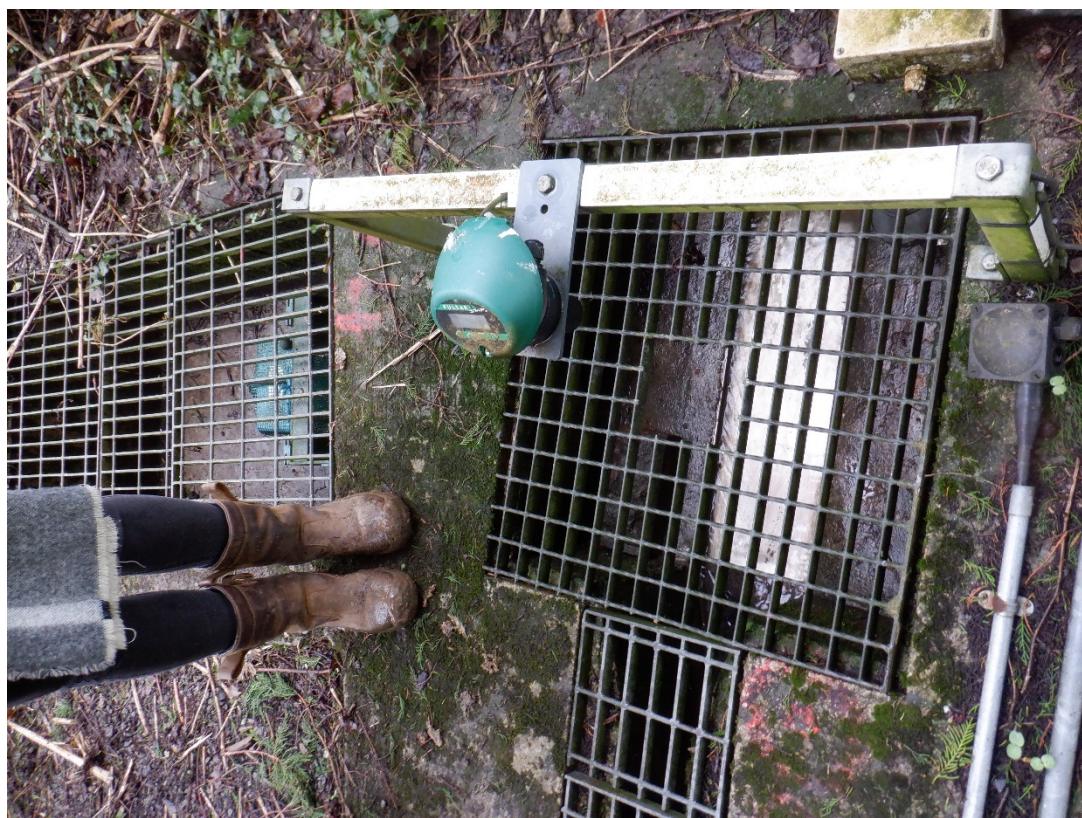
There is a storm overflow present at the inlet, this discharge is covered by a separate permit called Colden Grove WwTW Inlet CSO (BP0312601) and this will be covered by a separate CAR form. There is no screen in operation at the inlet of the works screening is done at the final effluent point and this is cleaned manually. There is no flow meter on the site, the only means of flow measurement is the EDM monitor on the inlet. The permit includes a flow monitoring condition, however as the Dry weather flows are so low at this asset (10.8 Cubic meters per day) we do not require a MCERTS flow monitor to be fitted at this time.

Figure 1: Inlet to the works with the storm overflow in the background.

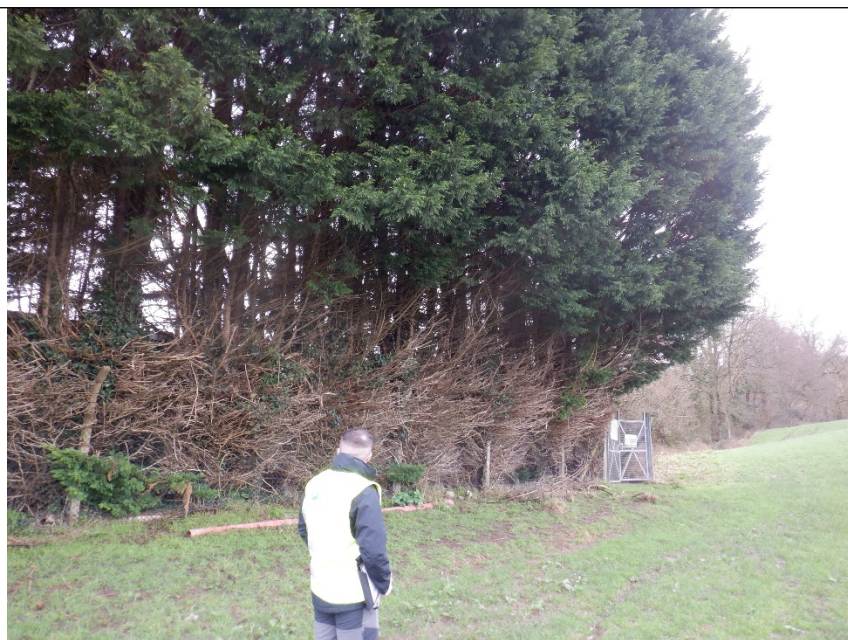
The site is a Wastewater Treatment works that processes residential and has telemetry in place for monitoring storm overflows. The permit for the site is for the discharge of secondary treated sewage effluent. The site was surrounded by a tree boundary made up of very tall conifers. There were no obvious signs of the tree roots causing damage to the infrastructure of the works.

Figure 2: Perimeter of site made up of tall conifers.

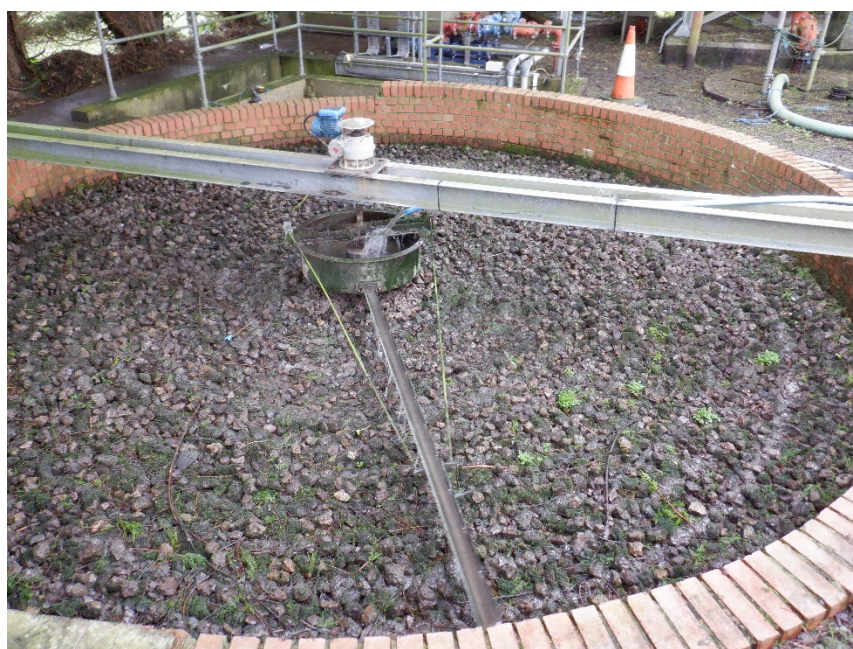
The flows then enter into a primary settlement tank. The sludge is pumped into holding tanks at the works, this is emptied every two months. Secondary treatment is achieved by a percolating filter bed. The rotation arms on the filter bed were moving free and unhindered. During the visit, the filter beds seem to work effectively with no sign of ponding or dry patches with no obvious leakages.

Figure 3: Filter bed

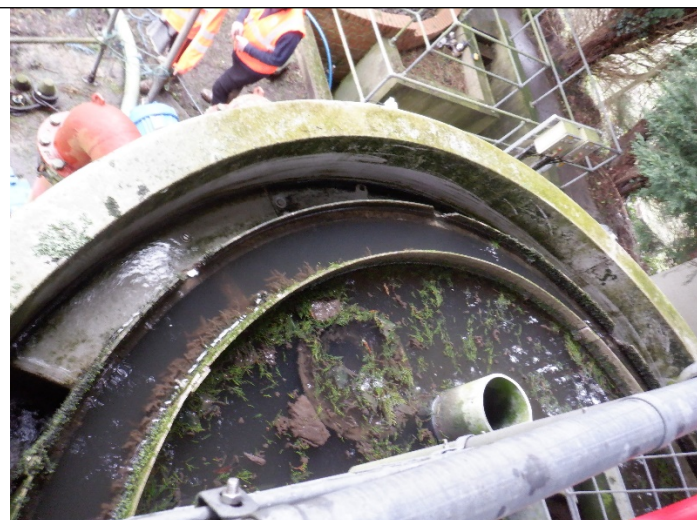
Figure 4: Final settlement tank

Following the filter bed treatment, the flow enters a final settlement tank. The final tanks seemed to work effectively at the time of the visit with no signs of built-up sewage fungus, there was some conifer needles present on the surface of the tank, these are manually cleared by operatives when on site. The site is visited twice a week.

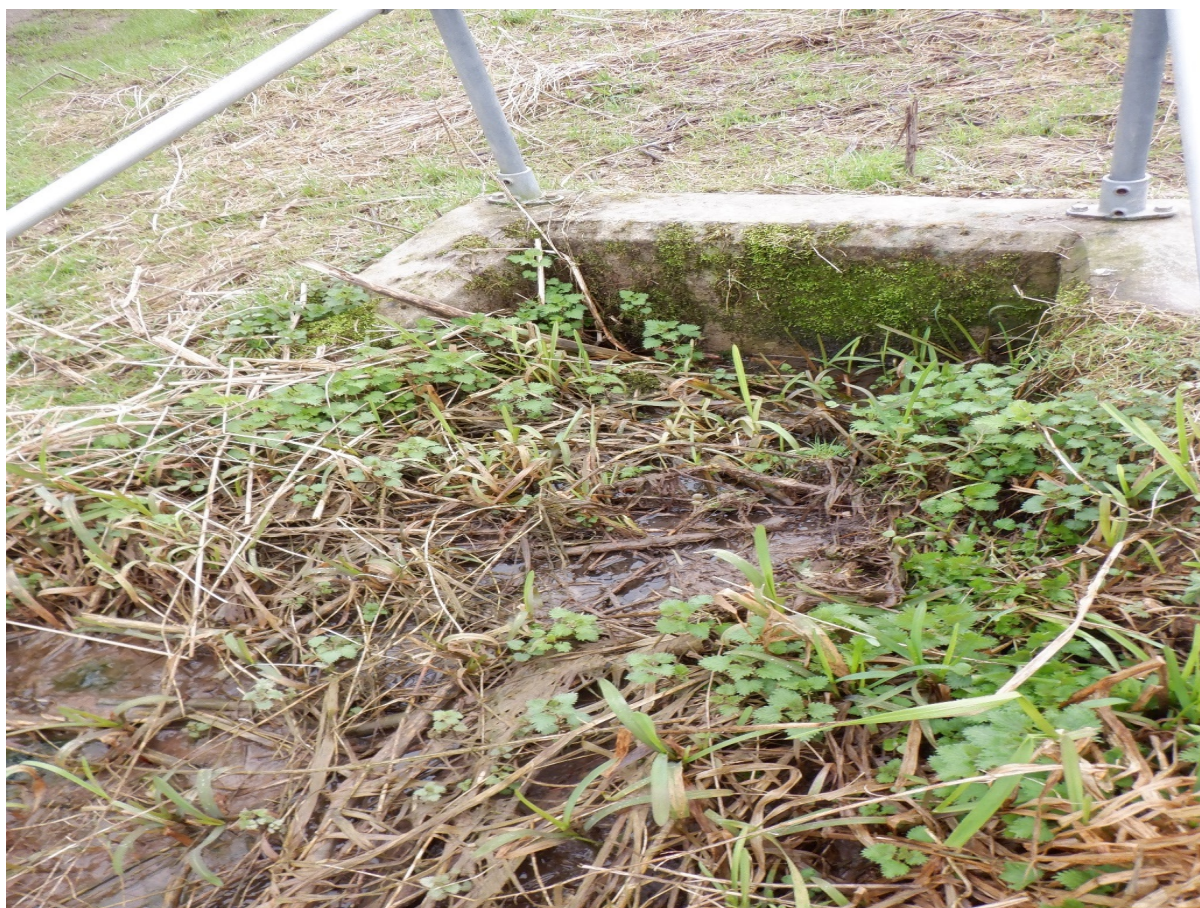
final effluent sampling station. The discharge point into the Afon Tywi was expected by officers later in the day, however the pipe was not visible due to siltation, but the discharge did not look to be causing any issues, with no fungus or odour present.

Figure 5: Discharge point

The outfall point is blocked and overgrown, due to proximity to the Tywi the outfall has silted up in times of high flows, this silt has now become overgrown. The discharge is making its way up through the silt and into

the Tywi, but the pipe is not visible. The discharge did not have any obvious odour and there was no fungus present.

The outfall point could do with some clearing up, however this may end up getting silted up again due to the nature of the Tywi and the location of the point.
