Compliance Assessment Report CAR_NRW0043792

Permit being assessed: VP3494FK.
For: Melin Plas Du, held by M O Jones
At: Yffor, Pwllheli, Gwynedd, LL53 6RF.

Type of assessment carried out: Site Inspection, Reason: Routine.
On 14/03/2024 between 14:00 and 15:30.
Parts of permit assessed: See below

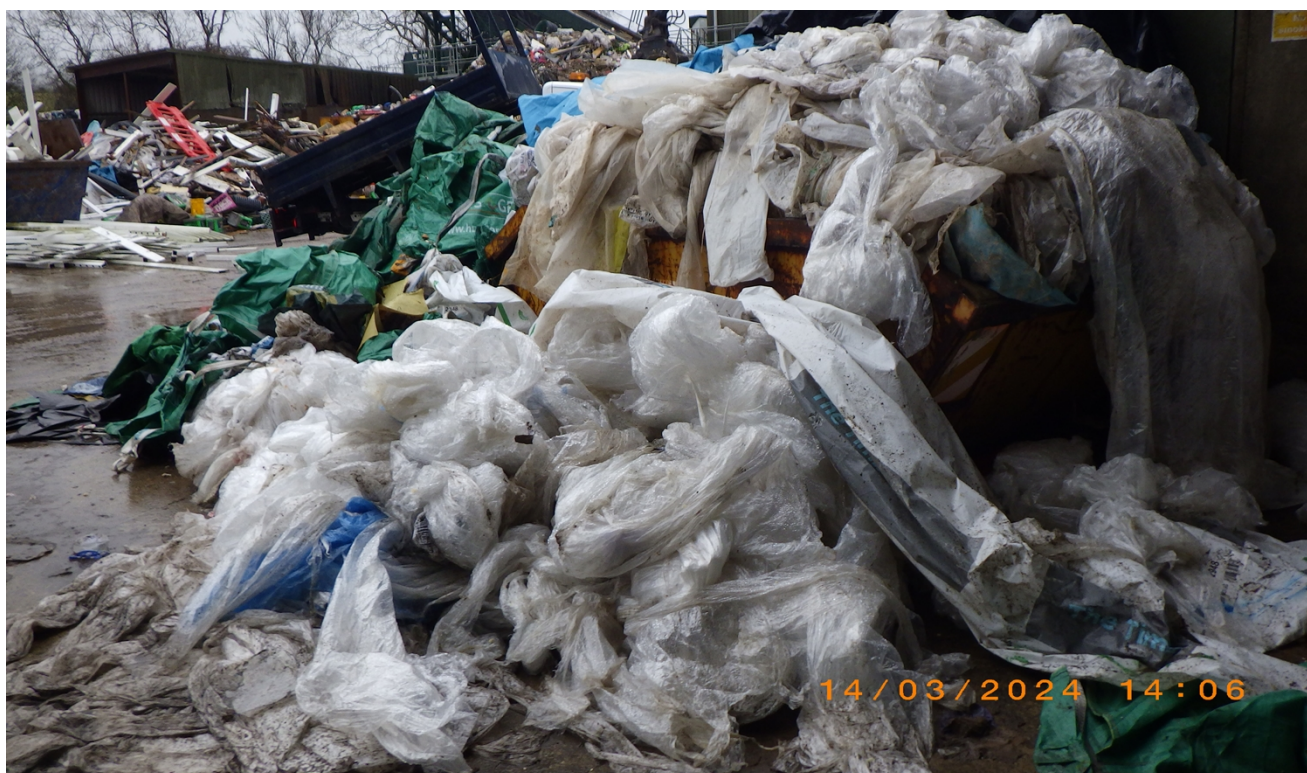
Photograph showing plastic storage on site

The above photograph shows a skip overflowing with plastic waste. Please ensure that loose, lightweight plastics are kept contained, to prevent the wind from taking this waste off site.

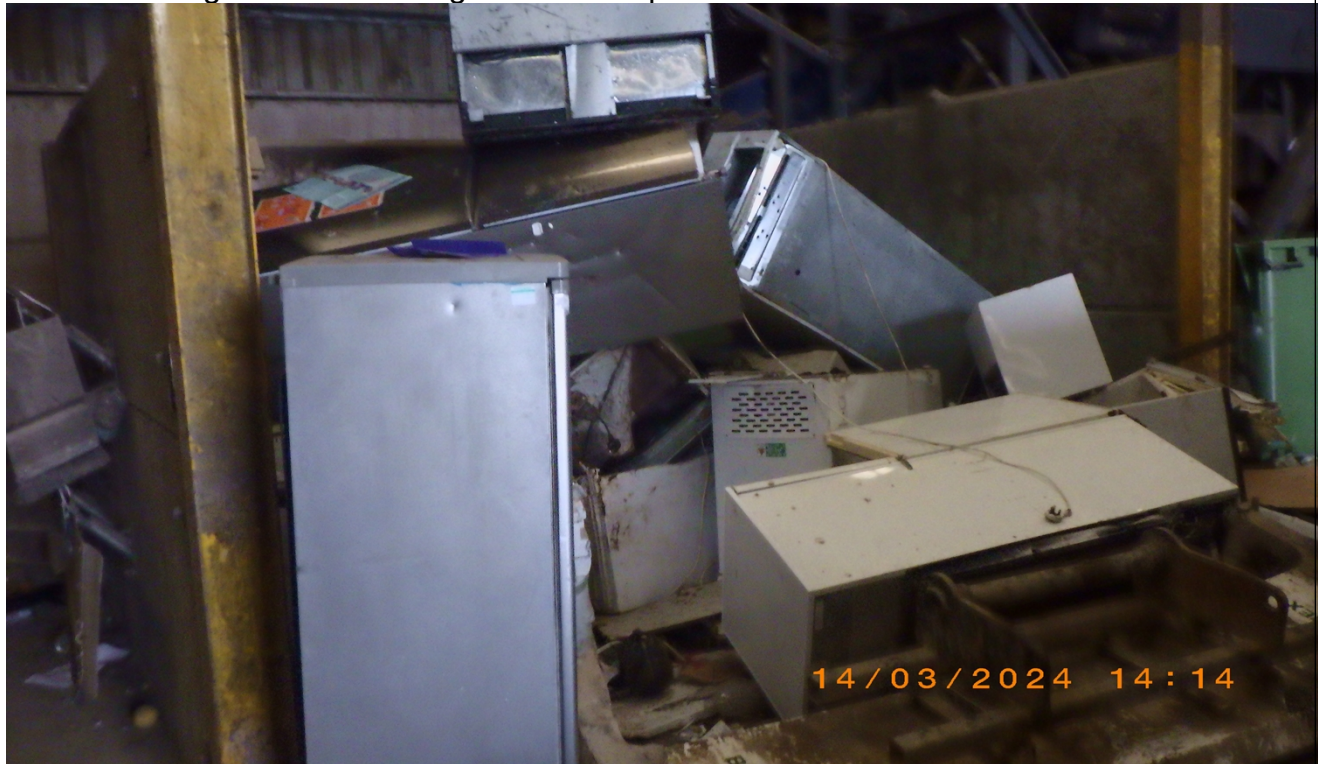
Within the shed housing mixed recyclables from Gwynedd Council, Officers observed a number of fridges/freezers being stored. See photo below.

Photograph showing storage of waste fridges/freezers

At the time of the inspection, Rhiryd informed officers that fridges were authorised by the site permit. However, a check of the site permit has found that the site is not authorised to accept fridges/freezers.

Schedule 2 of the site permit, does not contain any waste codes/descriptions that would allow the site to accept this kind of waste.

The permit has been scored a CCS 3 for this permit breach. The reasoning is because this waste type is potentially hazardous. Fridges/freezers can contain components such as circuit boards, motors and any plastic parts may contain hazardous chemicals or POPs. Coolants and foam may also be hazardous. Fridges were also being stored on top of one another and on their side. This increases the risk of damage to the appliances which may result in the release of hazardous components.

ACTION: No fridges/freezers should be accepted onto site. Fridges/freezers observed on site, should be removed to an appropriately permitted facility. Please provide NRW with consignment notes to evidence the removal.

Should you wish to accept fridges/freezers, you would need to apply for a permit variation.

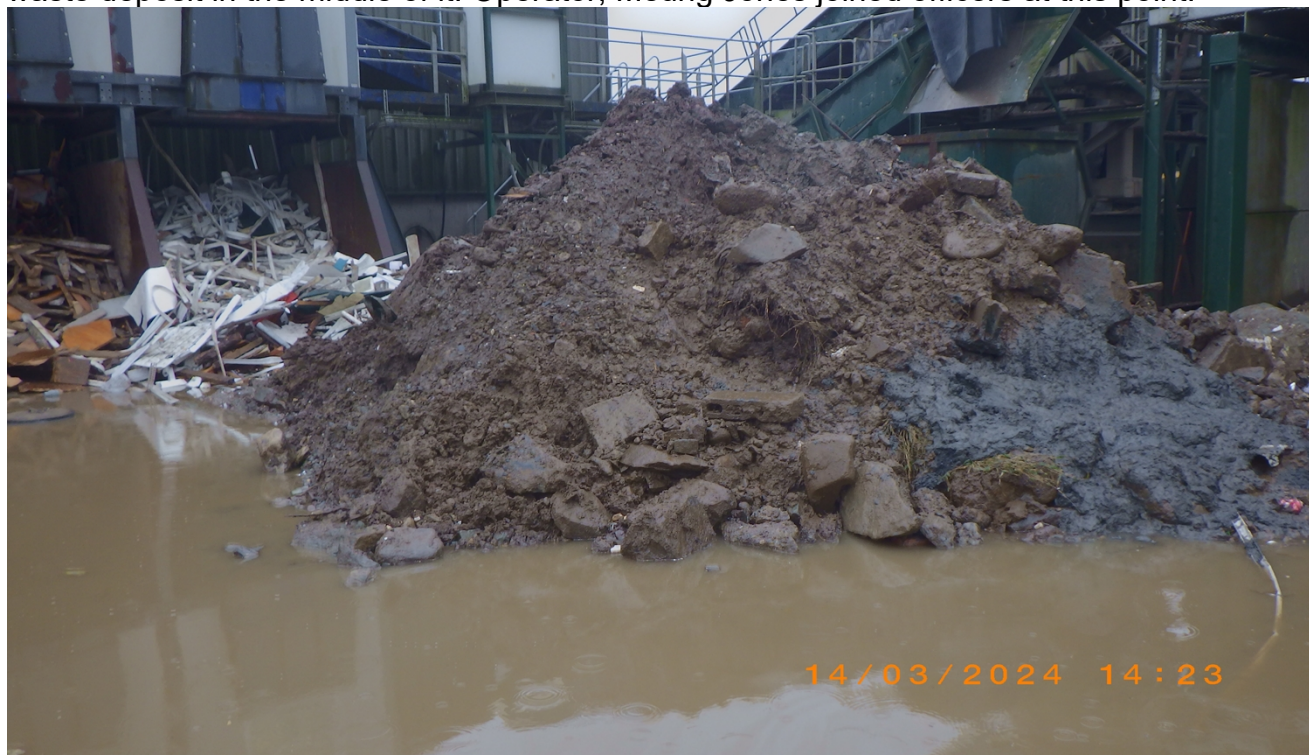
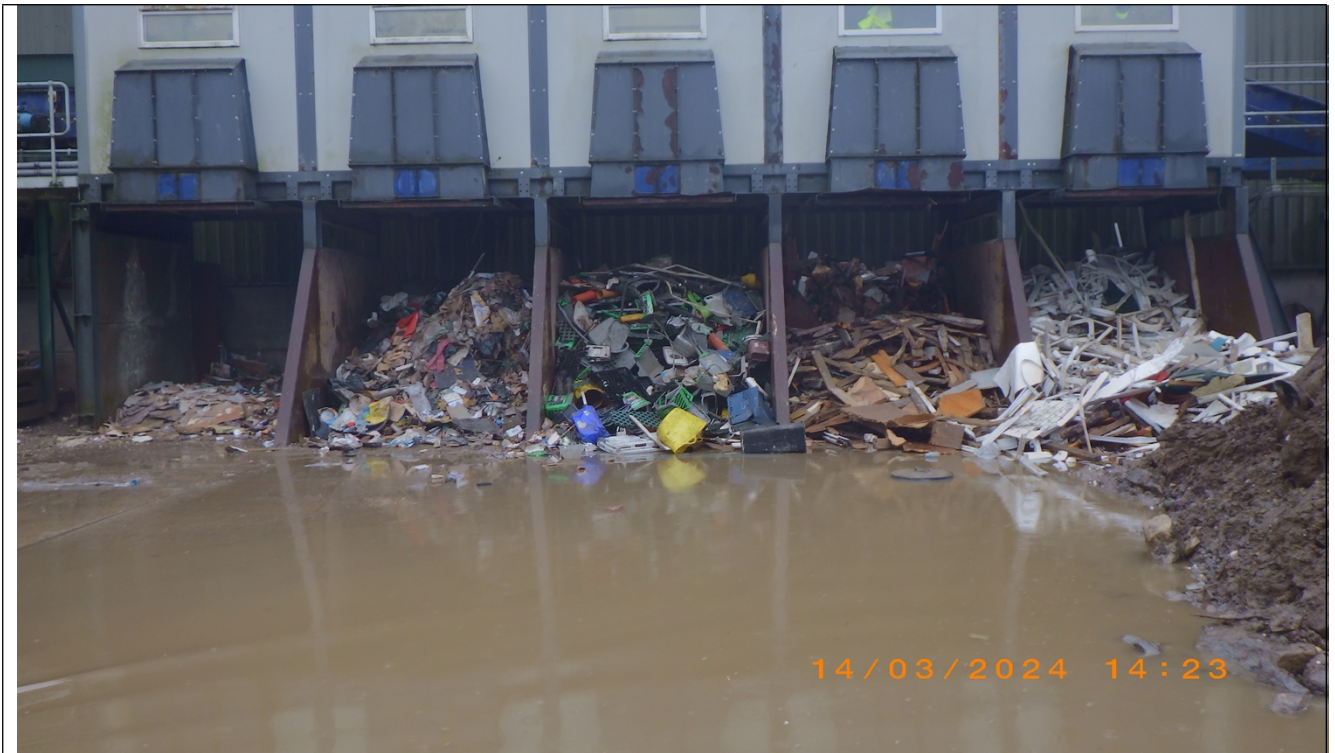
The inert waste treatment area is at the rear of the site, adjacent to the picking line. As officers walked round to this area, there was a significant amount of standing water, with a waste deposit in the middle of it. Operator, Meurig Jones joined officers at this point.

Photographs showing standing water on site

Meurig explained the waste had been brought in and placed on a drain which was causing the flooding issue.

Due to the standing water, it was difficult to tell what ground was underneath. On page 87 of the site EMS, it states inert waste still be 'Stored and treated on impermeable surface with drainage to soakaway after passing through an interceptor and silt trap or hardstanding'.

ACTION: Resolve flooding issues on site. All ground in the inert treatment area should be impermeable and maintained as such with appropriate drainage. Once flood water has subsided, please submit evidence to NRW to show all ground in this area is impermeable and that drainage is in full working order.

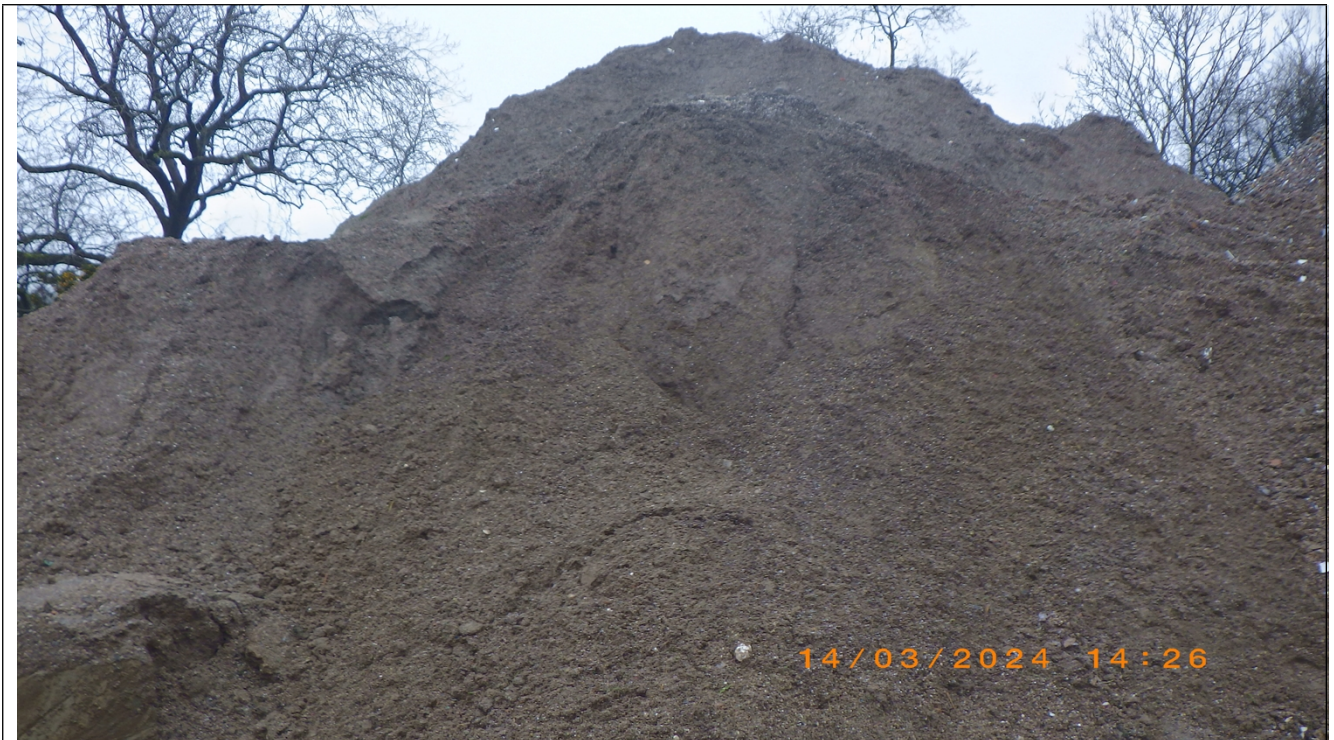
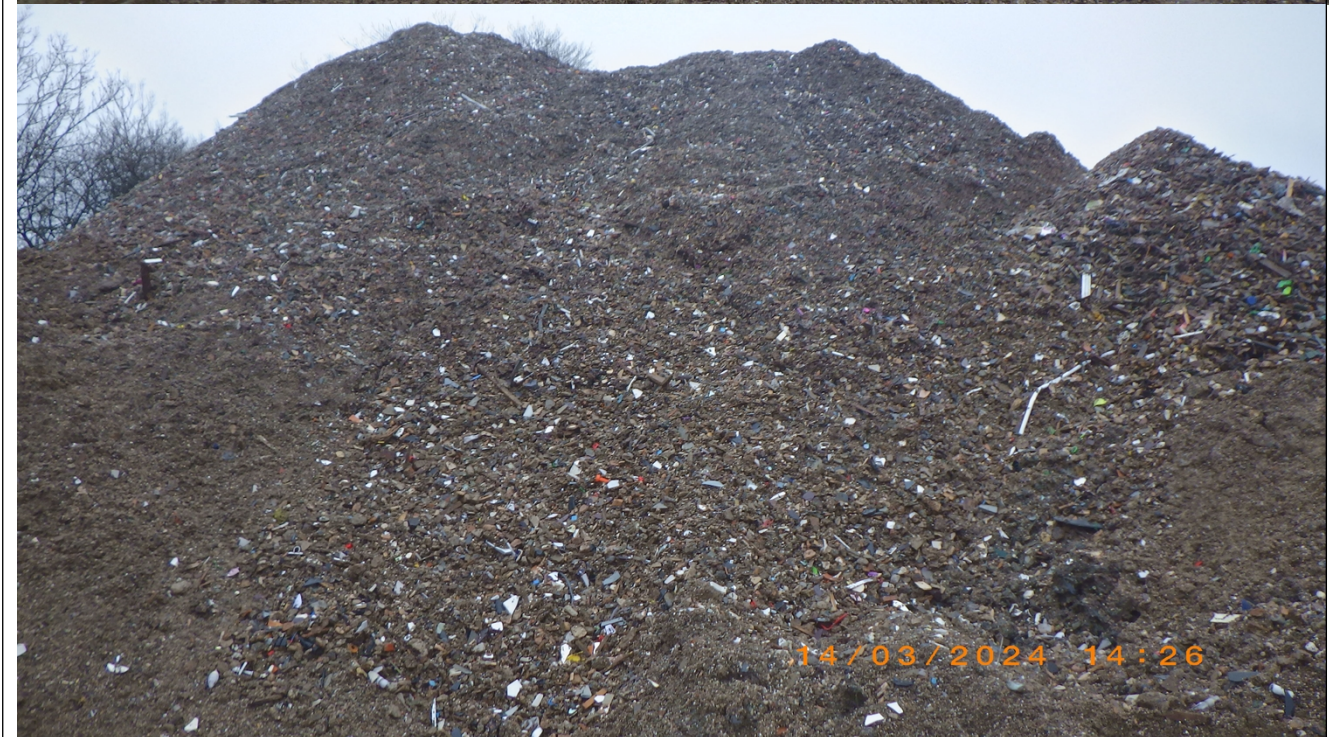
1st photograph: material described as 10ml down. 2nd photograph: material described as 10-50ml down.

The above photos show the storage of two distinct waste stockpiles. Both waste piles were visibly heavily contaminated. See photographs below which show this contamination.

ACTION: The waste observed on site, described as 10ml down / 10-50ml down, should not be sold as a 'product'. This material remains a waste due to levels of contamination and the fact site is not adhering to WRAP Quality Protocol.

This waste can only be removed from site as a waste and should be appropriately classified using WM3 guidance.

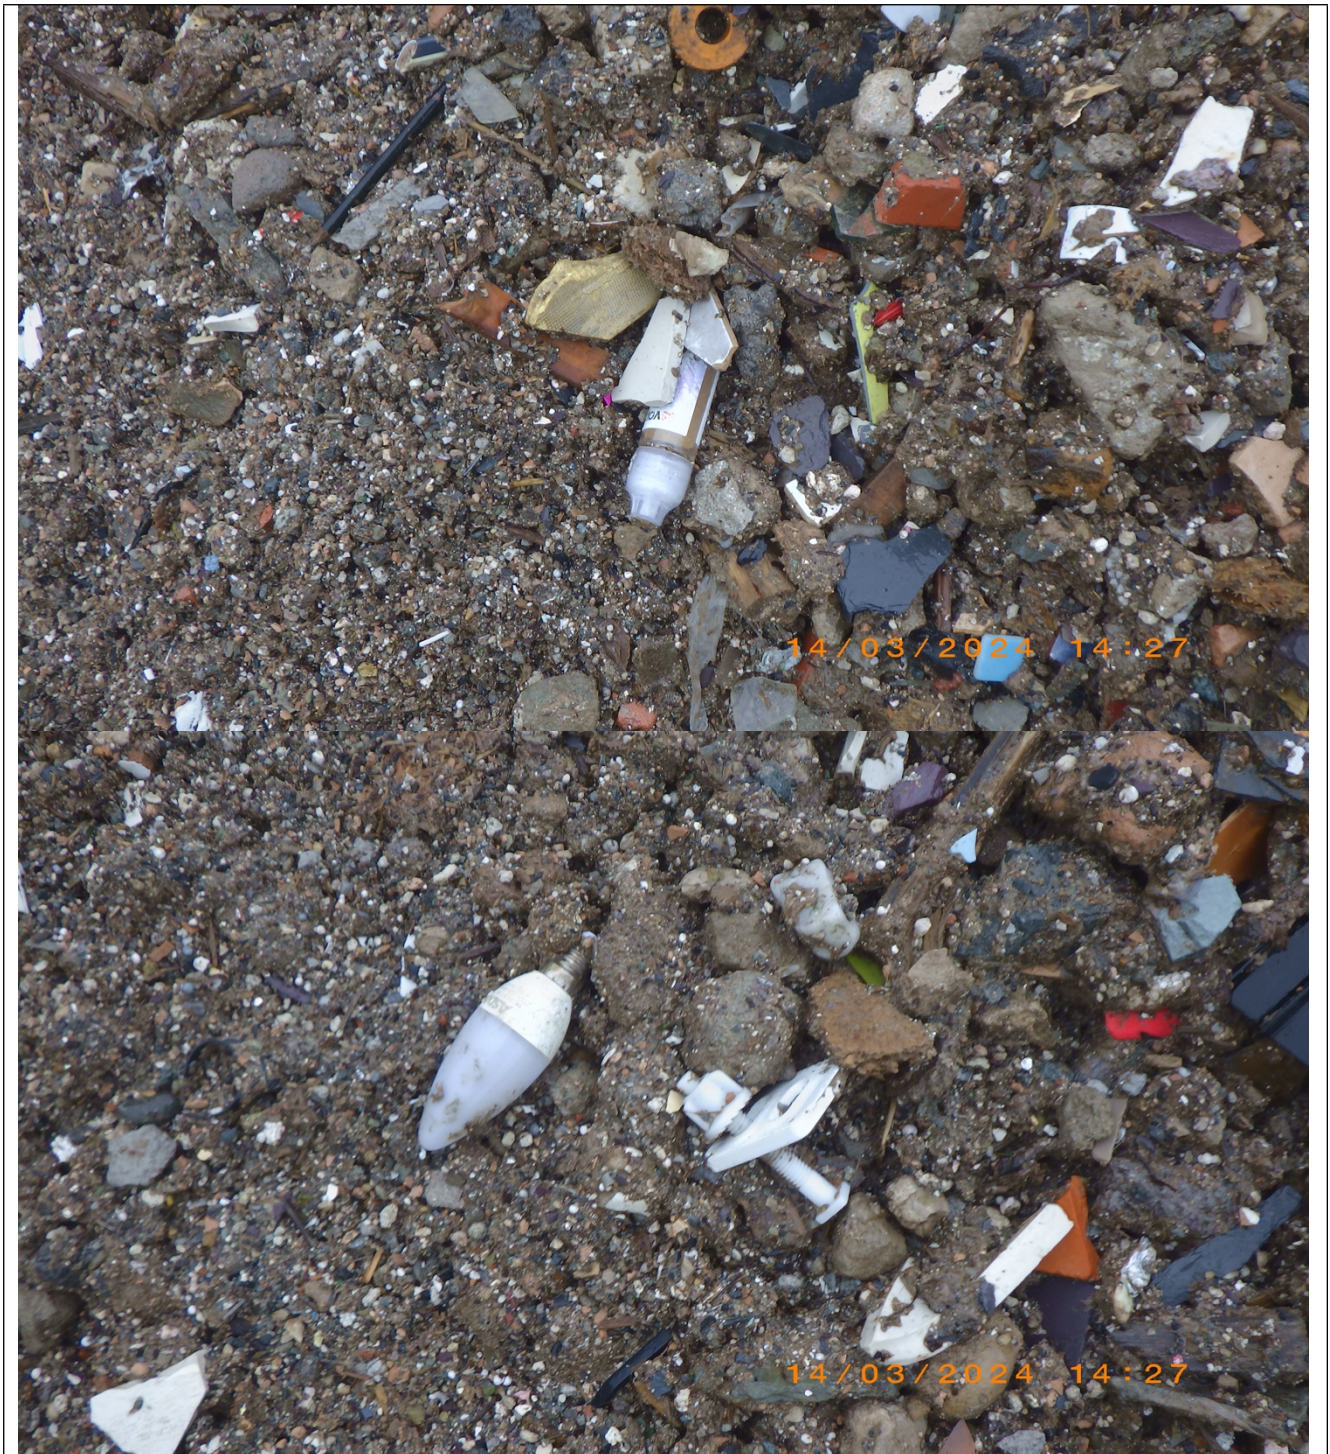
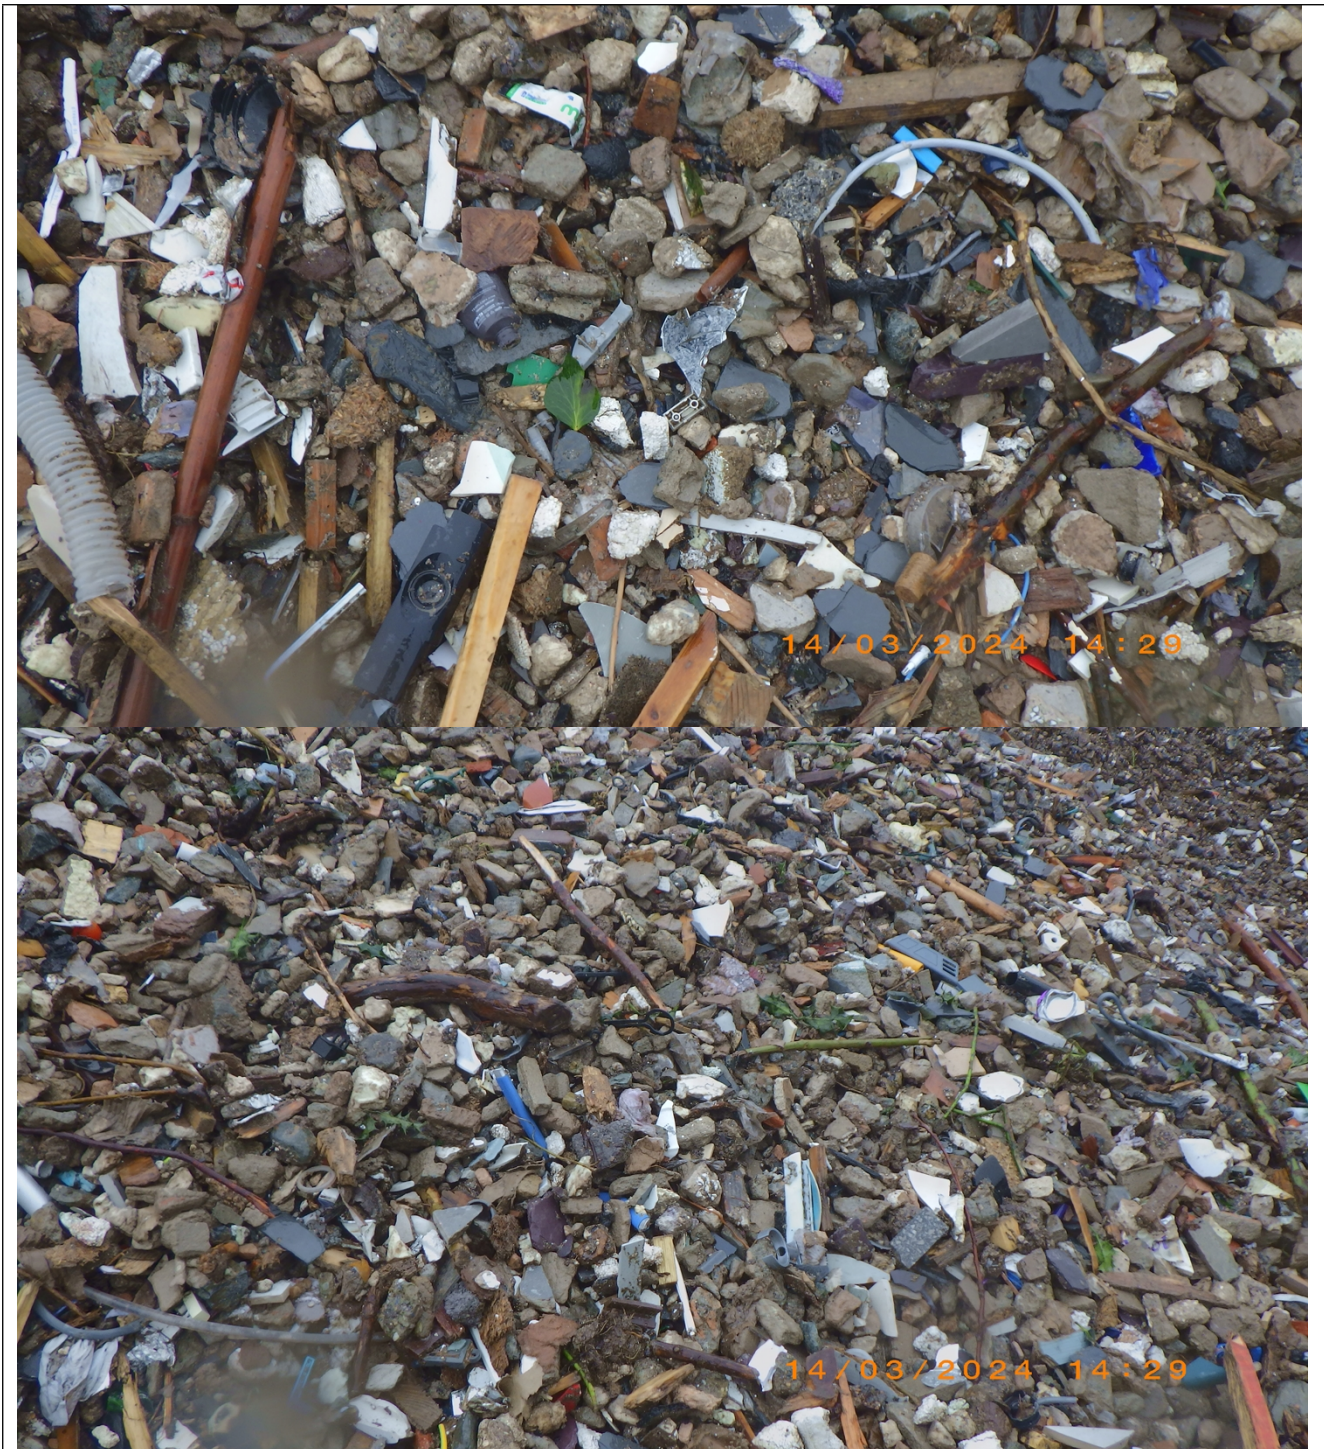
Close up photographs of '10-50ml down' material stored on site.

The above photographs demonstrate how heavily contaminated this material is with plastics, waste electrical equipment, vape liquid container and other small fractioned contaminants. Meurig explained that this material was a product which was being sold as '10-50ml down' and that it was treated in accordance with WRAP Quality Protocol.

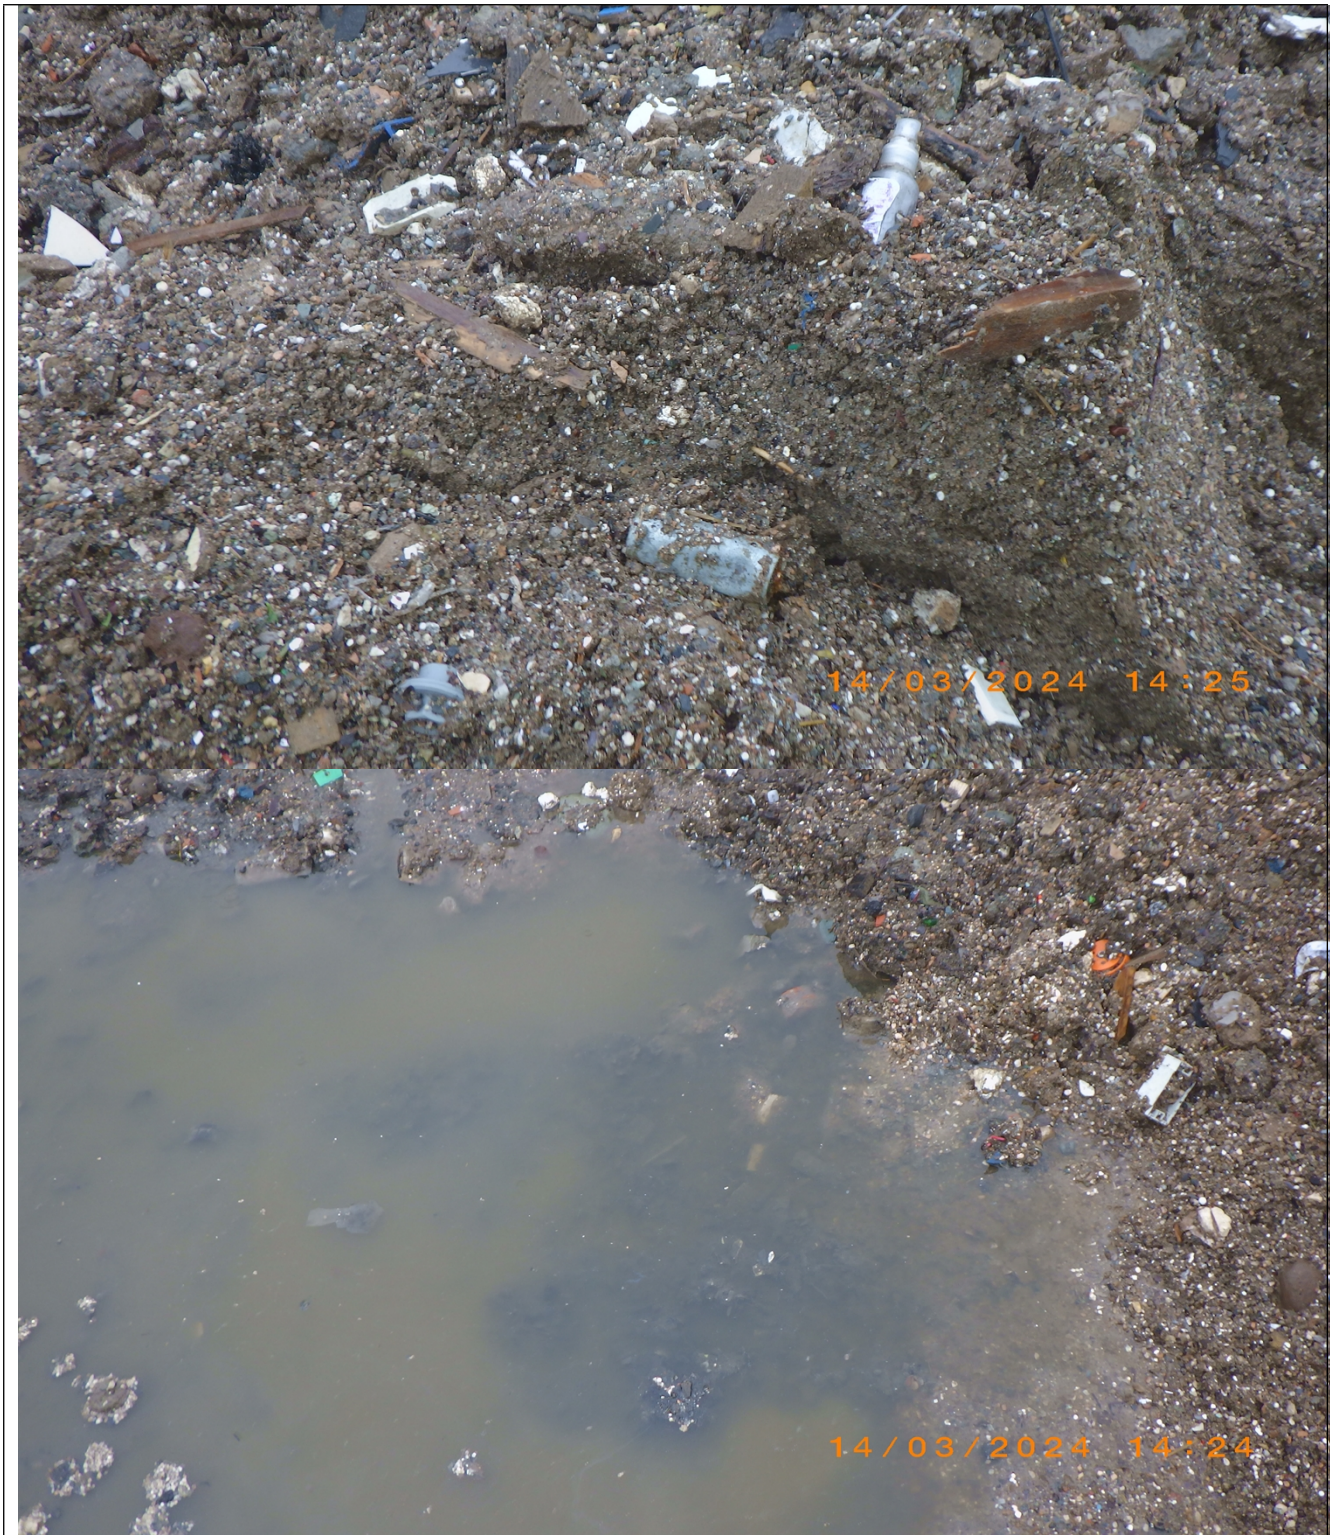
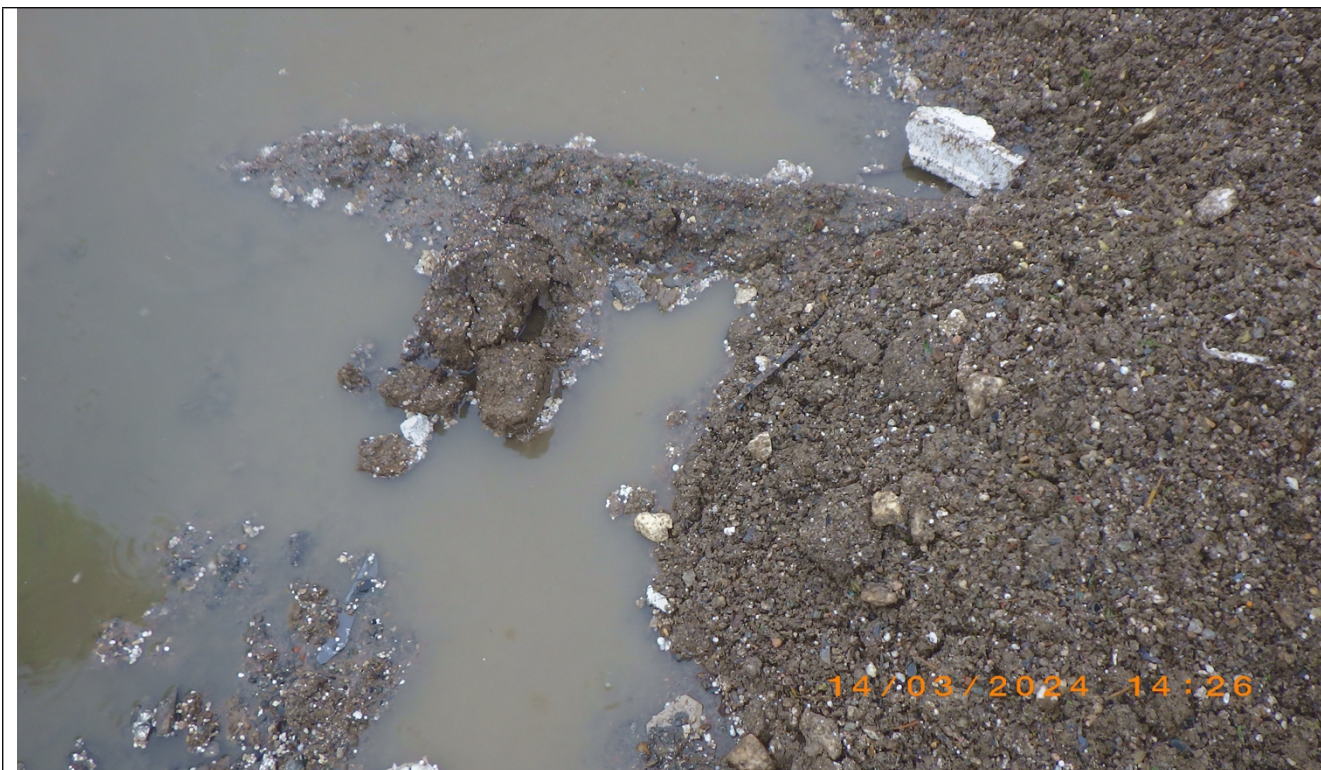
Close up photographs of '10ml down' and stagnant water at bottom of the stockpile

The above photographs show further contamination within the '10 ml down' material. This was also heavily contaminated, although finer in fragments. At the bottom of the stockpile, was a foul smelling area of stagnant water which was littered with polystyrene pieces. The waste was spongy to the touch. Given that this is supposed to be inert waste, it was very concerning that there was such a bad odour coming from this area. The polystyrene and contaminants identified, again reinforce the fact this waste is not appropriate for use as inert waste/product.

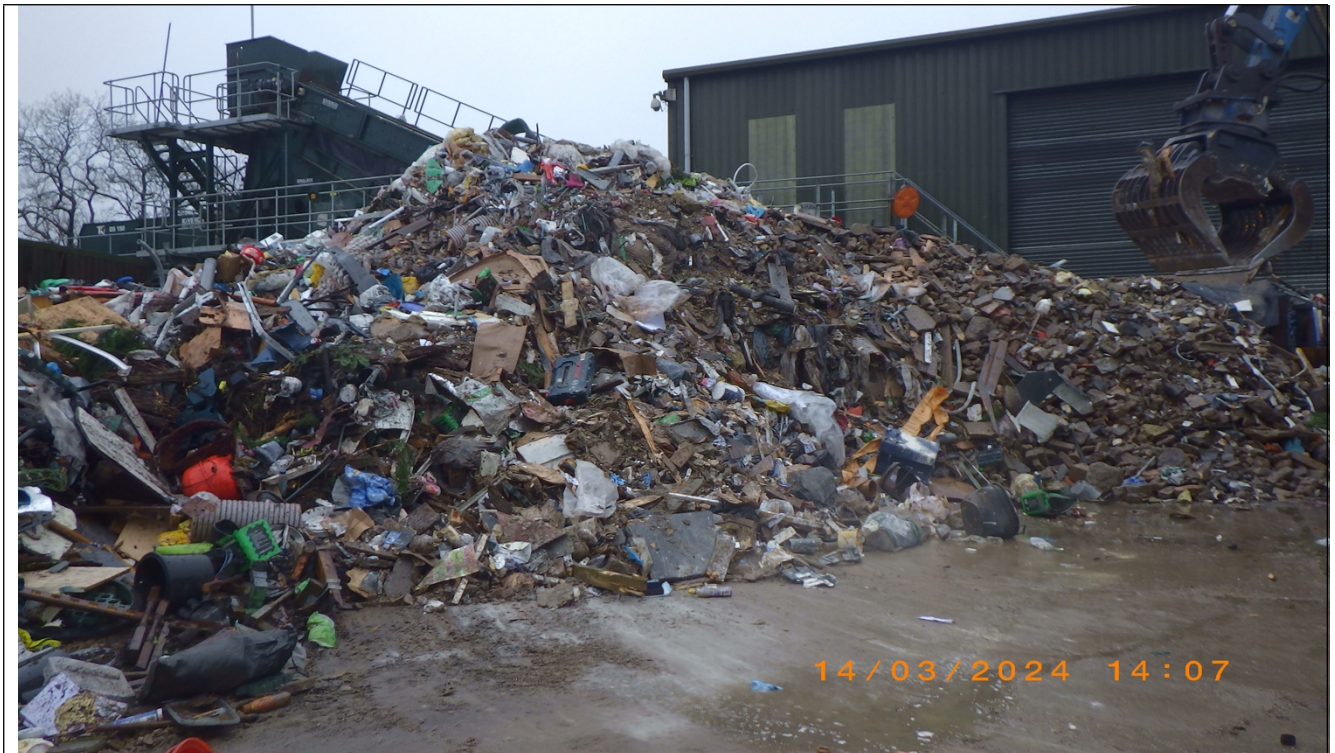
Photograph showing the waste input for the 10ml / 10-50ml down.

It was explained by staff on site that residual skip waste goes through a picking line and screener to generate the 10ml / 10-50ml down. The input of this material is residual skip waste. This is not a valid waste input of WRAP's Quality Protocol. Waste streams should be inert and uncontaminated. Meurig explained the machinery was faulty and that the wet weather was causing difficulties with the treatment of the waste.

Officers have serious concerns about the inputs of this waste stream and that is it being treated as an inert product.

Observations on site provide evidence that the site is not operating in line with WRAP's Quality Protocol.

The input of residual skip waste to the inert waste treatment area should cease immediately. The only inert waste codes that can be treated to make a WRAP compliant product, are detailed in Appendix C of WRAP's 'Aggregates from inert waste' document.

ACTION: The site Environmental Management System requires review and should include procedures for how the site complies with WRAP Quality Protocol. This should include details of the site's Factory Production Control and testing regime. Once reviewed, please ensure a copy of the reviewed EMS is submitted to NRW.

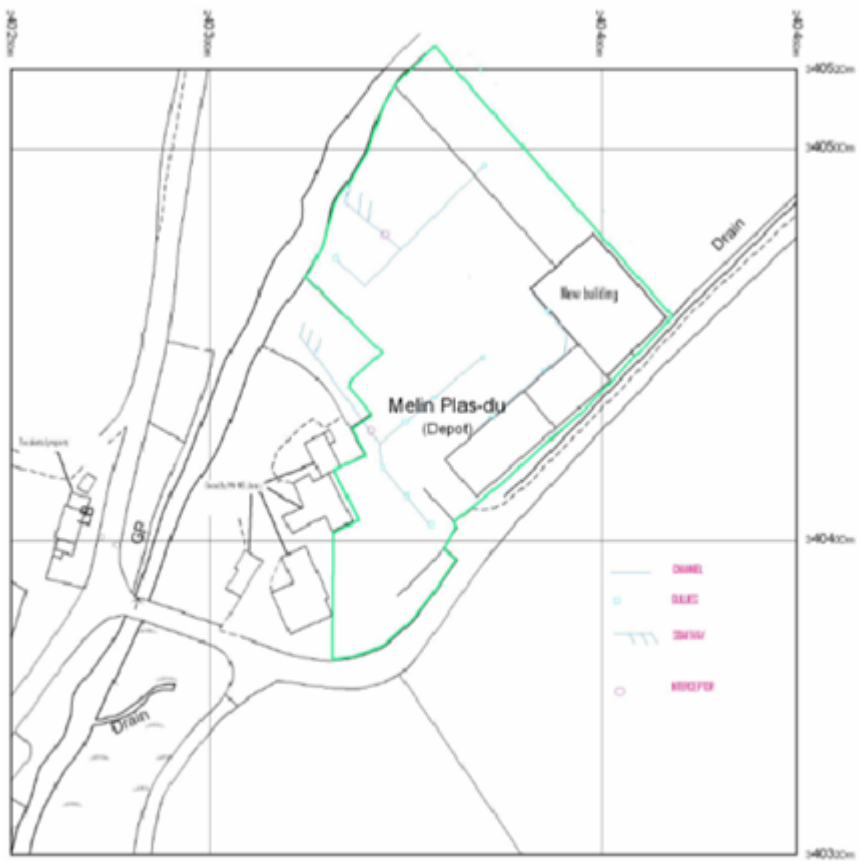
Schedule 7 - Site plan

Site Plan of Environmental Permit VP3494FK

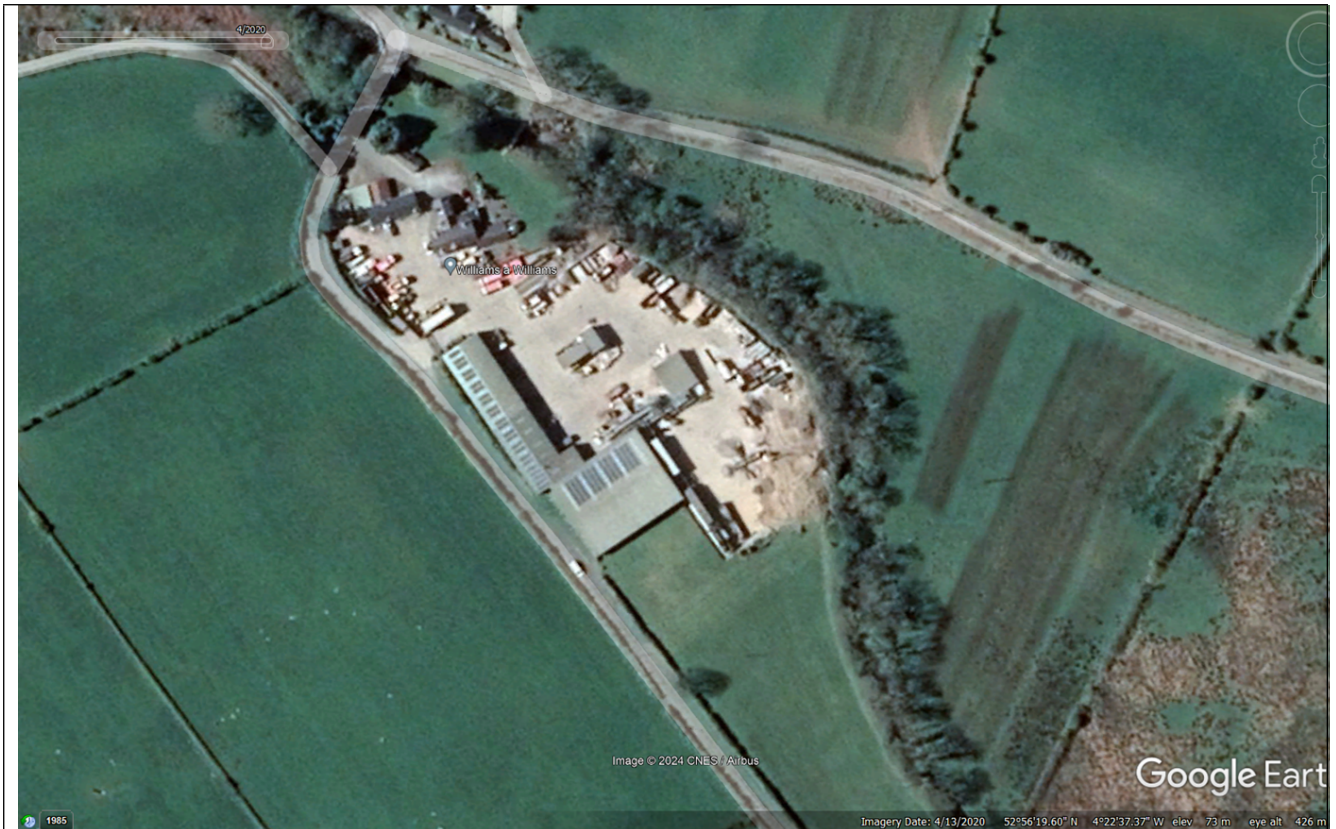
Towards the rear of the site (adjacent to the picking line). It appears the site has extended beyond the site permit boundary.
 Checks of satellite imagery has confirmed this. Please see image below.

Satellite Image taken from Google Earth

The site boundary should be in line with Schedule 7. As can be seen from satellite imagery, the permit activities have moved beyond that area.

Therefore, the permit has been scored a CCS3 for this permit breach.

This area of land has not been accounted for within a permit application and therefore the risks of operating here have not been assessed. This land is also not accounted for in the site's Environmental Management System. It appeared to officers that the ground was un-made here and so waste was not being stored on impermeable ground.

ACTION: All waste should be removed that is currently being stored outside of the permitted area (See schedule 7- site plan for confirmation of boundary). At the time of inspection, we believe this to be skips containing broken glass and some mixed waste storage piles. This also may include some of the picking line and waste piles beneath.

Should you wish to extend the permit boundary, then a permit variation would need to be applied for. See the following link: <https://naturalresources.wales/permits-and-permissions/waste-permitting/apply-to-change-to-or-vary-a-bespoke-waste-permit/?land=en>

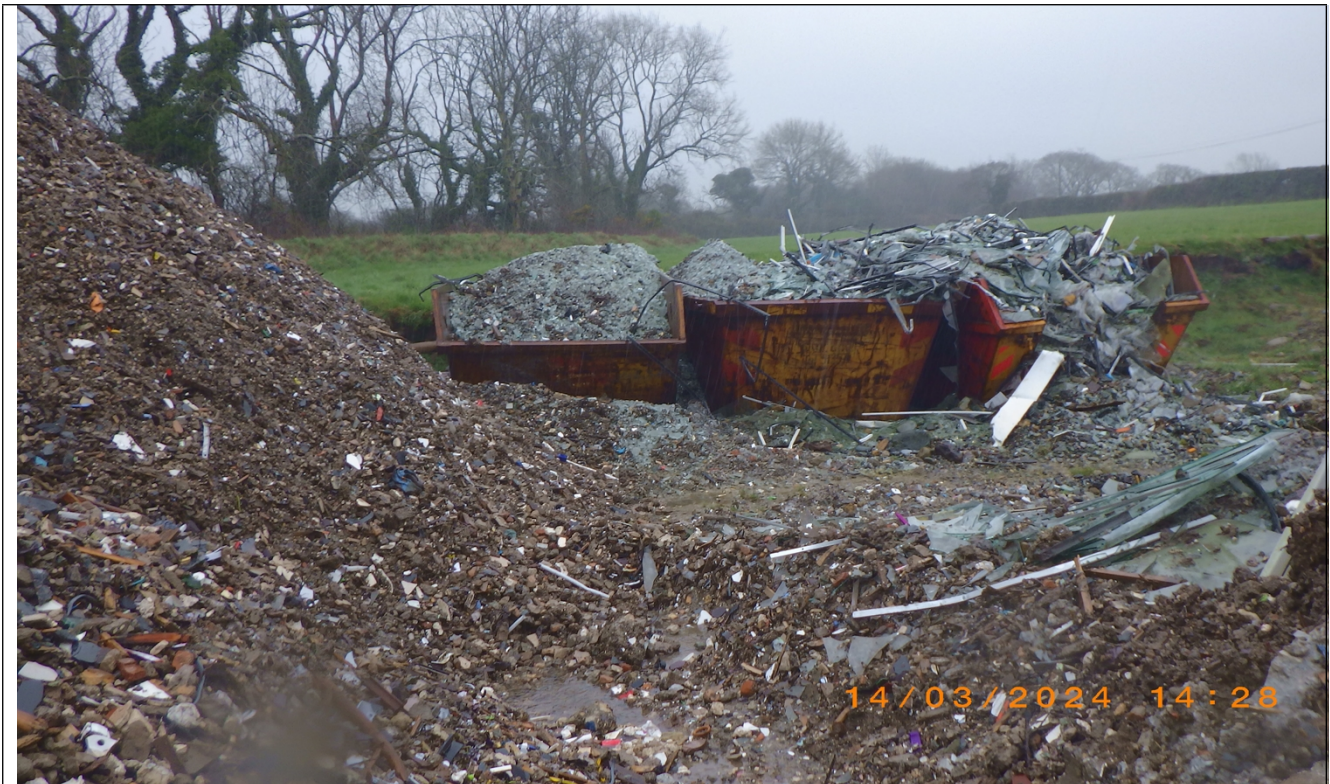
Photograph showing waste storage on site, extending beyond permit boundary.
