Compliance Assessment Report CAR_NRW0043804

Permit being assessed: BN0018001

For: Cwrt Henri Wastewater Treatment Works, held by DWR CYMRU CYFYNGEDIG
At: Track past 'Ael Y Bryn', Cwrt Henri, Carmarthenshire, SA32 8SA.

Type of assessment carried out: Site Inspection, Reason: Routine.

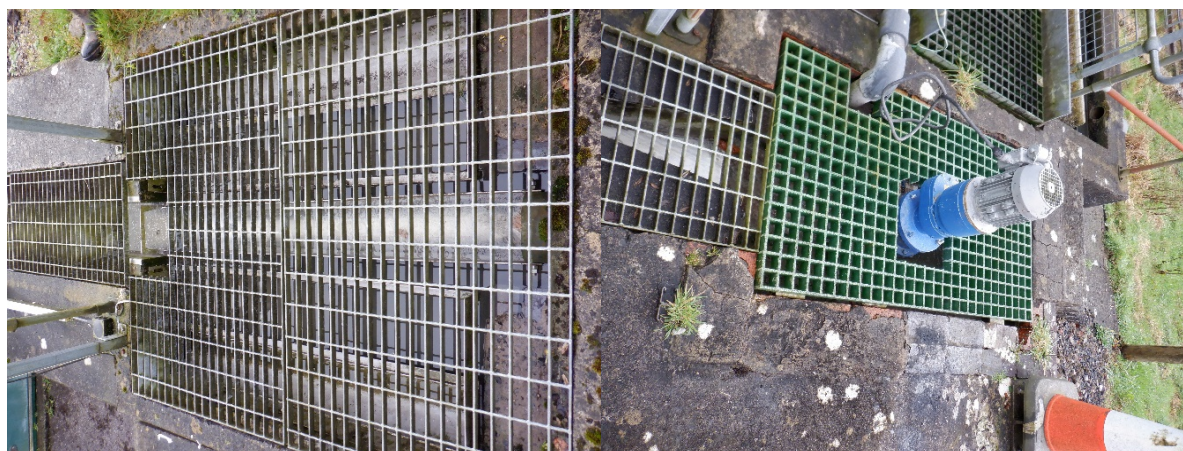
Sewage effluent enters the works at the inlet. Effluent then goes through a macerator which converts organic and gross solids into a slurry. Condition 2.3.1 (b) states that a macerator should not be used on site for the storm discharge. A screen should be installed instead (table S3.3).

Figure 1: The image on the left shows the inlet to the works. The image on the right shows the macerator.

Criteria	Action needed	Complete by
IR2C	Install screen on storm overflow instead of using macerator.	31/05/2024

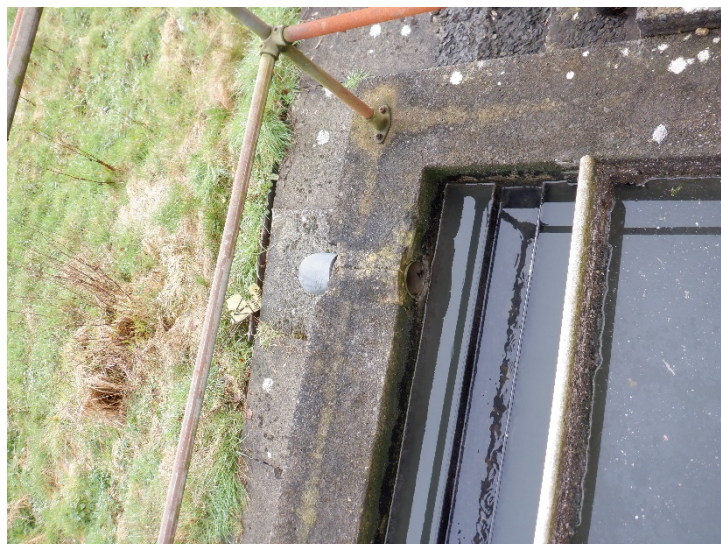
There is an overflow pipe on the PST which is connected to a disused filter bed.

Figure 2: An image of an overflow pipe situated in the PST.

- Block pipe which connects PST to disused filter bed.
- Manage the vegetation and pooling on the surface of the percolating filter bed
- Monitor and maintain percolating filter fed brickwork.

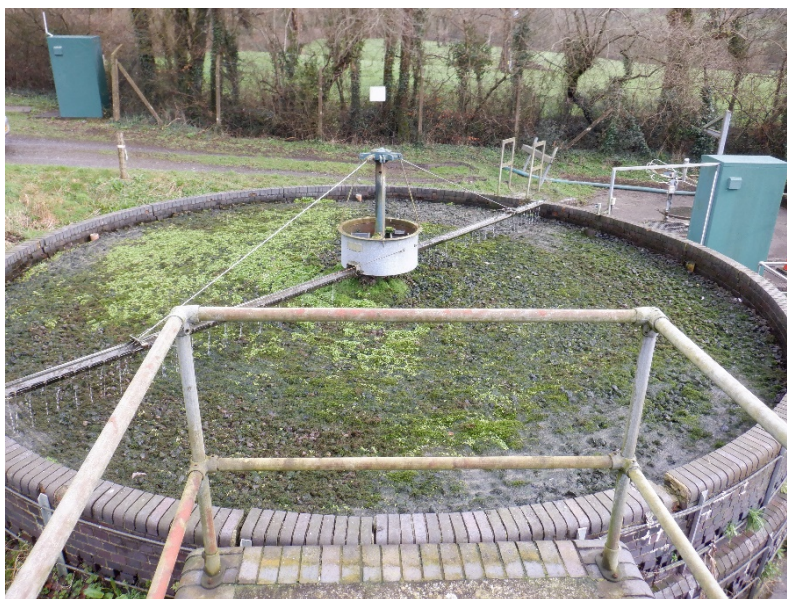
Effluent moves from the PST into a percolating filter bed for secondary treatment. The filter arms were in good working order. There was extensive vegetation growth and pooling upon the biofilter media, which may impede the system's efficacy.

Figure 3: An image of the percolating filter bed.

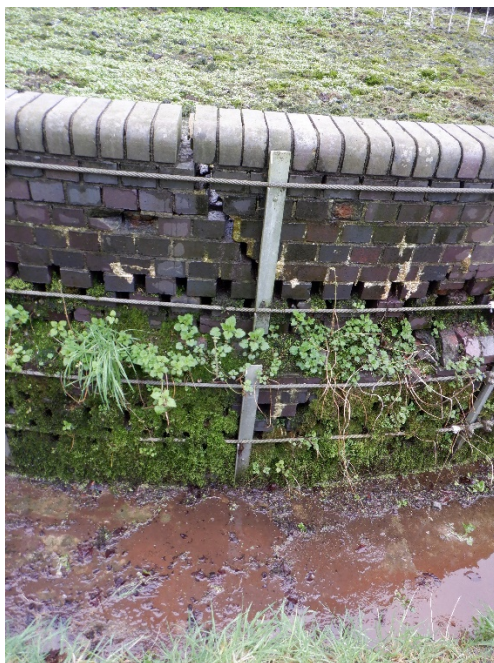
The brickwork on the percolating filter bed has cracks in it. There were no observable leaks at the time of the visit but the cracks could lead to effluent leaking out of the system in the future.

Figure 4: An image showing a crack in the brickwork of the percolating filter bed.

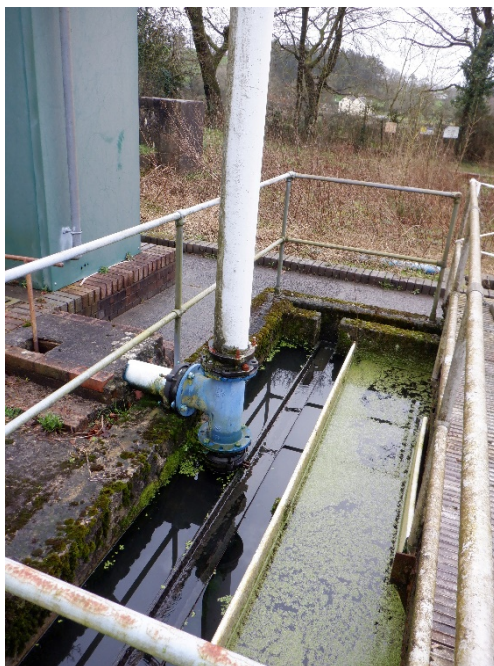
Effluent enters a humus tank/final settlement tank following secondary treatment. The Final Effluent then passes through the sampling point and is then discharged to the Afon Dulas.

Figure 5: An image of a humus tank/final settlement tank.

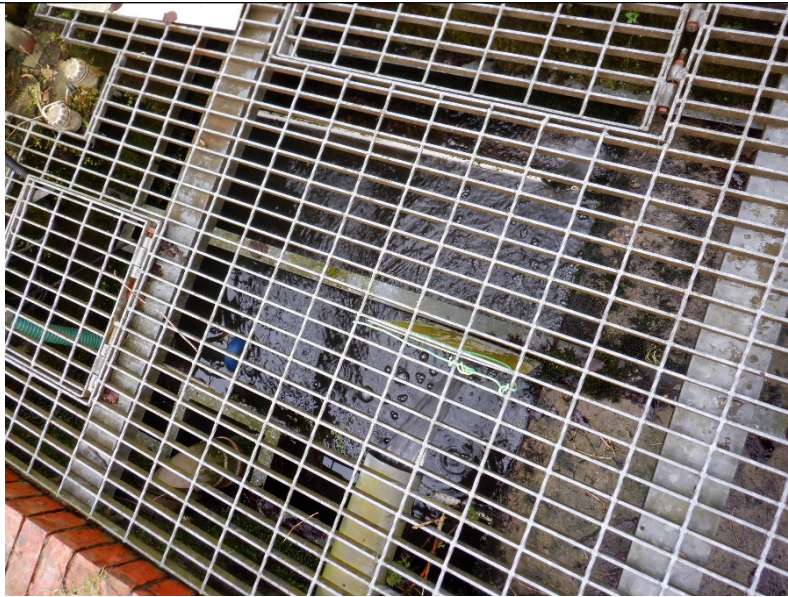
Figure 6: An image of the final effluent sampling point.
