Compliance Assessment Report CAR_NRW0044023

Permit being assessed: AW1004001

For: Llanyre Wastewater Treatment Works, held by DWR CYMRU CYFYNGEDIG

Type of assessment carried out: Site Inspection, Reason: Routine.

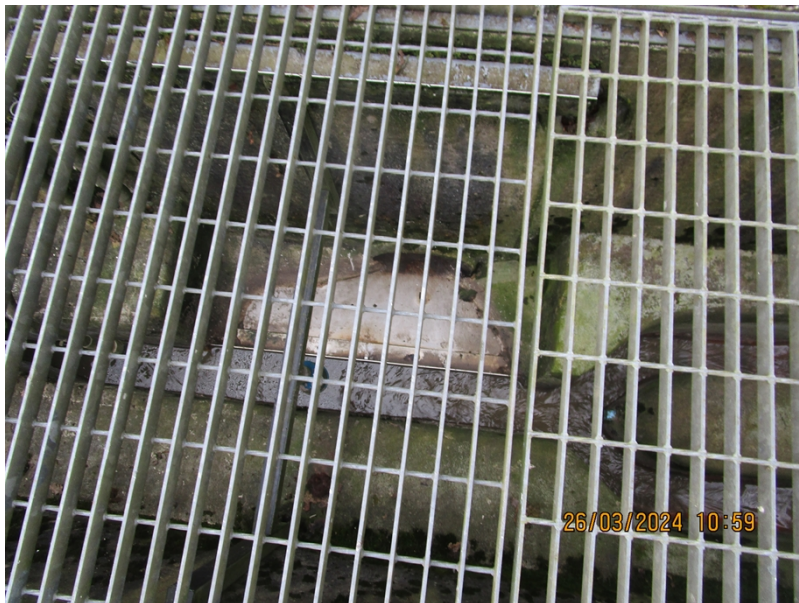
The incoming flow comes into the works via gravity, and the treatment process is gravity powered. At the inlet there are two macerators, only one of which is running at any time. The macerator in use was clearly operating as expected. There were no solids or rag present within the inlet following the macerator.

The storm weir on site is a hard-set storm weir, where flows can only spill over into the storm channel once the inlet level reaches the specified level. There is a level sensor in operation within the inlet channel at the storm weir, which appears to be being used to record when the works is running to storm.

The flows were well below the storm weir setting in place and there were no flows entering the storm channel. The storm channel appeared clear of debris or blockages. There is no additional screening, as all flows pass through the macerator before the storm weir.

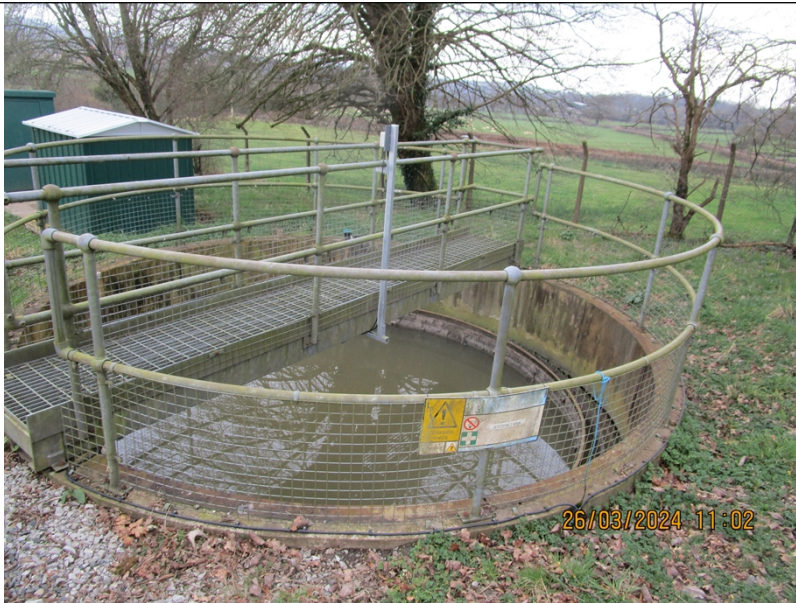
There is a single storm tank, which was contained water at the time of inspection. The storm sewerage will be returned to the head of the works manually when the incoming flow is low enough. There is a monitor in place within the outfall channel to record when the storm tank is discharging to the storm discharge point (to environment). There was no indication that any flow was leaving the works via the storm at the time of inspection as the level within the tank was below the overflow level.

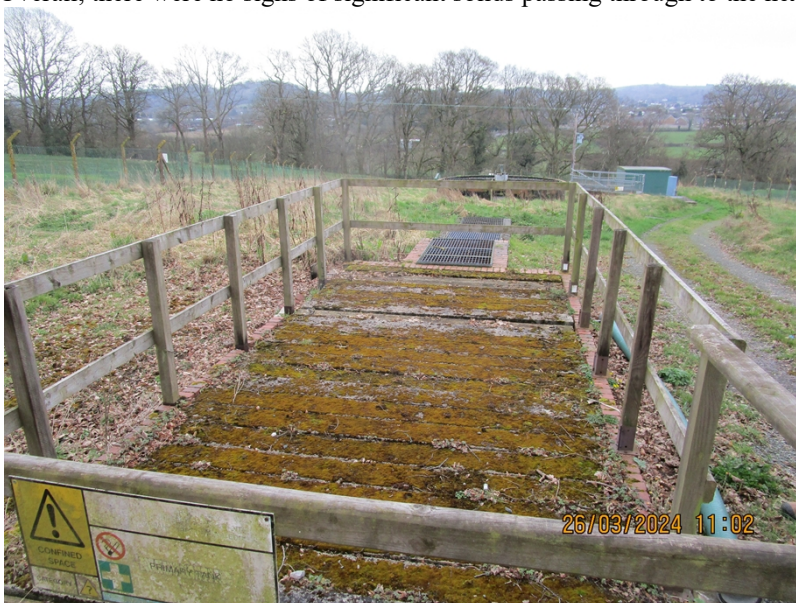
The primary settlement tank at the works is an undercover square shaped tank, with a lower outlet height for retaining solids, similar in design to a septic tank. Overall, the settlement system appeared to be operating effectively. There were no signs of significant solids in the outfall chamber from the primary settlement tank.

The outfall from the primary settlement tank flows down to the filter bed via three open brick chambers, on asking the purpose of these chambers, DCWW staff were not entirely sure as it was older infrastructure. It appears that by design they may potentially aid the treatment process, by reducing solids as they potentially will slow the effluent down. Overall, there were no signs of significant solids passing through to the next stage of the treatment process.

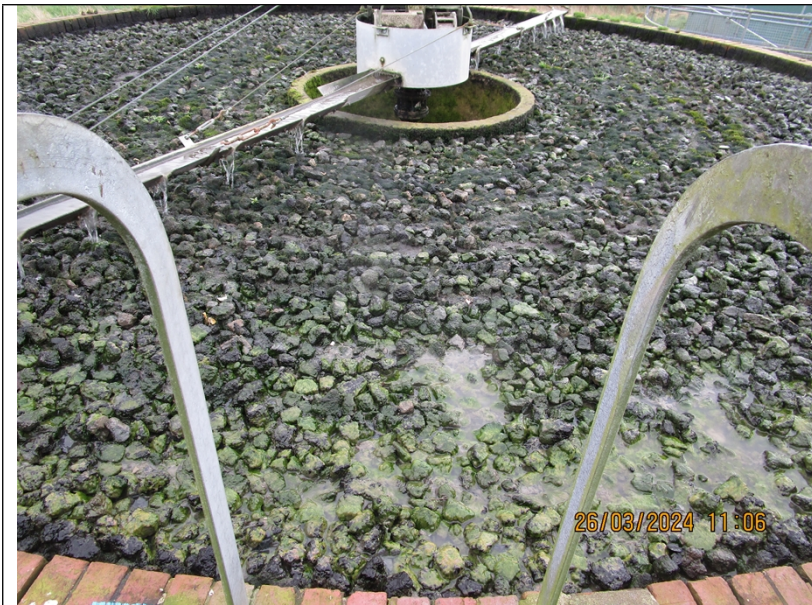
The works contains a single filter bed of stone media. The rotation arm was moving free and unhindered. The rotating arm appeared to be distributing effectively over the filter media.

There were signs of ponding on the filter bed surface in several places. At the time of inspection this did not appear to be preventing the effluent entering the filter media. This should be monitored as ponding cause problems within the treatment process and may lead to improperly treated effluent as a result.

The outfall from the filter bed appeared to be flowing clear and there were no signs of sewage fungus growth or solids passing over to final settlement.

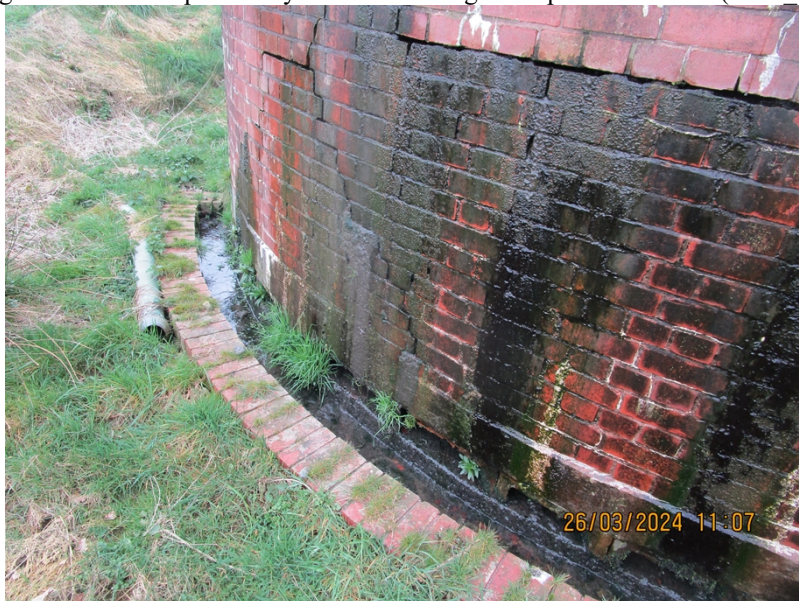
The brickwork around the filter bed is visibly in poor condition, in several areas appeared cracked and leaking. It appeared that currently, any leakage from the walls of the filter is entering the outfall channel and is not leaking to the ground. This has previously raised following an inspection in 2021 (CAR NRW0039060).

1. The filter bed clearly requires some maintenance. There are several areas where there are signs of leakage through missing cement/grout. If left without repair there is a risk that the tank could fail, causing a pollution to ground. As the leakage seen was contained within the process channel, I have on this occasion not classified this as a breach of permit, however if the situation deteriorates it will likely lead to noncompliances.
2. Either relocate the sampling chamber to before the storm discharge joins the outfall channel. Or alternatively, reroute the storm discharge to join the outfall channel after the sampling point. The currently location of the new sampling chamber may result in storm discharges being mixed in with the effluent sample.

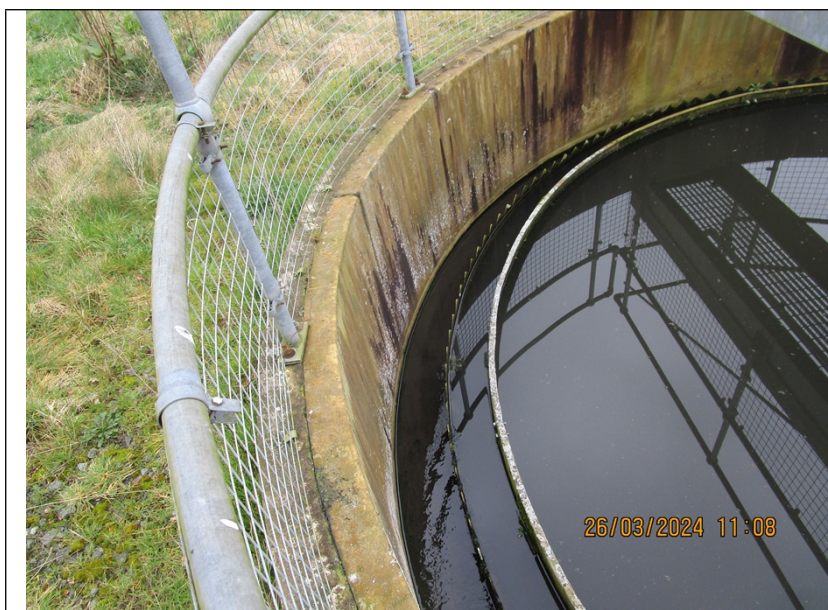
The humus tank on site is a single circular tank with retention boards to hold back solids. This appeared to be operating effectively and there were no signs of solids or sewage fungus within in the outfall channels.

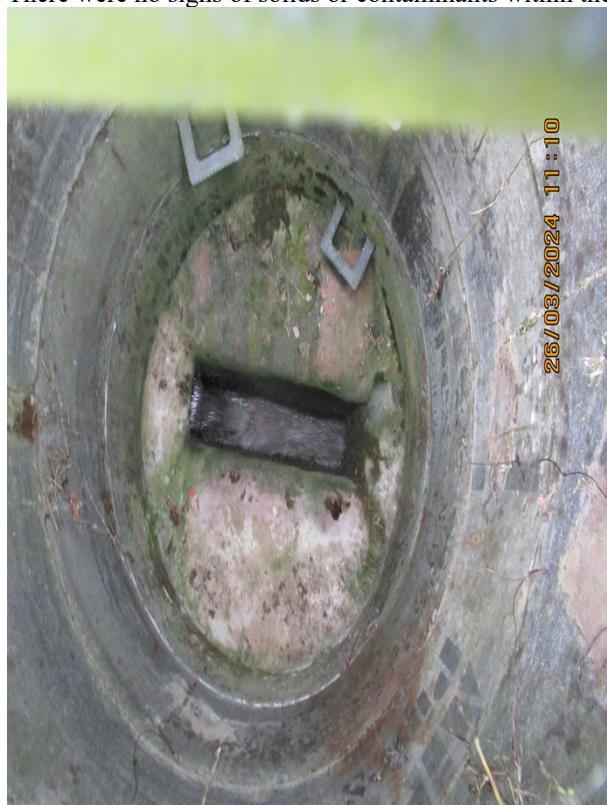
There is a new sample point which has been installed at the works, following from the variation of permit bringing in a set sampling requirement. The sample point was labelled with a temporary sign, which was clearly visible and appeared suitable until a permanent sign is installed. The outfall/sampling chamber appeared clear and effluent was flowing freely. There were no signs of solids or contaminants within the effluent.

At the time of inspection, it became apparent that the new sample point has been installed in a chamber after the storm discharge joins with the process effluent. The storm discharge at this works is made from the same outfall location and enters the outfall channel via a pipe in a chamber before the sampling chamber. At the time of inspection, the storm outfall pipe was not discharging into the outfall channel.

Currently if a sample was taken when the storm discharge was in operation, this would mean the effluent sampled would have storm effluent mixed in with it. This therefore would have a potential impact on the sample results, by increasing nutrient loading within the sample.

I do not believe this currently represents a noncompliance against the permit requirements. However, it would be advisable to move the sample point location to a point before the storm discharge enters the outfall channel, to ensure an indicative sample can be taken during storm events. This was discussed with DCWW operatives whilst on site, who are aware of the problem and are currently investigating changes which can be made.
