Compliance Assessment Report CAR_NRW0043842

Permit being assessed: BH0058001

For: Tregaron SPS (CSO and EO, held by DWR CYMRU CYFYNGEDIG

Type of assessment carried out: Report/Data Review, Reason: Incident Response (Incident number: 2309545).

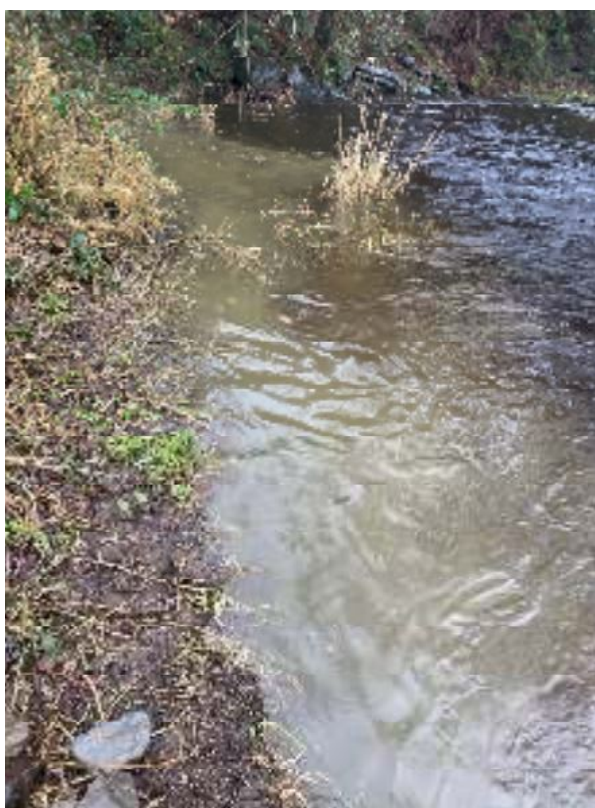
On 11 December 2023, NRW received a report describing white discolouration, sewage fungus and a strong odour at the outfall of Tregaron SPS. Dŵr Cymru Welsh Water (DCWW) were notified of the report and confirmed that the site was passing forward flows of 16l/s or more, therefore meeting the conditions required for a storm discharge under permit BH0058001. A DCWW Operator was sent to site and confirmed that the discharge from Tregaron SPS was brown/green in colour, causing discolouration within the Afon Brennig for approximately 15 metres downstream as shown in photograph 1 courtesy of DCWW below. DCWW suspect that the discolouration had been caused by the discharge of discoloured effluent into the sewer network by a third party holding a DCWW trade permit. DCWW have since commented that the third party have been compliant with the terms of this permit.

Photograph 1: Discolouration within the Afon Brennig downstream of Tregaron SPS on 12 December 2023. Photograph courtesy of DCWW.

Criteria	Action needed	Complete by
WQ-C1	Confirm what actions will be taken to (1) prevent further discharges of discoloured effluent entering the Afon Breninig; and (2) to prevent sewage fungus from building up at the outfall.	17/06/2024

As the SPS was pumping forward flows of ~16l/s or more before discharging to storm at the time of the two reported incidents above, the incidents are not currently believed to represent a breach of permit. NRW do however ask DCWW to confirm what actions will be taken to (1) prevent further discharges of discoloured effluent entering the Afon Brennig; and (2) to prevent sewage fungus from building up at the outfall. NRW ask that DCWW do this by no later than the **17 June 2024**. NRW wish to remind DCWW that although an asset may be compliant with its permit, pollution is considered separately to permit compliance and further action may be taken accordingly.

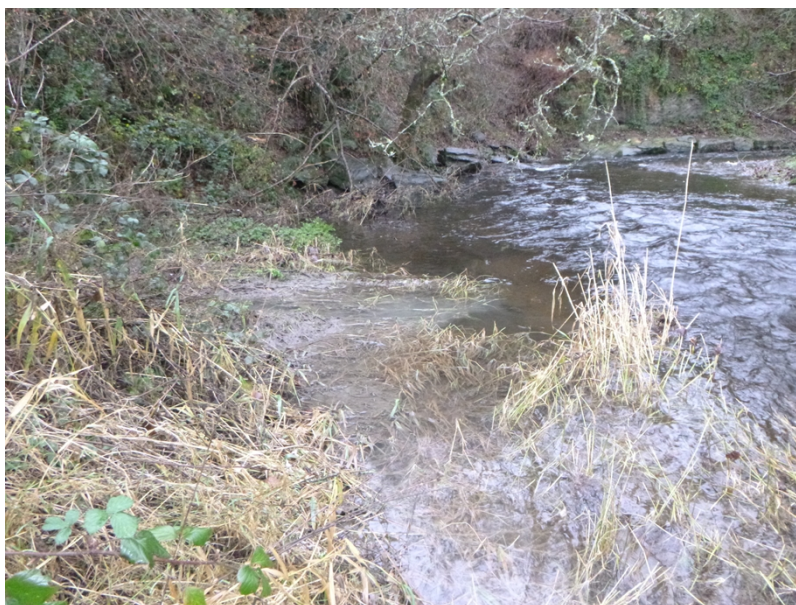
On 14 December 2023, NRW Officers viewed the outfall at Tregaron SPS. The SPS was spilling at the time of the NRW Officers' attendance, with the discharge resulting in a grey discolouration immediately around the outfall. The discolouration diluted quickly once flows entered the main Afon Breninig as shown in photograph 2 below. Sewage fungus was also noted in the vicinity of the outfall as shown in photograph 3 below.

Photograph 2: Discharge into Afon Breninig from Tregaron SPS on 14 December 2023

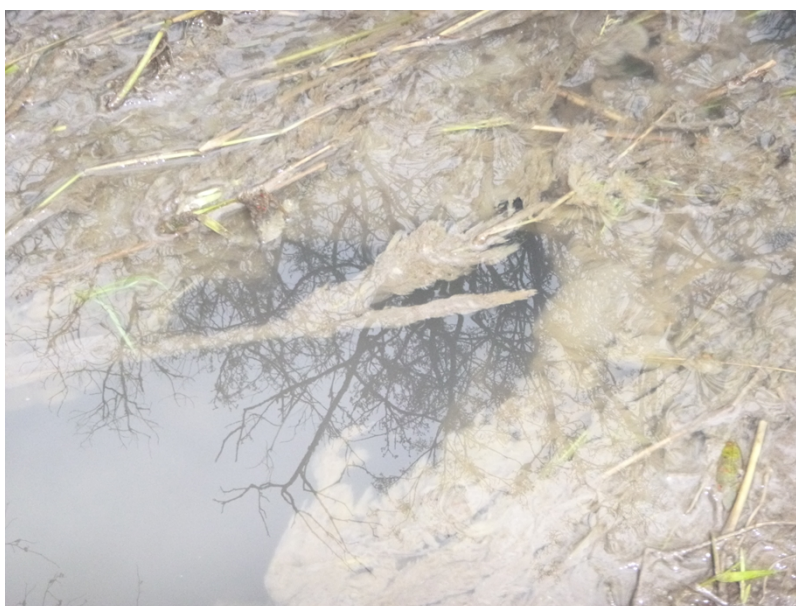
Photograph 3: Sewage fungus near Tregaron SPS outfall on 14 December 2023

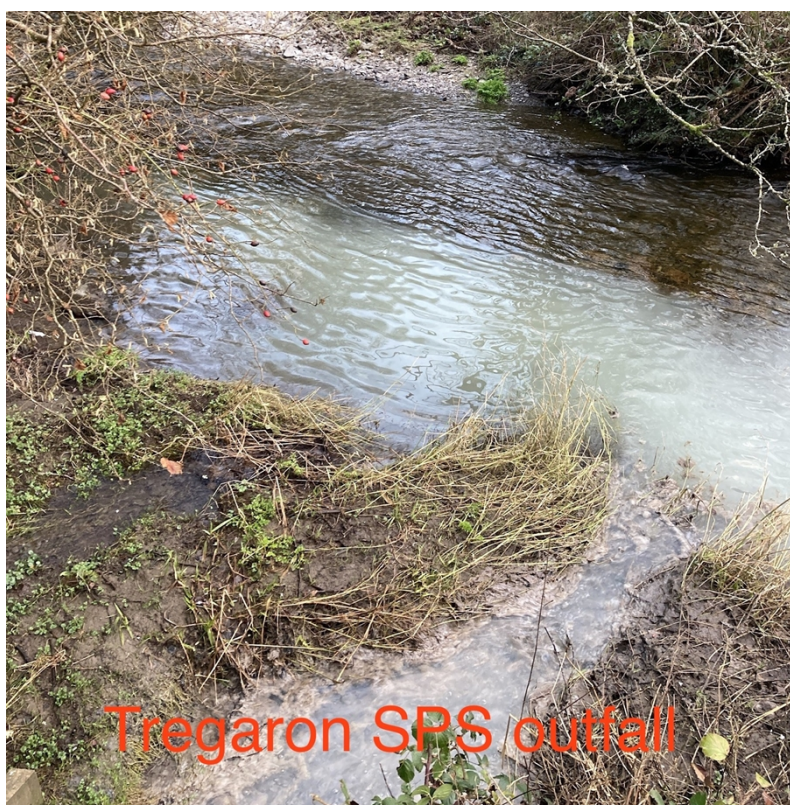
On 08 January 2024, NRW received a report describing a brown coloured plume hugging

the left-hand bank of the Afon Breninig for 30-40 metres downstream of Tregaron SPS. Notification was immediately sent to DCWW who stated that they were sending a crew to site to investigate. DCWW later confirmed that the SPS was found to be working as designed, passing forward flows of 15.9l/s. With the storm pumps in operation, a plume had been visible in the Afon Breninig for 10-15 metres downstream as shown in photograph 4 supplied by DCWW below. As with the incident reported on the 11 December 2023, DCWW suspect that this discolouration had been caused by the discharge of discoloured effluent into the sewer network by the same third party holding a DCWW trade permit.

*Photograph 4: Grey plume in Afon Breninig at Tregaron SPS outfall on 08 January 2024.
Photograph courtesy of DCWW.*

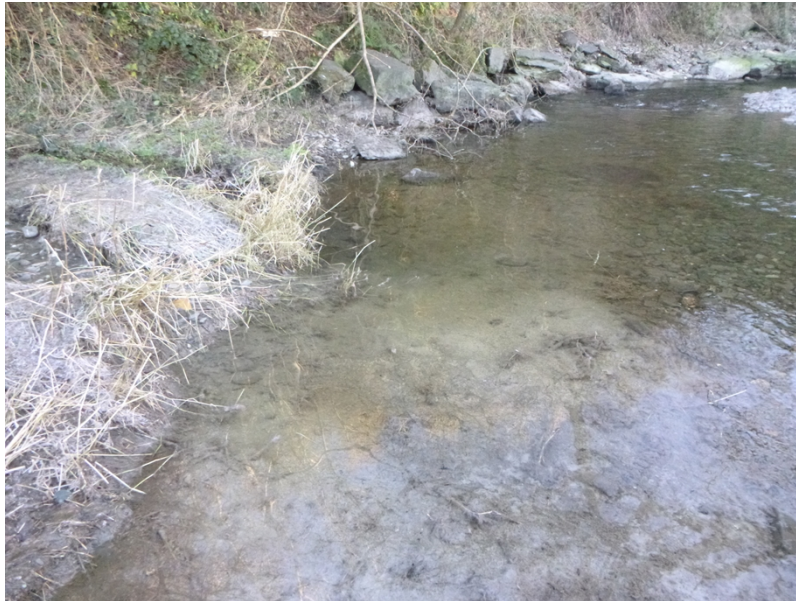
On 18 January 2024, NRW Officers revisited the outfall at Tregaron SPS. Only a trickle of effluent was seen discharging from the SPS at the time of the NRW Officers' attendance. As

shown in photograph 5 below, the riverbed appeared light grey in colour surrounding the outfall in contrast to the darker, coarser riverbed observed elsewhere. Sewage fungus may also have been present near the outfall.

Photograph 5: Afon Brennig near Tregaron SPS outfall on 18 January 2024
