Compliance Assessment Report CAR_NRW0044056

Permit being assessed: BU8002IT.

For: Cross Hands, **held by:** Dunbia UK

Type of assessment: Site Inspection,

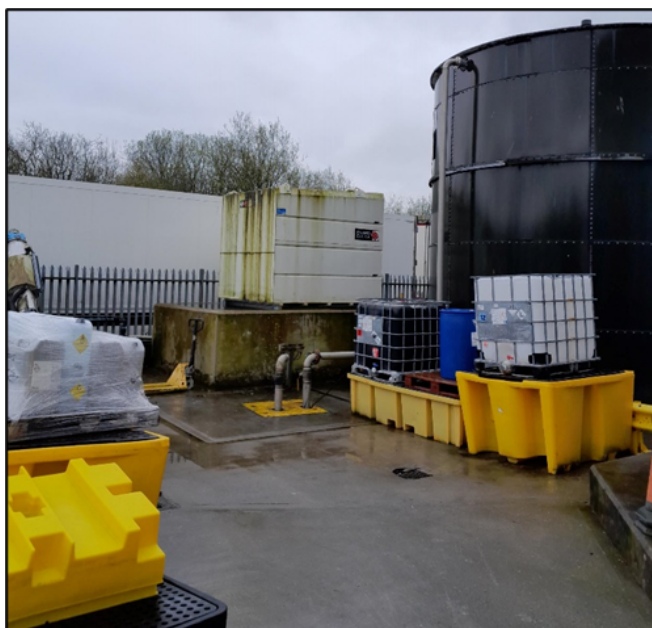
Officers inspected the site's treatment plant area located outside. This area is afforded with suitable impermeable surface which is fenced-off from the neighbouring work areas. It consists of an initial effluent reception where solids are separated, balance tanks, and a DAF unit. Chemicals are not automatically dosed to the system. The DAF is housed inside a unit with a sampling station under cover. There were no issues apparent at the time of inspection.

Image 1 – showing part of the effluent treatment plant with chemicals on secondary containment bunds

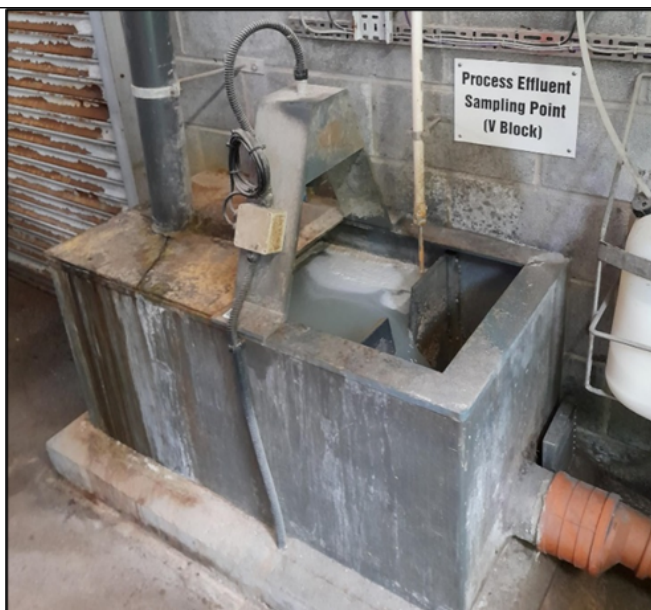
Image 2 – DAF showing effluent discharge housed within a unit

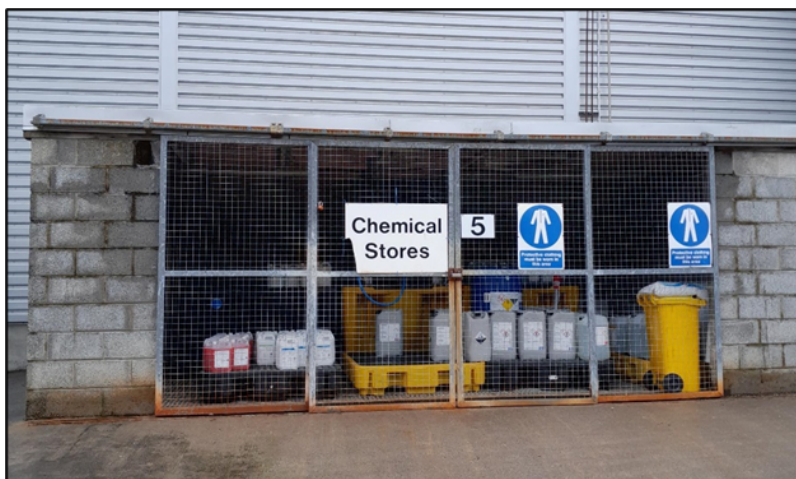
There is a chemical store on site housed in concrete block structure with a lockable metal fencing gate. All chemicals within the unit were provided with suitable secondary containment bunding for the various vessels with spill kits located nearby.

Image 3 - showing the chemical storage area
