Compliance Assessment Report CAR_NRW0043692

Permit being assessed: CB3593HF.

At: Unit 103, Zone 1, Deeside Industrial Park, Flintshire, CH5 2LR.

Type of assessment: Site Inspection,

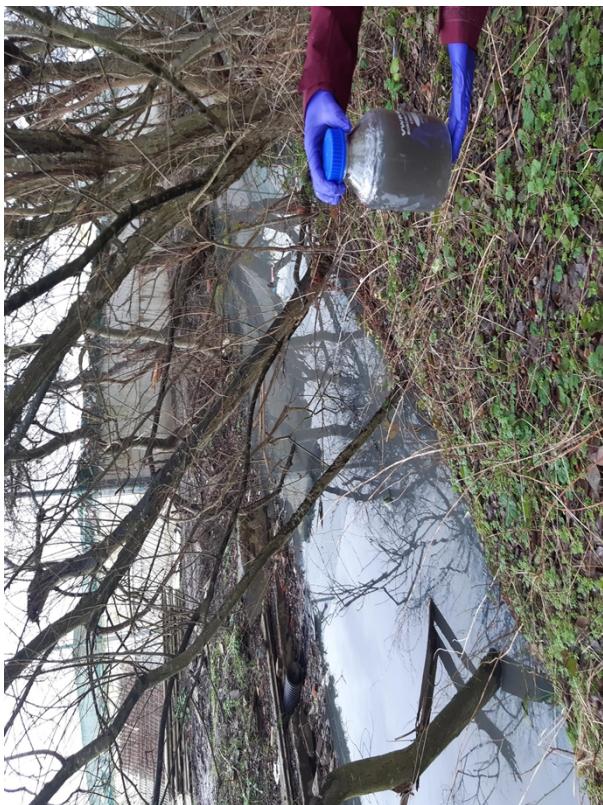
Prior to arriving onsite at Parry and Evans, Officers attended the ditch to the rear of the site where the pollution had been reported. The ditch was seen to be heavily discoloured. A pipe was seen to be discharging a grey/black liquid. A sample was taken of this discharge.

Photograph of sample taken of the discharge from site interceptor into ditch to the rear. A clear line of more heavily discoloured water can be seen from the discharge pipe, along

with black staining directly under the pipe itself. It was later confirmed that this interceptor serves the Parry and Evans site. (due to format settings, photo is showing sideways).

Criteria	Action needed	Complete by
W3B	Ensure discharge from site is compliant with conditions in Table S1.1. Submit to NRW a written improvement plan to bring the site back into compliance, including timescales.	24/05/2024
W1A	Ensure site is fully secure to prevent unauthorised access.	17/05/2024

A Category 2 non-compliance score has therefore been given as a result of this permit breach. An action has been given to provide a written improvement plan to bring the site back into compliance. **A site warning has also been issued.**

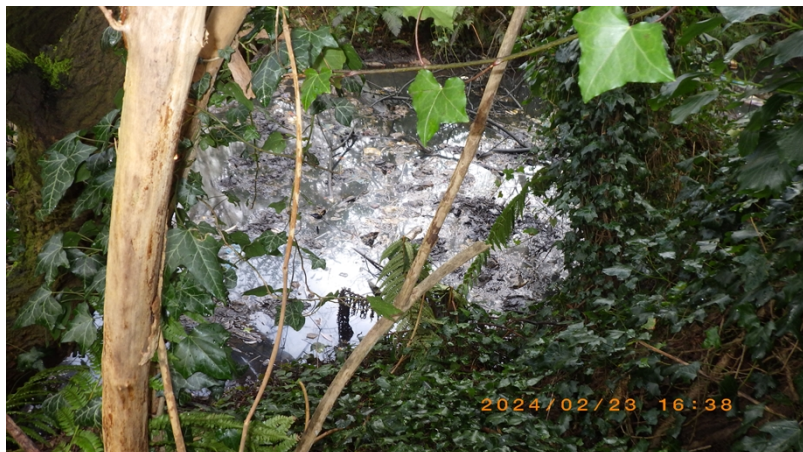
Another pipe was also seen to be discharging to the rear of the site, there appeared to be a thick black oily looking substance on the surface of the water in the vicinity of this discharge pipe. Access prevented a sample being taken at this time. It was noted that the ditch at this point was full of litter to the rear of the site also. This is the discharge location shown on the drainage plans submitted under the most recent permit variation for the site.

Photograph taken of oily looking substance on water near to pipe 2.

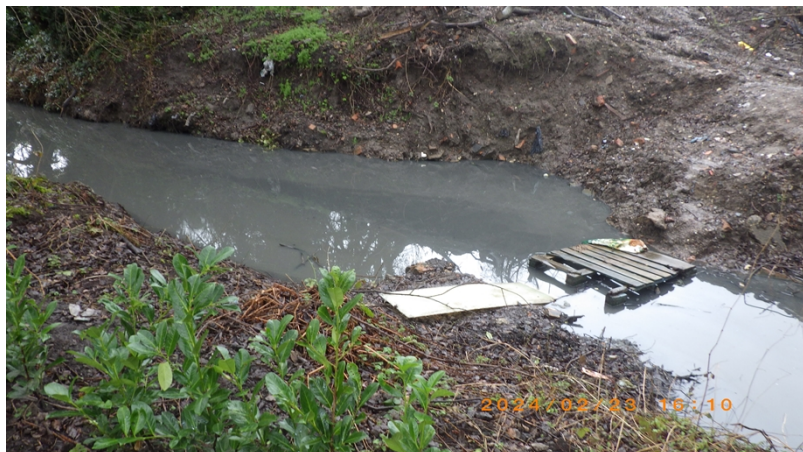
Officers followed the ditch to the west of the site, although there was only a very slight flow to the water, the direction of this was seen to be towards the west of the Parry and Evans site, where water could be seen flowing underground out of the ditch. A downstream sample was taken.

Photograph showing flow of black water towards the west of the site.

It was also noted that the rear of the site had open access and was not secure. A path across the ditch had been made with pallets, as shown in the photograph above. From this area, the permitted site could be easily accessed as part of the wall has been removed. This poses an arson risk to the site.

Whilst onsite, the site security was also raised and discussion took place about previous break-ins. The site was advised the rear of the site needed to be made secure.
