Compliance Assessment Report CAR_NRW0042767

Permit being assessed: XB3393HM.

For: Project Red Recycling, **held by:** Project Red Recycling Limited

Type of assessment: Site Inspection,

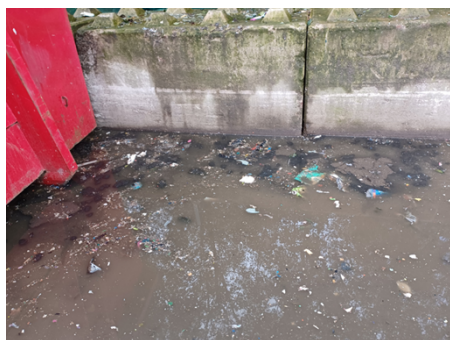
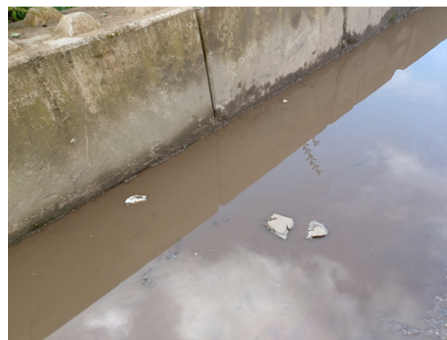
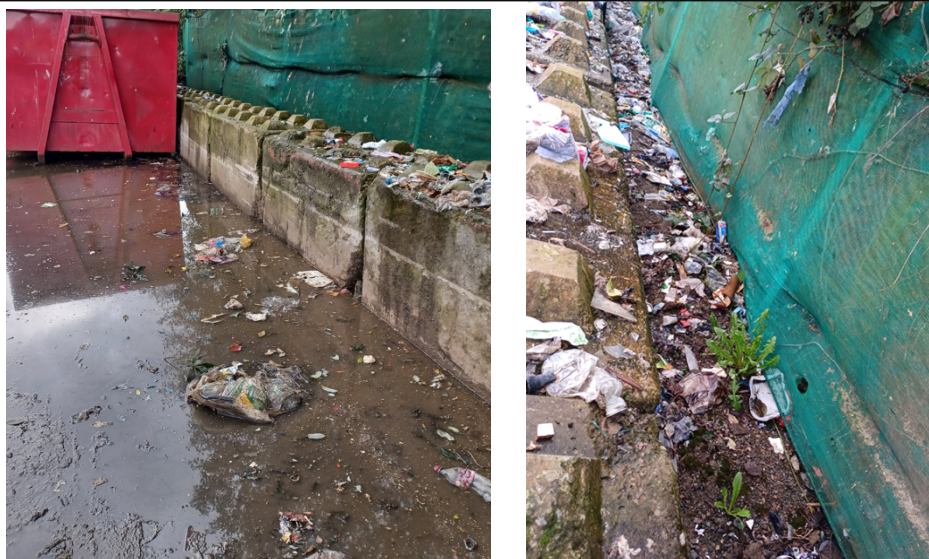
During the visit, officers raised the drainage channels, the sites sump and the concrete blocks which skirt the perimeter of the area of the site which benefits from an impermeable surface with sealed drainage.

The sites TCM explained the concrete blocks were voluntary improvements that were made and are in addition to the existing concrete bund. Whilst we appreciate that this was a voluntary improvement, this was raised, as gaps between the concrete blocks were visible during the inspection (shown below) and a concrete bund behind was not visible, or apparent (shown below), to enable us to inspect the condition of the concrete bund during the inspection. As well as the drainage channels, which were also not visible for inspection, due to pooling water and the position of the Roll On Roll Off (RORO) skips containing wood waste.

From the photographs provided above, it appears the gaps between the blocks have been filled. However, if there are remaining gaps, please ensure the concrete bund behind the concrete blocks remains visible for inspection purposes, so the integrity of site's infrastructure can be assessed, by site operatives during routine maintenance and NRW during inspections.

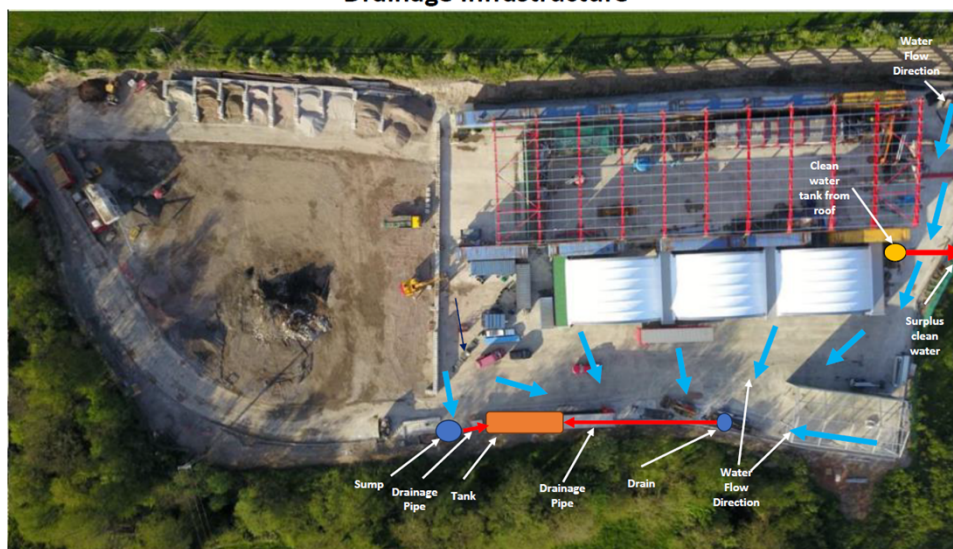
Drainage Infrastructure

The location and logistics of inspecting the site's sump were also discussed, as access appeared challenging due to overgrowth. Below is the drainage infrastructure currently in place. I believe during the visit, the discussion did not entirely address that the tank and sump are separate drainage infrastructures, both requiring regular inspection.

The site's TCM advised that the concrete bund was not visible due to the accumulation of windblown waste behind the concrete blocks. Therefore, evidence demonstrating the condition of the site's concrete bund, drainage gullies and sump were subsequently requested and followed up via email following the visit.

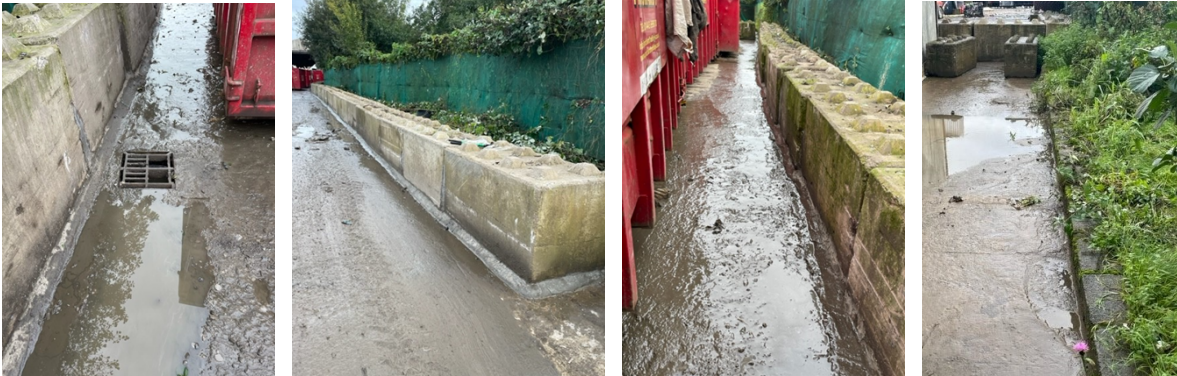
In correspondence following the visit on 25th September 2023, the site's TCM demonstrated the condition of the site's infrastructure listed above, post-site inspection, providing photographs and evidence of a recent inspection performed by OK Environmental. Whilst we appreciate the photographs and evidence provided post-inspection, the site condition is assessed based on the condition observed during the site inspection. This is prevalent, as inspections undertaken by site operatives as routine checks done to assess the condition of the site's infrastructure would also not be possible, as they would also be unable to assess

condition of infrastructure that is not visible.

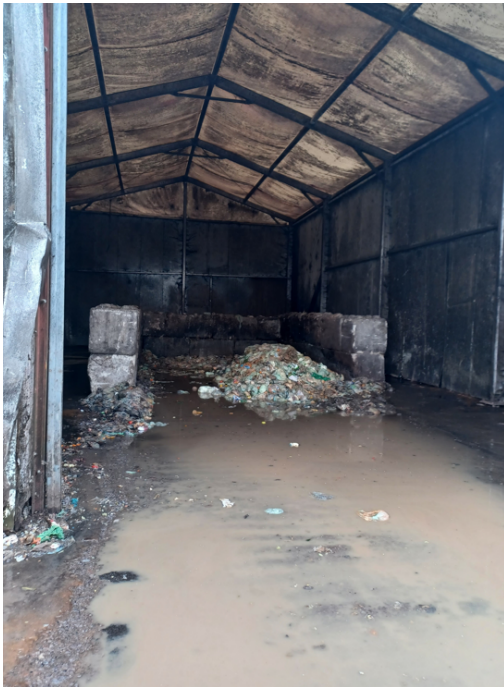
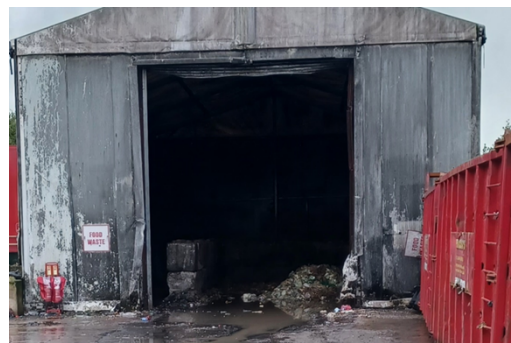
1. The sites EMS titled 'PRR_EMS_Consolidated_February 2021', states: *'Any food waste is also received on the concreted area in separate building with a roller shutter door and sealed skip within'*. I note, during the visit, the food waste was not contained within a sealed skip and the roller shutter door was not in working order.

Please note, the implementation of suitable containment measures here could also mitigate any odour and pest issues. As stated in the sites EMS 'Due to the changes in EWC code following the recent variation, there is an increased risk of pest infestation at the site.'

I also note, the EMS states: *'If any defects are found across the infrastructure of the site, these will be recorded within the site diary and appropriate action (remediation and repair work) will be taken to prevent any potential pollution events occurring. Repair work will aim to be completed within 5 working days of the initial defect report.'*

Action Required: Please ensure the sites operations are managed in line with the sites EMS and provide evidence that the site has ensured compliance by addressing the issues highlighted above, points 1 to 12, and the action detailed under sub-heading 'Sump'. As part of this, please provide a date by which an updated EMS can be provided to NRW for review.

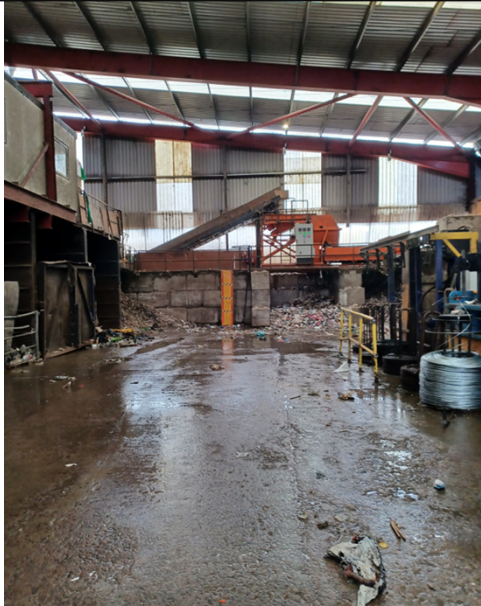
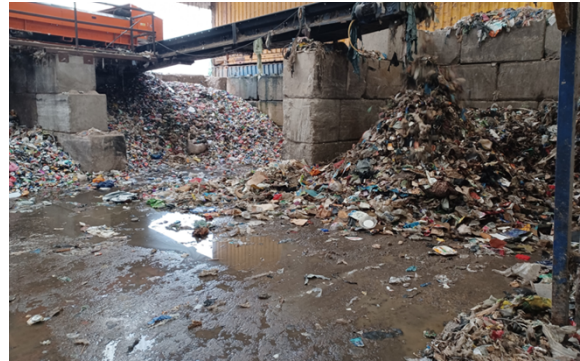
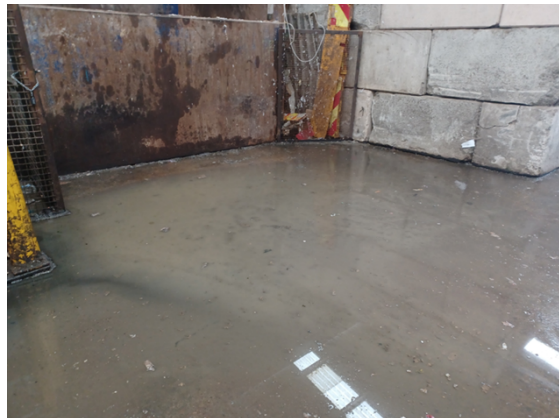
2. In relation to the buildings, the sites EMS states: *'The building'... 'does not allow for any ingress of water.'* During the visit, this did not reflect operations found on site, as water was present within both buildings. Please ensure the buildings meet the above specification, *'The building'... 'does not allow for any ingress of water.'*

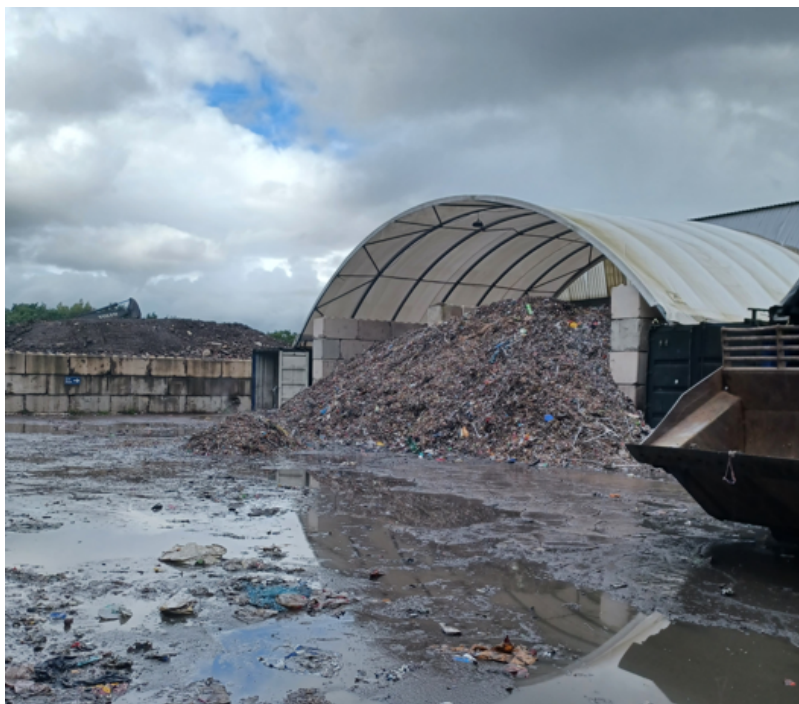
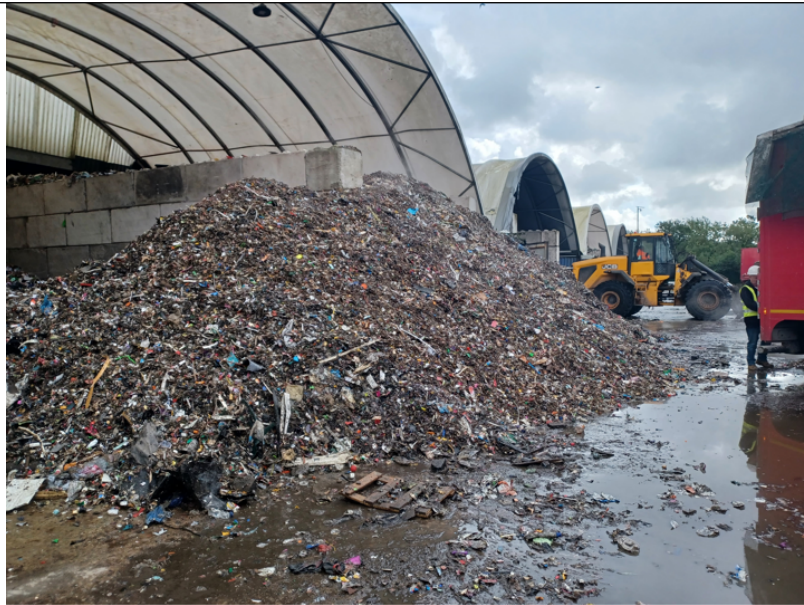
Table S1.1 states under A2- Household, Commercial and Industrial : ‘All activities must take place within a building equipped with suitable containment measures’.

During the visit, officers observed the below storage practices.

Please ensure the necessary improvements to operations are undertaken to ensure that HCI waste is stored, as specified by the permit. Please also note, the sites FPMP states 'The vehicles will deposit the waste directly into the building where it will be bulked up into individual stockpiles.' This information does not correlate with the operations observed on site.

Action Required: Ensure waste is stored in line with Table S1.1, 'within a building equipped with suitable containment measures.' And is as described in the sites management systems.

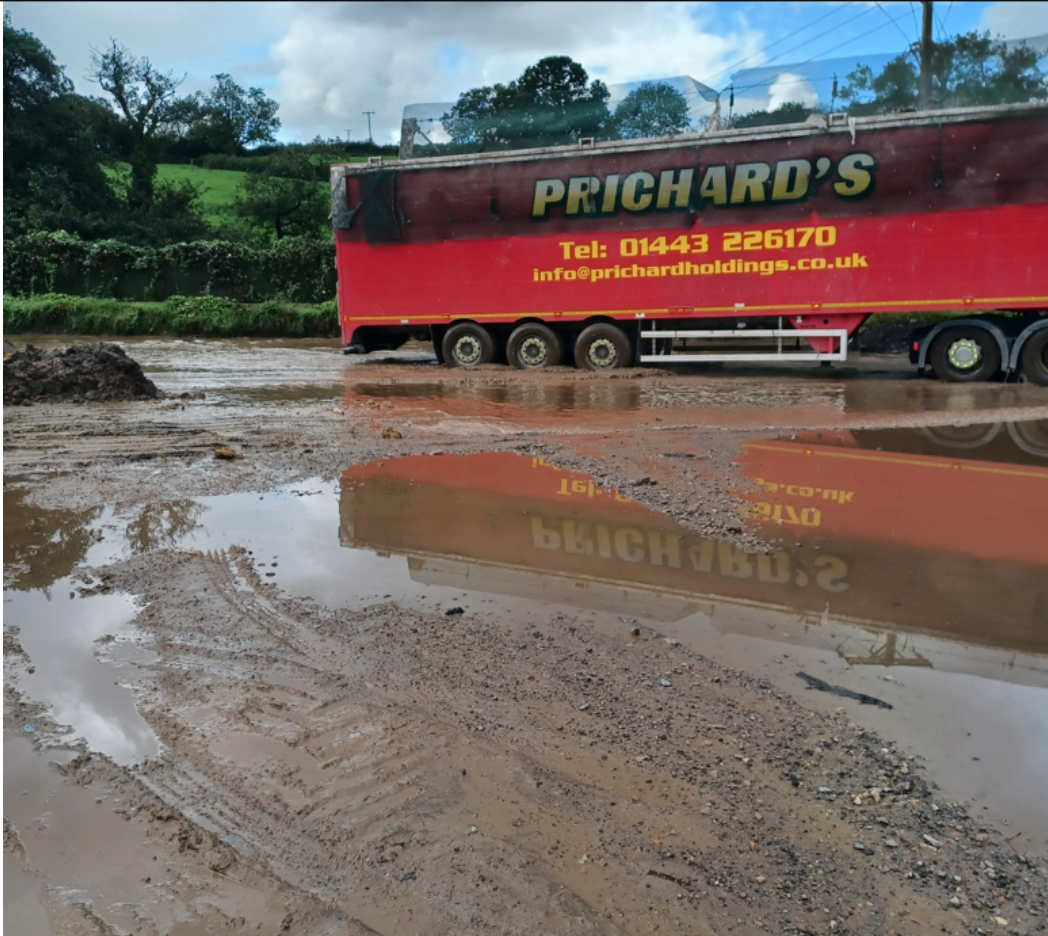
Hardstanding means ground surfaced with a durable hard material. It must be level, load-bearing, not prone to rutting or surface water ponding, and able to be kept clean of debris.

I note, during the visit, significant pooling was observed in this area of the site and therefore, does not meet the above requirements for a hardstanding.

In relation to the above, the sites EMS states 'The external yard is drained through surface infiltration and percolation. The nature of the site allows for clean (uncontaminated) water to freely drain into the ground and the substrate acts as a natural filter to prevent the passing of silts to the watercourse. This surface will need to be maintained as the heavy plant that is stationed at the site causes the hard standing to compact, preventing infiltration. These areas will need to be excavated and re-filled with clean hard core to allow the drainage to work effectively once more. This will be done as and when required based on the findings of the site supervisor.'

The EMS is not clear here on, in what circumstances, maintenance is required vs mechanical intervention to address pooling and how this is assessed by the site supervisor. Therefore, please address this in an updated EMS, as the EMS should explain how that assessment is made to determine what action is required, i.e., at what volumes of water or frequency of pooling, does there become a need to resurface the hardstanding, as these are likely indicators that infiltration is being prevented due to compaction, as opposed to resorting to ongoing mechanical intervention.

I also note, during the inspection, no mechanical intervention was in place addressing the pooling on site, as stated as the procedure in the sites EMS. Furthermore, the sites boundary sits within approximately 20 metres of the nearby watercourse, therefore if the earth bund failed, containing the pooling water, which should be percolating to ground via the hardstanding, there is a potential for the waste activity to have an impact on the

Action Required: Undertake the necessary improvements required to ensure the hardstanding can meet the standard required, as described above.

Action Required: In updating the management system, ensure that the content within the EMS regarding maintenance vs mechanical intervention of the hardstanding and how that assessment is made, is defined within an updated EMS.

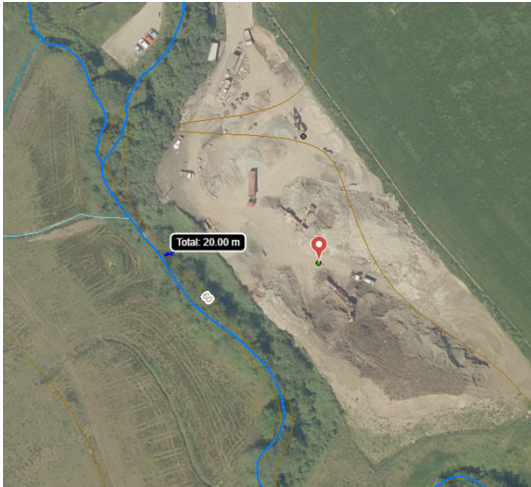
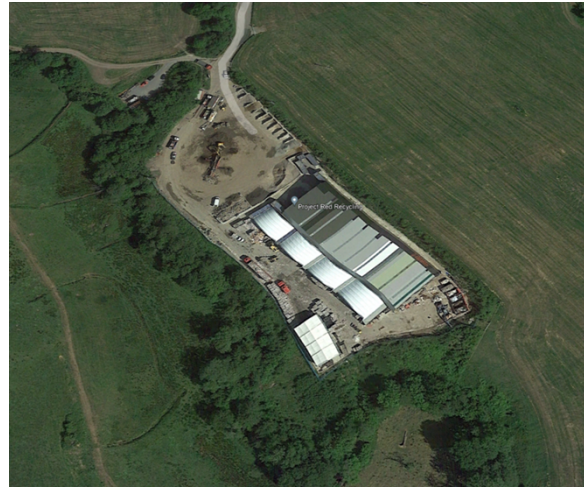
Nant Myddlyn. The map on the left below illustrates the position of the watercourse and the aerial on the right shows the site in relation to its proximity to the watercourse.

Please also consider the location of where the water is pooling, being the only access and egress point for the HCI waste transfer station part of the site. Which if not addressed, has the potential to impact the only access and egress route for the HCI waste transfer station, for example, in the event of an emergency.

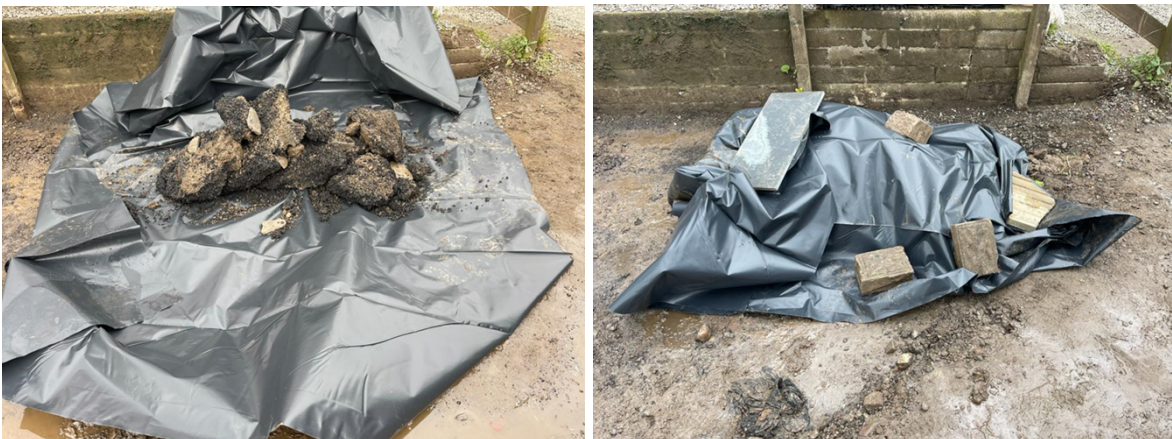
During the site inspection, officers observed the acceptance of bituminous mixtures with visible hydrocarbons present, without waste acceptance checks being performed, as described in the sites EMS, or relevant documentation furnished, as required under permit condition 2.3.2. In addition to this, in the absence of the above being followed, the waste was then deposited onto an existing stockpile of non-hazardous inert waste. The operator is required to comply with condition 2.3.2. for documentation, and 2.3.1., which requiring waste acceptance procedures to be followed. Therefore, a breach of condition 2.3.1 and 2.3.2 have been recorded on this occasion, because of, the absence both relevant documentation i.e., a waste transfer note and waste acceptance checks, there is a potential for the site to inadvertently accept a waste which they are not permitted to accept, e.g., hazardous waste.

The sites Environmental Manager/TCM holder informed me that steps had been taken following the visit, to quarantine the material, as a precautionary measure on this occasion, pending analysis (as shown below).

- 1). Please confirm that the site's sampling procedure was followed to ensure that the sample was representative of the waste concerned.
- 2). Please confirm that suitable containers were used for sample and transport, and that integrity was maintained during the transport and receipt of sample.
- 3). It is noted that all VPH/EPH were assigned to "asphalt (bitumen) petroleum group for blacktop", please could you provide the justification for this choice of substance.
- 4). Please also incorporate the sites sampling procedure as part of the updated EMS.
