# Saint Ishmaels Groynes & Ferryside Sea Defence Maintenance

## Water Framework Directive (WFD)

| DOCUMENT INFORMATION | | | |
|---|---|---|---|
| Title | Water Framework Directive Assessment | | |
| Document Ref | EV000990/WFD-2 | Issue / Revision | 1 |

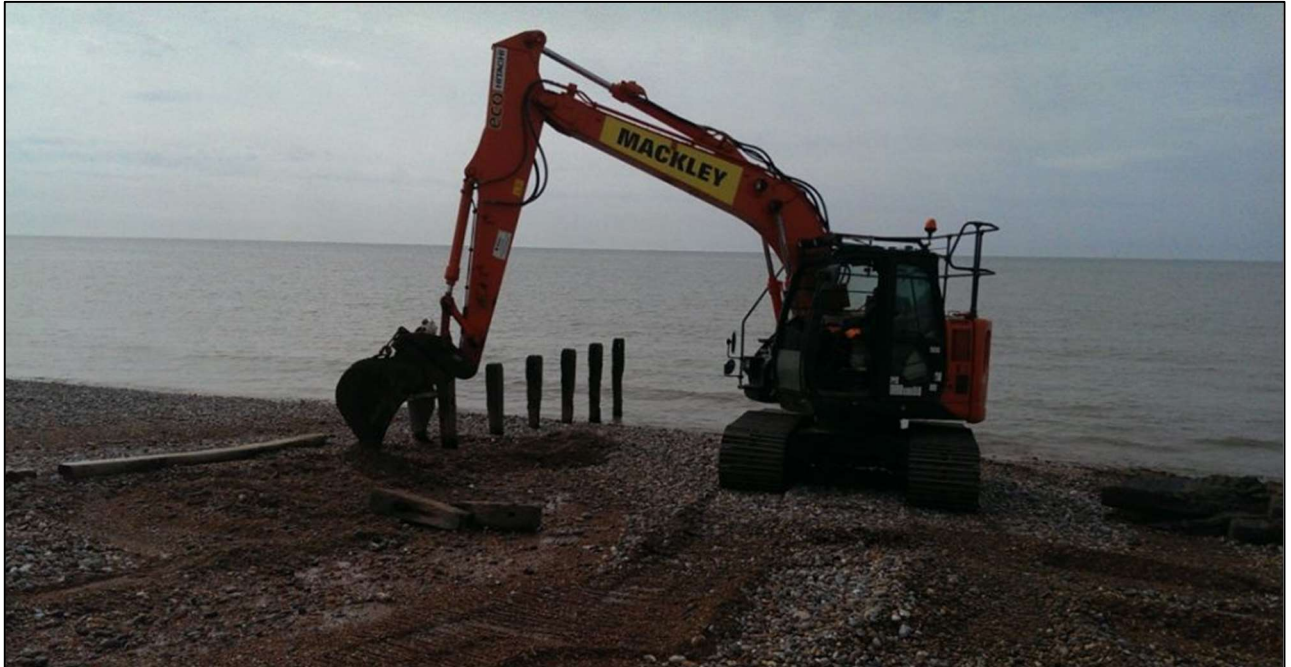
- 4.4.1 The removal of beach groynes will occur during daytime low tide conditions. Access to the works location will be via the Network Rail access ramp, north (upstream) of the groynes. A 13t Plant Machine and supporting 6t wheeled dumper will be used to remove the groynes.

*Figure 4: Example of similar tonne excavator removing timber groynes.*

- 4.4.2 In the first instance it is intended to attempt to pull out the upright metallic remnants of the groynes to avoid the need for excavations. Should this not be successful however, then excavation down to a depth of approx. 800mm will be required. Foundation depth, if foundations exist, is not known. Once the buried portions of groyne are exposed, the remains will be cut at the dig depth and removed. The excavation will then be backfilled. The back filling will endeavour to match the beach characteristics to reduce the chance of depressions developing.

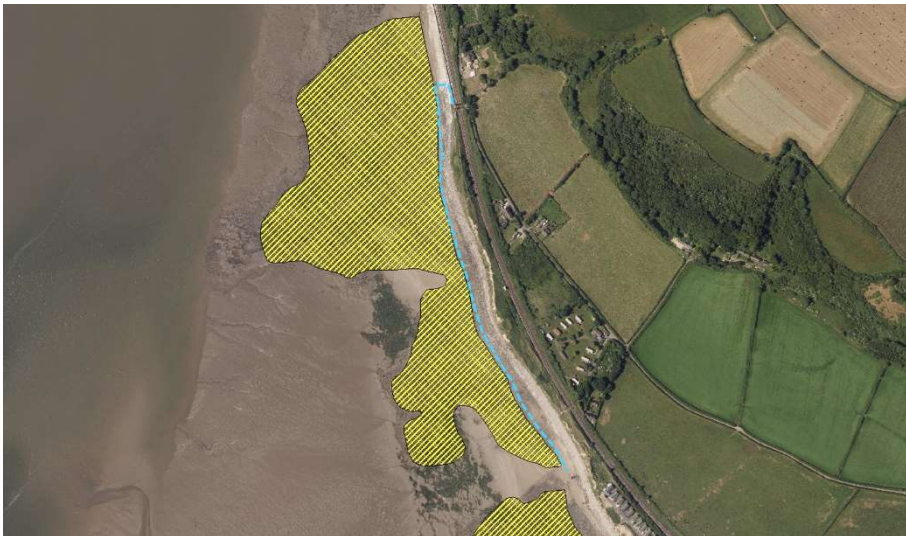
| Potential Hazard | Mitigating Circumstances / Mitigation Measures | Likelihood of Impact with Mitigation |
|---|---|---|
| WFD Higher Sensitivity Habitats – Muscle Beds | <p>Muscle beds are close to the proposed access point and location of the groynes. However, from available mapping, it appears that with clear demarcation, these sensitive areas can be avoided. Consultation with the local fisheries team will be undertaken, to ensure any concerns or unmapped muscle bed locations are accounted for.</p> | Impact Not Likely to be Significant |
