Compliance Assessment Report CAR_NRW0044686

Permit being assessed: AD0002101

For: Llanfrynach Wastewater Treatment Works, held by DWR CYMRU CYFYNGEDIG
At: Track opposite Tŷ Mawr Cottages, Llanfrynach, Nr Brecon, LD3 7LJ.

Type of assessment carried out: Site Inspection, Reason: Routine.

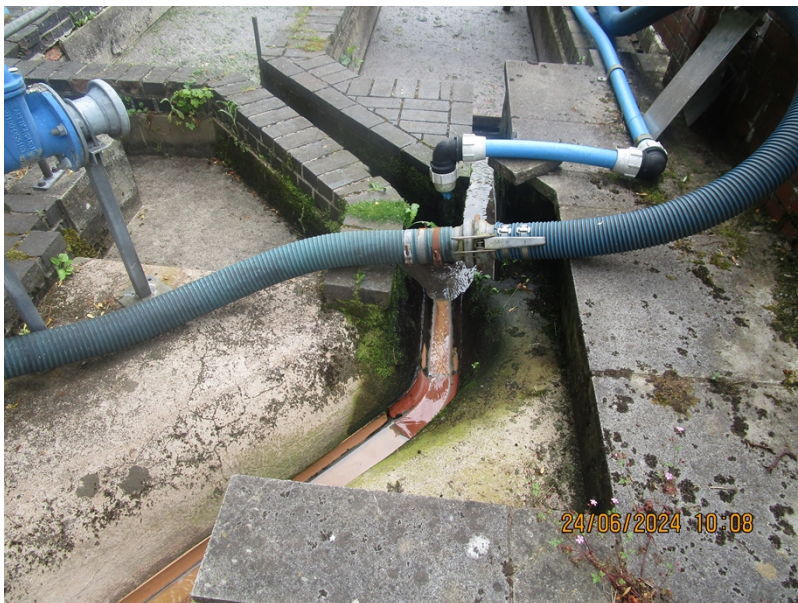
The storm weir on site is a hard-set concrete weir within the inlet channel. Flows can only overflow into the storm channel once levels reach a certain height. At the time of inspection, the works were not running to storm, as the flows were well below the weir height. The storm channel appeared completely dry and there were no indications of the site running to storm.

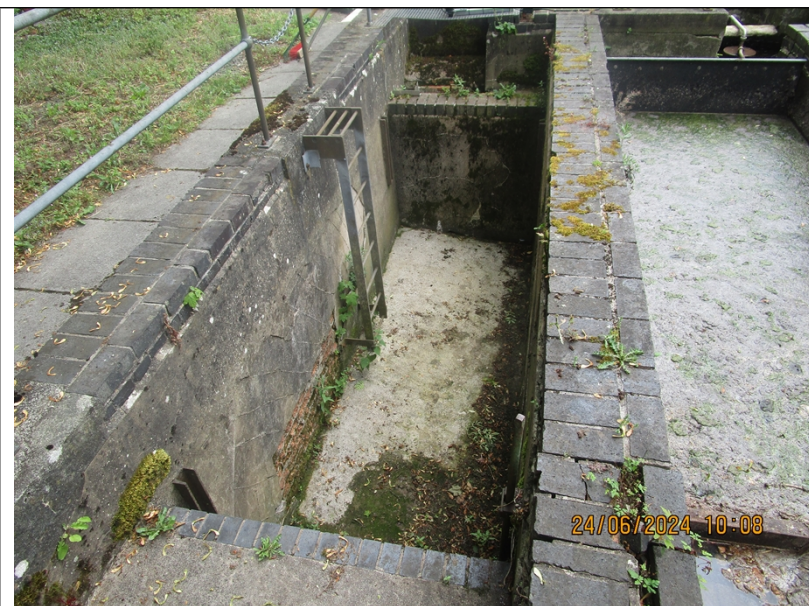
There is a single rectangular storm tank in operation on site. The outfall channel is located at the top of the tank, meaning a discharge can only be made once the storm storage is fully utilised and levels are high enough to pass into the channel. The storm tank was empty at the time of inspection, and visually looked like it had not been used for some time. There is an EDM level sensor in operation within the storm tank. The storm tank on site is manually returned to the head of the works as required.

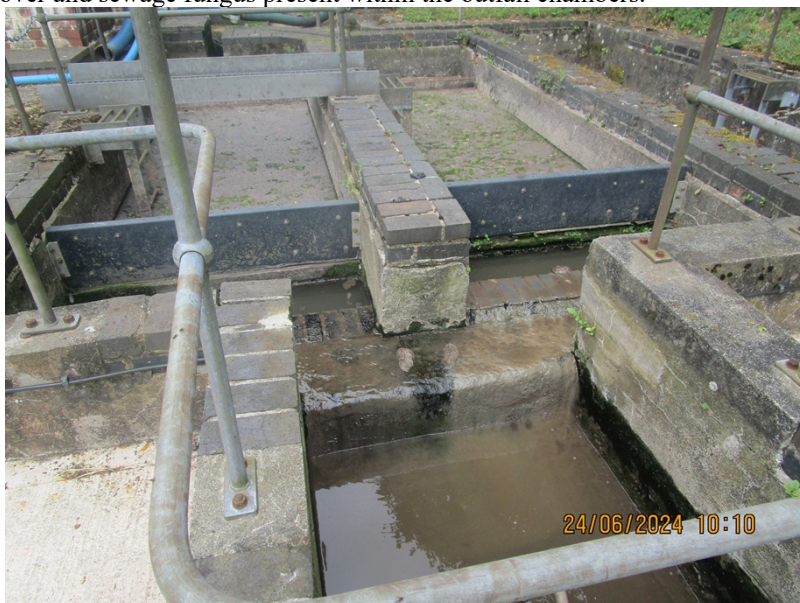
The primary settlement tanks are two parallel rectangular tanks, with retention boards to retain solids within the tank and slow down flows. Both tanks had what appeared to be a thick surface coverage of sludge/scum, which was being contained within the tanks by the retention boards. I questioned when the primary was next due for sludge removal and was advised that the tanker was due later that day. The sludge is manually removed by a tanker every two weeks.

There was evidence of some solids passing through from the primary settlement tanks and a visible blanket of sewage fungus within the outfall channels of the tanks. This sewage fungus build up likely indicates higher nutrient content in the effluent. It would be advisable to investigate whether this can be prevented by increasing the frequency of tanker removal, as this could potentially lead to problems within the final effluent.

Overall, the primary settlement system did not appear to be completely effective, as there were signs of solids passing over and sewage fungus present within the outfall chambers.

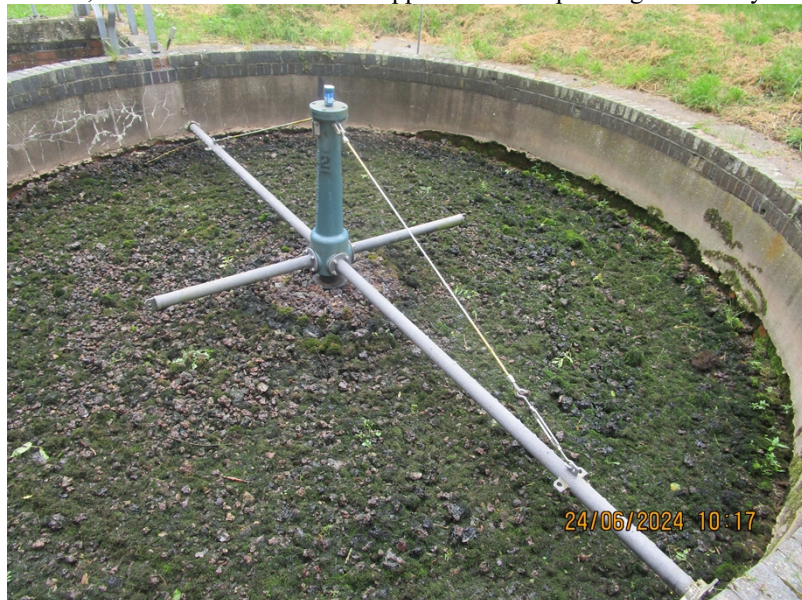
The works contains two small filters bed of stone media. On arrival at the works the filter arms were not rotating, as the syphon had not yet sent flow into the filter beds. Once the syphon activated, the rotation arms were moving freely and unhindered. There were no signs of blocked outlets and the rotating arms appeared to be distributing effectively. There were no signs of ponding or dry patches across the filter beds. There was a slight coverage of moss on surface of filter bed two, however this was not excessive and did not appear to be preventing distribution to the filter media.

Overall, the filter bed at the works appeared to be operating effectively.

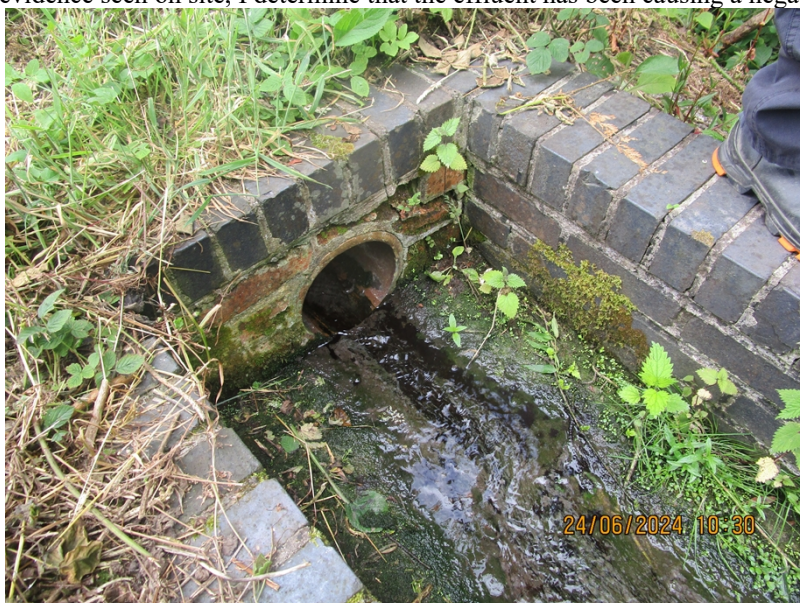
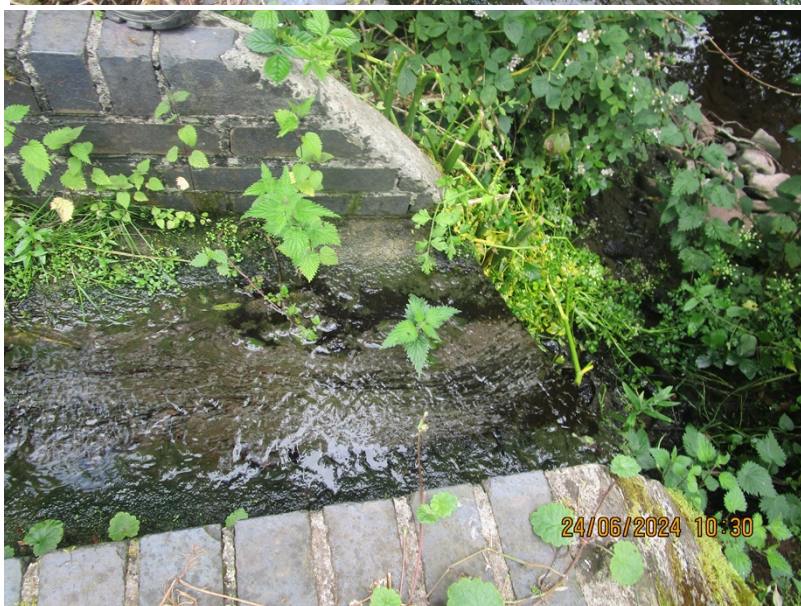
The outfall into the watercourse was inspected. At the time of inspection there was a build up of sewage fungus present both around the outfall pipe and on the riverbed where the effluent enters the watercourse. The sewage fungus was largely localised at the point of ingress but was clearly as a result of the effluent from the WWTW. Based on the evidence seen on site, I determine that the effluent has been causing a negative impact on the receiving watercourse.

The effluent from the WWTW is having a negative impact on the receiving watercourse and is therefore causing a pollution. This may have been prevented by improved monitoring and maintenance on the site. This is therefore a noncompliance against the following permit conditions.

This has been assessed as a category 3 noncompliance based on the low level impact to the receiving watercourse. This noncompliance is assigned as the evidence suggests that the pollution may have been as a result of a lack of maintenance

and monitoring of the site. The visible sludge build-ups and carry over from primary and final settlement tanks will have attributed to the sewage fungus growth at the outfall.

1. Provide specific details for installing a suitable sample point at Llanfrynach WWTW- Including plans for what is to be installed and expected completion dates.
2. DCWW to suitably clean out the outfall area into the watercourse, to remove sewage fungus build up. Provide confirmation that this has been completed.
3. Investigate the cause for the sewage fungus build up and around the outfall, and update site process as required to prevent reoccurrence of this issue. Provide details of the investigation and subsequent finding.

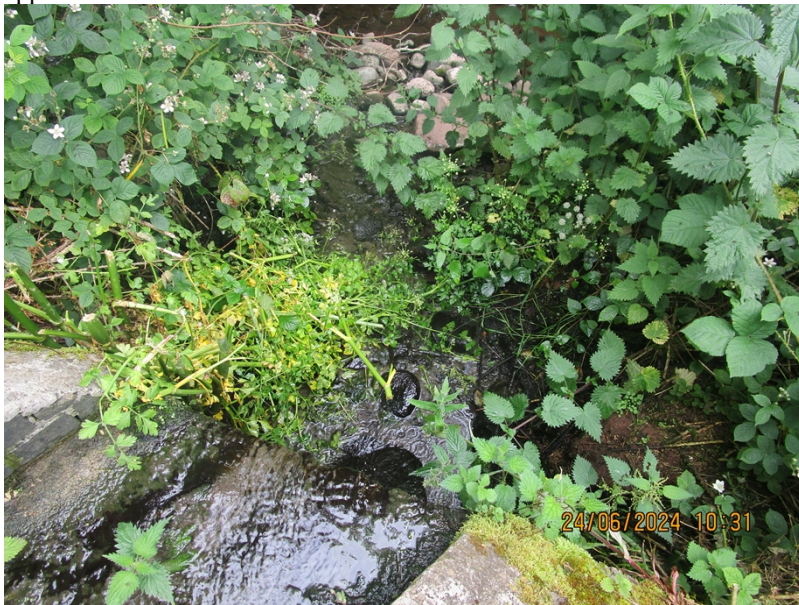
This has been assessed as a category 3 noncompliance based on the low level impact to water quality within the receiving watercourse. Ammonia and Biochemical oxygen demand are not currently the out within emissions limits, however the presence of sewage fungus indicates increased nutrient loading in the effluent, therefore condition 3.2.1 applies.
