Compliance Assessment Report CAR_NRW0045175

Permit being assessed: AW1002901

For: Llandrindod Wells Wastewater Treatment Works, held by DWR CYMRU CYFYNGEDIG
At: Park Lane, Llandrindod Wells, Powys, LD1 5NN.

Type of assessment carried out: Site Inspection, Reason: Routine.

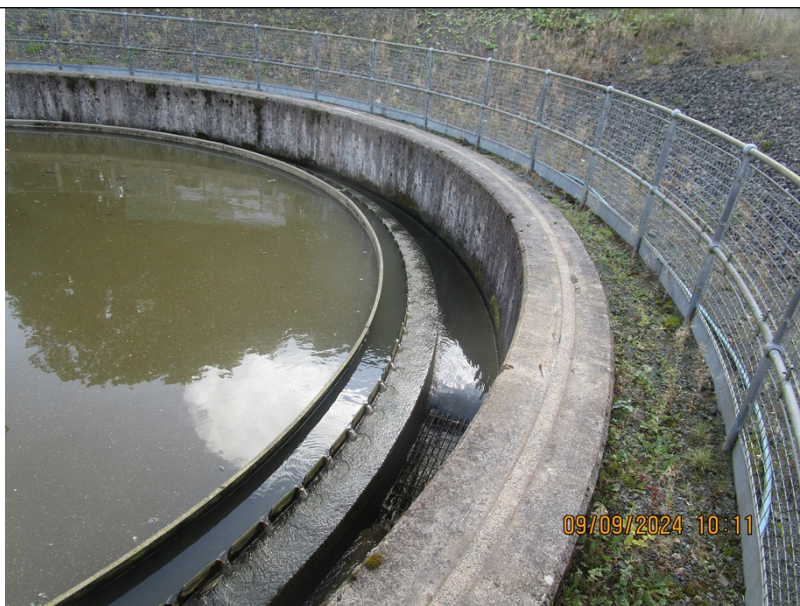
The works has two circular primary settlement tanks with rotating bridges, scum scrapers and outfall channel brushes. The two primary settlement tanks appeared in good working order. There were no signs of significant solids carrying over from either of the settlement the tanks or signs of sewage fungus within the outfall channels. Both outfall channels were running clear.

The flows from the Primary Settlement tanks are then sent to a distribution chamber, which distributes the flow to the four filter beds on the site.

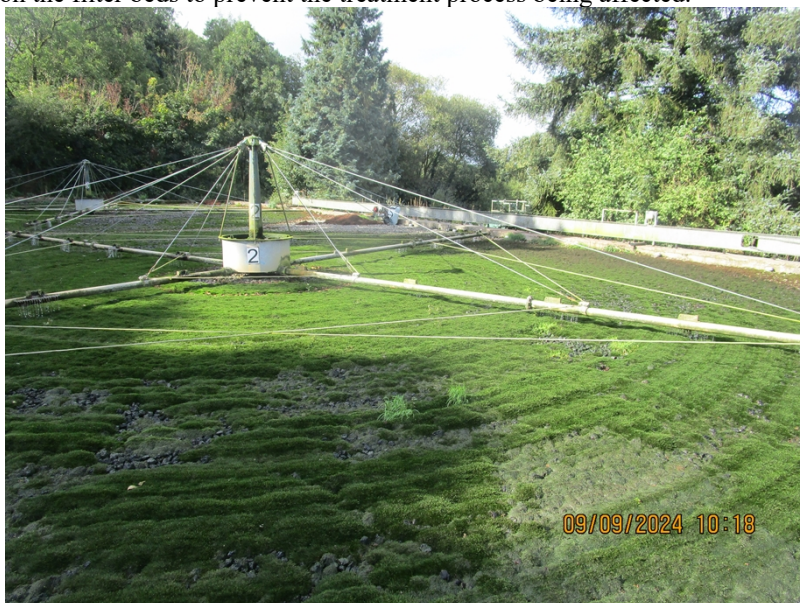
Filter Beds 1-3 are also rotating distribution arms onto stone media, however all three are contained within one large rectangular filter bed housing, which contains stone media of approximately 2m deep. Each filter bed is clearly labelled. Filter beds 2 and 3 bed had extensive areas of moss/grass coverage, it would be advisable to increase vegetation removal on the filter beds to prevent the treatment process being affected.

The moss coverage and ponding on the filter beds is a cause for slight concern, as it can lead to issues with infiltration and affect the treatment process. Indications currently are that they not impacting the treatment process; however, it is advised to undertake increased moss removal and address the ponding on the filter beds before the issues develop further.

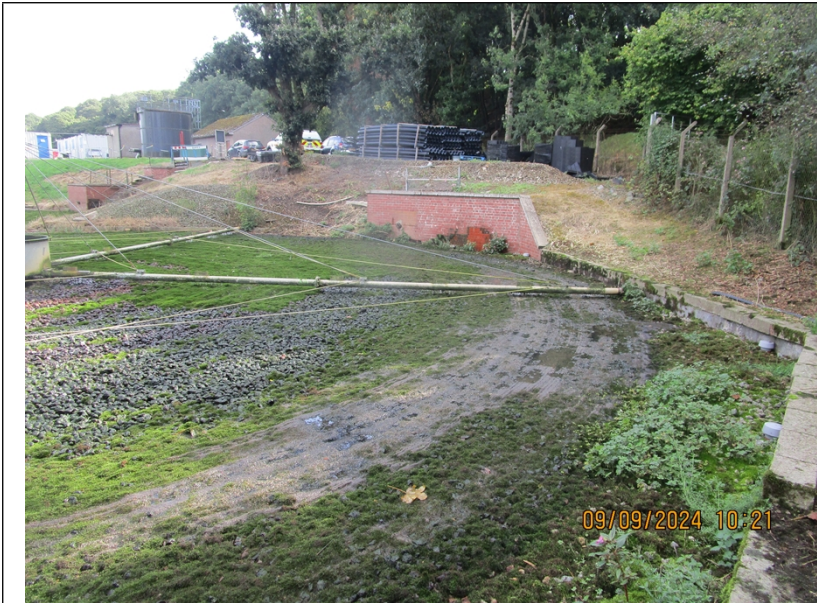
There was surface pooling present on the filter media of filter bed 3. This appears to be preventing ample distribution to the filter bed media. There had been heavy rainfall within the preceding days, which may have contributed to the pooling, however it is not clear if this is the sole cause. This should be monitored and addressed as soon as possible to prevent problems within the treatment process.

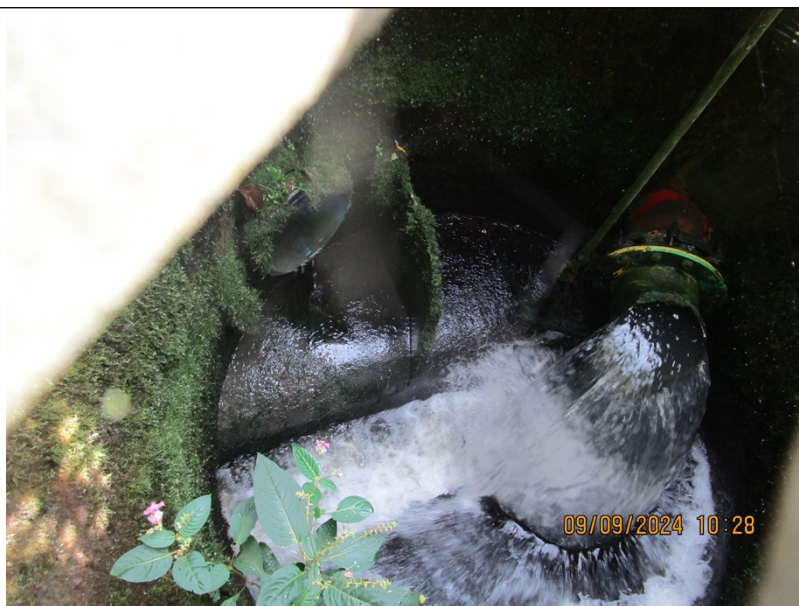
The effluent within the sample chamber appeared to be flowing clear of any solids or signs of polluting matter. There was some moss growth within the outfall chamber, however this did not appear to be having any impact on the effluent within the chamber. The storm outfall pipe is also located on the side of this chamber. At the time of inspection there were no flows coming from the storm outfall pipe.
