## Compliance Assessment Report CAR\_NRW0043909

**Permit being assessed:** AN0236801

For: MAENDY QUARRY UPPER CHURCH VIL, held by VEOLIA ES CLEANAWAY (UK) LTD

**Type of assessment carried out:** Site Inspection, Reason: Incident Response (Incident number: 2402161).

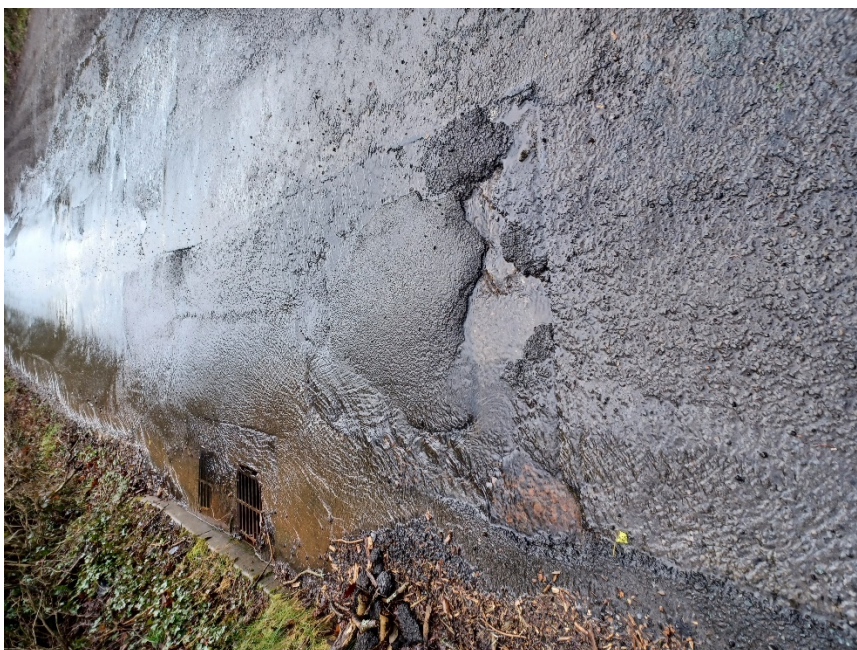
The discharge coming out of the road was running down the road for approximately 130 metres. Some of the discharge was entering the highway drain a short distance down the road, the rest was running down along the side of the road and entering a field to the East of the road.

Figure 1: discharge running down road

Criteria	Action needed	Complete by
WQ-B2	Operator to ensure discharge is to permitted point only. Where this is not possible because of the design of the site, discussions should commence regarding the suitability of the permit and potential variation to reflect actual site discharge activity.	28/02/2025

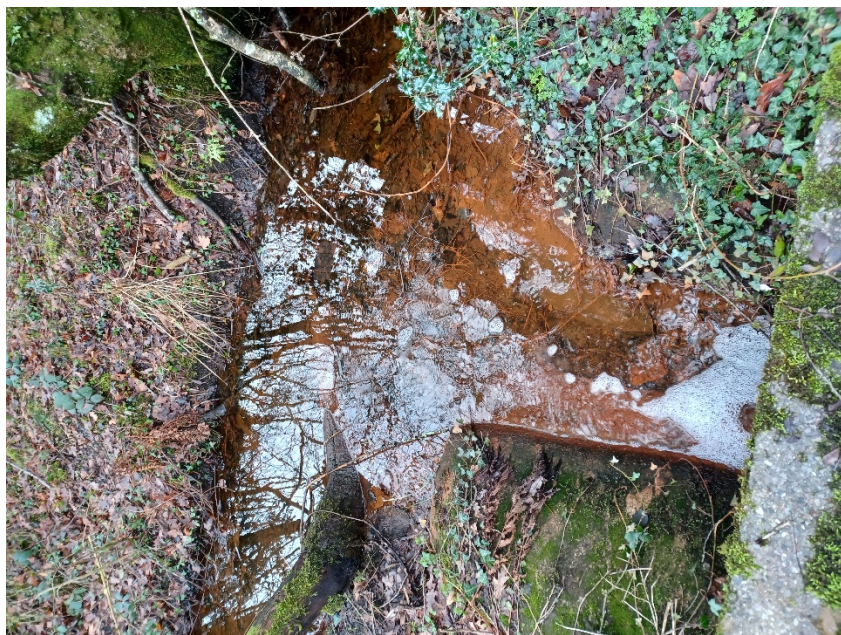
Figure 2: discharge from Western Quarry

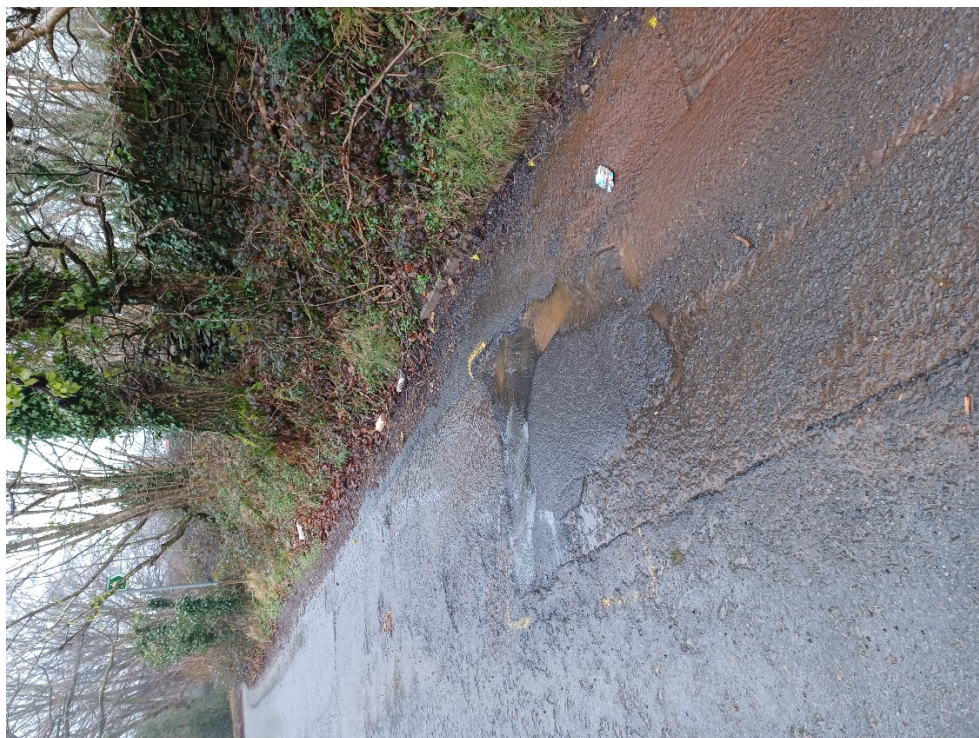
The discharge from the Quarry was again investigated on 12/03/2024 following further complaints. NRW Environment Officers arrived on site at 12.20. Weather was wet with rain showers. The discharge was odorous and discoloured as before. Water quality samples were taken at the same locations as those on the 07/02/2024.

Figure 3: Discharge from road. Public right of way sign shows approximate location of

quarry boundary.

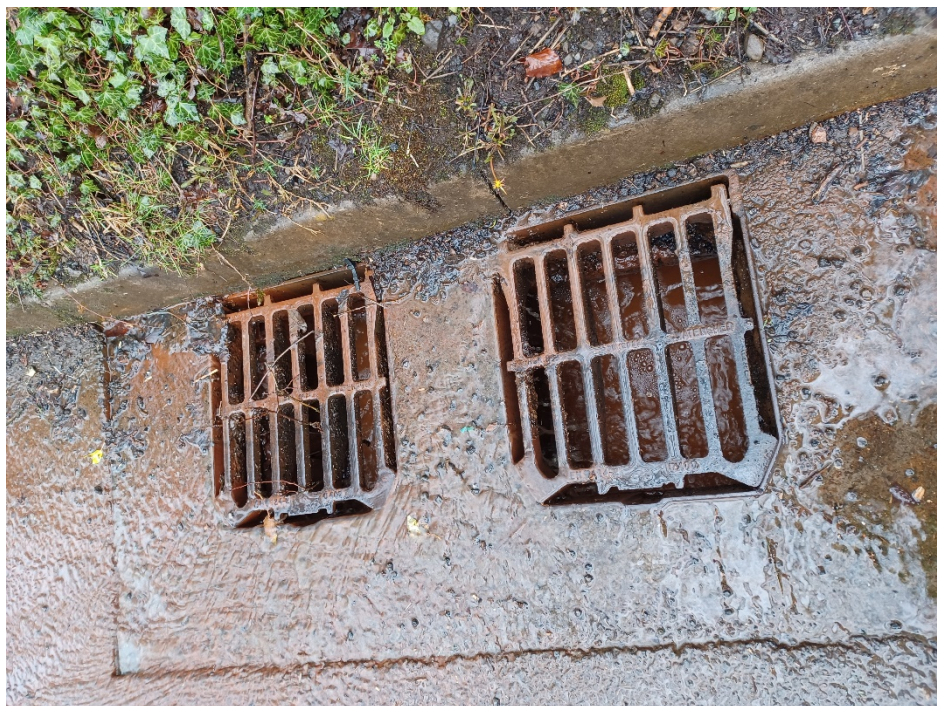
Figure 4: discoloured water entering highway drain.

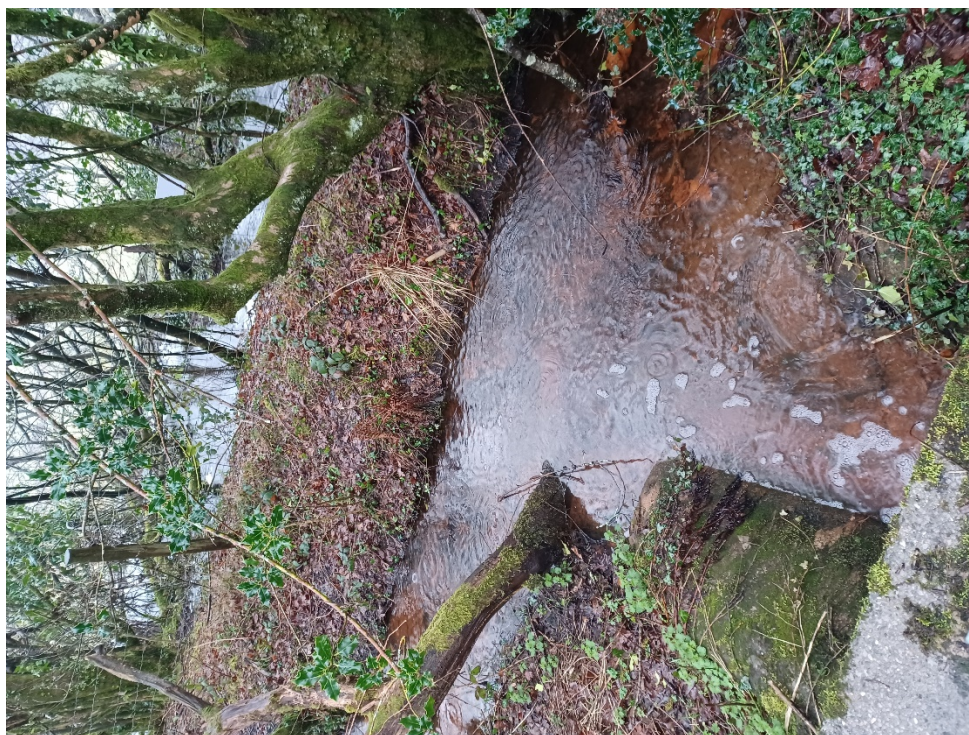
Figure 5: discharge from Western Quarry

The water quality results indicate that the discharge from the road likely contained some discharge effluent from the quarry discharge as it contained many of the chemical elements and compounds identified in the Western Quarry discharge. The water quality results **did not show any non-compliance** with the current permitted emission limits in permit
