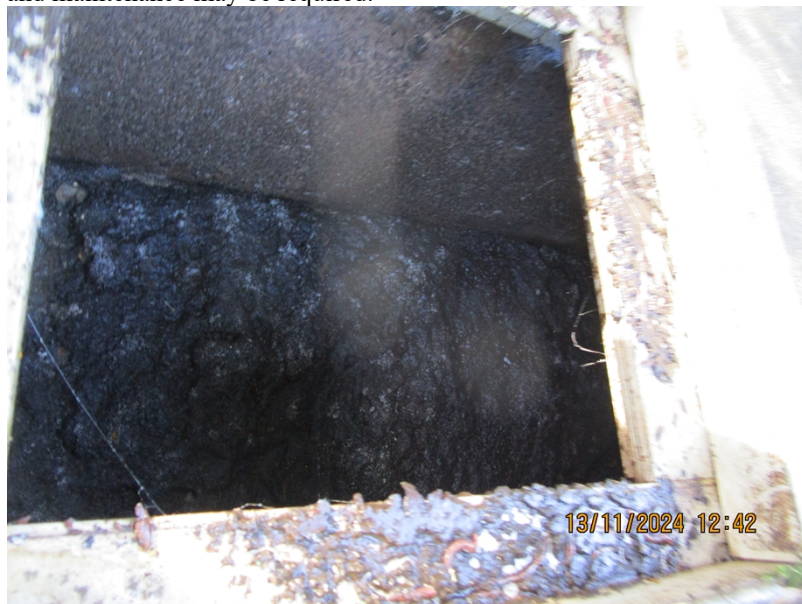
The flows into the works flow directly into a covered rectangular primary settlement tank. The settlement tank has an outfall pipe at a lower level than the inlet pipe, to retain surface solids within the tank. This is similar in design to a septic tank. On inspection there was a thick layer of scum and sludge present on the surface of the tank. A certain level of build-up would be expected, however there was quite a thick layer present. This may indicate that increased emptying and maintenance may be required.

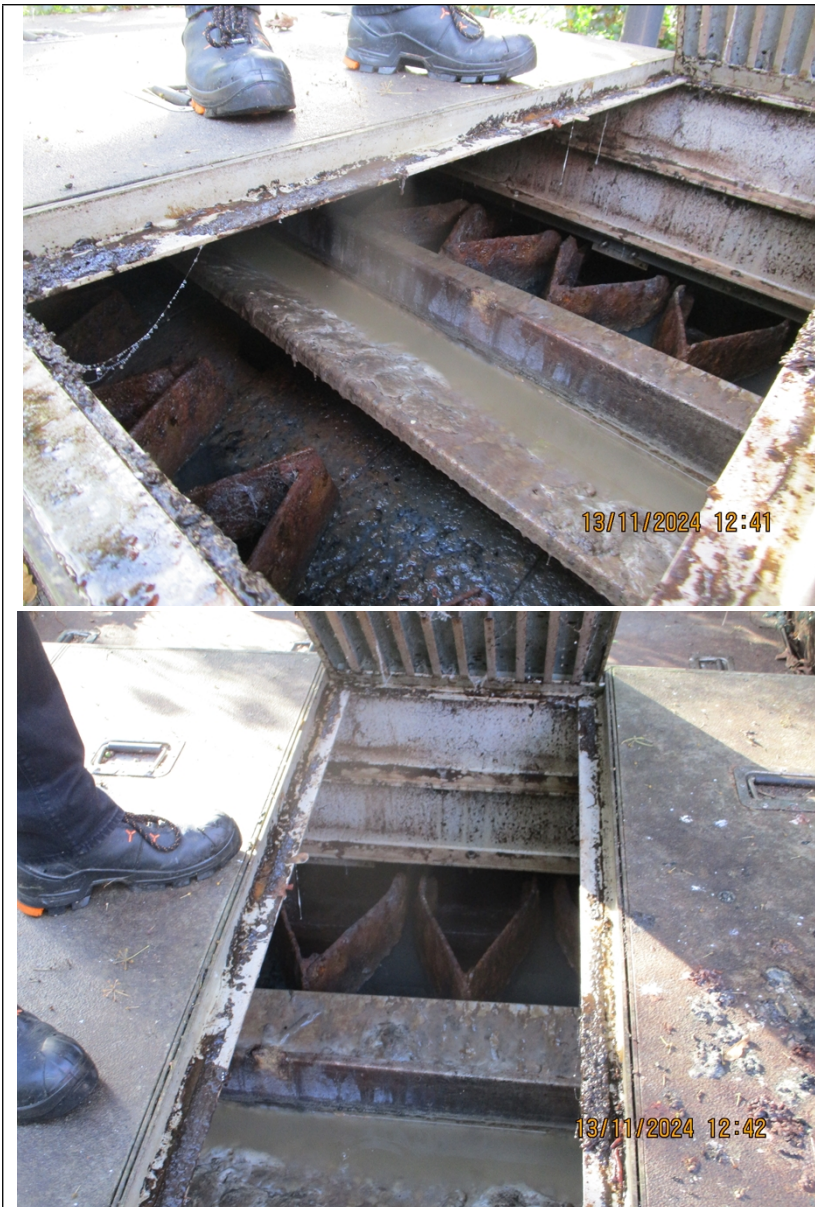
The works contains a single filter bed of stone media. On arrival the tipper tray was still in the process of filling, and it was not possible to observe the distribution onto the filter, due to the low flows entering the works. The filter trays had an extensive build-up of white sewage fungus present. This was also present within the channels leading to the distribution points.

Overall, the filter bed at the works appeared to be in need of cleaning/maintenance. The extensive build-up of sewage fungus present at this stage is a cause for concern as there is no further treatment processes after the filter bed at the works. It was not possible to see the effluent from the filter beds, which discharges directly to the watercourse as there is no final settlement or further treatment at this works.

The significant presence of sewage fungus at this point is sufficient evidence to suspect that the effluent from the works would be having a negative impact on the receiving environment.

This is therefore a breach of condition 7 of the permit.

This has been classified as a category 3 noncompliance, as this could potentially have a minor impact on the receiving watercourse.

1. Investigate the cause of the sewage fungus build up within the filter bed tipper tray and take appropriate steps to clean this up and prevent further pollution to the receiving environment. Please provide details of the investigation, actions taken and evidence to show a clean-up has been completed, by 04/01/2025.

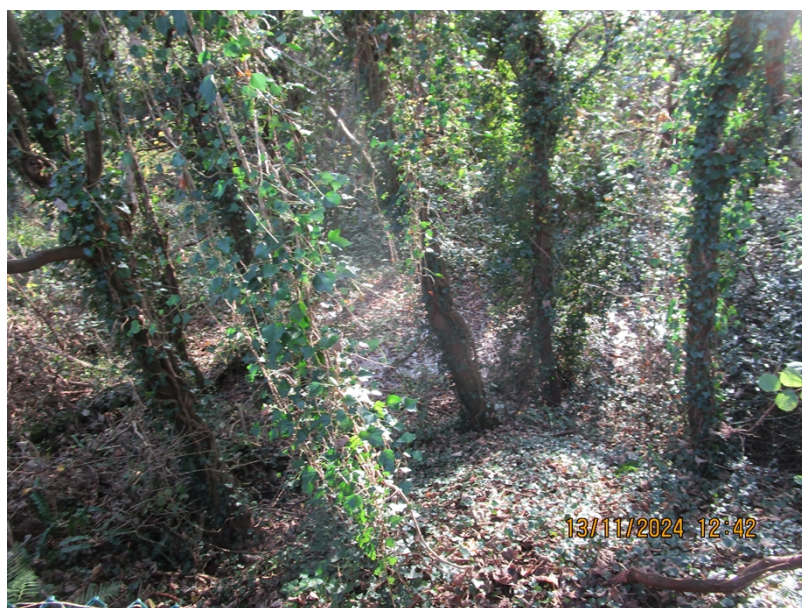
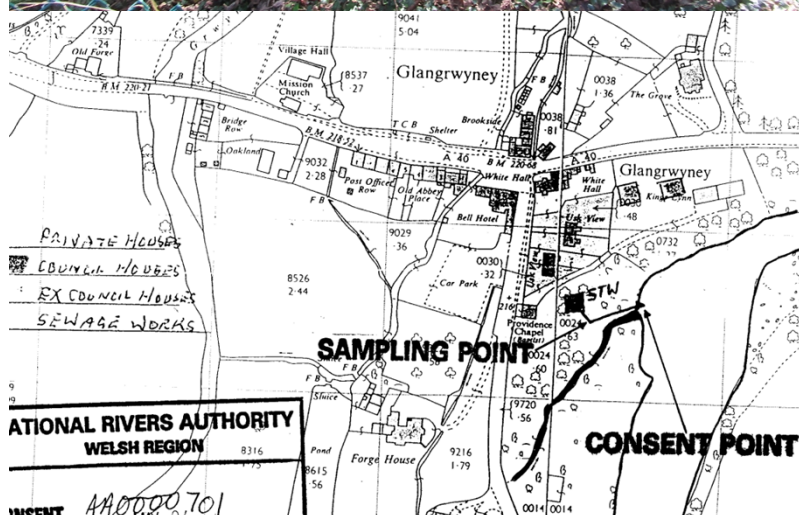
There are no inspections chambers or outfall channels present within the works. At the time of inspection, it was not possible to locate the outfall into the watercourse, as there was no clear access down to the outfall pipe, which appears to be located down a steep wooded area. Operatives on site were also unsure where the physical outfall is, or the outfall was not inspected on this occasion.

There is currently no facility available on site to collect a representative sample of the discharge. There is currently no OSM sampling requirement at this location, however the permit specifies a facility should be available. Therefore, this is a breach of condition 3 of the permit.

This has been classified as a category 3 noncompliance, as the visual evidence from onsite suggests that the effluent may be having a minor impact on the receiving watercourse. If there is a manhole present at the location specified, it is not currently safely or conveniently accessible. Operatives on site were unsure which is a concern, as this would mean that

2. Investigate and provide details of the sampling point and outfall to the watercourse at Glangrwyney STW. This should include an updated site plan to accurately show the location of the chamber and outfall. Should any works be required to create suitable access to the specified sampling point, provide a plan of works detailing what will be installed and the expected completion date. To be provided by 04/01/2025
