## Compliance Assessment Report CAR\_NRW0045865

**Permit being assessed:** AD0000701

For: CRAY STW CRAY BRECON POWYS, held by DWR CYMRU CYFYNGEDIG

**Type of assessment carried out:** Site Inspection, Reason: Routine.

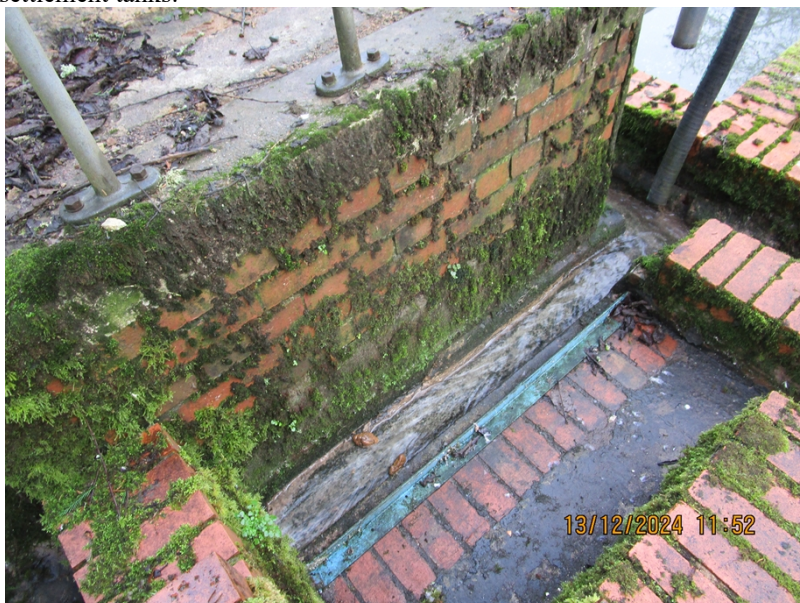
The incoming flow comes into the works via a gravity sewer. The treatment process at the works is entirely hydrologically powered. There is no screening in place at the inlet to the works. At the time of inspection there were no signs of rag/solids entering the works at the time. The inlet flows past the storm weir before passing on to the primary settlement tanks.

The storm weir in place is a hard-set weir at the side of the inlet. The works can only run to the storm channel storm when flows reach the level of the weir. The storm channel has no additional screening in place. At the time of inspection, flows were below the weir height, and no flows were passing to the storm tanks. There was some rag/paper residue present within the channel leading to the storm tank, suggesting recent use. There a level meter within the storm tank but no EDM equipment in place.

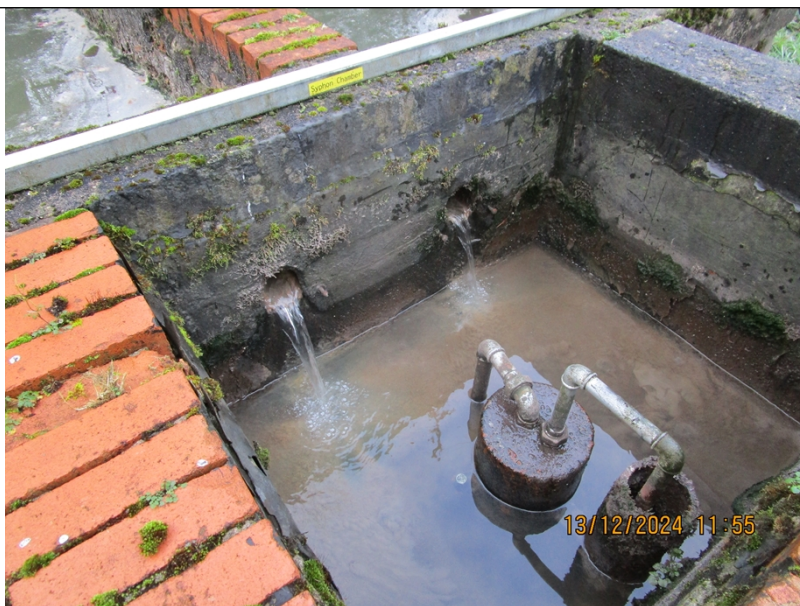
The outfalls from the primary settlement tanks lead to a syphon chamber, which fills up before discharging to the two filter beds on site. This is to ensure there is enough water pressure to rotate the filter bed arms. The base of the outfalls from the settlement tanks and syphon chamber had build-ups of sewage fungus present, which indicates a high nutrient content within the influent. This was not a sign of noncompliance at this time.

The syphon was clearly operational at the time of the inspection and was effectively sending flows to the filter bed.

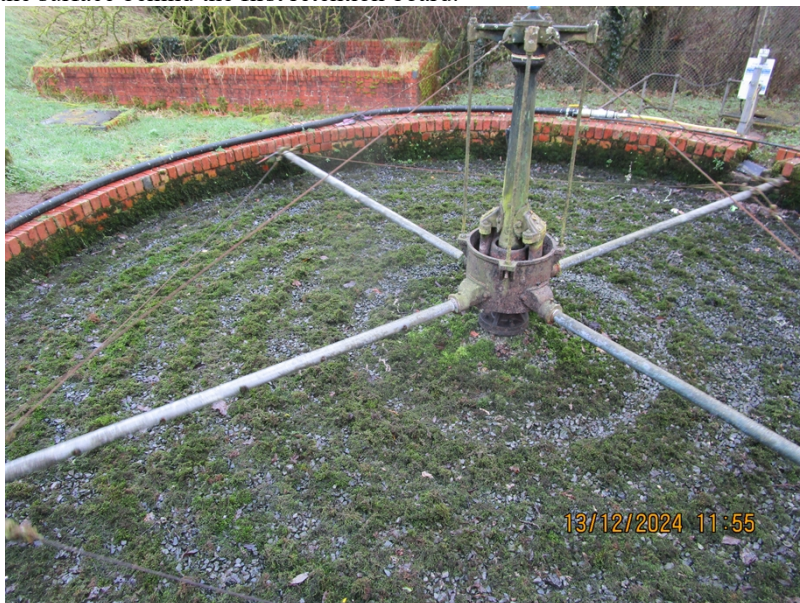
The works contains a single filter bed containing stone media. The rotation arm was moving free and unhindered. There were no signs of blocked outlets, and the rotating arms appeared to be distributing effectively. The filter beds had some coverage of moss growth on the surface of the filter; however this was not excessive and did not appear to be affecting infiltration to the filter media. The filter bed discharges directly into the Humus tank of the works. The filter beds at the works appeared to be operating effectively and the outfall appeared to be running clear, with some minor froth visible on the surface behind the first retention board.

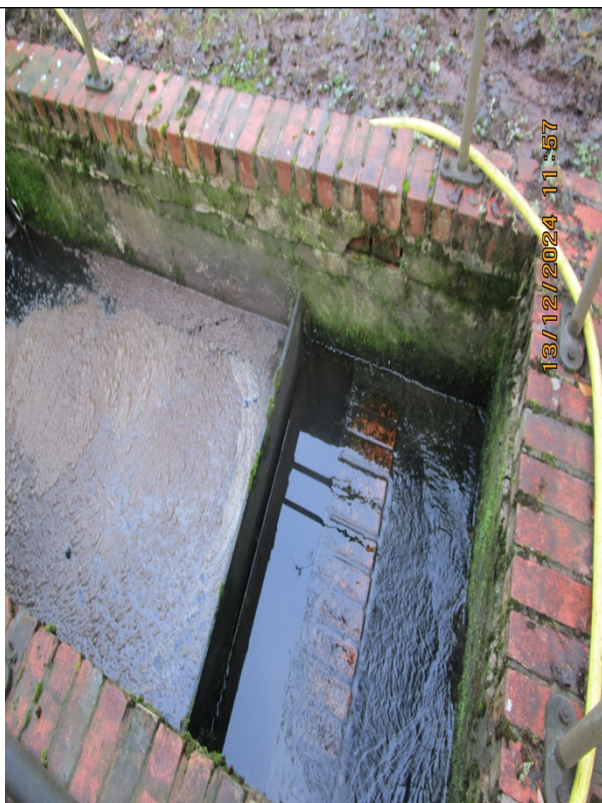
The humus settlement tank on the works is a small rectangular tank with a retention board to slow the flow down and prevent solids passing over. There is a pipe within the humus tank, which is for recirculation to the head of the works.

The final settlement system appeared to be operating effectively. The outfall channel at the time appeared to be running clear and there were no signs of significant solids passing through or sewage fungus growth.

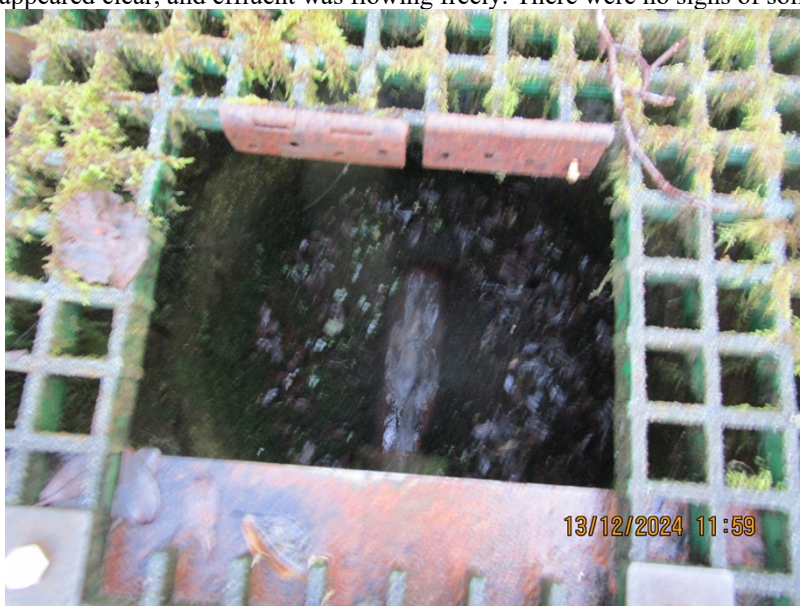
The Final effluent sampling point was clearly marked and easily accessed. The effluent at the time of inspection appeared clear, and effluent was flowing freely. There were no signs of solids within the effluent.

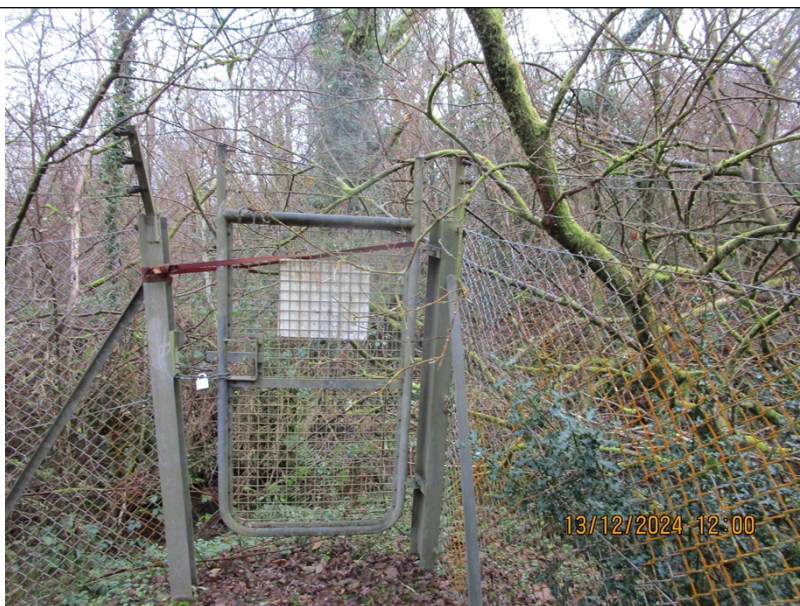
It was not possible to assess the outfall into the watercourse, due to limited access. The fencing at the site has previously damaged, and the gate is currently tied closed. As a result, we were unable to pass through the gate to get closer to the watercourse. The area between the fence and the watercourse has seen recent flooding and there has been erosion of the bank, and several trees have fallen. This has also resulted in the fence no longer being fully upright.

DCWW to investigate options for restoring access to the outfall into the watercourse, to ensure it is possible to fully monitor the impact of effluent on the receiving watercourse.

- DCWW to take appropriate steps to restore access to the outfall into the watercourse. Details of any plans of works required and expected timeframe for completion, to be sent to NRW by 31/12/2025.
