Compliance Assessment Report CAR_NRW0046147

Permit being assessed: AC0140301

For: Sennybridge Wastewater Treatment Works, held by DWR CYMRU CYFYNGEDIG
At: Sennybridge Army Camp, Sennybridge, Powys, LD3 8TS.

Type of assessment carried out: Site Inspection, Reason: Routine.

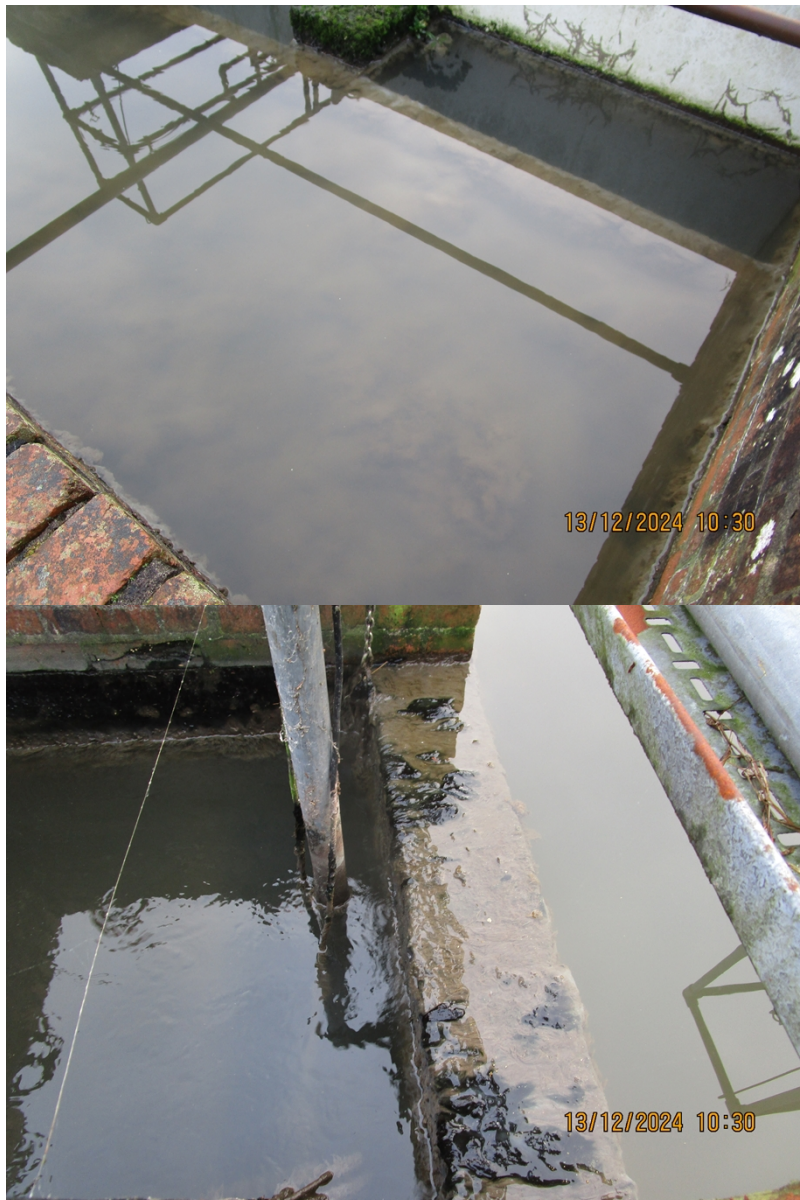
The outfall channel from the tanks appeared to be flowing with clear effluent, however there was an extensive coverage of sewage fungus present within the outfall channels for the primary settling tanks. Sewage fungus growth is an indication of high nutrient loading within the effluent and may indicate problems with treatment process. The level of build up is a cause for concern, as it indicates that appropriate maintenance and cleaning has not been taking place, which increases a risk of pollution being caused. This is therefore a breach of permit condition 1.1.1 (a) which states.

This has been classified as a category 3 noncompliance, as this could potentially have a minor impact on the receiving watercourse.

***Action required- Clean up the Primary Settlement Tank Outfall channels, to remove sewage fungus build up.

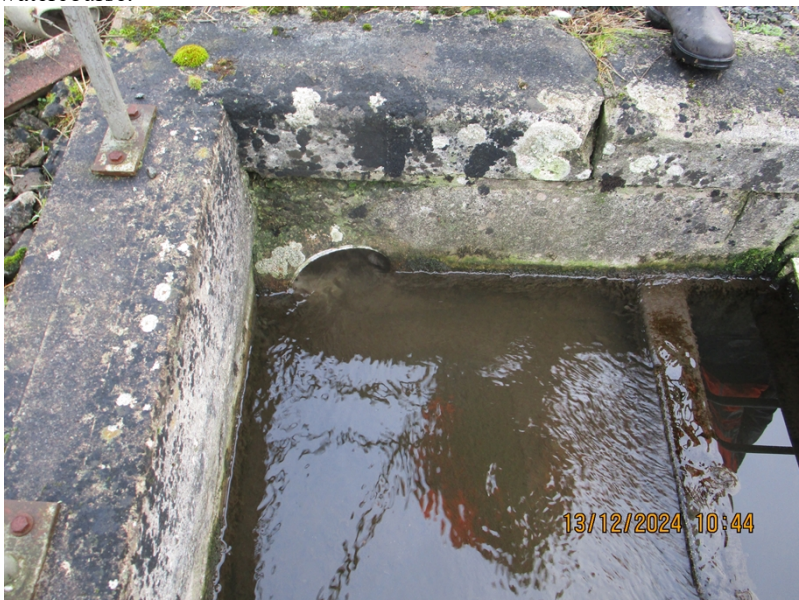
The works has two parallel rectangular settlement tanks with retention boards to retain solids. There was a thick build-up of foam present on the surface of the inlet channel to the settlement tanks, which potentially indicates high nutrient

loading or turbidity. This was being held back by the first set of retention boards and was not passing through to the outfall. Overall, the humus tanks appeared to be operating effectively. There were no signs of solids passing into the outfall channel and the effluent was running clear. There was a visible build up of sewage fungus on the bed of the outfall channel and on the base of the outfall pipe of the humus tanks. As with the primary tanks this build up is a cause of concern as it indicates high nutrient content and a lack of appropriate monitoring/ maintenance. This is therefore a breach of permit condition 1.1.1(a).

This has been classified as a category 3 noncompliance, as this could potentially have a minor impact on the receiving watercourse.

1. Clean up the sewage fungus build up within the Primary Settlement and Humus Tank outfall channels. Provide confirmation and pictures to show that this has been completed by 28/02/2025.
2. Advisory Action- Cut back the vegetation which is blocking access to the outfall into the watercourse. To create a safe access route to the watercourse for environmental impact monitoring. Provide any plans for this work to be completed by 28/02/2025.

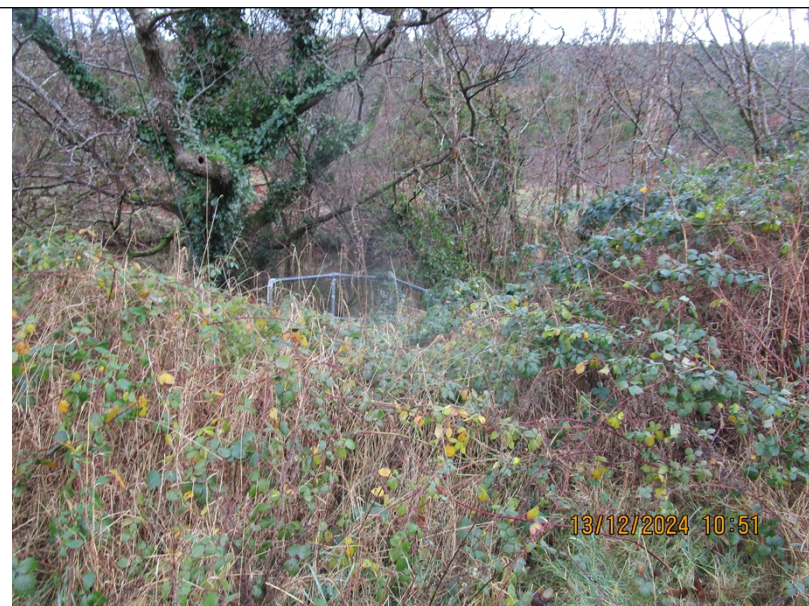
The Final effluent sampling point is clearly marked with appropriate signage including the sample point number. The sampling point appeared appropriate for an indicative sample to be taken. At the time of inspection, the outfall was flowing freely and there were no signs of significant solids passing through or sewage fungus within the outfall chamber.

It was not possible to physically inspect the outfall into the receiving watercourse, as there was thick vegetation growth in the field which made the outfall inaccessible. It would be beneficial for the vegetation to be cut back, to restore safe/easy access to the outfall into the watercourse, to allow for appropriate monitoring of the impact on the watercourse. This is not a noncompliance against permitted conditions; however, it results in it not being possible to monitor the watercourse for any signs of impact.
