## Compliance Assessment Report CAR\_NRW0045857

**Permit being assessed:** FB3190HP

For: CARDIFF AIRPORT, held by CARDIFF INTERNATIONAL AIRPORT LIMITED

**Type of assessment carried out:** Site Inspection, Reason: Routine.

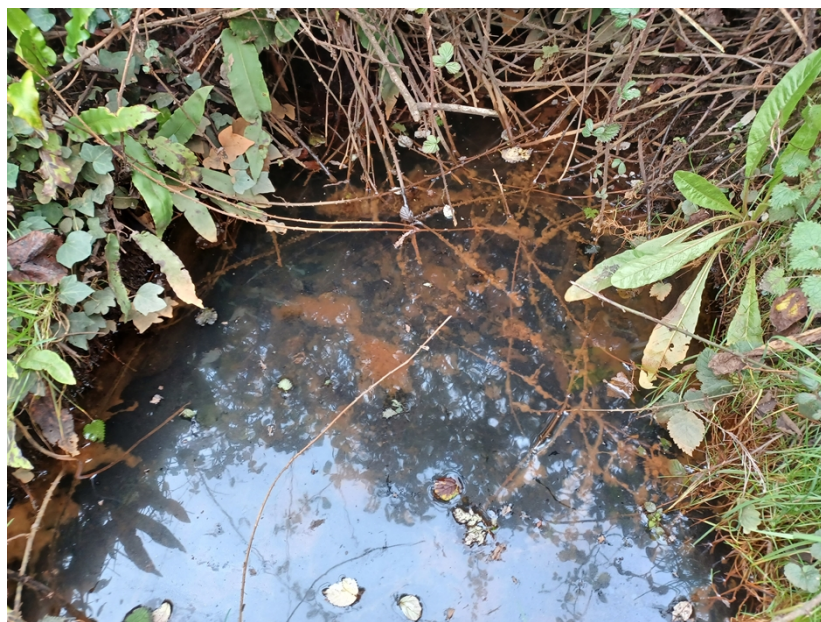
The coffer dam was inspected and had a layer of biofilm, this is likely due to slow flows. The vegetation in the coffer dam outfall area was showing signs of ochre growth, this may be due to rusted pipes prior to the coffer dam outlet and should be investigated. There is an concrete block and inspection chamber prior to the outfall area, this doesn't appear to have been opened for access before and may show some of the rusted infrastructure.

- Investigate the drainage infrastructure to the cofferdam for signs of rust causing the ochre growth.

- Lift and gain access to the inspection chamber prior to the outfall.

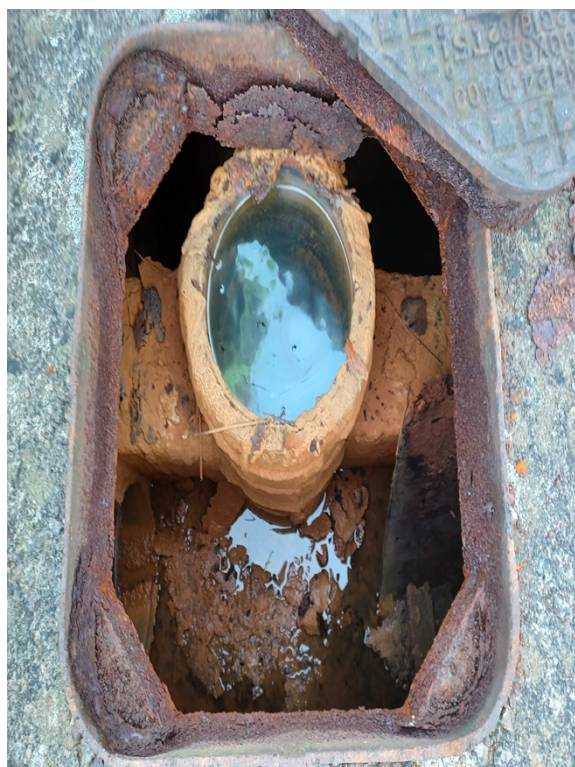
The reed bed services the firefighting area and receives run off including dilute firefighting foam used for training. This area enters a storage tank which then flows into the reed bed, which then discharges to the ground via infiltration. The channel from the settlement tank to the reed bed had a fair build up of sediment which would restrict the flow. The inlet to the reed bed also had a build up of sediment which had grass growing on it, as well the sediment had risen to obstruct some of the inlet pipe. The reeds appeared in good health. The outlet chamber from the reed was quite severely rusted.

- Clear the sediment from the channel between the storage tank and the reed bed.
- Clear the sediment at the start of the reed bed around the inlet outfall.
- Remove the rusted infrastructure from the outlet pipes and chamber so that this does not leech in to the soil from the discharge.

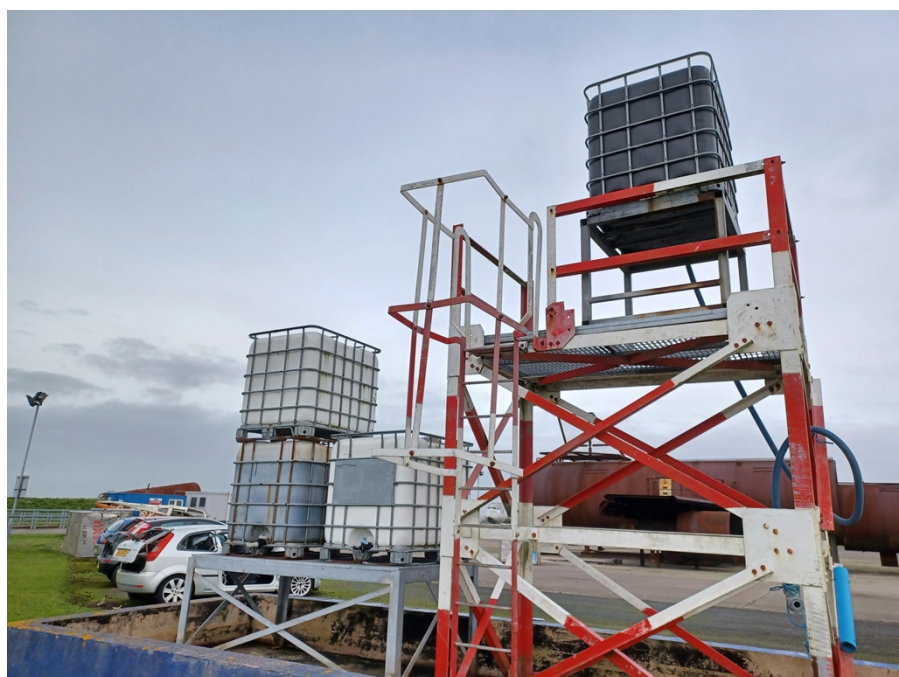
In the firefighting area there are storage containers that are elevated above the bunded area. This is practically nullifying the bund as if the container blew over, or a pipe split etc then the contained substance would spill outside of the bunded area and potentially lead to a pollution incident.

| Criteria | Action needed | Complete by |
|---|---|---|
| WQ-C3 | Move the storage containers so that are within the effective bunded area should a spill take place. | 24/02/2025 |

- Move the storage containers so that are within the effective bunded area should a spill take place.
