***Raynes Quarry: Hydrogeological Impact Assessment***

*CEMEX UK Materials Limited  
Raynes Quarry  
Abergele Road  
Llysfaen  
Colwyn Bay.  
LL29 9YW.*

**SH8878 TS 220711**

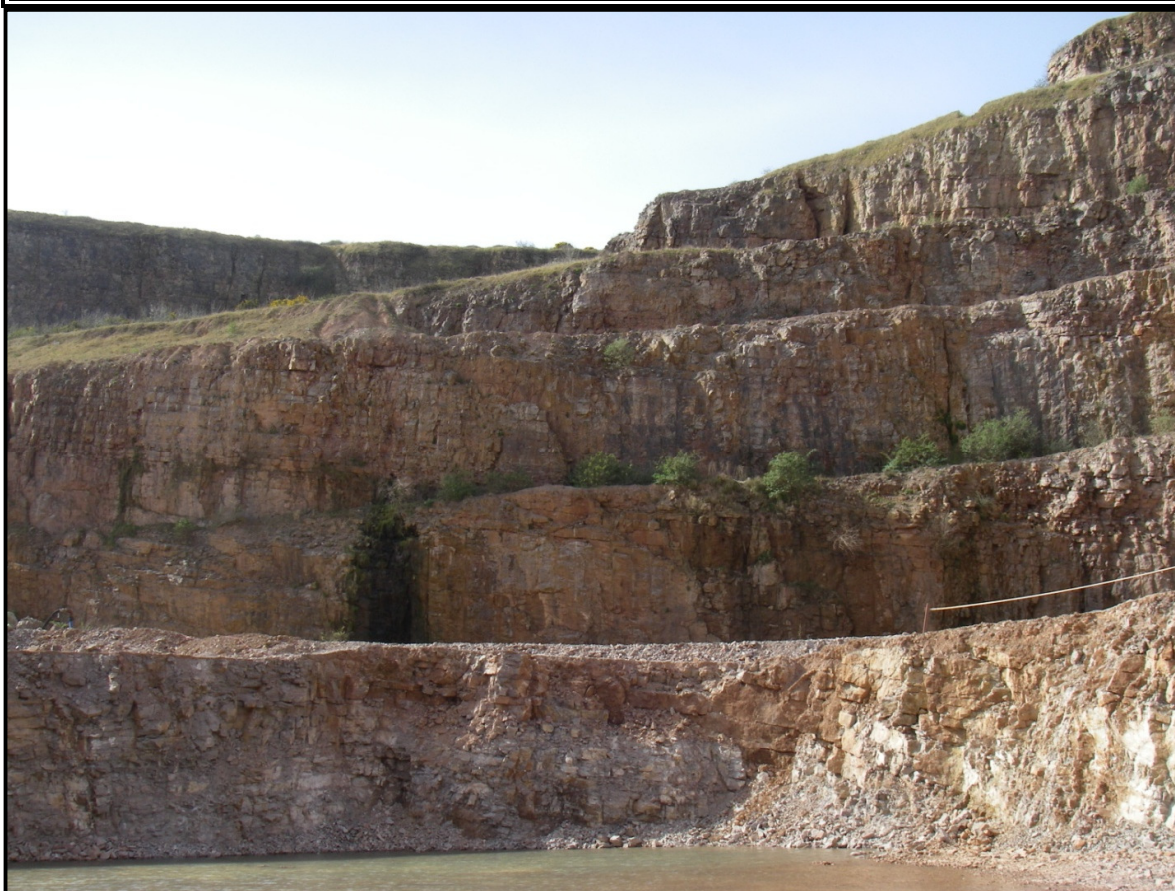
### ***Front cover photograph***

*The photograph shows the north-western face of the quarry. Water which accumulates at the quarry floor mainly result from direct rainfall contribution and surface runoff from the surrounding high ground. Some of the water comes from seepage along bedding planes on the quarry face.*
