Compliance Assessment Report CAR_NRW0046079

Permit being assessed: BL7108IM.

For: Port Talbot Steel Works , **held by:** Tata Steel UK Limited

Type of assessment: Site Inspection,

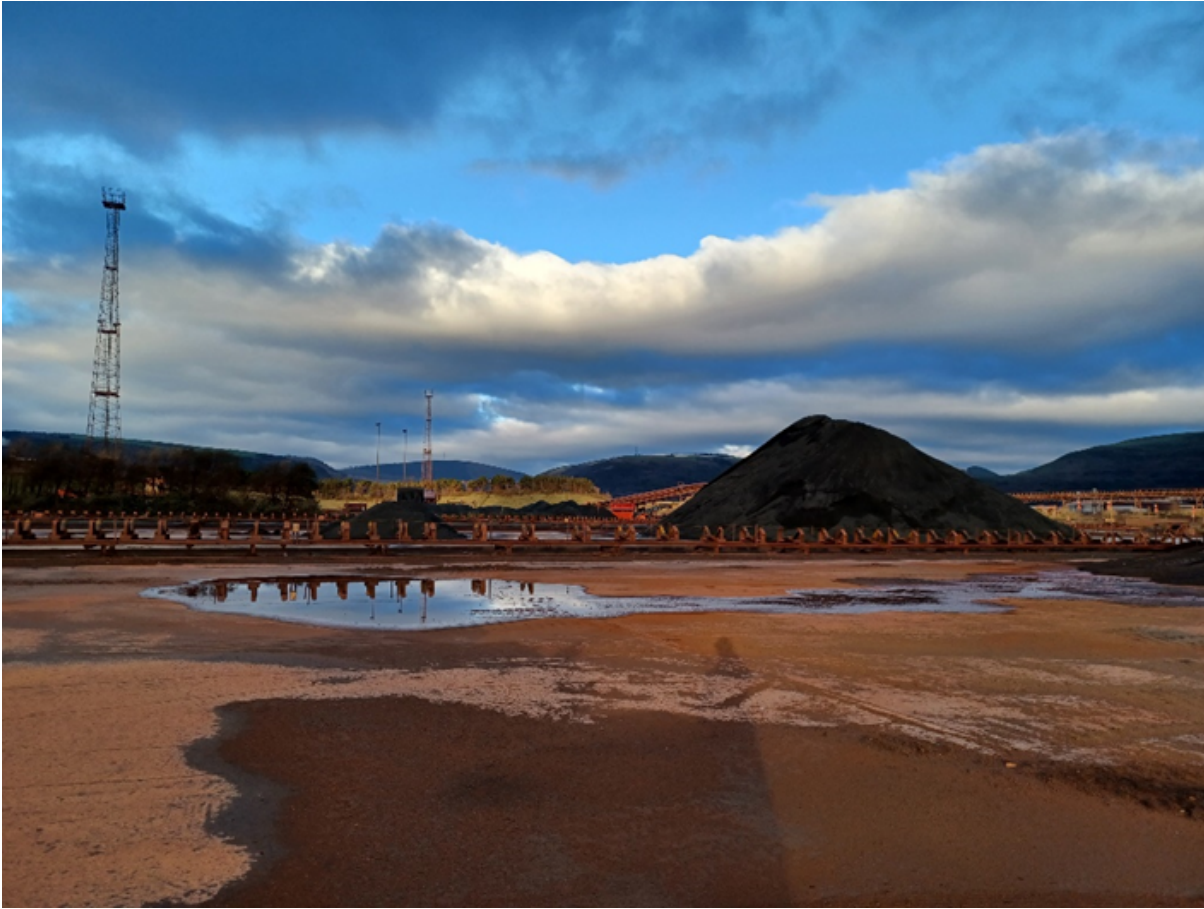
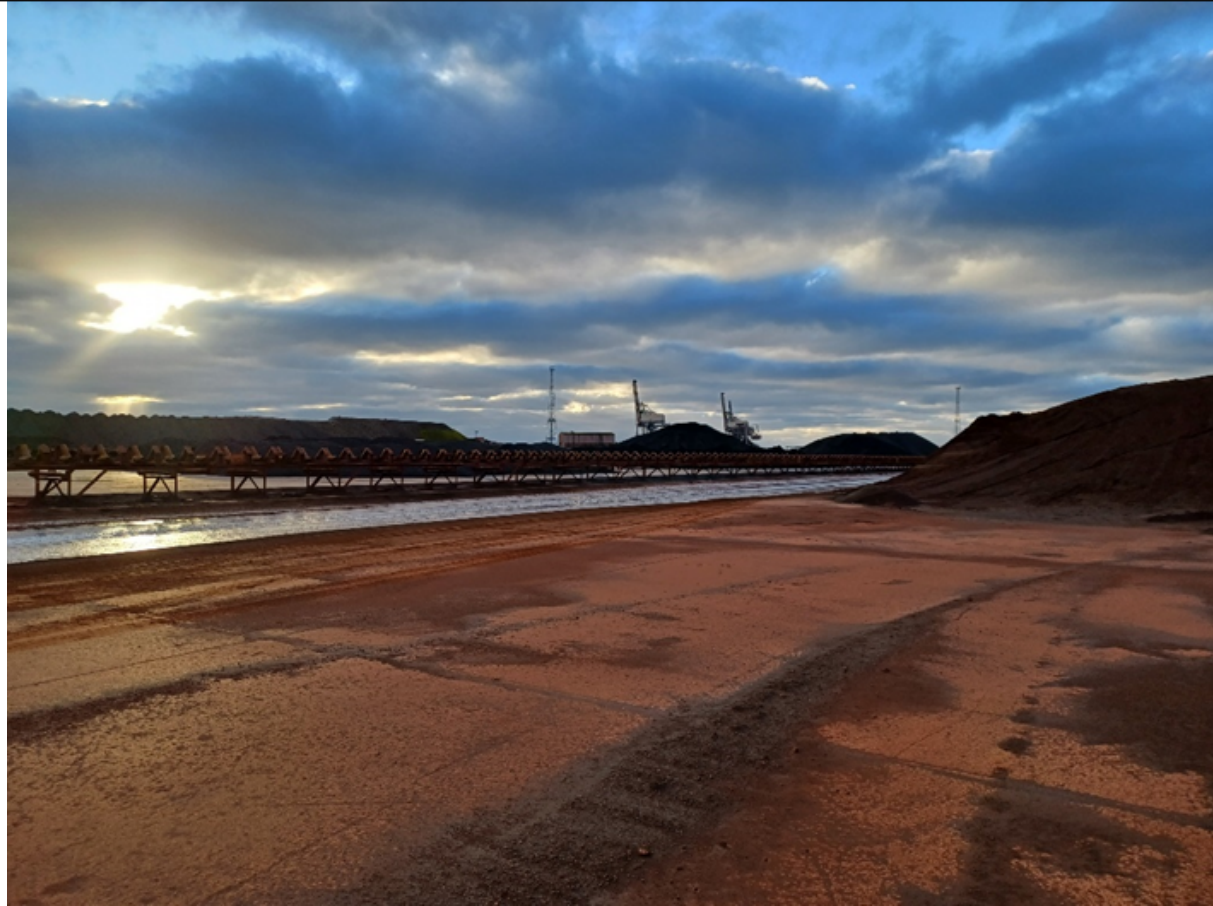
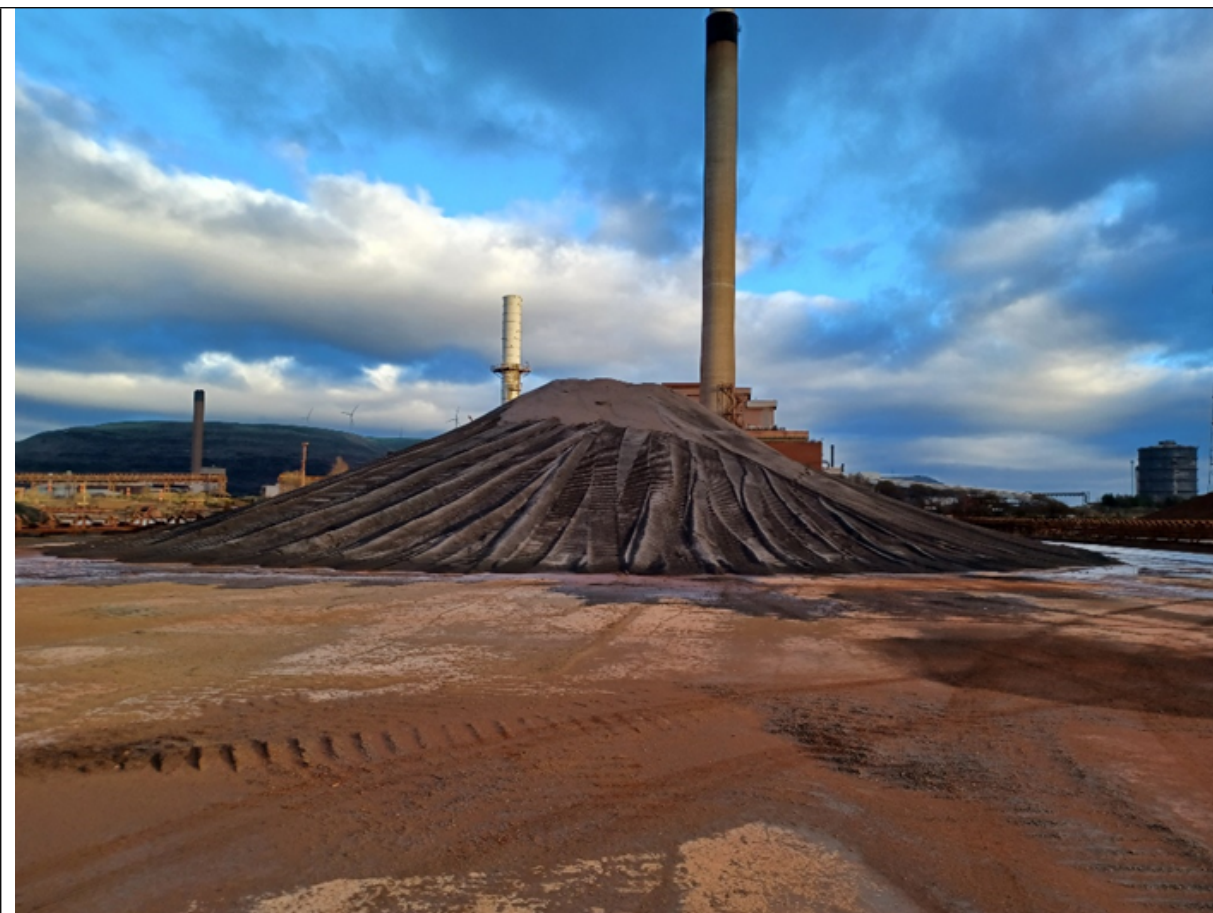
Image 1: View of Primary Ore Stockyards

Image 2: View of Primary Ore Stockyards.

Image 3: View of Primary Ore Stockyards.

The Primary Ore Stockyards were used to store the various ores and fluxes associated with the Heavy End operation. The Primary Ore Stockyards are split into six elongated bays across three yards, NRW were informed that Bays 1-3 were used to house the iron ores, Bays 4-5 store carbon fluxes and Bay 6 held the coke required. It was noted that the material was stored upon hardstanding concrete, NRW were informed that the Primary Ore Stockyard surface water drains to a soakaway, entering Sumps 1 and 2 prior to discharge to controlled waters via W1 (LSO).

Operator is to submit to NRW their updated Ad-Hoc Maintenance Procedure for the Primary Ore, Secondary and Morfa Coal Stockyard Areas. The procedure document

must include details on how TSUK will implement the maintenance procedures and how they will be managed as the landscape of each stockyard continues to change.

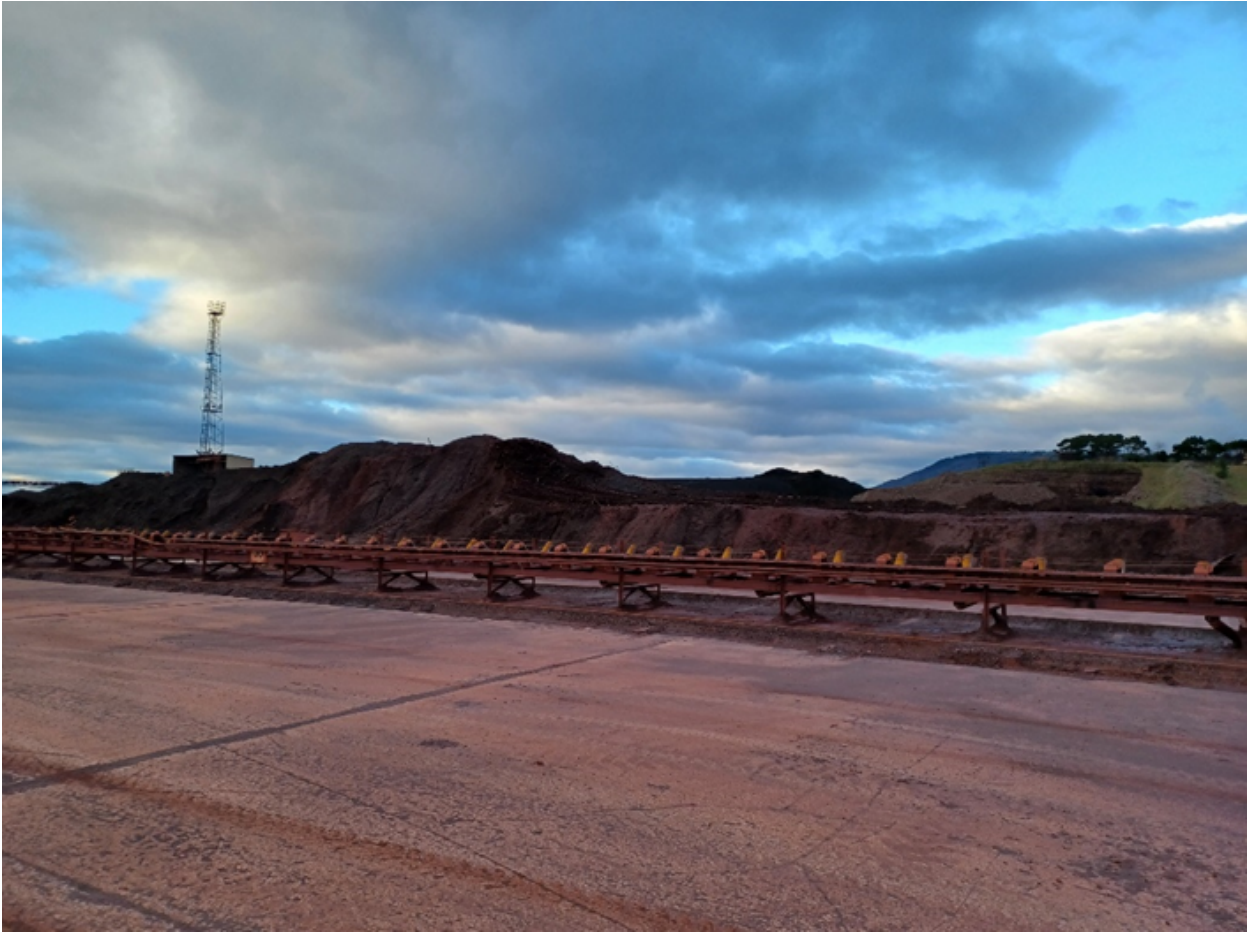
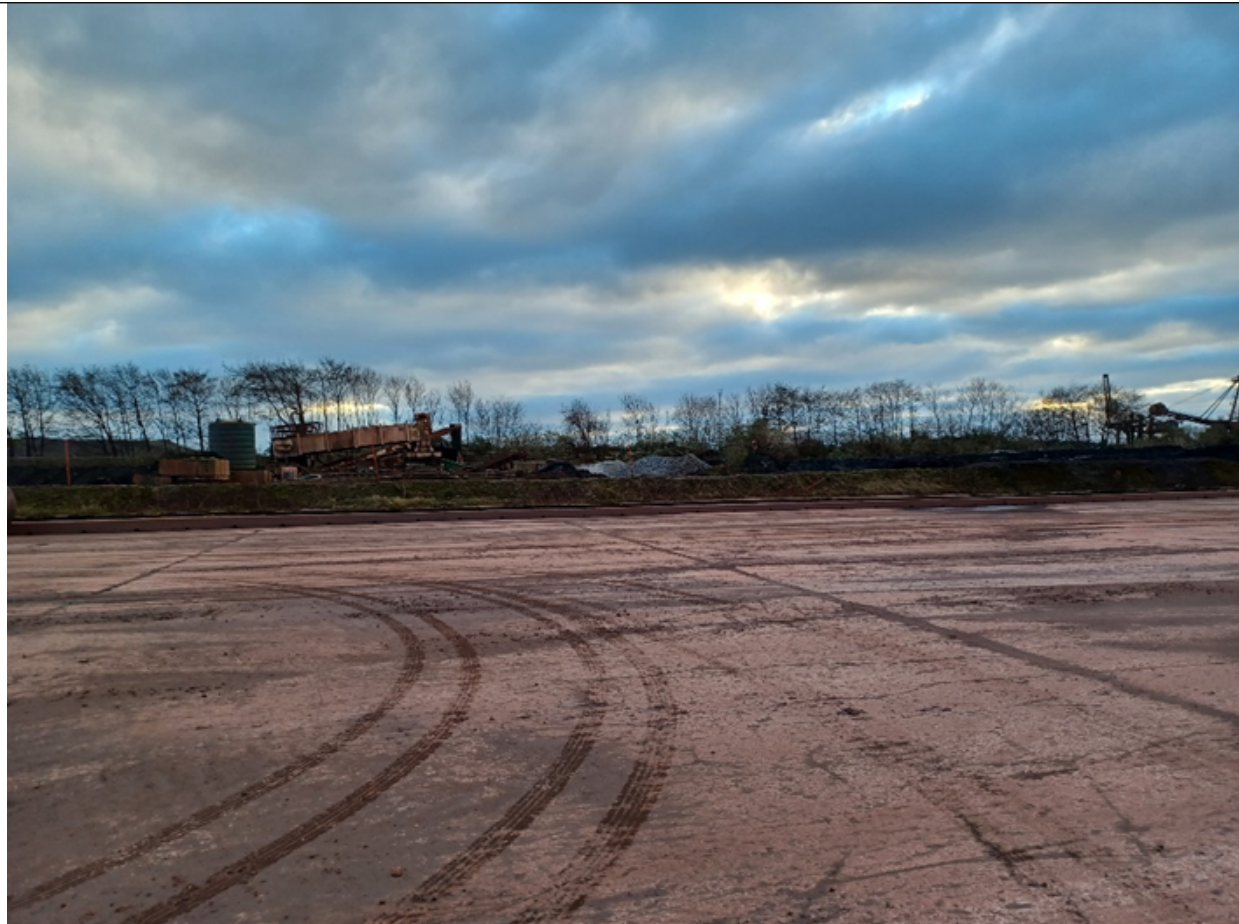
Image 4: View of Secondary Ore Stockyards

Image 5: View of Secondary Ore Stockyards

The Secondary Ore Stockyards held screening material such as pellets, lumps and scrap, which were readied for utilisation within the Blast Furnaces. It was noted that there was a quantity of material currently housed within the Secondary Ore Stockyards, the Operator specified that this material was sourced from the clean down of alternative works areas including the Sinter Plant and Yards. The Secondary Ore Stockyard is within the parcel of land that is proposed to be surrendered during the transition to EAF, the Operator assured NRW that they will undertake robust sweeping activities to ensure cleanliness prior to its surrender. NRW identified linear drainage channels (French drains) along the concrete kerbing of the ore stockyards which receives surface water prior to discharge to W4. It is our understanding that the Secondary Ore Stockyards was the source of the iron rich material that caused red discolouration to the River Afan on the 6th of October 2024, the Operator informed NRW that there was no material stored on that day which attributed to the pollution incident.

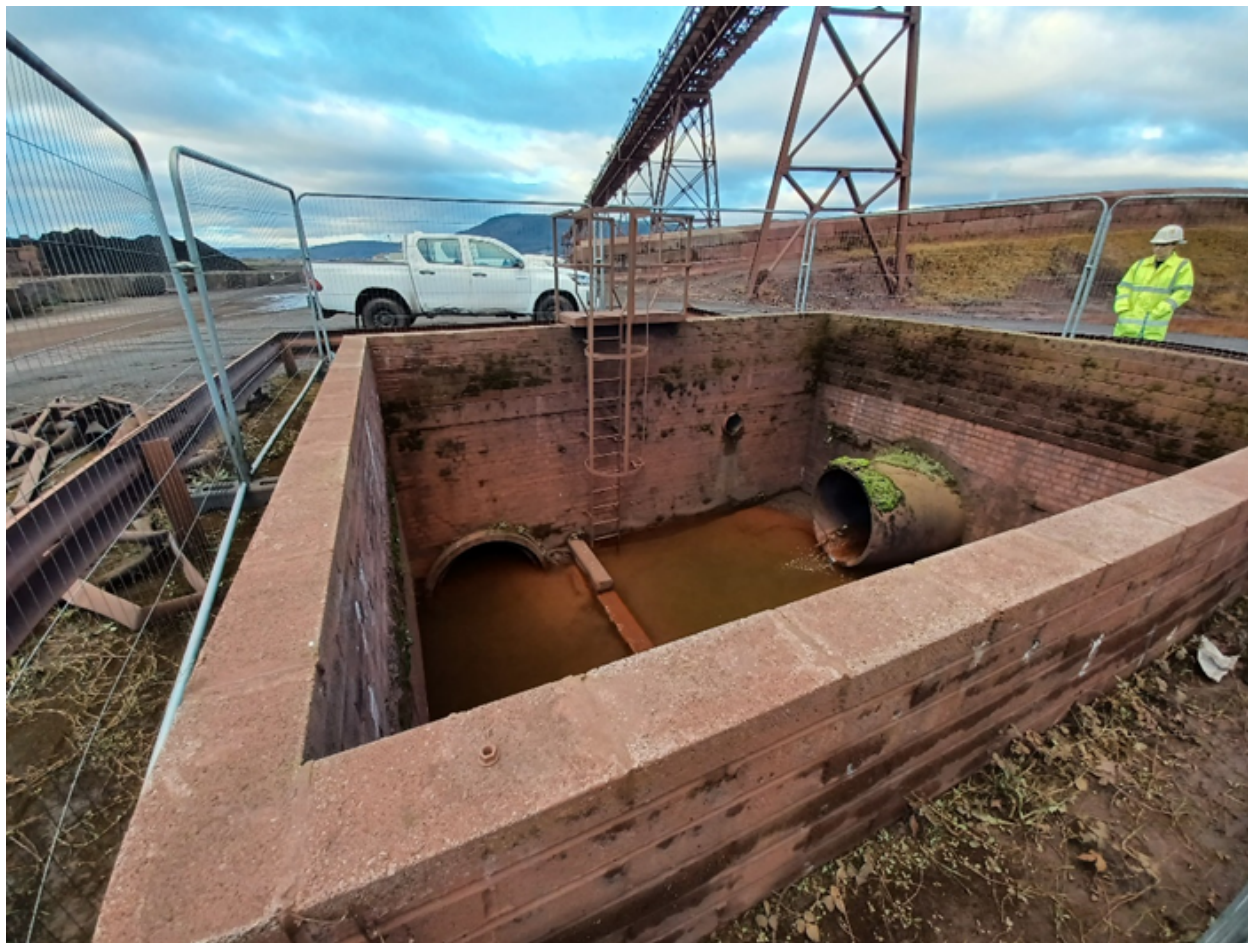
Image 6: W4 Sump - Monitoring Chamber

W4 Sump was noted to be a masonry brick built chamber, with a baffle wall separating the inlets from the outlet. A section of the baffle is lowered, allowing for the water to pass over acting as a weir. There was an accumulation of material noted within the chamber and visible sections of pipework, notably the outlet pipework with an observed cross-sectional loss of approximately 55%. The Operator previously notified NRW of the mechanical sludge removal of W4 Sump which is now undertaken on an Ad-Hoc basis.

Operator is to submit to NRW their records detailing the maintenance and servicing that has undertaken on the W4 Sump, this should include both the time leading up to and since the water pollution incident on the 7th of October 2024.

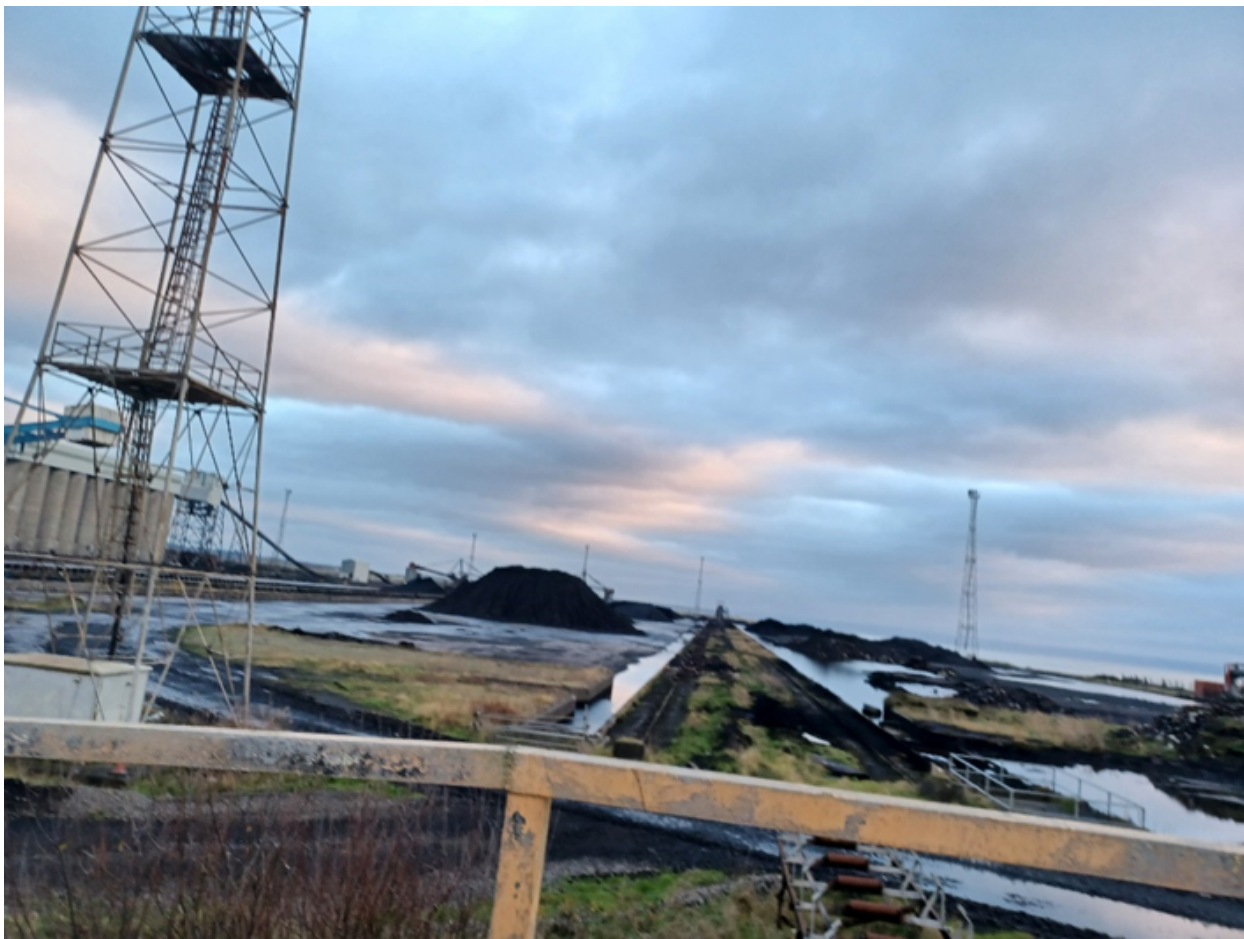
Image 7: View of Morfa Stockyards (Primary Coal Stockyards)

The Morfa Stockyards (Primary Coal Stockyards) was used to store coals, tarred misc, etc which was associated with the adjacent MCO. The Operator specified that the Stockyards are split into four separate yards A, B, C and D. It was noted that there were still quantities of material being stored throughout the Stockyards, NRW were informed that the Operator plans to remove most of this material by the end of January 2025, Yard A contains material awaiting screening prior to removal. The Stockyards is underlain by hardstanding concrete, surface water is directed to guttering which runs parallel along the yard edges. These are connect to the Deep Sump and Sump 10 prior to discharge via W2. As part of the Site's transition to EAF, Yards B, C and D of the Stockyards will be utilised as laydown areas during construction works. During the site walkover, NRW Officers observed the deployment of mobile bowsers to minimise the risk of fugitive emissions from dust lift off.
