## Compliance Assessment Report CAR\_NRW0046182

**Permit being assessed:** AG0011001

For: PENDOYLAN STW, held by DWR CYMRU CYFYNGEDIG

**Type of assessment carried out:** Site Inspection, Reason: Routine.

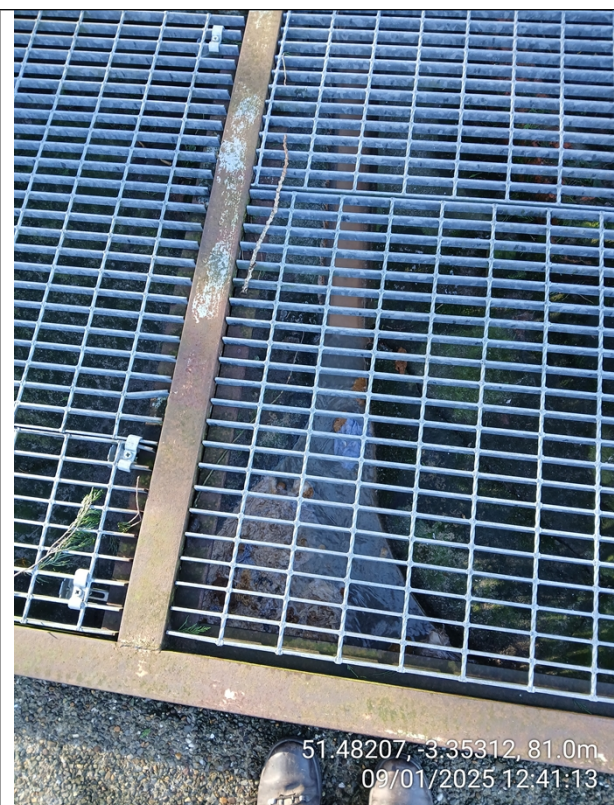
There are no inlet screens at this site but there is a scum board at the entrance to two primary settlement tanks (emptied by tanker weekly alongside the humus tanks); solids were observed at the inlet channel with a steady but low flow. An odour stronger than expected was noticeable throughout the site.

*Inlet channel at site*

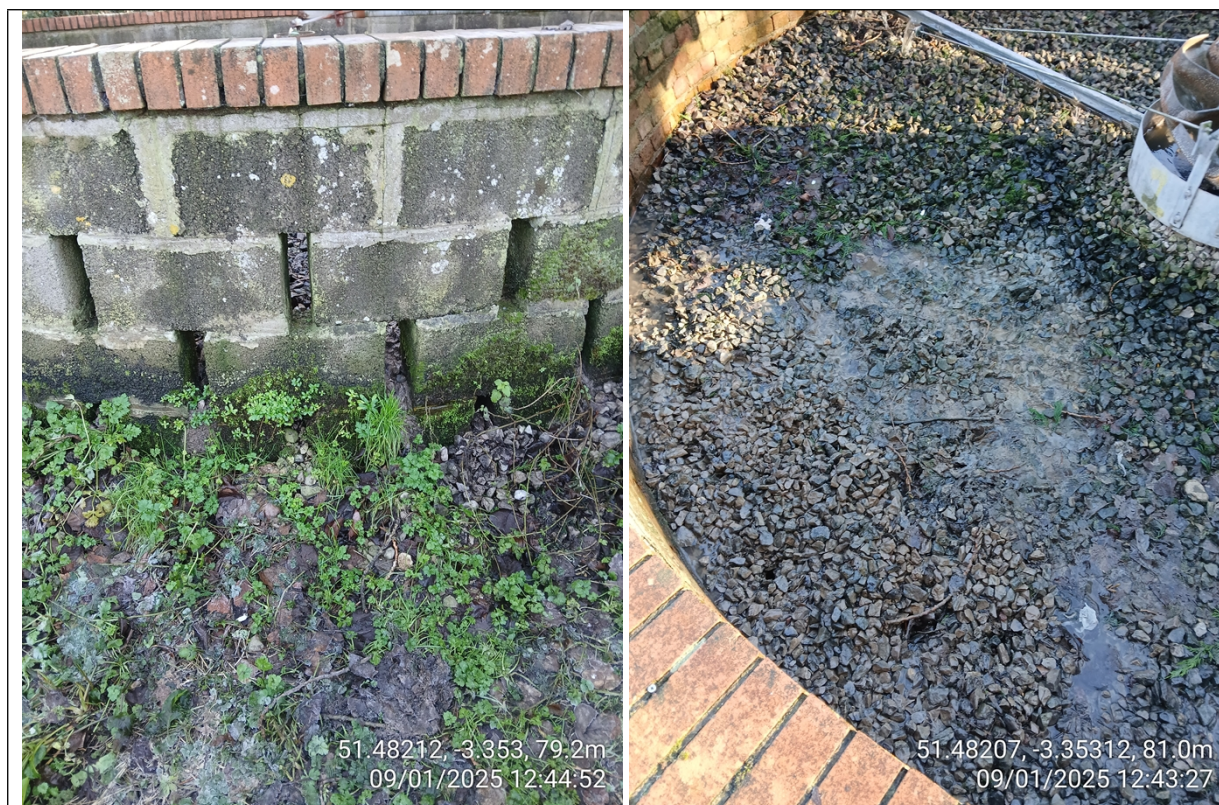
This is comprised of two gravity filter beds which appear to be in generally poor condition. There was ponding at the surface of both beds and effluent continued to seep through ventilation gaps between breeze blocks of the filter bed structure on one of the tanks, as noted during the previous inspection in 2022, both of which compromise the treatment process. Overall, the beds continued to lack maintenance and function poorly. It was discussed on-site that there is no set maintenance regime but it is currently in discussions within DCWW.

*Left: Gaps between breeze block in filter bed 1.*

*Right: Pooling on the surface of filter bed 2.*

**Action: Address the seepage coming from the filter beds to ensure all effluent is remaining within the treatment process. Also, level out the gravel in the other filter bed and consider some general maintenance.**

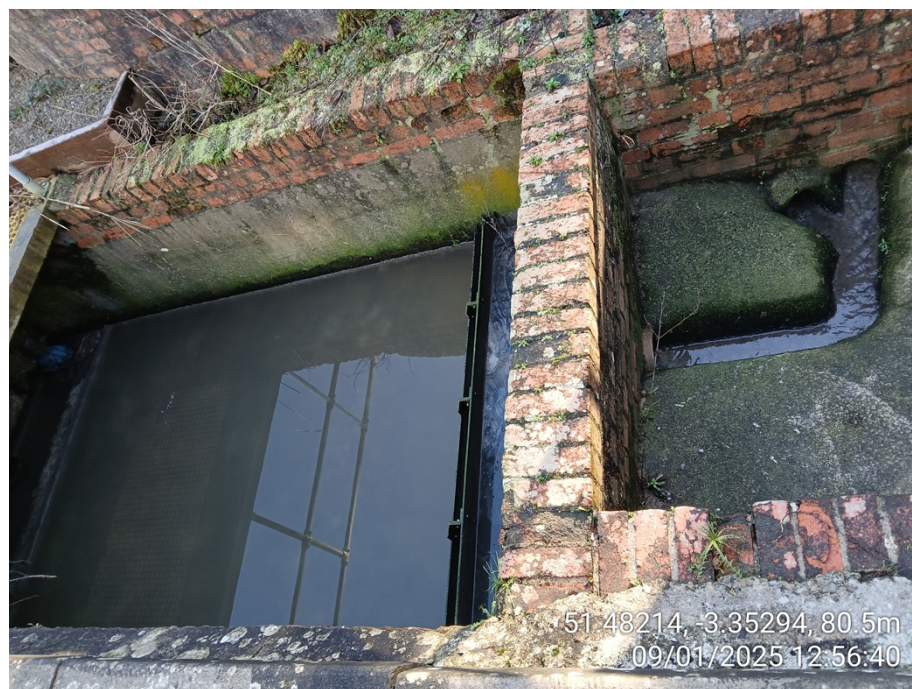
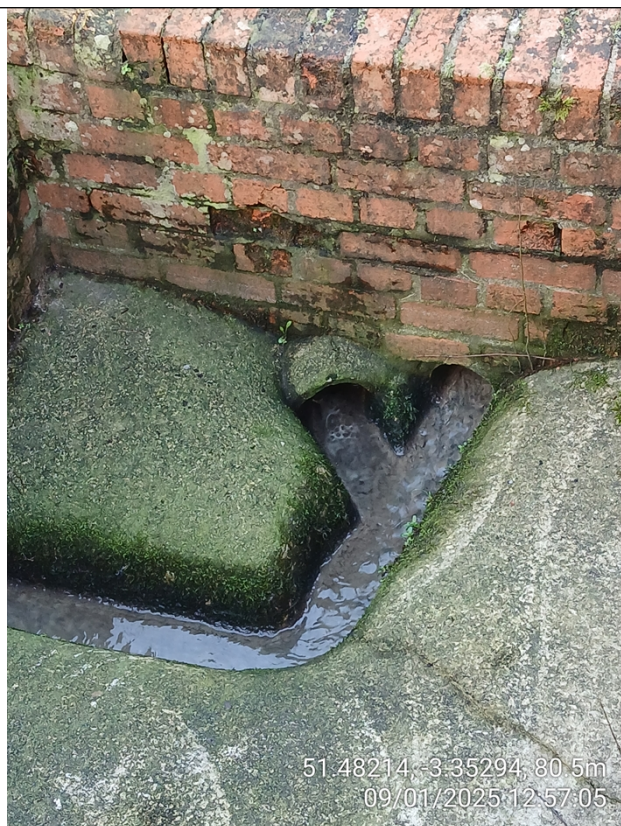
Following this, filtered flow settles in humus tanks which are now emptied weekly, following issues raised during the 2022 inspection. At the time of inspection, these had just been emptied so did not have any fats or solids present, though the inlet to the humus tanks did show clear growths of sewage fungus and grey staining, indicative of poor treatment.

*Humus tank (top), inlet pipe to humus (bottom).*

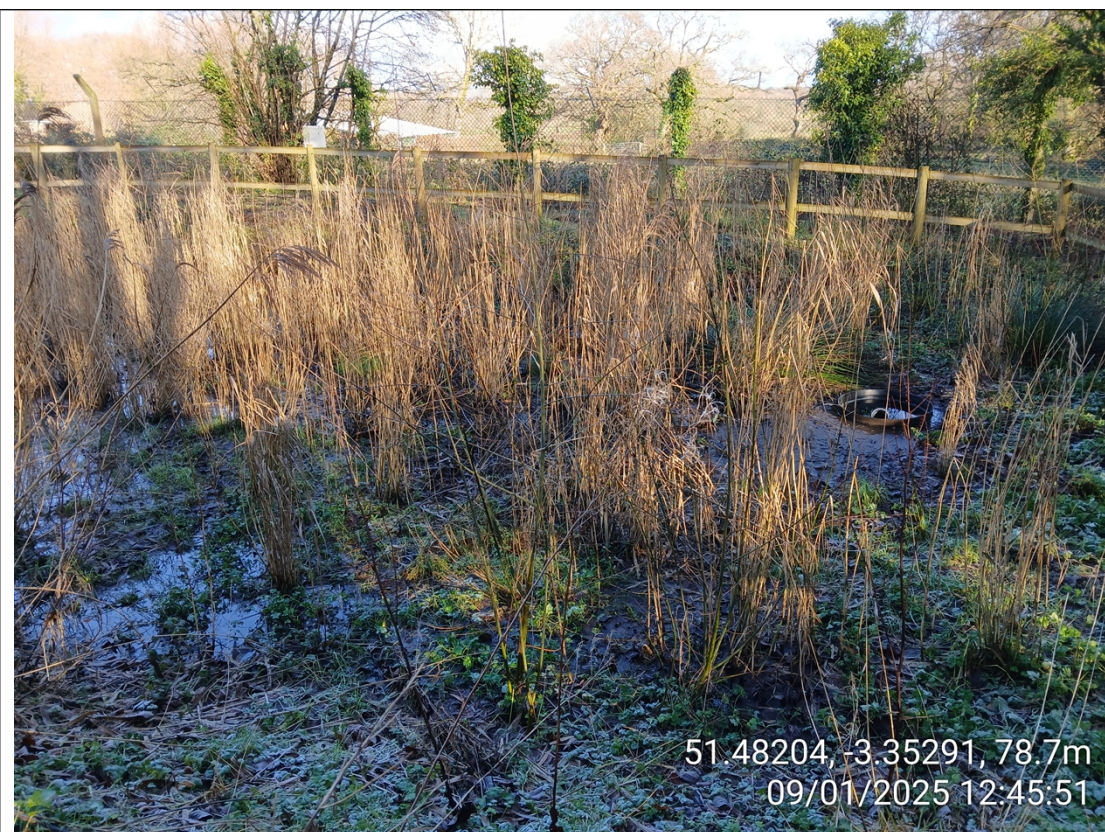
From the humus tanks, effluent goes through a reed bed before leaving site which had been cut back and secured following the previous inspection in 2022, but did not appear to be in good working condition. There was ponding on the surface throughout and the reeds appeared to be relatively few and far between; overall, better maintenance and perhaps replenishment is needed.

*Pooling on the reed bed*

**Action: Investigate the effectiveness of the current reed bed and provide a plan to remediate.**

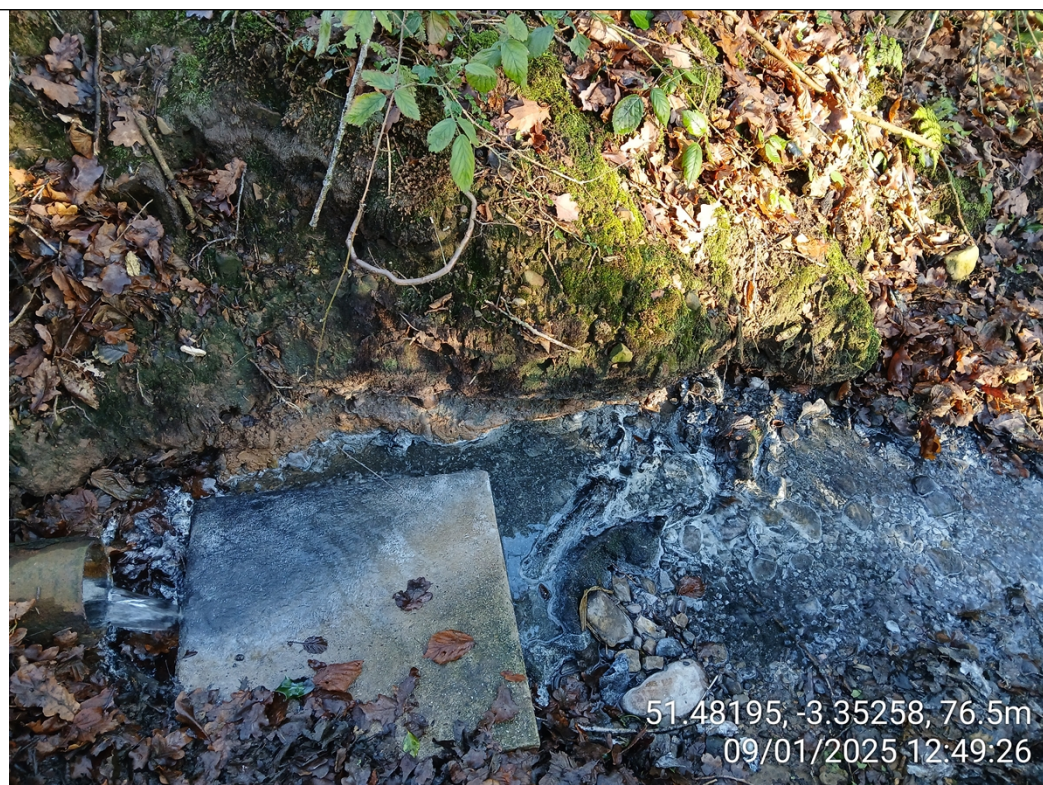
The Final Effluent sample point was clearly labelled and within the site compound, yet had a noticeable odour and displayed signs of the white fungus witnessed back in 2022, albeit to a lesser extent. At the outfall itself which is easily accessible from the site, the FE appeared clear in composition but again strong in odour and white fungus deposits were visible for approx. 3-4 metres - pictured below. It is noted that the discharge point is approximately 1.5 metres from the mixing point with the Pendoylan Brook, however this same issue (to a greater extent) was recorded during the 2022 inspection.
