## Compliance Assessment Report CAR\_NRW0045529

**For:** Teifi Park Abattoir EPR/BV9683IH, **held by:** Dunbia UK

**At:** Teify Park , LLANYBYDDER, Carmarthenshire, SA40 9QE.

**Type of assessment:** Site Inspection,

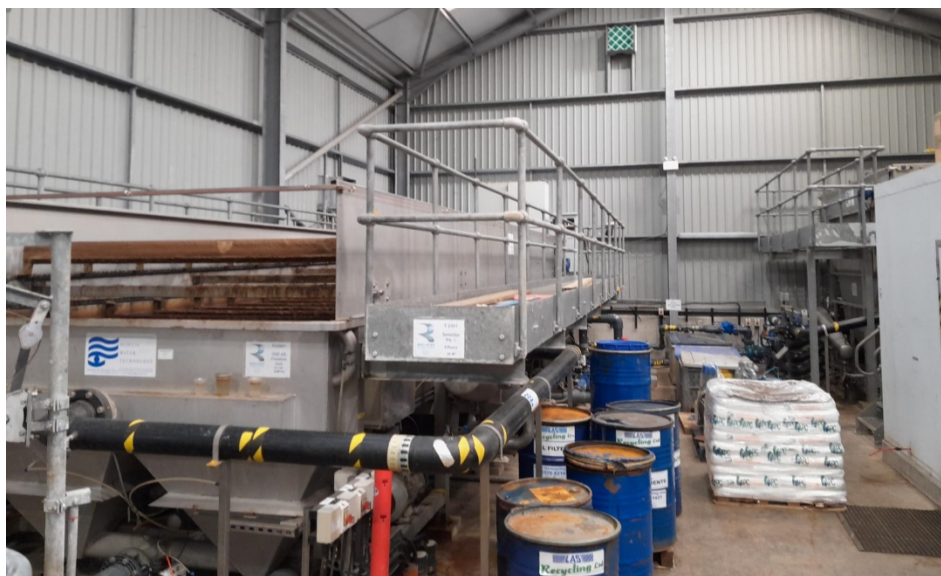
The ETP has a dissolved air flotation (DAF) phase which is housed within an enclosed building, as seen in Image 1.

Image 1 – showing DAF within the enclosed building, taken on 3 October 2024

The ETP is identified as an odour source within the site's OMP and the operator has identified and implemented appropriate control measures to reduce potential odour emissions from this location as far as reasonably practical.

Once solids have been separated and scraped off, dried material is collected in the sludge cake trailer in the building annex. This room has fan ventilation in the walls vented through an air filter. This part of the process previously used to utilise a centrifuge for the dewatering of the sludge, which was replaced with a screw press; this has reduced odour and noise due to less turbulence of material.

The Officer questioned the shutter door to the unit being partially open. It was stated that allowing a slight gap is conducive for aeration and prevents build-up of odour particles and eventual release when having to open the shutter door for vehicle manoeuvring. Material is collected in a trailer until full and taken away approximately 3 times a week.

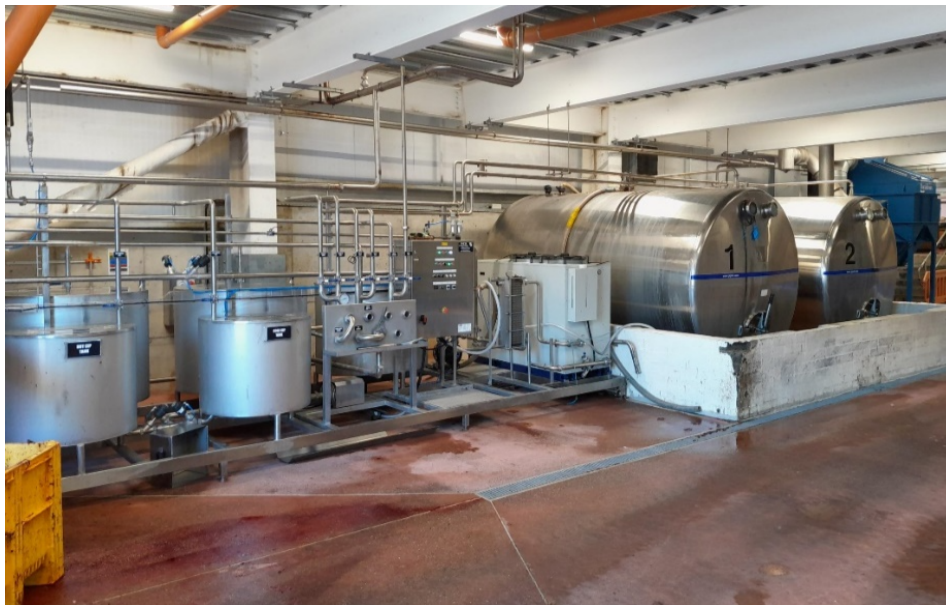
Blood tanks have also been identified as potential odour source within the permitted area. Tanks are located within the main unit with a shutter door that remains largely open during operational

Blood is removed from the site tank on a frequent basis approximately three times a week. Odour abatement is installed on the blood storage tank vents - during blood collection the tanker connects to a carbon filter on site and any exhaust air expelled from the tanker passes through the carbon trap.

The beef blood collection tank is refrigerated, and no animal by-products or materials are left in open storage vessels overnight. The area is inspected by staff and ensure shutter doors and closed during the night. When emptying the tanks, connecting pipes are attached using a closed pipe mechanism as to minimise any residual material from escaping.

Image 2 – showing blood tanks and refrigeration systems, taken on 3 October 2024

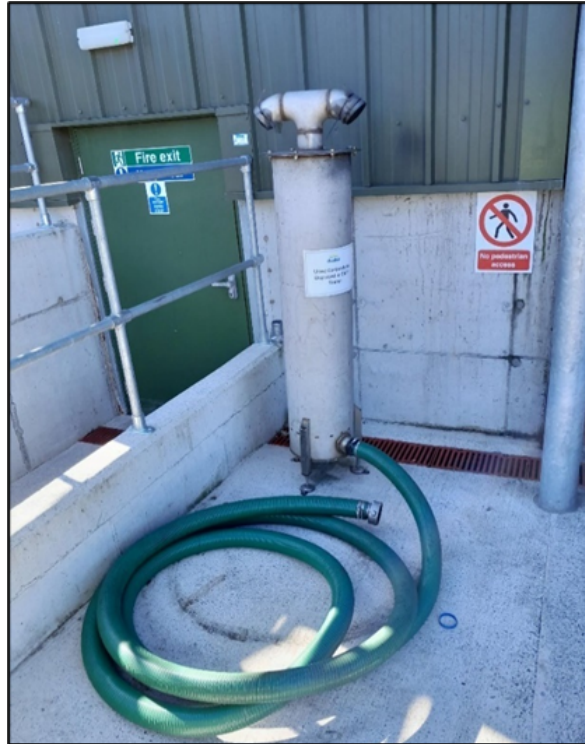
During inspection the operator agreed with the importance of using the carbon filters as an odour abatement measure. A filter for the blood storage area is located within close proximity to the unit, as seen in image 3. A carbon filter is also used on the tanker to capture any gas emissions displaced by the tank vessel in order to create the vacuum required to withdraw the blood from the tank. This is considered good practice to which the operator agreed and confirmed that this abatement measure would be continued going forward.

The Officer queried how frequently the carbon filters are replaced as to ensure their effectiveness in molecular filtration and minimising odour emissions - these are done biannually. This is sooner than the manufacturer recommendations, however, again demonstrates good practice to ensure the filters are functioning and effectively capturing fugitive odour from the transfer activity.

Image 3 – showing carbon filter outside the blood storage unit, taken on 3 October 2024
