## Compliance Assessment Report CAR\_NRW0046674

**Permit being assessed:** AN0222302

For: TAFFS WELLL QUARRY HEOL GOCH, held by Breedon Trading Limited

**Type of assessment carried out:** Site Inspection, Reason: Routine.

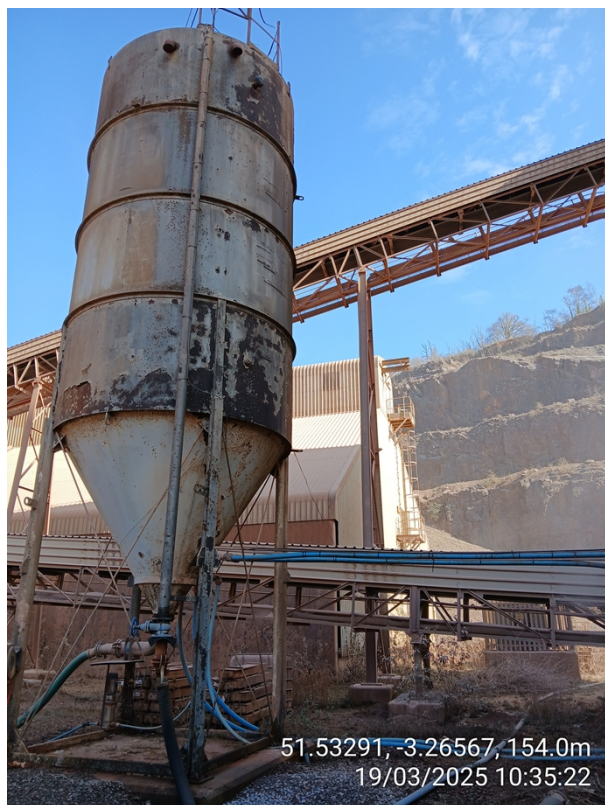
A site walkover then took place, primarily to assess the abstraction elements of the site in reference to CAR\_NRWNRW0048102. Officers wish to thank the Site Manager for escorting them to both the quarry face and the permitted outfall. It was discussed that the reason the discharge is rainfall dependent, and not linked to the abstracted water, is because that is kept in an on-site water tank which is filled once or twice a day as necessary and thereafter primarily used to feed the wheel-wash facility, as well as dust suppression when required. Meters on site record the volume both entering the tank and heading to the discharge location – though the latter requires verification. **Action: Please confirm if the abstracted water which is stored in the site water tank is later discharged to the outfall and River Taff.**

***Water holding tank***

1. **Action:** Site Manager to share records of sampling & outfall visits for the last 12-18 month period.
2. **Action:** Please confirm if any of the abstracted water which is stored in the site water tank is later discharged to the outfall and River Taff.
3. **Recommendation:** prior to pumping/discharging in future, photos are to be taken of the material to be discharged and of the outfall as best practice and to assist NRW in investigations where required.

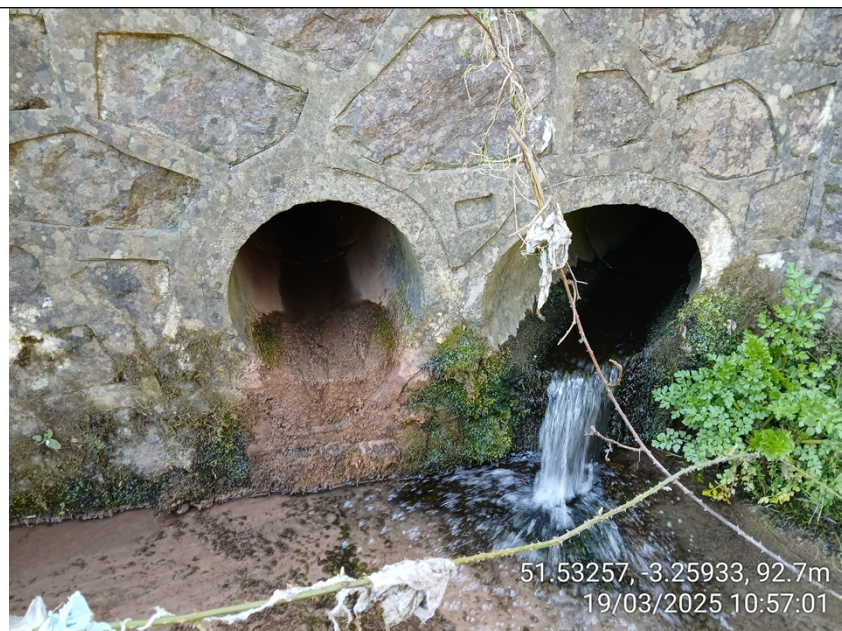
The site outfall (left) was not discharging at the time of visit, but the surface water outfall not linked to the site was (right). The location was noted as in line with **Condition 4**.

***Outfall location: Left is quarry, Right is surface water.***

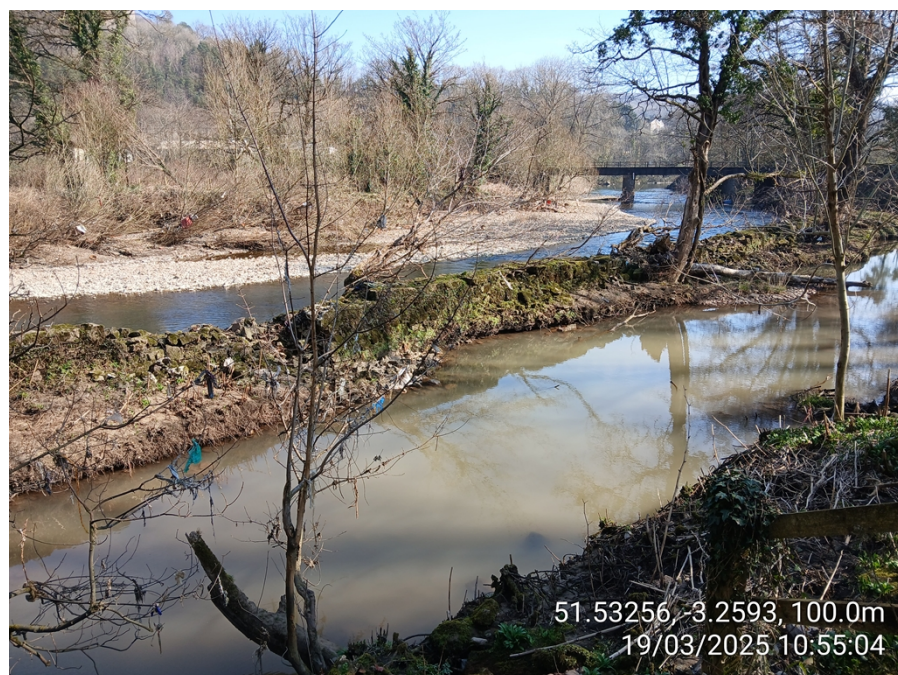
There was then discussion around the WIRS earlier referred to, regarding the pathway of silted water entering the River Taff near this location. The outfall discharges into a waterbody which is separated from the main river by a brick wall, the purpose of which is unclear but is presumed to have historical context, within which any suspended solids settle out due to its mostly stagnant nature. The Site Manager, however, has witnessed that during heavy rainfall the main river often rises in level to overtop this brick wall and spill over into the separate channel, which then disturbs the sediment and provides a means of it spilling over into the main channel. It was speculated that when the discharge from this site is in action, it too may disturb settled sediment, however there was silt discolouration visible within the outfall pipe as pictured. The Site Manager intends to document and share this the next time the main river overtops into the separate channel.

***Waterbody separated from main River Taff by a brick wall, confluence just past the edge of photo.***

It was mutually agreed that in future, before pumping/discharge takes place photos will be taken of the outfall and of the material to be discharged, both in order to assist NRW in any future WIRS investigations and as best practice for the site. The discharge is checked visually prior to discharge from site and it was noted that there are working faces above the abstraction point so the site is not reliant on pumping if water does not pass the visual inspection.
