## Compliance Assessment Report CAR\_NRW0048319

For: Llanyre Wastewater Treatment Works, held by DWR CYMRU CYFYNGEDIG

**Type of assessment carried out:** Site Inspection, Reason: Routine.

On 02/05/2025, between 10:25 and 10:45.

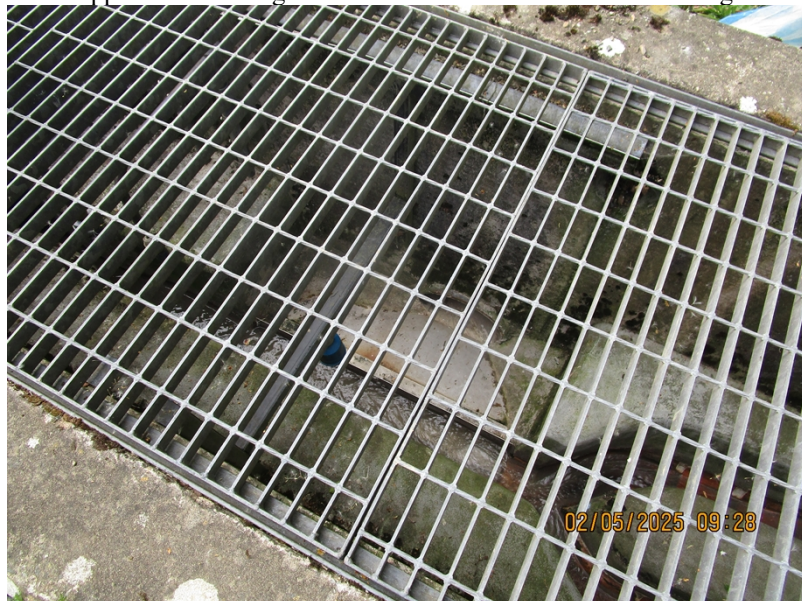
The incoming flow comes into the works via gravity sewer. At the inlet there are two macerators in place, only one of which is running at any time. The second macerator operates as a standby. The macerator in use was clearly operating at the time of inspection, and there were no solids or rag present within the inlet following the macerator.

The storm weir on site is a hard-set storm weir, where flows can only spill over into the storm channel once the inlet level reaches the specified level. There is an EDM level sensor in operation within the inlet channel at the storm weir, which appears to be being used to record when the works is running to storm.

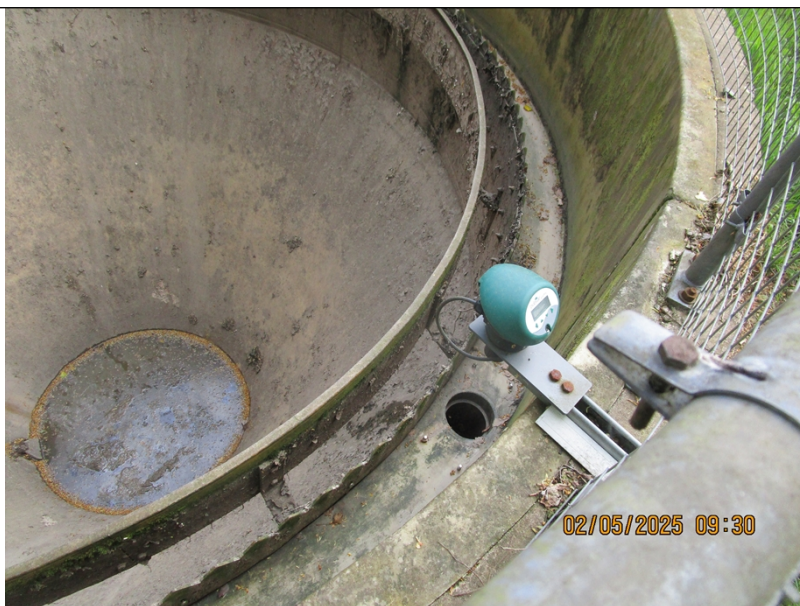
The flows were well below the storm weir setting in place and there were no flows entering the storm channel at the time of inspection. The storm channel appeared clear of debris or blockages. There is no additional screening, as all flows pass through the macerator before the storm weir.

There is a single storm tank, which was empty upon inspection. The storm tank auto returns to the head of the work once incoming flows fall below a set level. There is an EDM monitor in place within the outfall channel to record when the storm tank is discharging to the storm discharge point (to environment). There was no indication that any recent discharges via the storm discharge channel.

1. The storm sewage sampling point was not labelled at the time of inspection. It would be advisable to install an appropriate sign to ensure sample are collected from the correct place (if required)

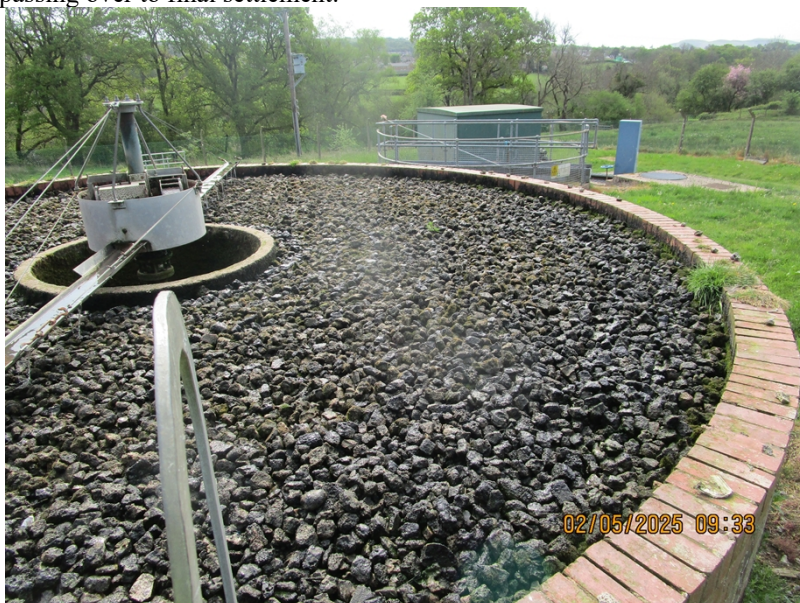
The works contains a single filter bed of stone media. The rotating arm is powered by a water wheel in the centre column of the filter bed. This was moving freely and unhindered. The rotating arm appeared to be distributing effectively over the filter media and there were no signs of ponding or excess vegetation growth present at the time of inspection. The outfall from the filter bed appeared to be flowing clear and there were no signs of sewage fungus growth or solids passing over to final settlement.

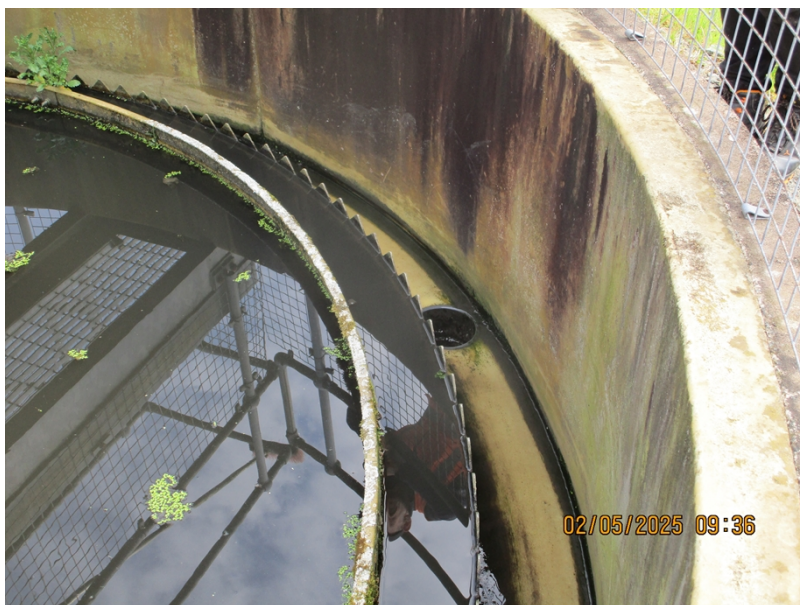
The humus tank on site is a single circular tank with retention boards to hold back solids from the outfall. This appeared to be operating effectively and there were no signs of solids or sewage fungus within in the outfall channels.

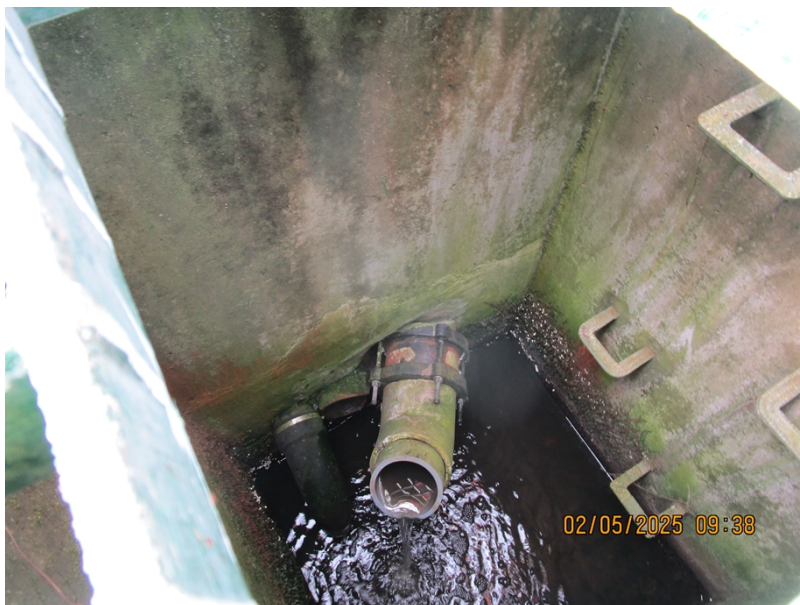
The sample point was clearly labelled and appeared appropriate for collecting a representative sample of the effluent. The storm discharge point is also located within this chamber, but it is set at a level below the sampling point to ensure that it cannot contaminate the final effluent sample. The effluent within the outfall chamber was flowing clearly at the time of inspection. There were no signs of discoloration, significant solids or sewage fungus present within the outfall chamber.
