## Compliance Assessment Report CAR\_NRW0048656

**Permit being assessed:** BB3197FK

For: BikePark Wales, held by Beic Parcio Cymru Ltd

**Type of assessment carried out:** Site Inspection, Reason: Routine.

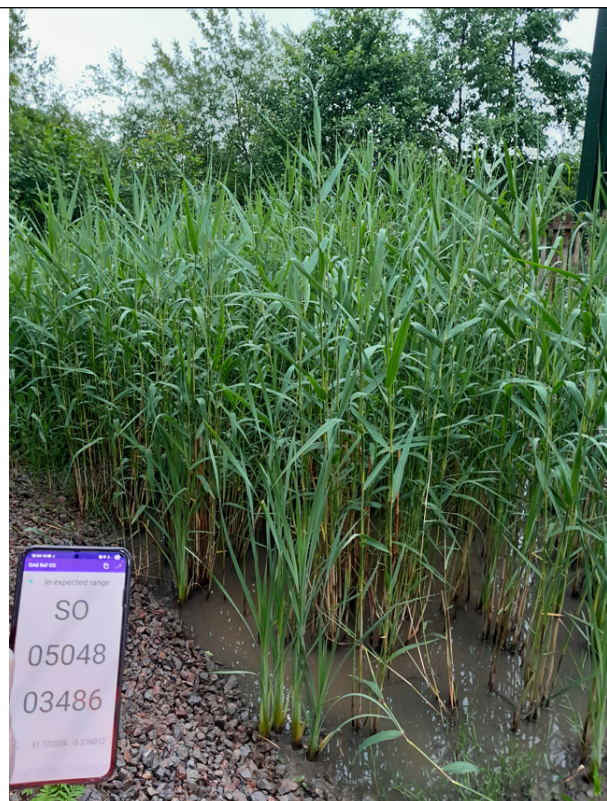
The silt trap was clear prior to the reed bed and water flowing freely into the treatment process. Reeds appeared to be in good condition (*photograph 1*) and I was informed that the last maintenance was completed in January 2025. A written management system is in place for the system. A daily/weekly check log is kept as seen in previous site visits and part of their records management. The site was setup as per schedule 7 of the permit with two separate bike wash stations with all effluent passing through a reed bed prior to discharge at the Nant Graig. This outfall is also fed by the PTP (EPR-AB3591CP) on site.

*Photograph 1: Reed bed*

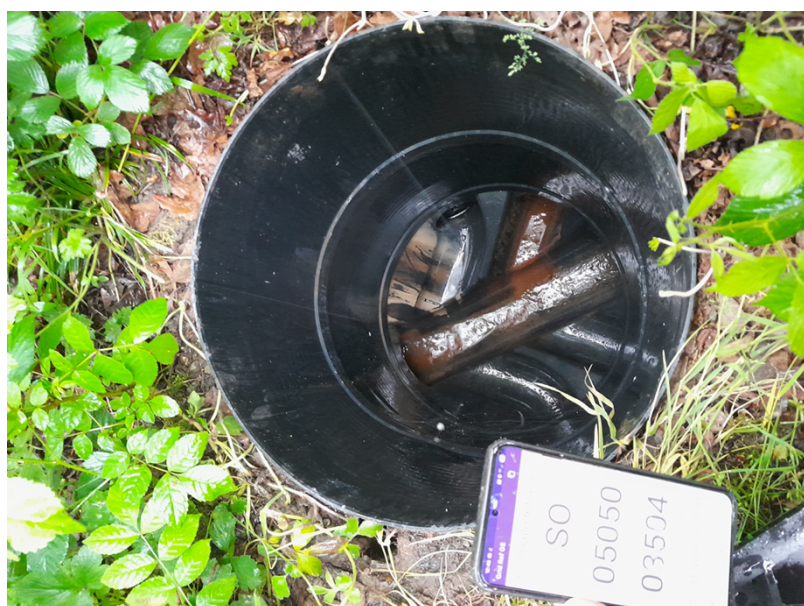
The monitoring point location for the bike wash was checked against Table 3.3 of the permit. An inspection chamber was present in the correct location, NGR SO 05050 03504. There appeared to be ingress of silt into the pipework from the side of the chamber which may be allowing suspended solids into the system (*Photograph 2*). The bike wash pipework also appeared to have silt sitting on the bottom of the pipe (*Photograph 2*). The bike wash could not be sampled at this time due to low flows and small pipework meaning taking a representative sample would be impossible without disturbing any sediment which had settled out (therefore not being representative of any discharge).

*Photograph 2: Bike Wash Monitoring Point*

Both the ingress of water and deposited silt at the bike wash monitoring point (as seen in photograph 2) have the potential to increase suspended solids in the discharge. Although not impacting at the time of the visit (as seen in the sample result) under higher flows it is likely these solids will be mobilised and seen in the discharge. This may be related to

intermittent exceedances seen in sample results for the discharge.

- Investigate the cause of suspended solids seen in the bike wash monitoring point pipework. Detail what measures have been taken to rectify the problem. Complete by 25/07/2025.
- Investigate the cause of suspended solids ingress in the bike wash monitoring point pipework. Detail what measures have been taken to rectify the problem. Complete by 25/07/2025.

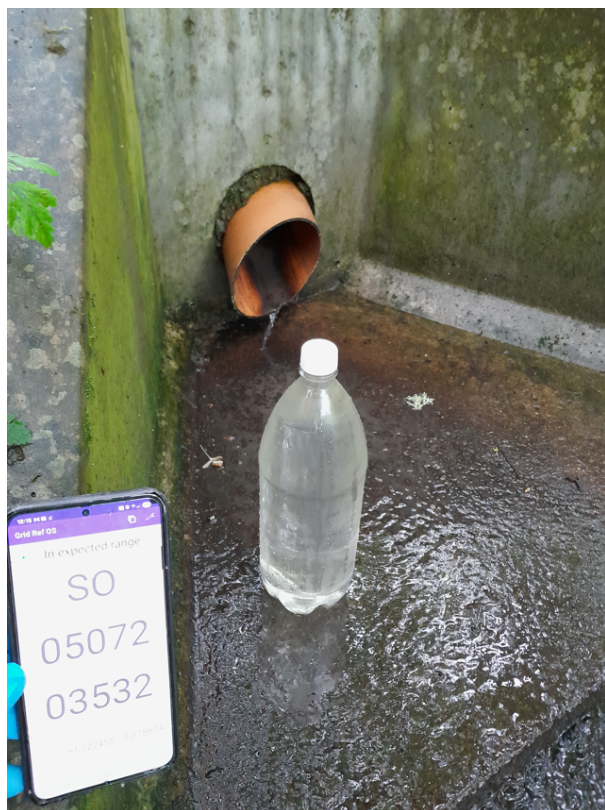
Despite not being able to sample from the monitoring point a sample was taken from the discharge as part of the inspection of permit EPR/AB3591CP. As previously noted both the PTP and Bike wash discharge at this location. The suspended solids result for the sample was 6mg/l which is within the limits for Table S3.1 of Schedule 3. No grease or oil were visible in the discharge (*Photograph 3*).

*Photograph 3: Discharge point and Sample*
