Compliance Assessment Report CAR_NRW0048683

Permit being assessed: NP3894FK.

For: Point Of Ayr Treatment Facility, **held by:** Delyn Metals Ltd

Type of assessment: Site Inspection,

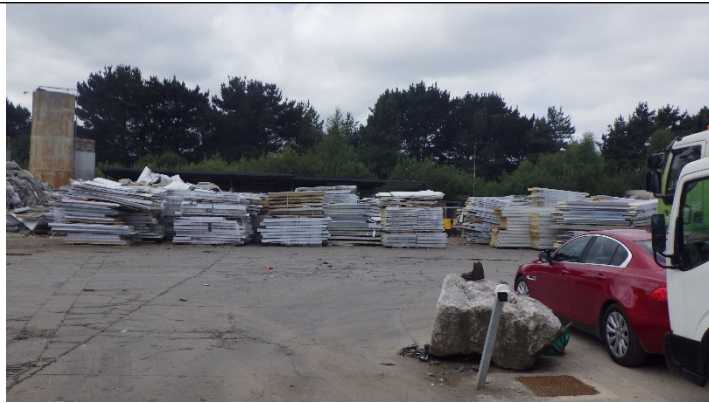
During the inspection officers saw a large number of insulation panels being stored there. It was raised with the site manager who stated that this was a temporary measure as the site had been unable to process them due to high winds.

It's noted that the storage of the insulation panels was almost identical during the last visit and had been discussed with the management at the time.

The area where the panels were stored is not included in the site plan and therefore a breach of the condition 1.1.1 which states: "No waste management operations shall be authorised by this licence unless, 1 specified in and undertaken in accordance with the limitation in the following table. Table 1.1. Specified waste management operations – Storage The storage of waste shall be restricted to the areas identified for this purpose and outlined in red on site plan reference No. DELYN/PDA/002 16092006. This breach has been assigned a **CCS3 score**.

Panels stored on site

Action: Please ensure ELVs are stored in compliance with the site permit. Please comply by the **18th of July 2025**.

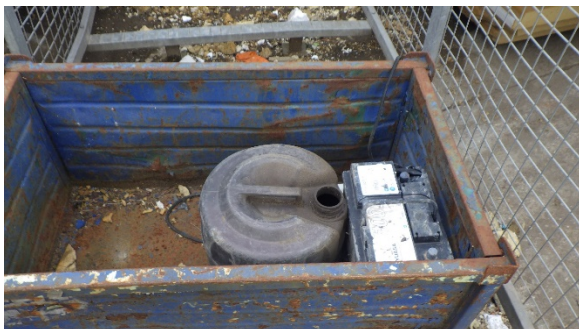
The batteries storage area was checked and the officer saw a number of batteries stored in unsuitable containers with some of them being corroded and perforated in places. Some of the batteries were seen stored on a pallet, open top boxes with no weatherproof cover and a one directly on the ground. Please see the photos below.

Table 4.4 b) v) states: “Lead acid batteries shall be stored in containers with impermeable, acid resistant base and a lid to prevent ingress of surface water”.

Battery stored in an open top container with no cover

Action: Please ensure the batteries are stored in compliance with the site permit. Please comply by the **18th of July 2025**.

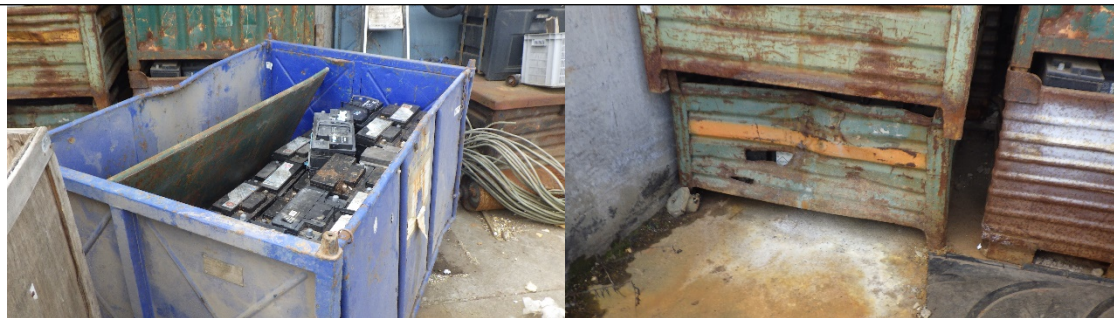
Batteries stored in an open top container and in a perforated container under cover

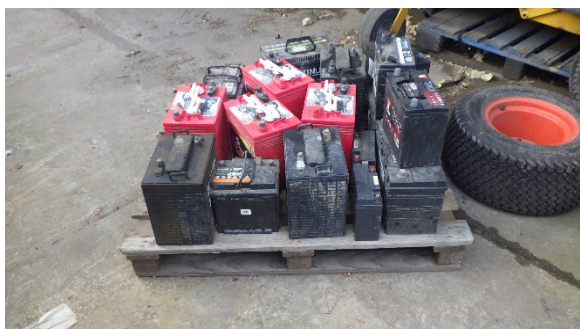
Batteries stored on a pallet

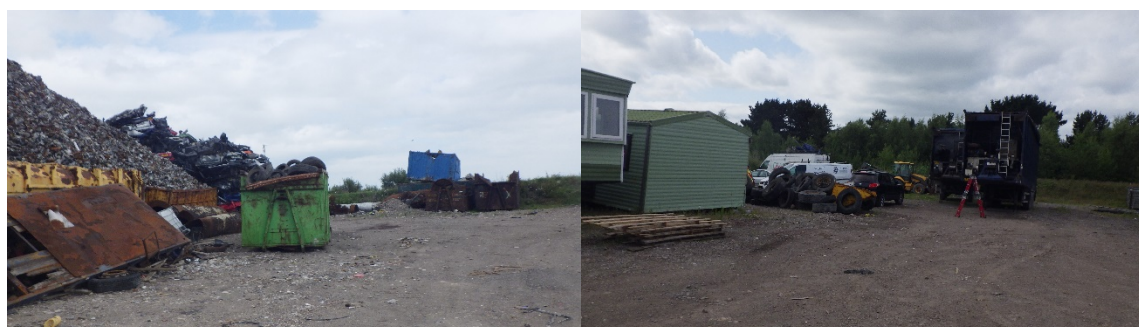
Officers noticed tyres being stored in random places, including on permeable ground. Please see photos below.

Tyres stored in a metal skip on permeable ground and in a pile on permeable ground

Once removed from vehicles, these waste types shall be stored **in separately designated areas** provided with an **impermeable pavement and sealed drainage** in accordance with condition 2.1

Tyres shall be stored in **stable stacks** with individual capacities of no greater than 50 cubic metres and to a height of no greater than 3 metres. Individual tyre stacks shall not be stored within 6 metres of each other. Individual tyre stacks shall not be stored within 15 metres of the site boundary or building. Tyre stacks shall not be located within 10 metres of any area used for flame cutting operations”.

Action: Please ensure the tyres are stored in compliance with the site permit. Please comply by the **18th of July 2025**.

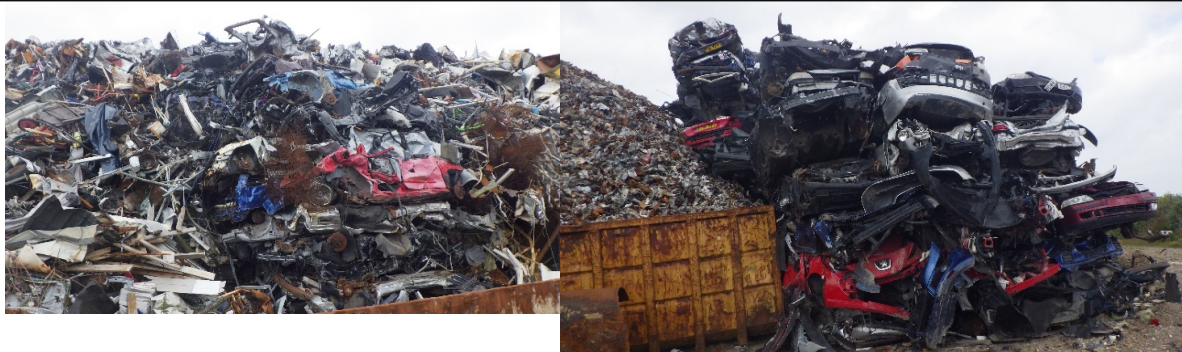
It was noted that ELVs were randomly stored in piles around the site, with one ELV placed on a broken metal container filled with other metal waste. Please see the below photos.

ELVs mixed with other metals

ELVs stored close to the bund at the back of the site

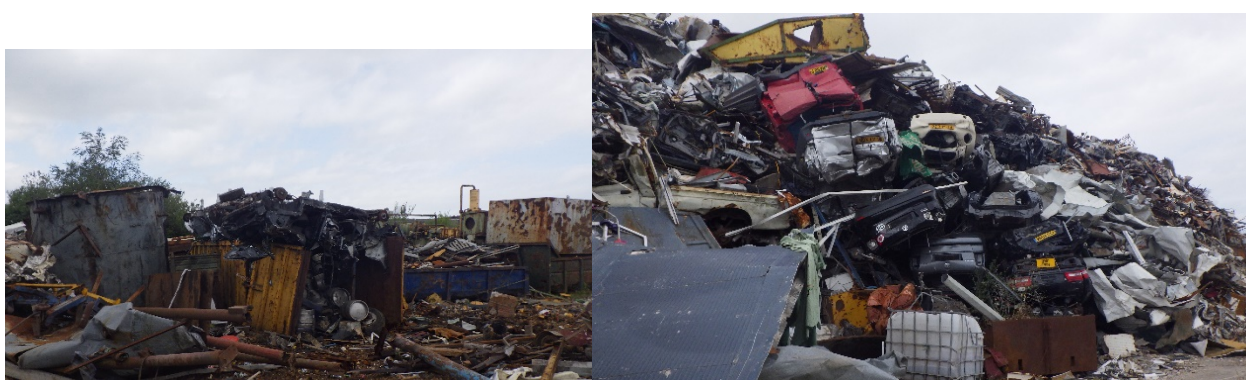
ELV stored on top of broken metal container

ELVs mixed with other metal waste

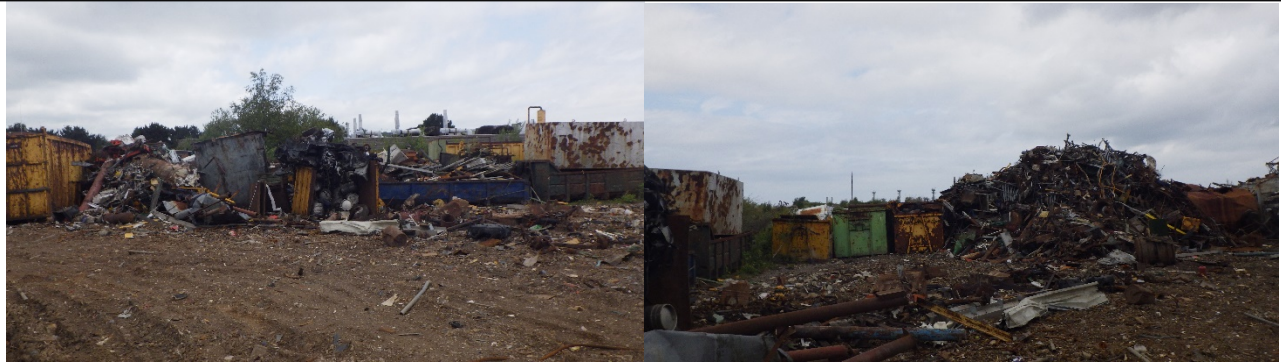
As NRW officer walked around the site it was noted that some paths were completely blocked by waste.

The arrangements are not as described in the current Working plan and are also a hazard should an emergency situation arise on site. This issue was discussed with the site manager and an immediate action is required to ensure emergency services have access to all parts of the site should they deal with an emergency situation i.e. fire.

Access path to the left strewn with metal pieces which would be unsuitable for vehicular access

Action: Remove waste blocking the path by the **18th of July 2025** and provide photographic evidence of the storage area.

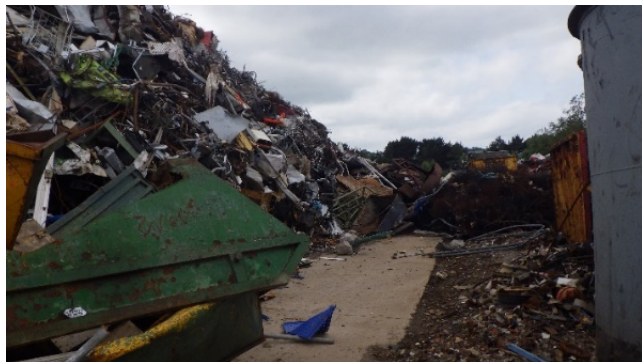
Waste completely obstructing the access path

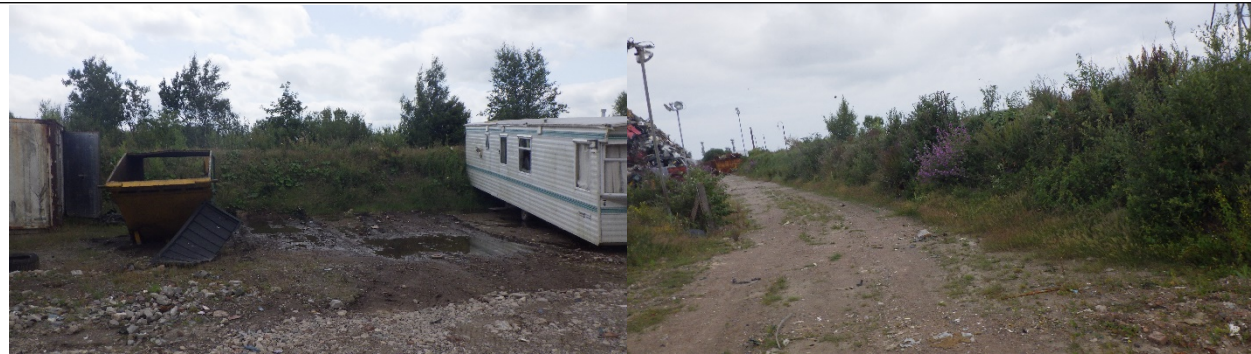
The deposit of trommel fines and using them as material to build a bund on site is a breach of permit condition 1.1.1.

Keeping the trommel fines at the current location on site constitutes an illegal deposit. As a result a **CCS3 score** has been assigned for this breach.

Bund created using trommel fines

Action: Remove all trommel fines, **used to create the bund**, from site and provide duty of care documents for the removal. Please comply by the **8th August 2025**.

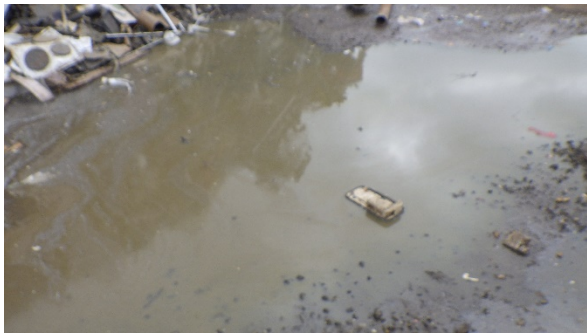
Officer noted that storage areas surfaces had water pooling in several places. It was discussed with the site manager who assured the officer he would look into this issue.

Standing water on site

Action: Please assess all surfaces and ensure they are kept in good condition and in compliance with the below section of the site permit. Please comply by the **31st of July 2025**:

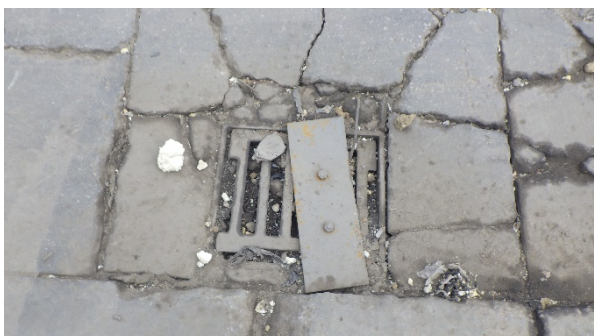
A surface drain in the area behind the site office, where the insulation panels were being stored, appeared to be completely blocked with debris, pieces of foam and mud. Cracks in the concrete, which may affect impermeability, were also seen as seen on the photo below.

Please ensure the drainage system is clear of debris and compliant with the permit section **5.3.1.2**.

Should the drainage system appear blocked the issue should be rectified without delay.

Action: Please clear the drains and provide photographic evidence to NRW. Please comply by Friday the **18th of July 2025**.

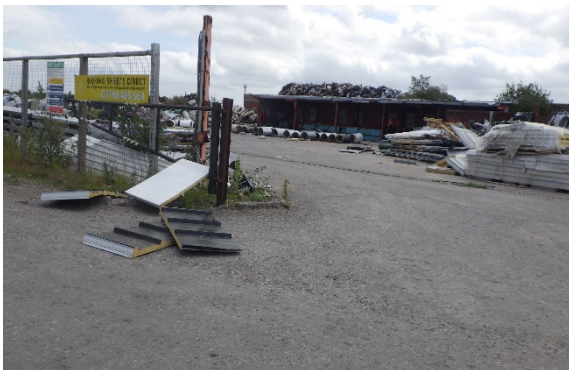
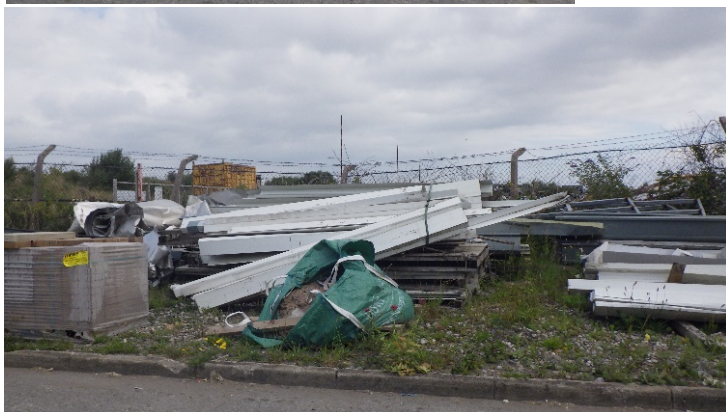
It is noted that a T9 exemption has now been registered to enable the activities in the front yard. As officers were leaving the site they noticed that waste was stored outside the boundaries of the yard.

Waste stored outside the secure yard

Action: Please ensure all waste is stored securely within the yard to ensure compliance with the conditions of the waste exemption. Please remove the waste from outside of the boundaries and store securely within the yard. Once completed please provide photographic evidence to NRW. Please comply by Friday the **18th of July 2025**
