## Compliance Assessment Report CAR\_NRW0048795

For: Devauden Wastewater Treatment Works, held by DWR CYMRU CYFYNGEDIG

**Type of assessment carried out:** Site Inspection, Reason: Routine.

On 09/07/2025, between 10:00 and 10:30.

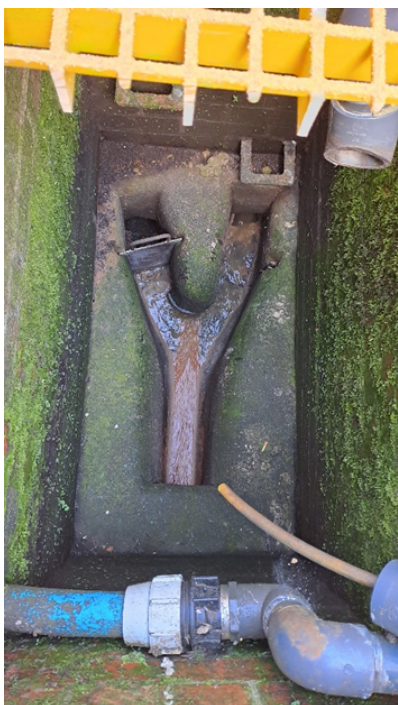
The flow into the site is split between two alternative Primary Settlement Tanks (PSTs). These are used on a rotational basis every few weeks. While one is in use, the other is emptied and cleaned. This is because of previous problems of crust build up in the PSTs. This is referred to in CAR\_NRW0042888, 26/10/23. The photo below shows the incoming flow split into two, with one route shut off.

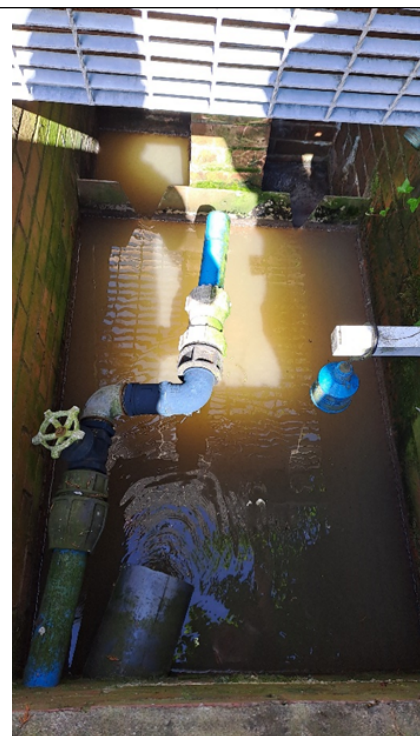
Both PSTs flow into a single distribution chamber where the 'settled primary' is split into the filter beds. This looked clean, with no crust flowing over from the PSTs.

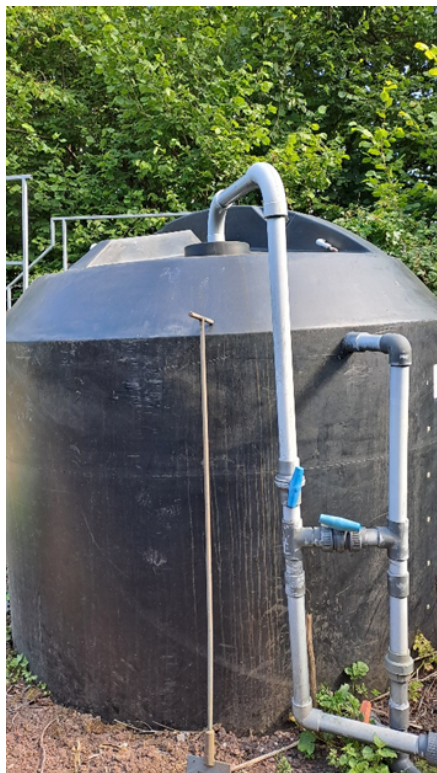
During times of low flow, there is a return from the filter beds to the ‘settled primary’ to stop the system drying out.

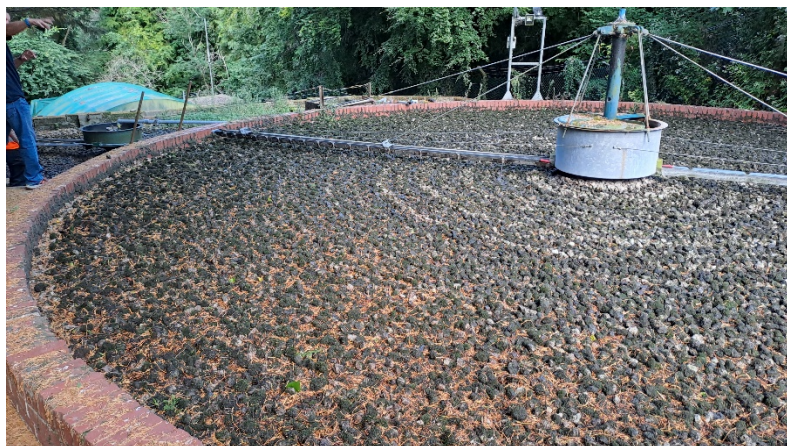
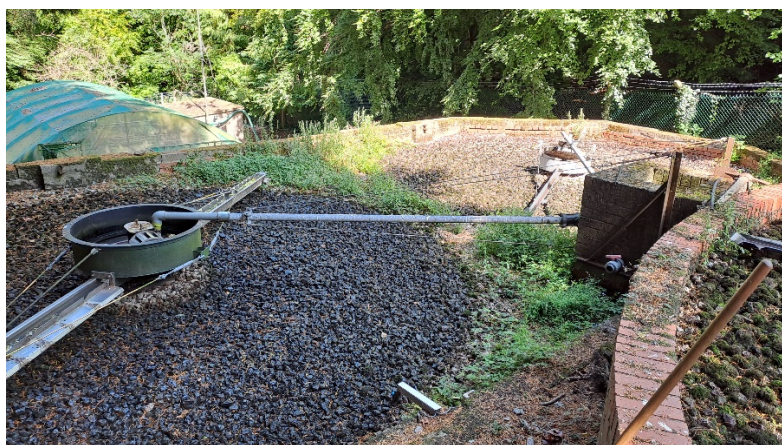
There was leaf litter / tree debris and moss on the filter bed medium from the overhanging trees, particularly the conifers which were (presumably?) once planted to screen off the site from the adjacent road.

| Criteria | Action needed | Complete by |
|---|---|---|
| WQ-A1 | Moss and leaf litter/vegetation must be regularly removed from the filter medium. Consider cutting back the conifers to prevent so much debris falling on the filter medium. And/or consider covering the filter bed to prevent debris falling into it. | 11/10/2025 |

**ACTION:** Moss and leaf litter/vegetation must be regularly removed from the filter medium.

Consider cutting back the conifers to prevent so much debris falling on the filter medium. And/or consider covering the filter bed to prevent debris falling into it.

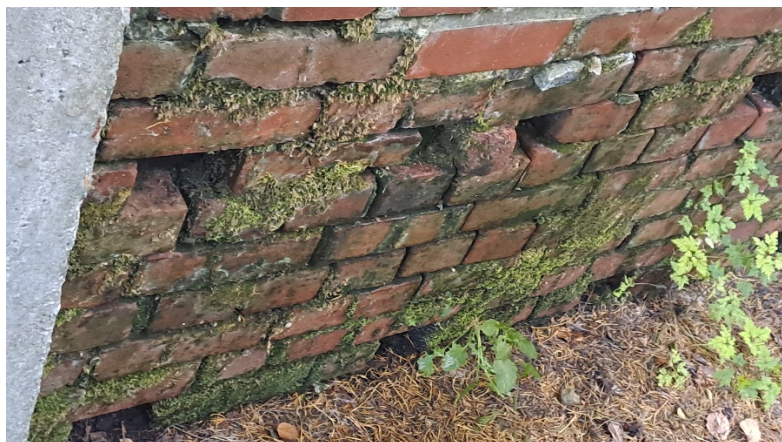
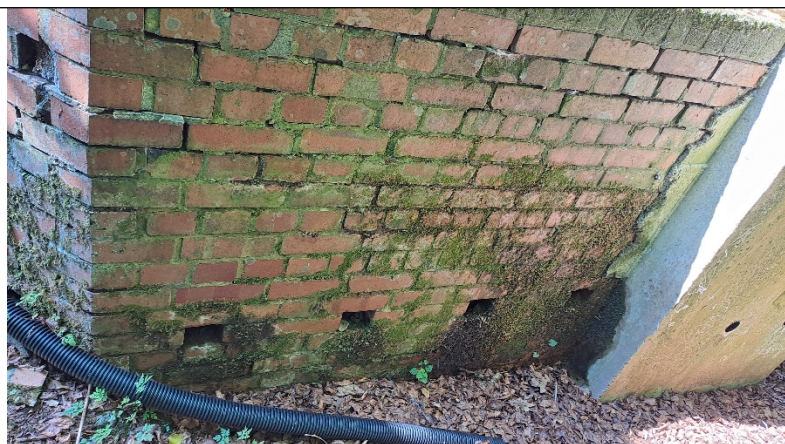
Some of the filter bed masonry was in poor condition, with cracks in the mortar and missing bricks. It is possible that a small quantity of effluent was leaching out from the bottom of one wall.

| Criteria | Action needed | Complete by |
|---|---|---|
| WQ-A1 | Any faults in the filter bed walls should be repaired and made water tight. | 11/10/2025 |

**ACTION:** Any faults in the filter bed walls should be repaired and made water tight.

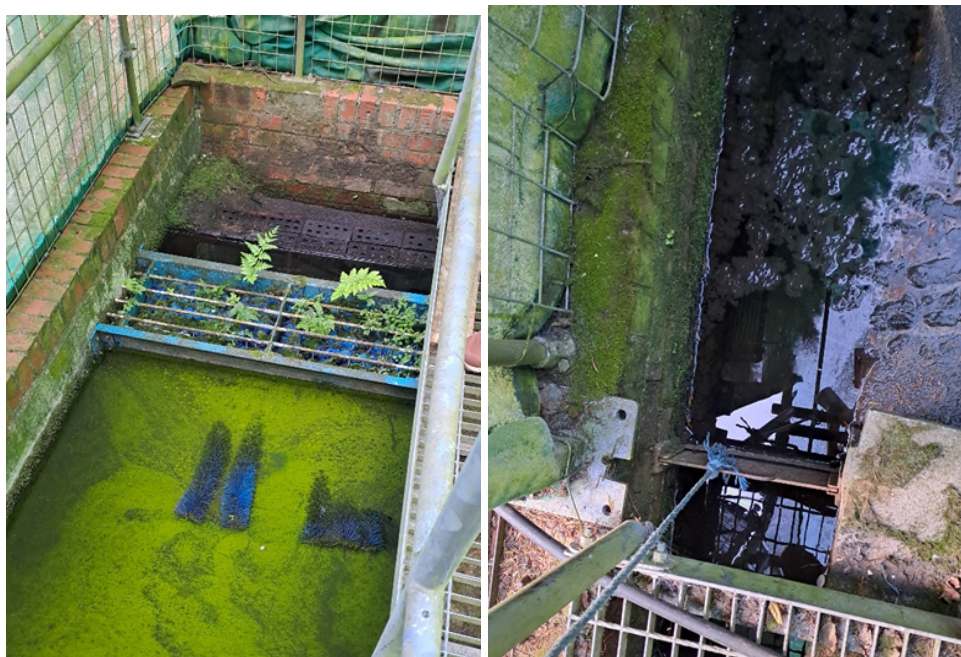
The final discharge was clear, with no sludge being carried over. However, there was a build up of sludge in the hummus tanks. There was also vegetation growth on the Lambs Tails / Cora Brushes. One of the tanks has been taken offline and the brushes are broken.

CAR\_NRW0042888 (2023) referenced that cleaning the lambs tails is difficult due to their location under the walkways. As was stated previously, consideration should be given to moving the lambs tails to allow easier/safer access for cleaning.

| Criteria | Action needed | Complete by |
|---|---|---|
| WQ-A1 | Clear vegetation and repair Lambs Tails / Cora Brushes. Bring the offline tank back online. | 11/10/2025 |

**ACTION:** Clear vegetation and repair Lambs Tails / Cora Brushes. Bring the offline tank back online.
