**Report No: ARL2024/ENV/01**  
**Apr-24**

**REVIEW OF ENVIRONMENTAL MONITORING  
RESULTS AT THE  
NANT-Y-GWYDDON LANDFILL SITE DURING THE  
PERIOD JAN 23 – DEC 23**

**Amgen Rhondda Ltd.  
Bryn Pica Landfill Site  
Llwydcoed  
Aberdare  
CF44 0BX**

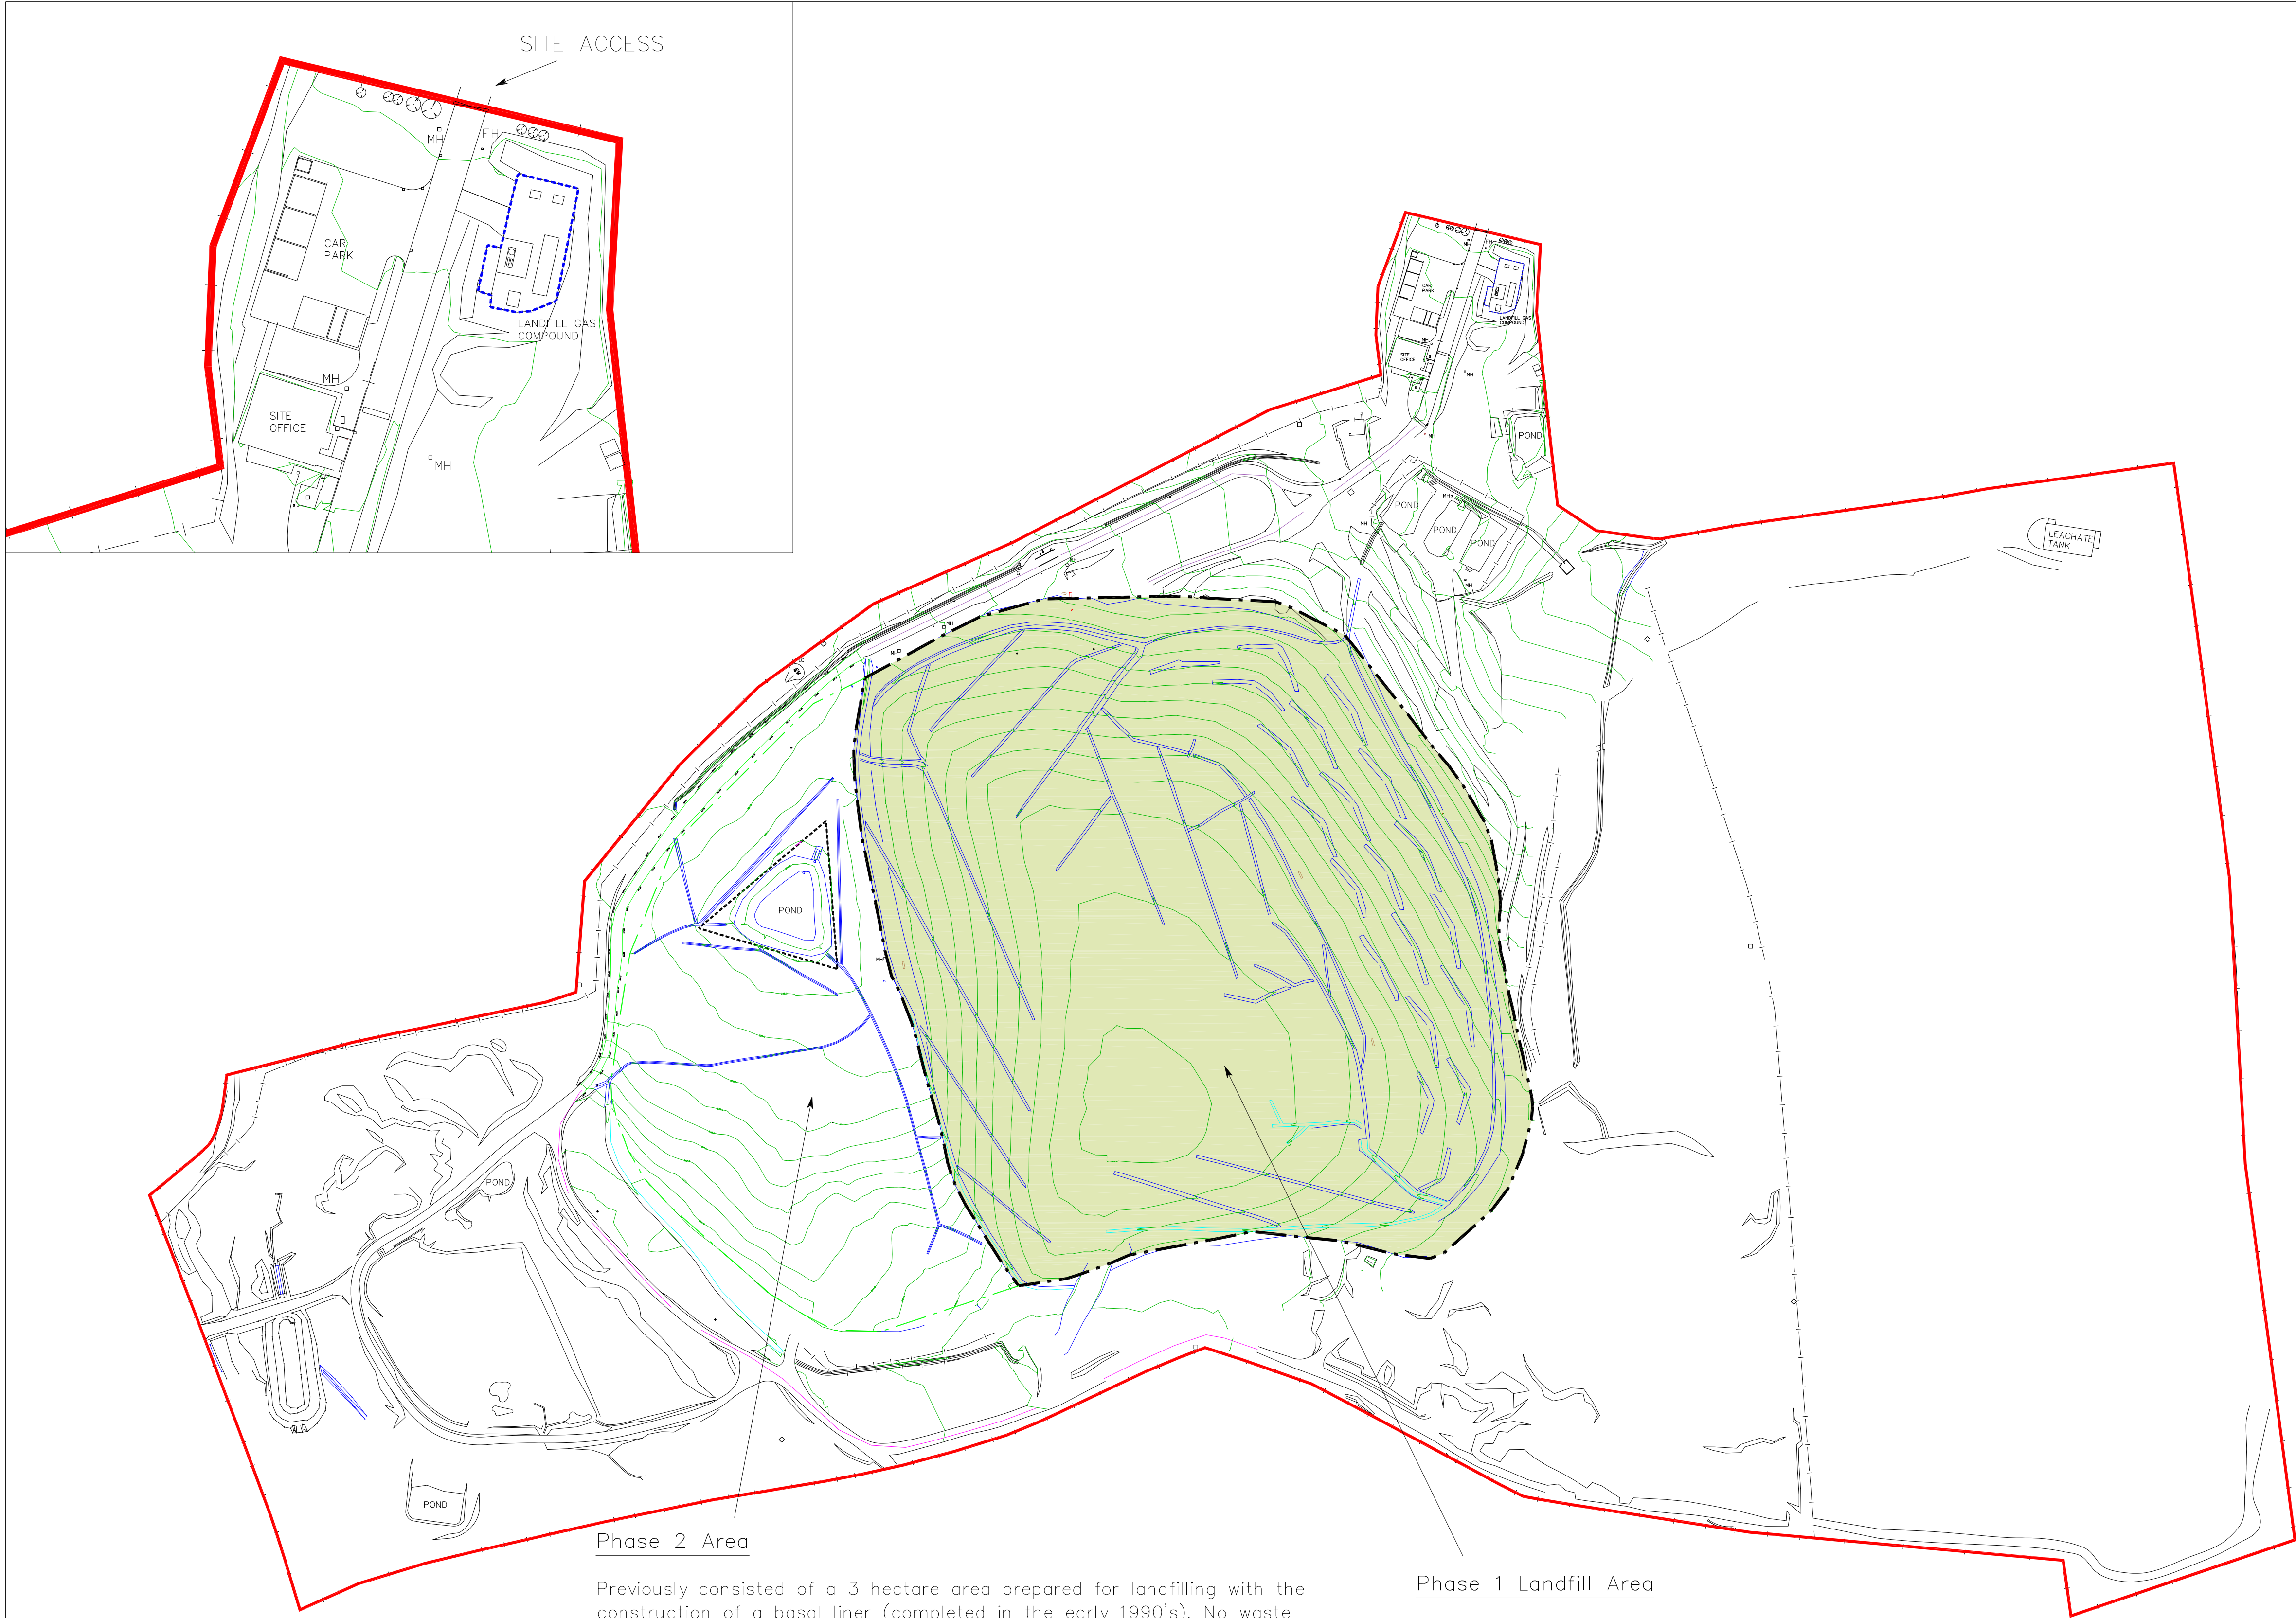
| SCALE | SHEET | DRAWING NO. | REVISION |
|---|---|---|---|
| 1: 2500 | A2 | ARL2024/ENV/01/002 | — |

Phase 2 Area

Previously consisted of a 3 hectare area prepared for landfilling with the construction of a basal liner (completed in the early 1990's). No waste was ever deposited within this area.

The Phase 1 landfill covers an area of approximately 9.5 hectares and was operated during the period November 1987 – March 2002. It contains approximately 1.25 million tonnes of Household, Commercial and Non-Hazardous Industrial Waste.

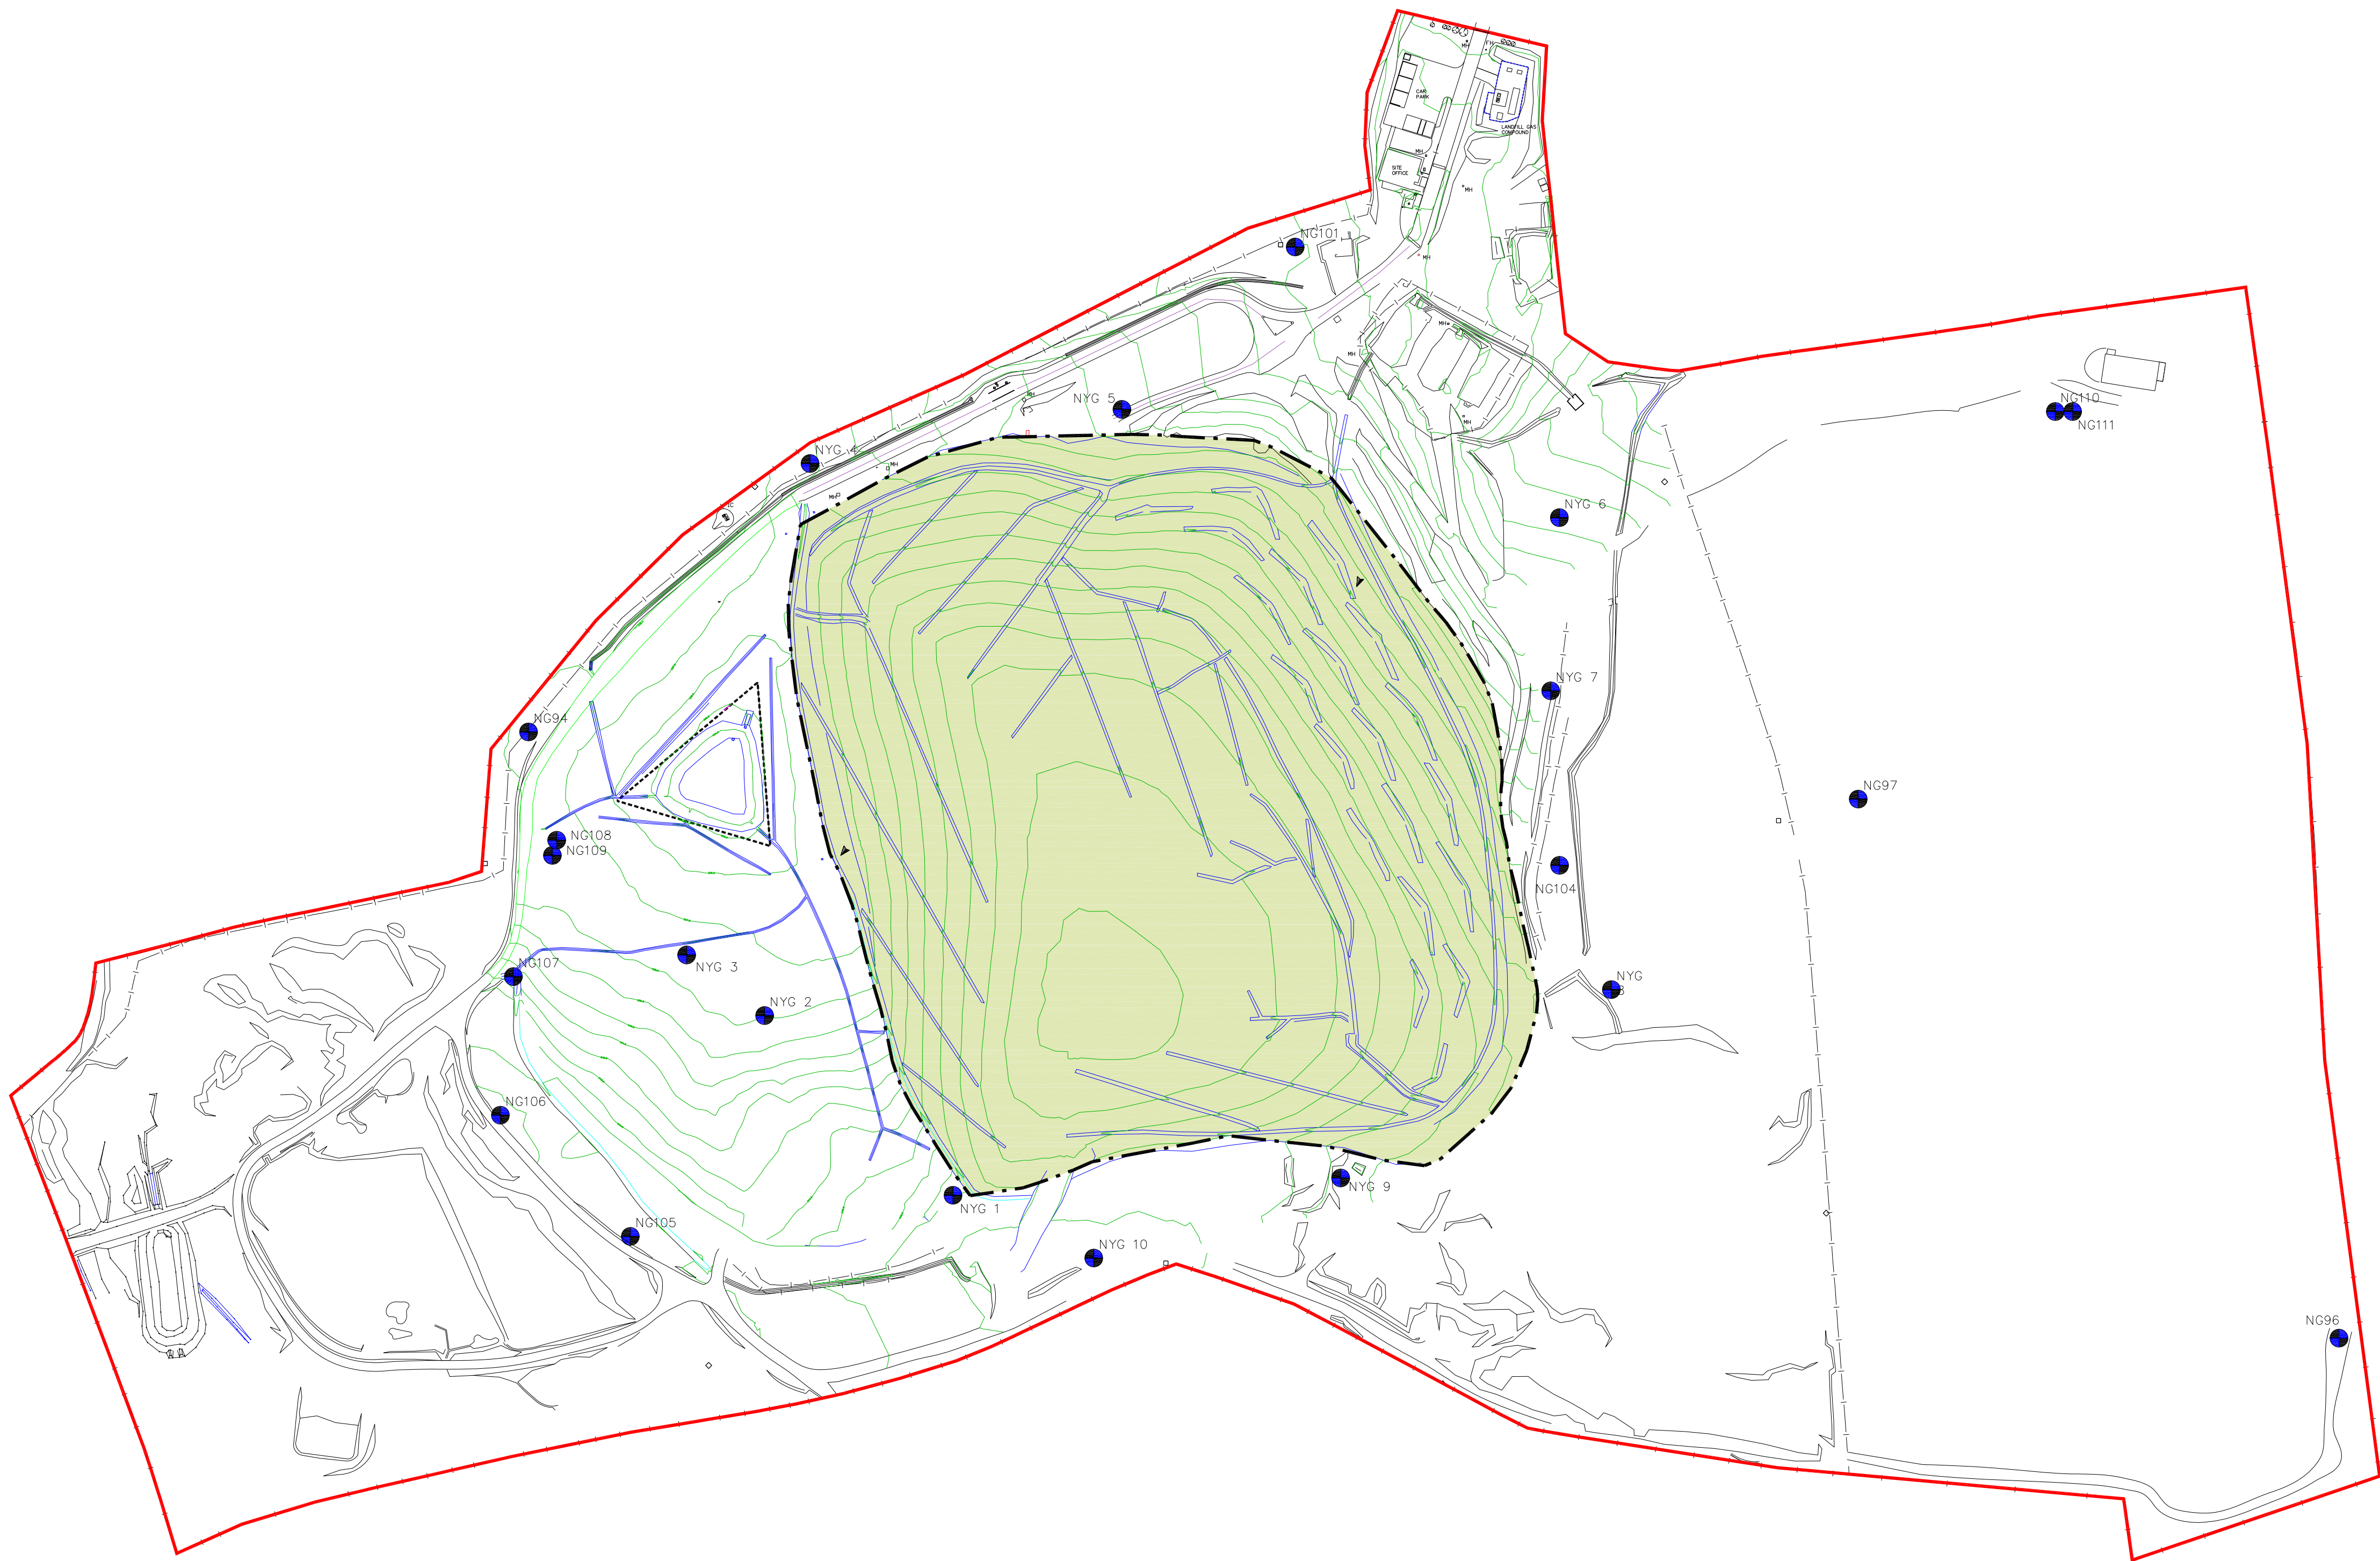
- WML BOUNDARY
- PHASE 1 LANDFILL AREA
- GAS MAIN
- GAS LINE (UNDERGROUND)
- GAS LINE (SURFACE)
- GAS EXTRACTION WELL WITH MONITORING POINT
- SUBSURFACE LANDFILL GAS MONITORING BOREHOLE
- LEACHATE INSPECTION CHAMBER
- LANDFILL GAS CONTROL MANIFOLD AND DEWATERING KNOCKOUT POT

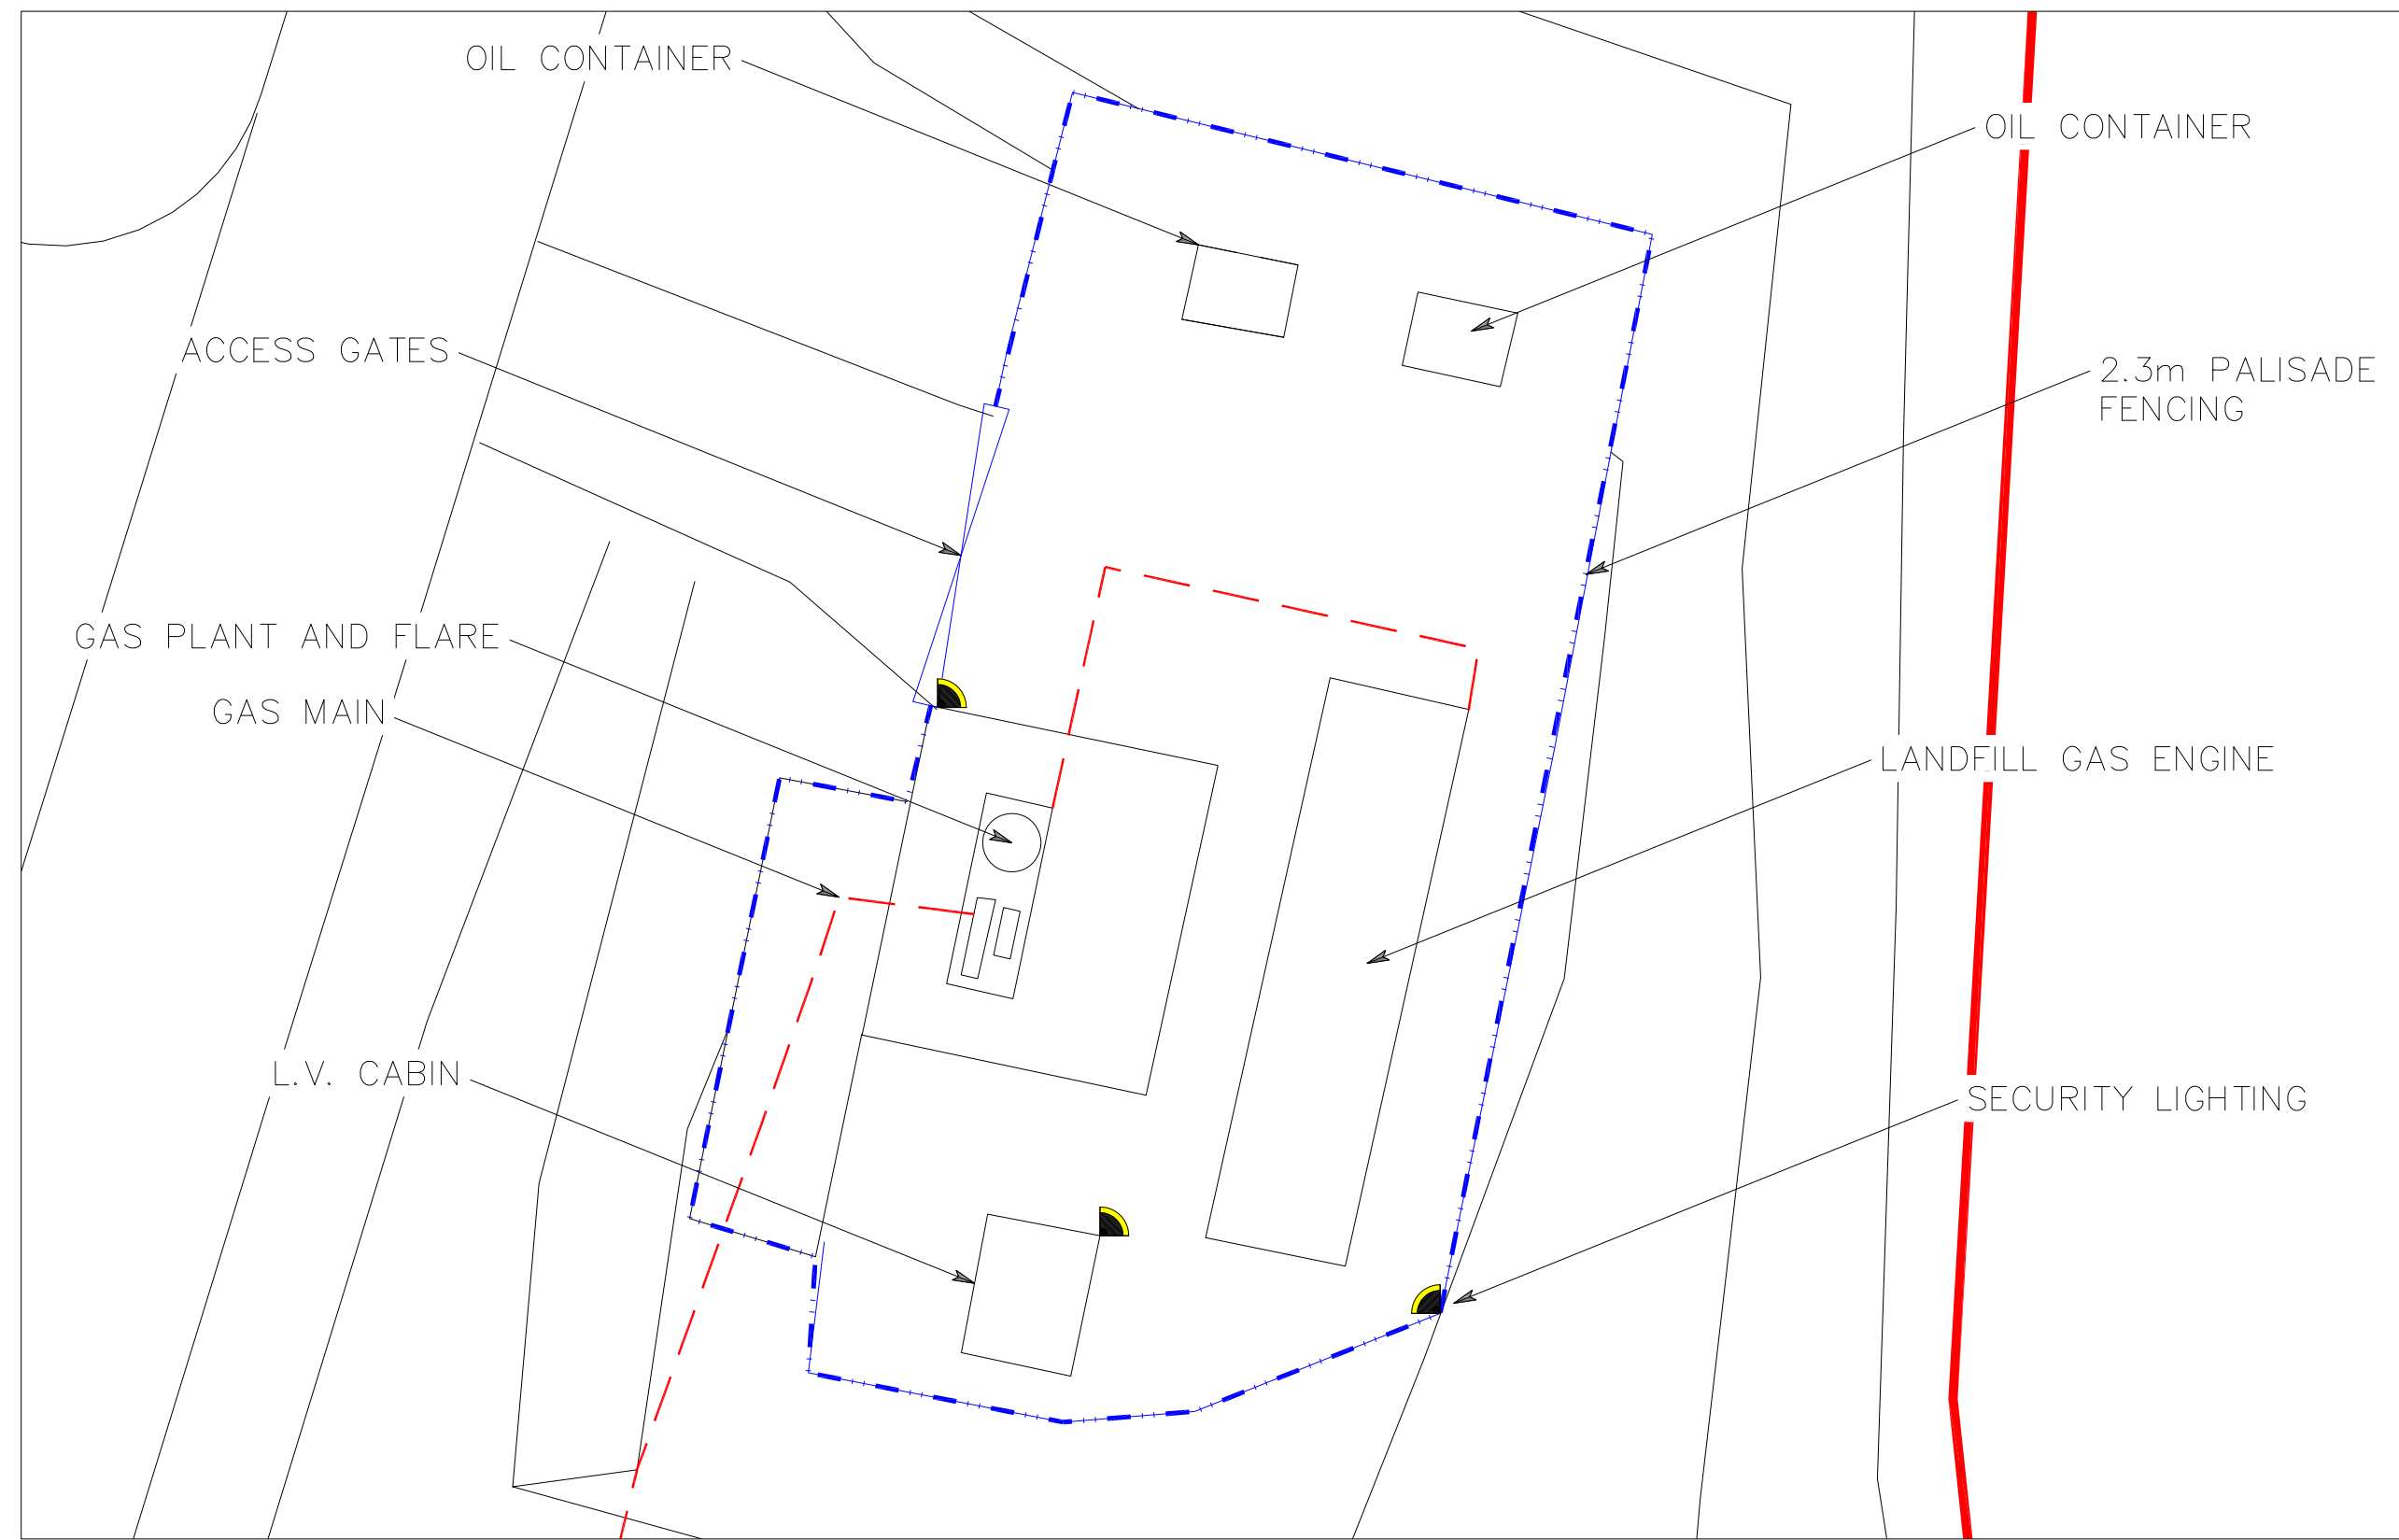
GENERAL LAYOUT OF LANDFILL GAS  
POWER GENERATION COMPOUND

SCALE 1 : 200

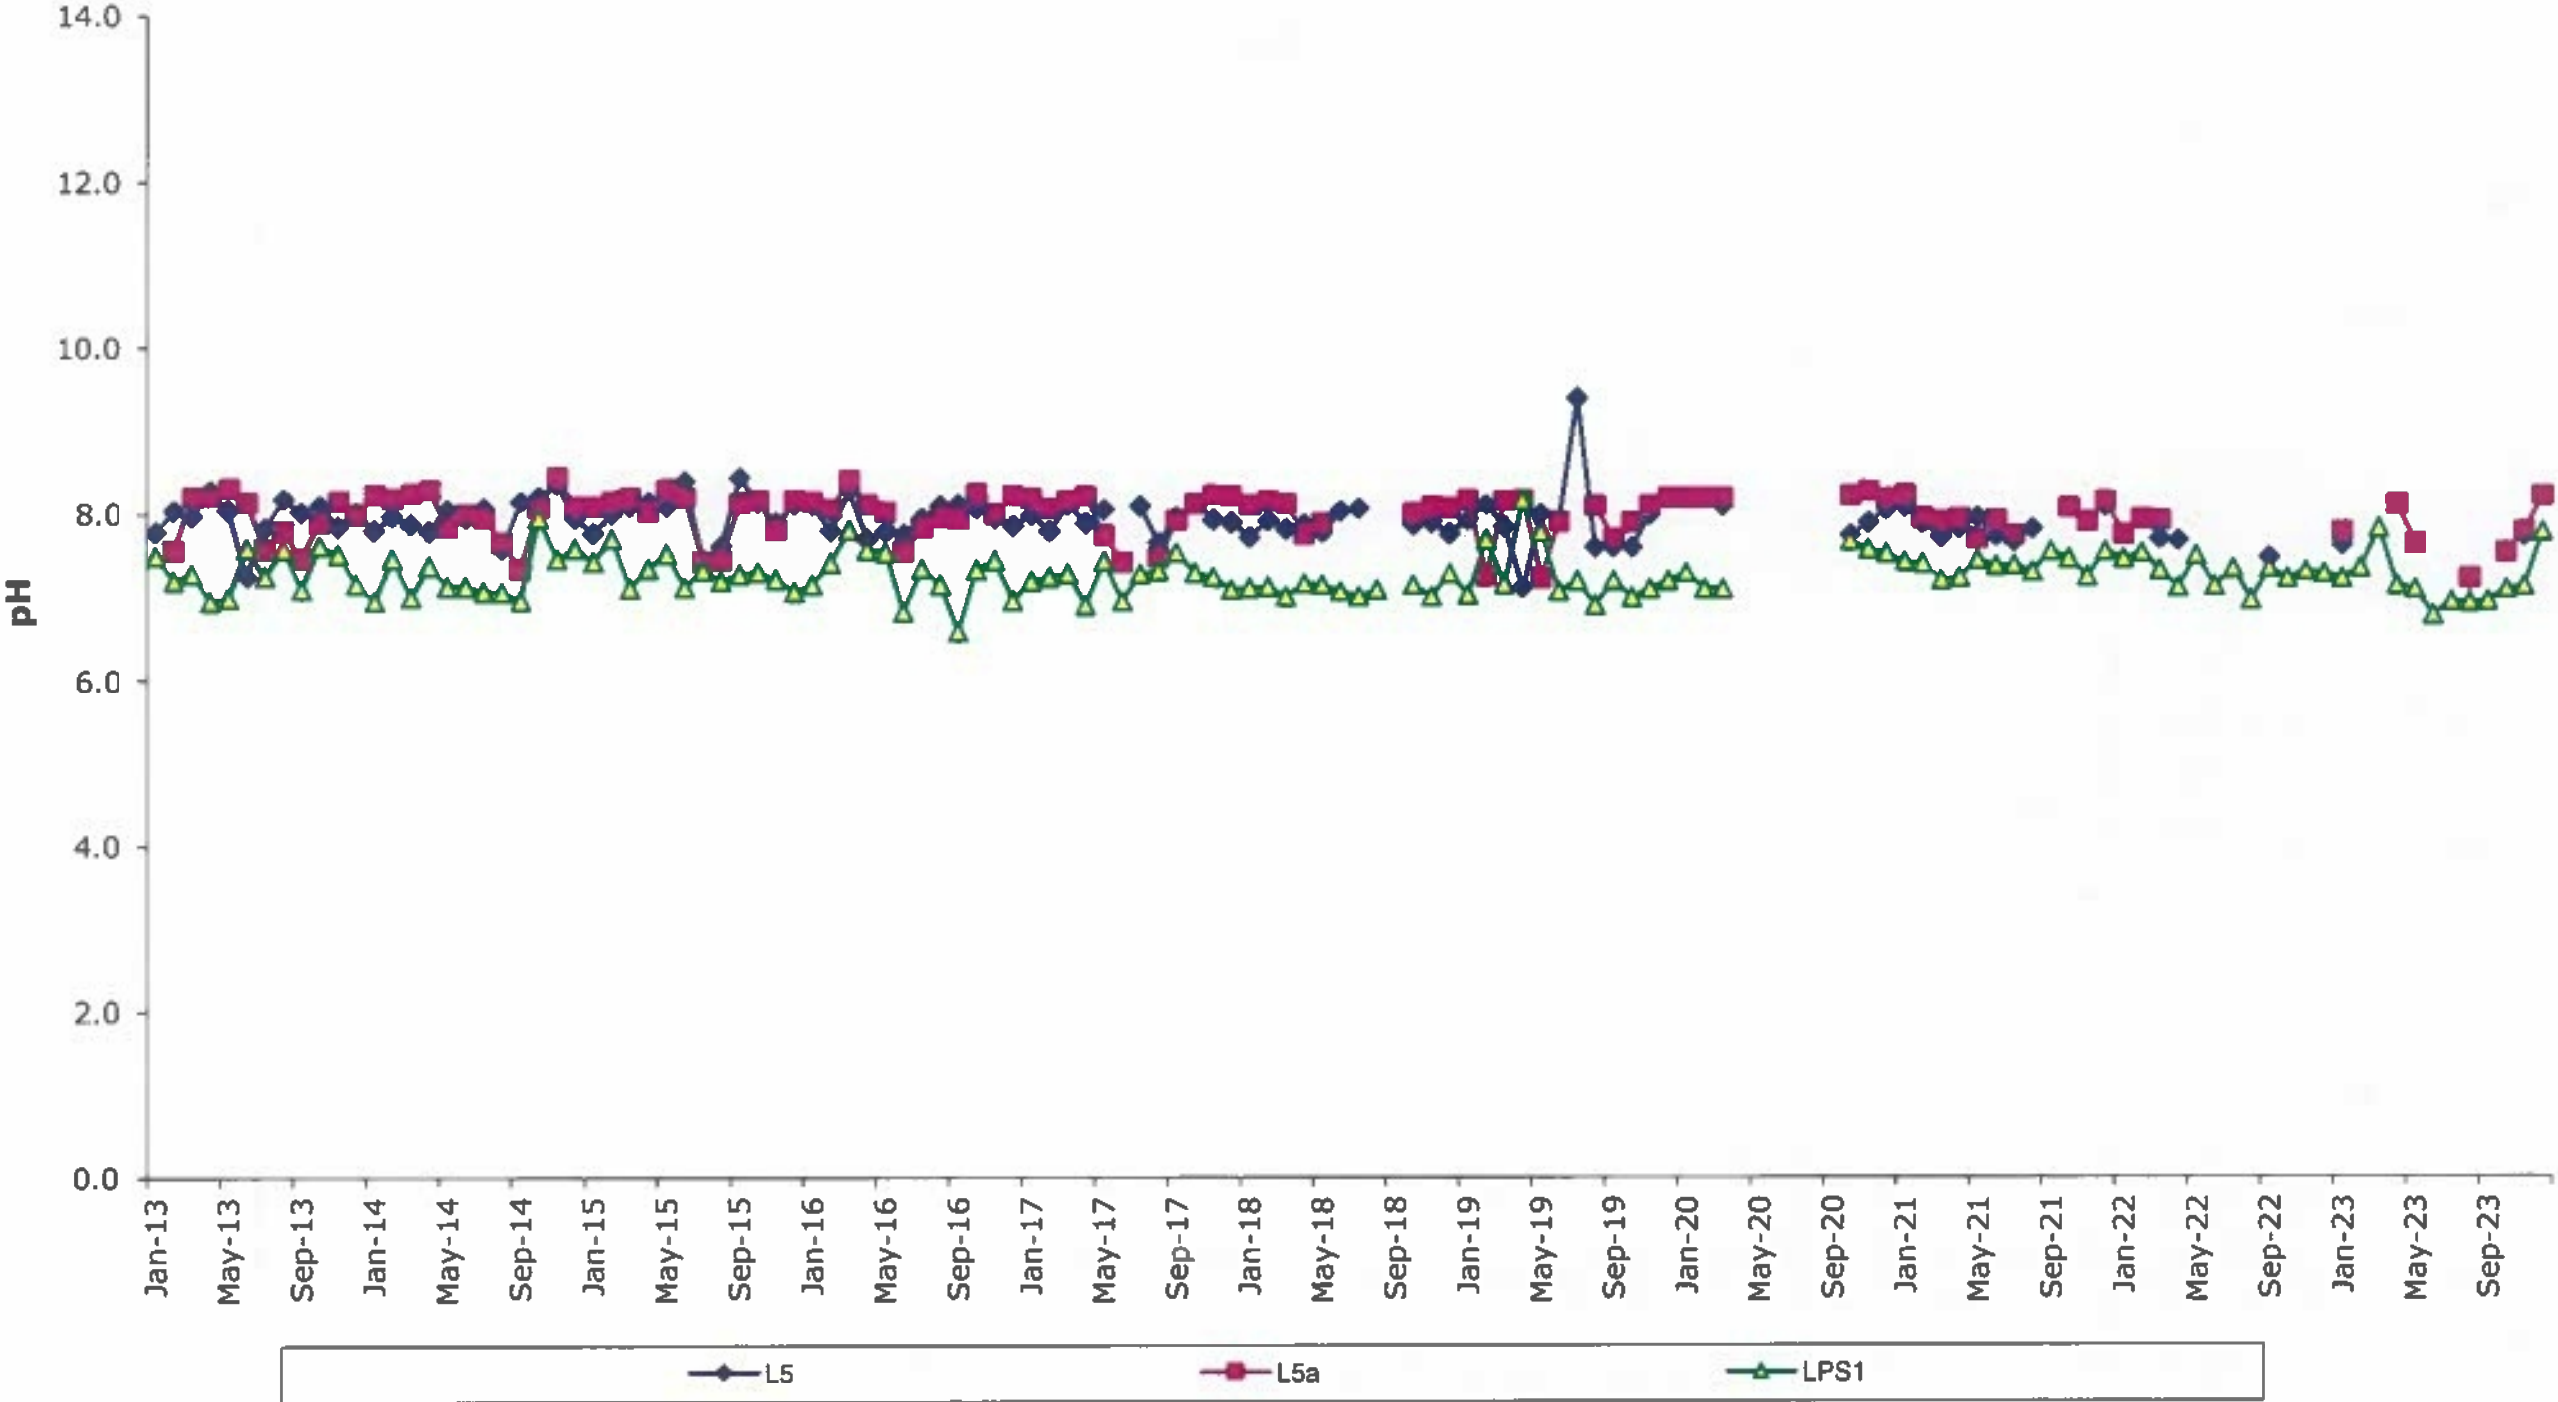
**Lab analysis of pH levels in leachate sampled by Amgen Rhondda Ltd at the Nant-Y-Gwyddon Landfill**  
**Site during the period Jan 2013 - Dec 2023.**

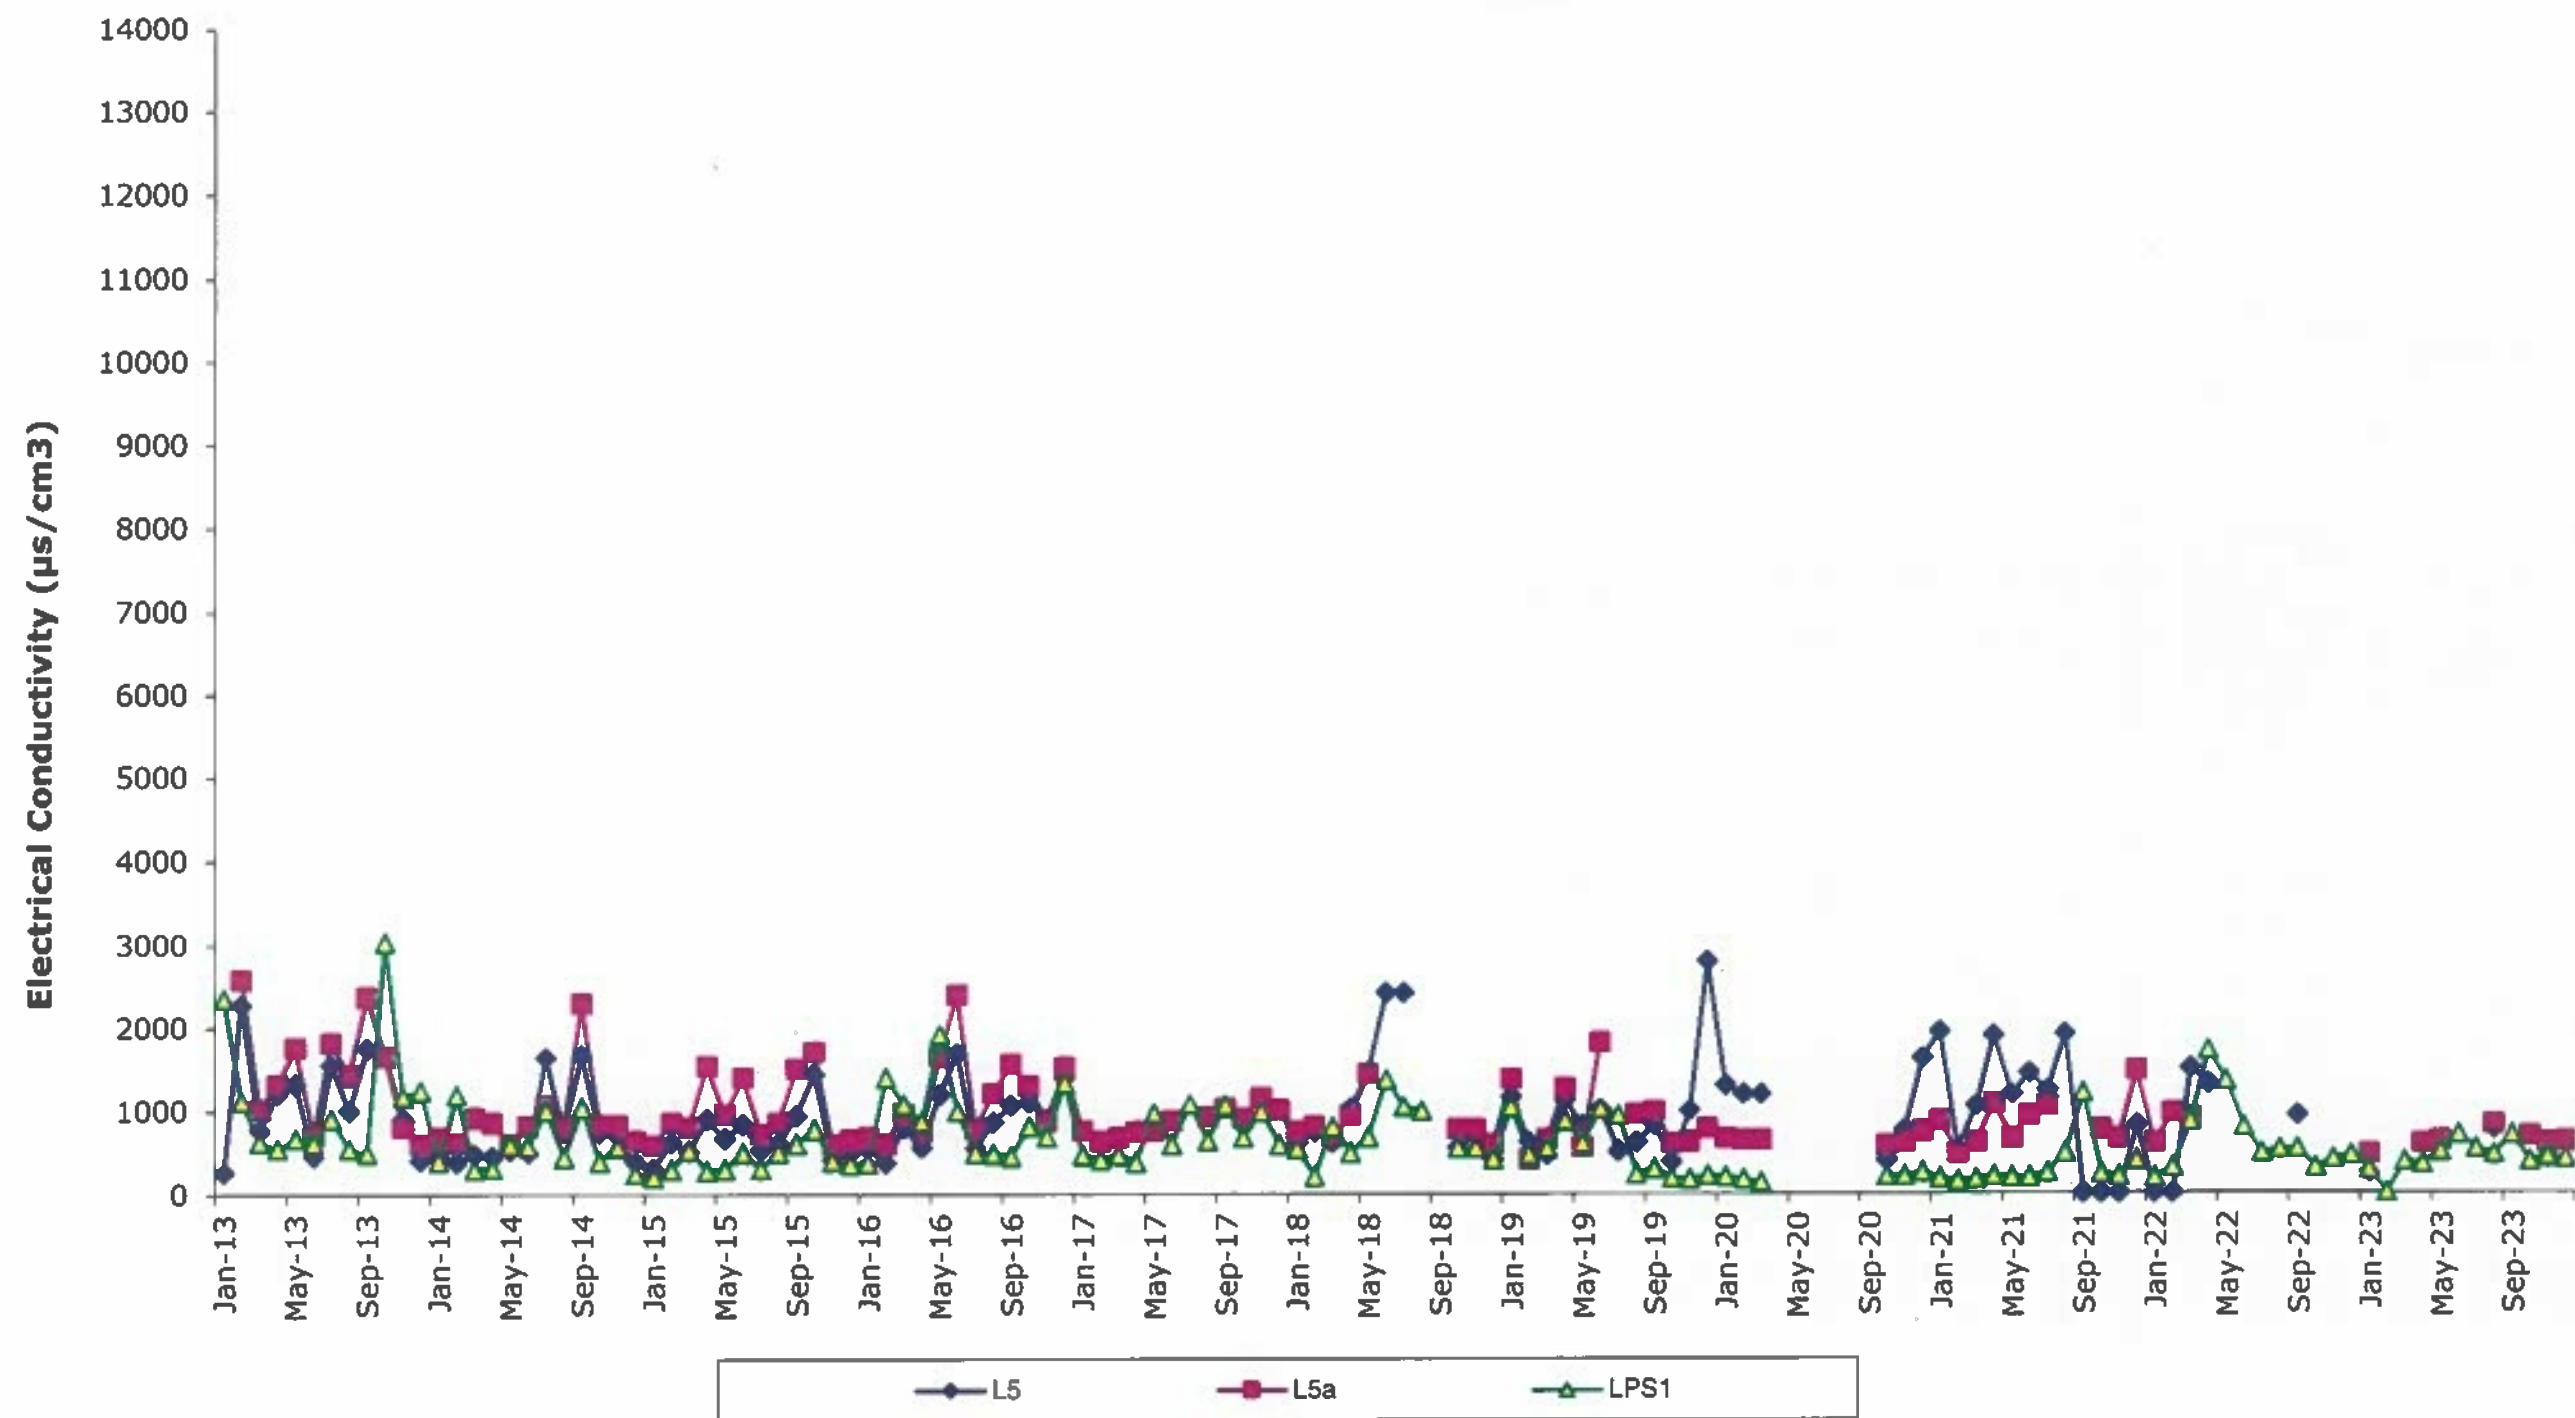
**Lab analysis of Electrical Conductivity levels in leachate sampled by Amgen Rhondda Ltd at the Nant-Y-Gwyddon Landfill Site during the period Jan 2013 - Dec 2023.**

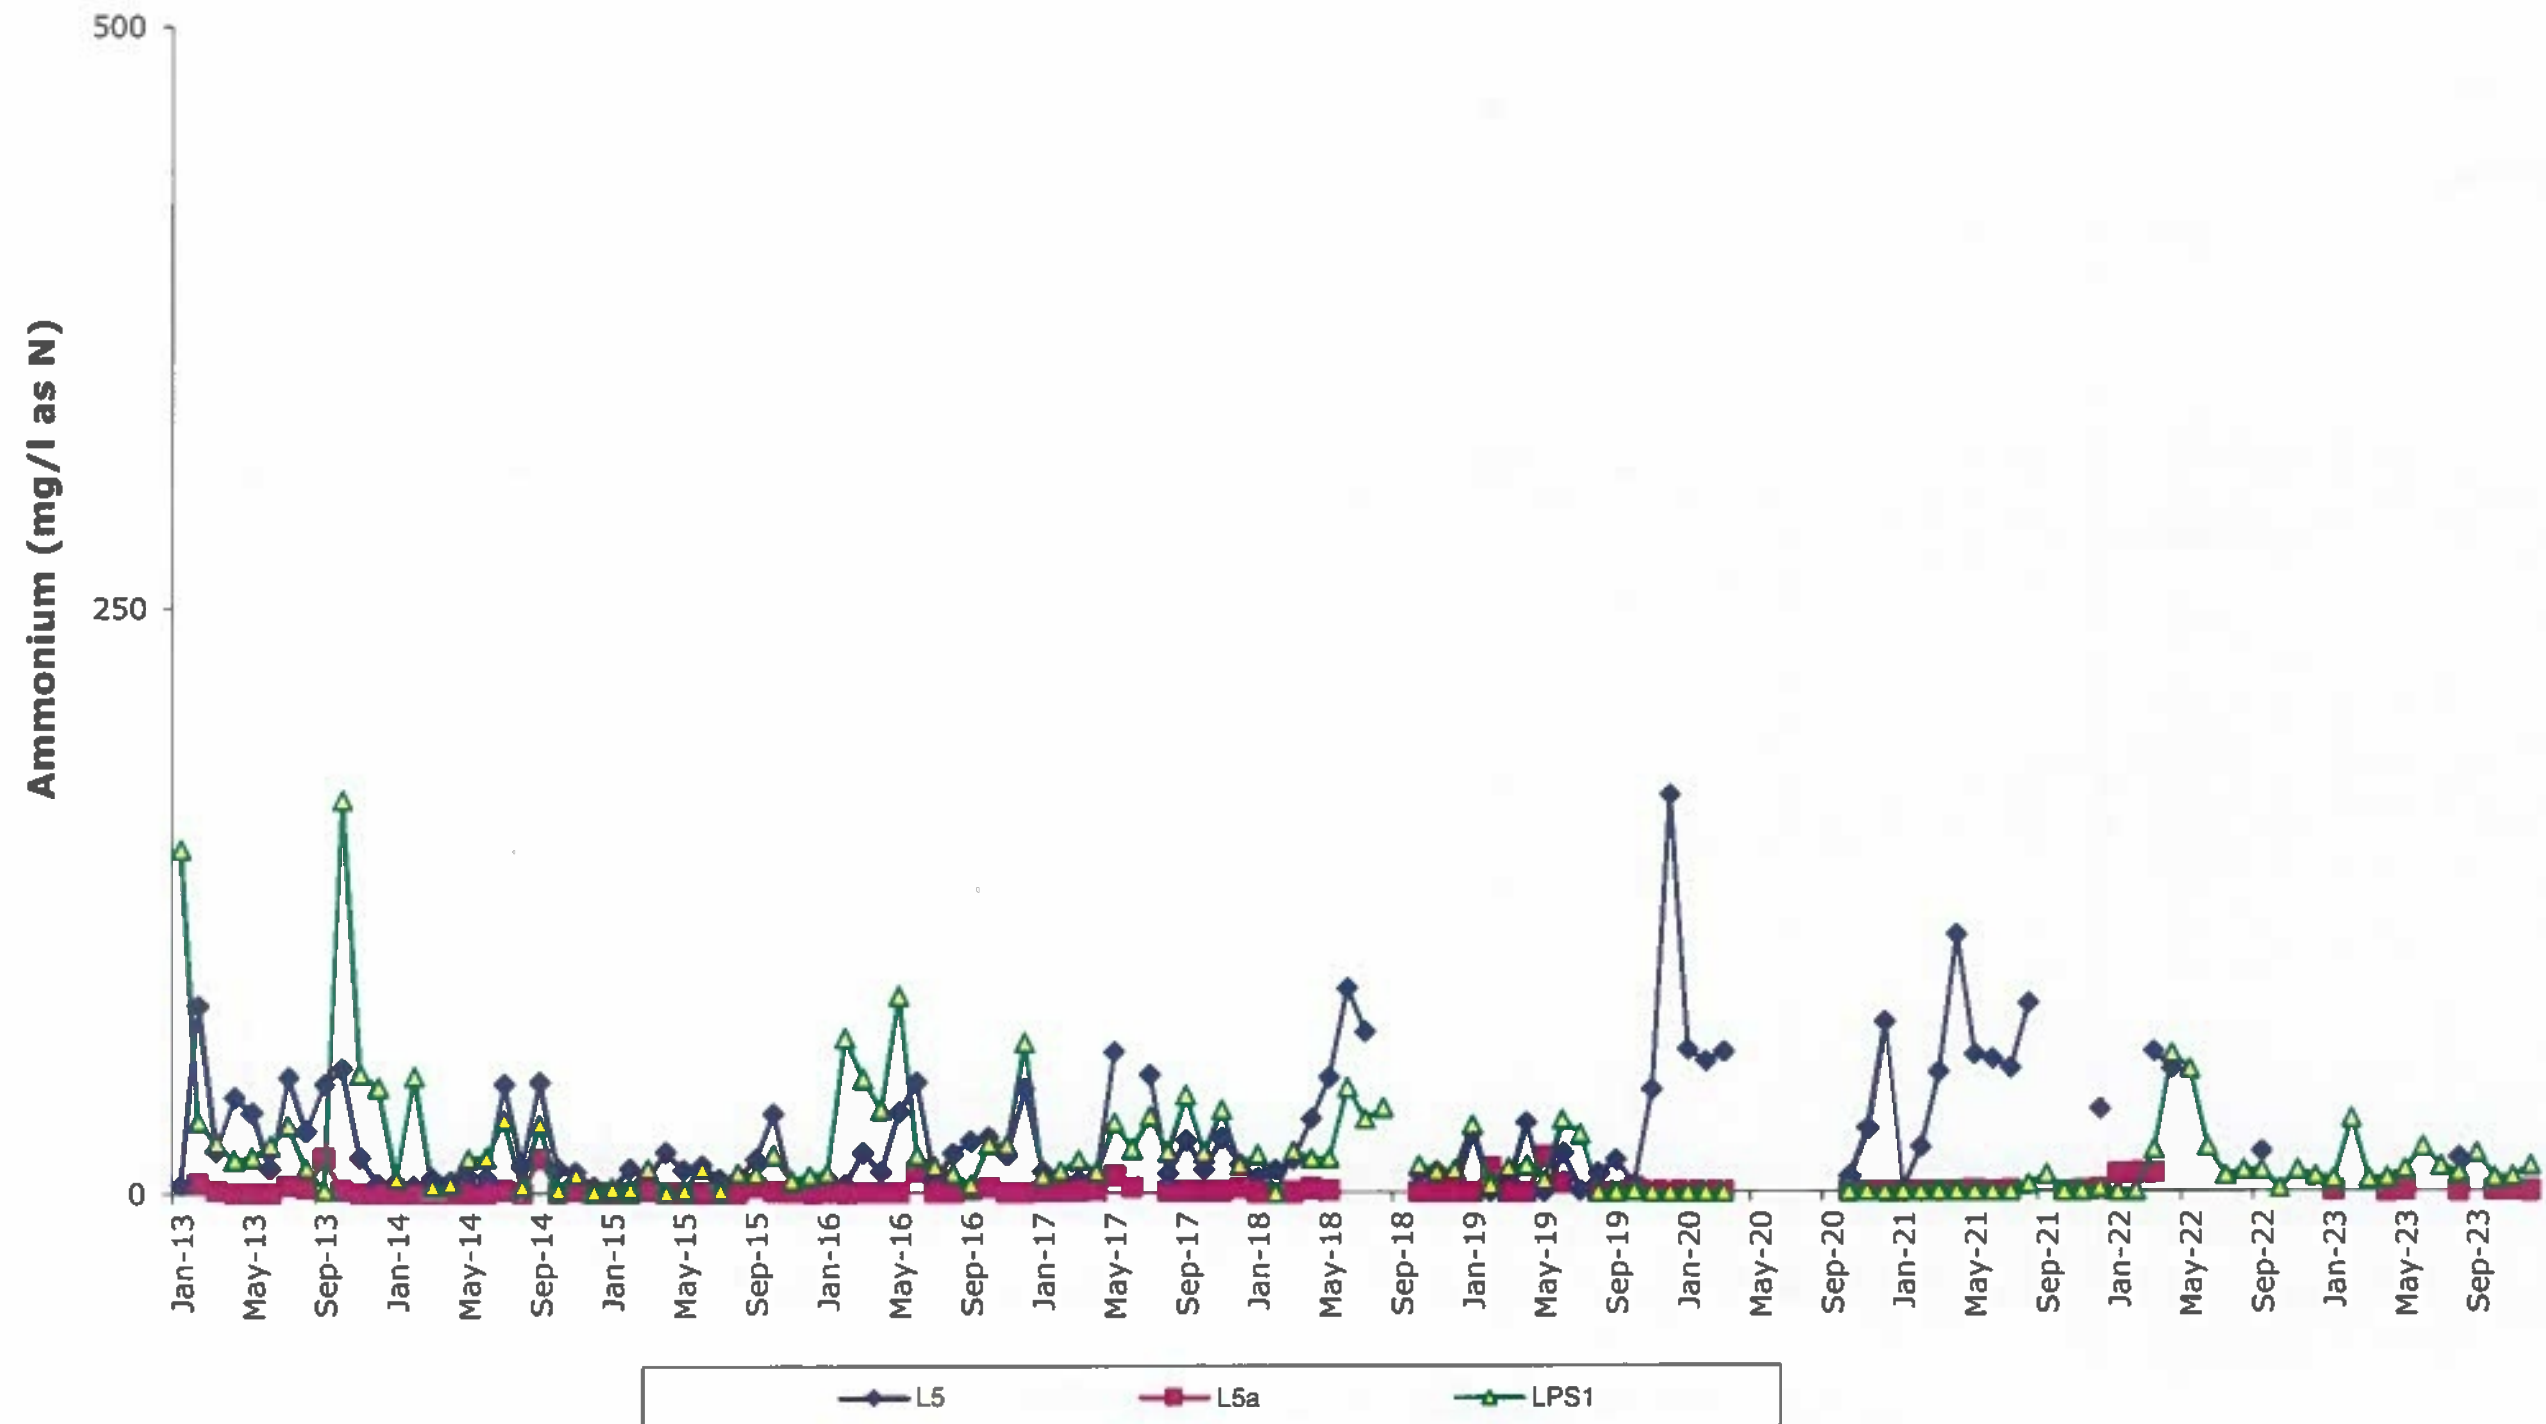
**Lab analysis of Ammonium (as N) in leachate sampled by Amgen Rhondda Ltd at the Nant-Y-Gwyddon Landfill Site during the period Jan 2013 - Dec 2023.**
