**Report No: ARL2024/ENV/01**  
**Apr-24**

**REVIEW OF ENVIRONMENTAL MONITORING  
RESULTS AT THE  
NANT-Y-GWYDDON LANDFILL SITE DURING THE  
PERIOD JAN 23 – DEC 23**

**Amgen Rhondda Ltd.  
Bryn Pica Landfill Site  
Llwydcoed  
Aberdare  
CF44 0BX**

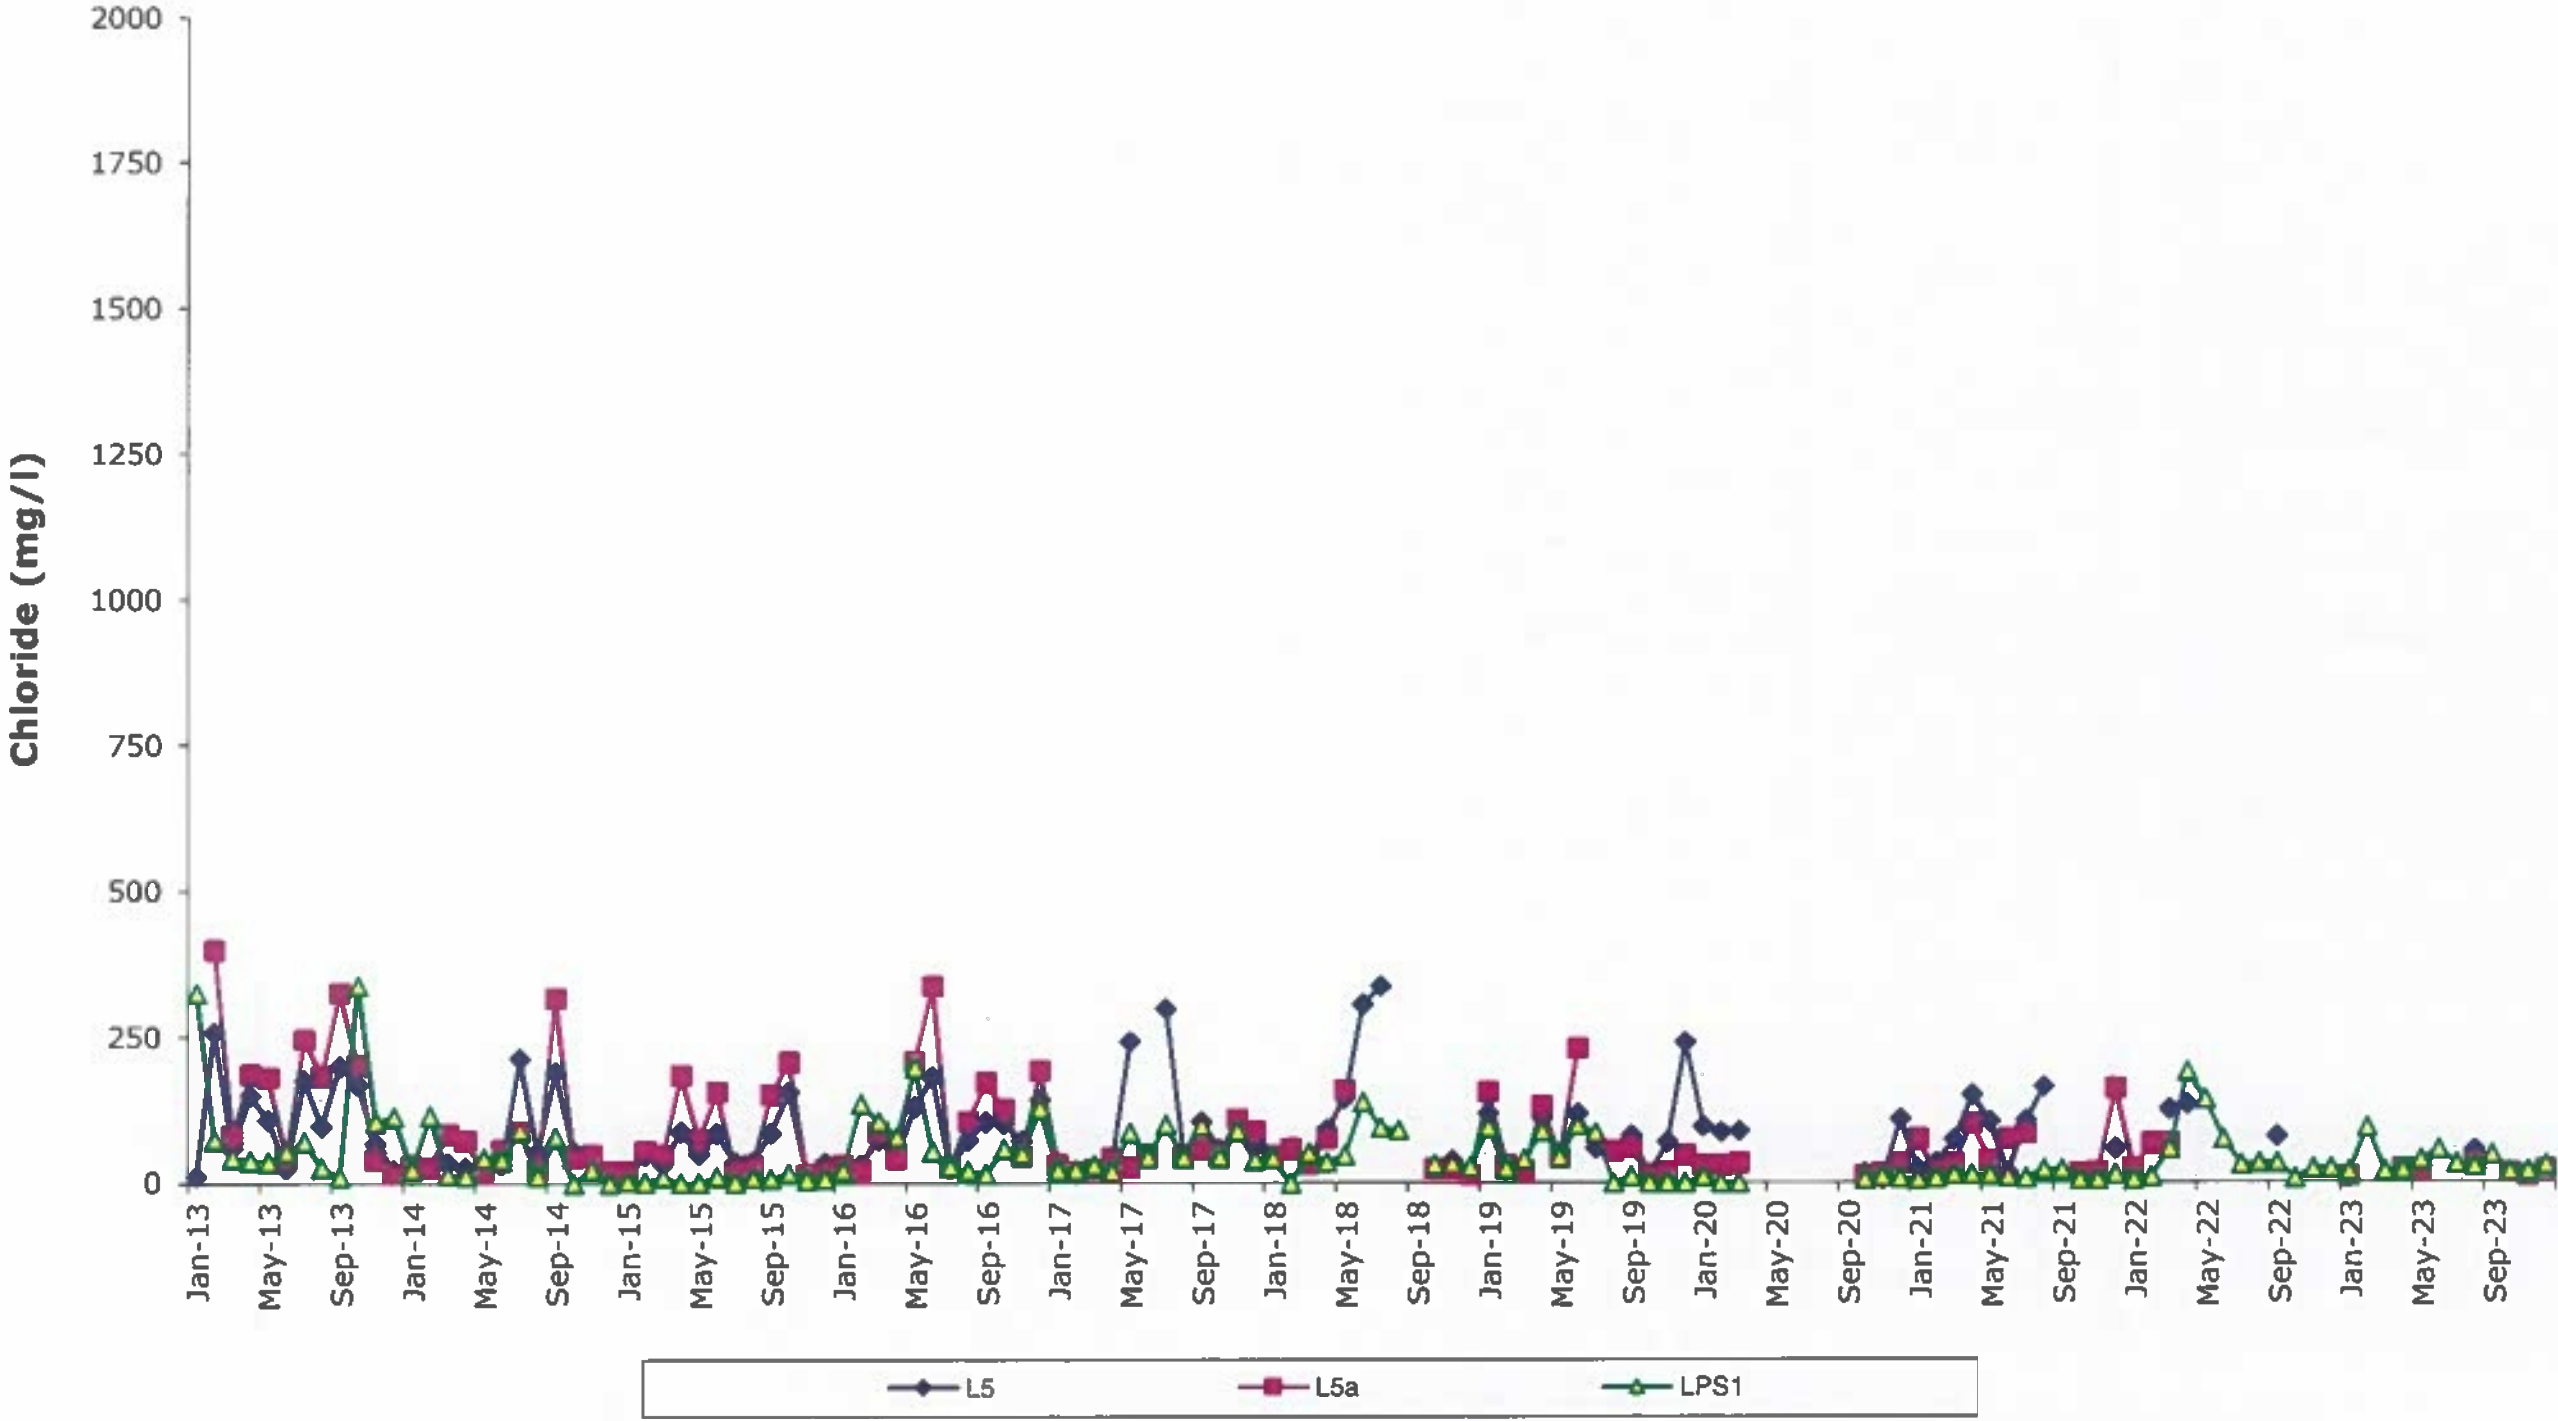
**Lab analysis of Chloride in leachate sampled by Amgen Rhondda Ltd at the Nant-Y-Gwyddon Landfill Site during the period Jan 2013 - Dec 2023.**

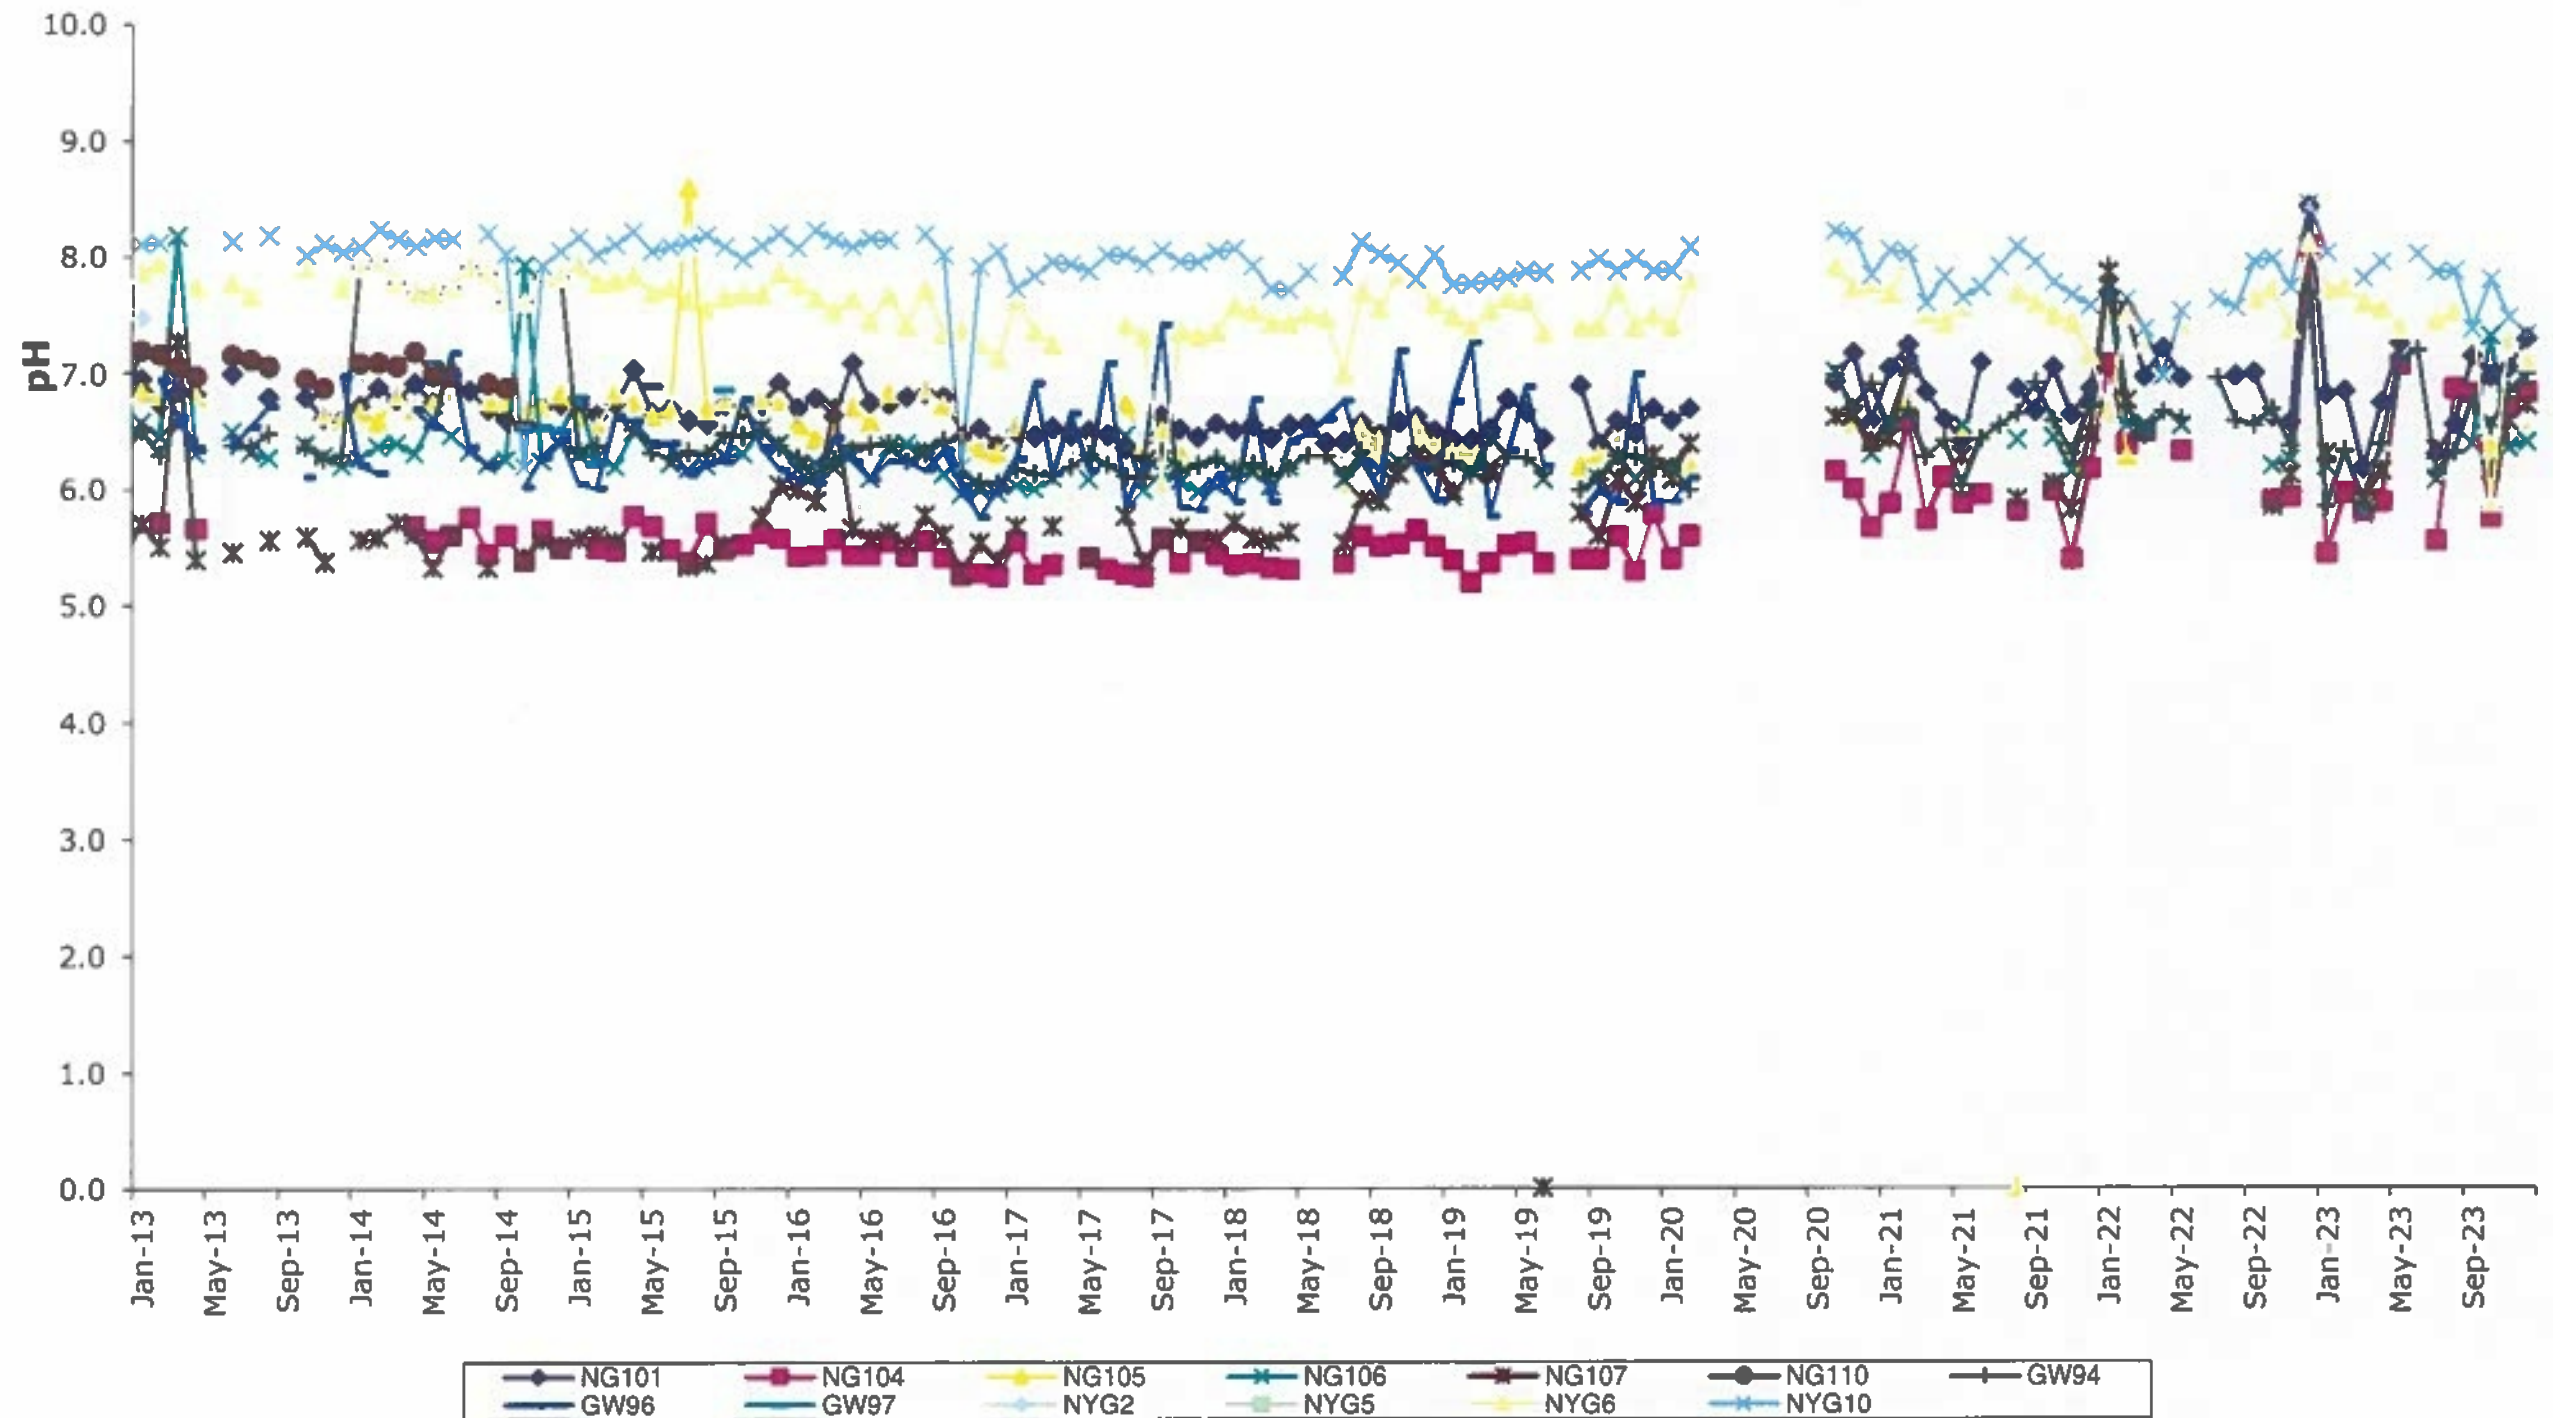
**Lab analysis of pH values in groundwater sampled by Amgen Rhondda Ltd at the Nant-Y-Gwyddon  
Landfill Site during the period Jan 2013 - Dec 2023.**

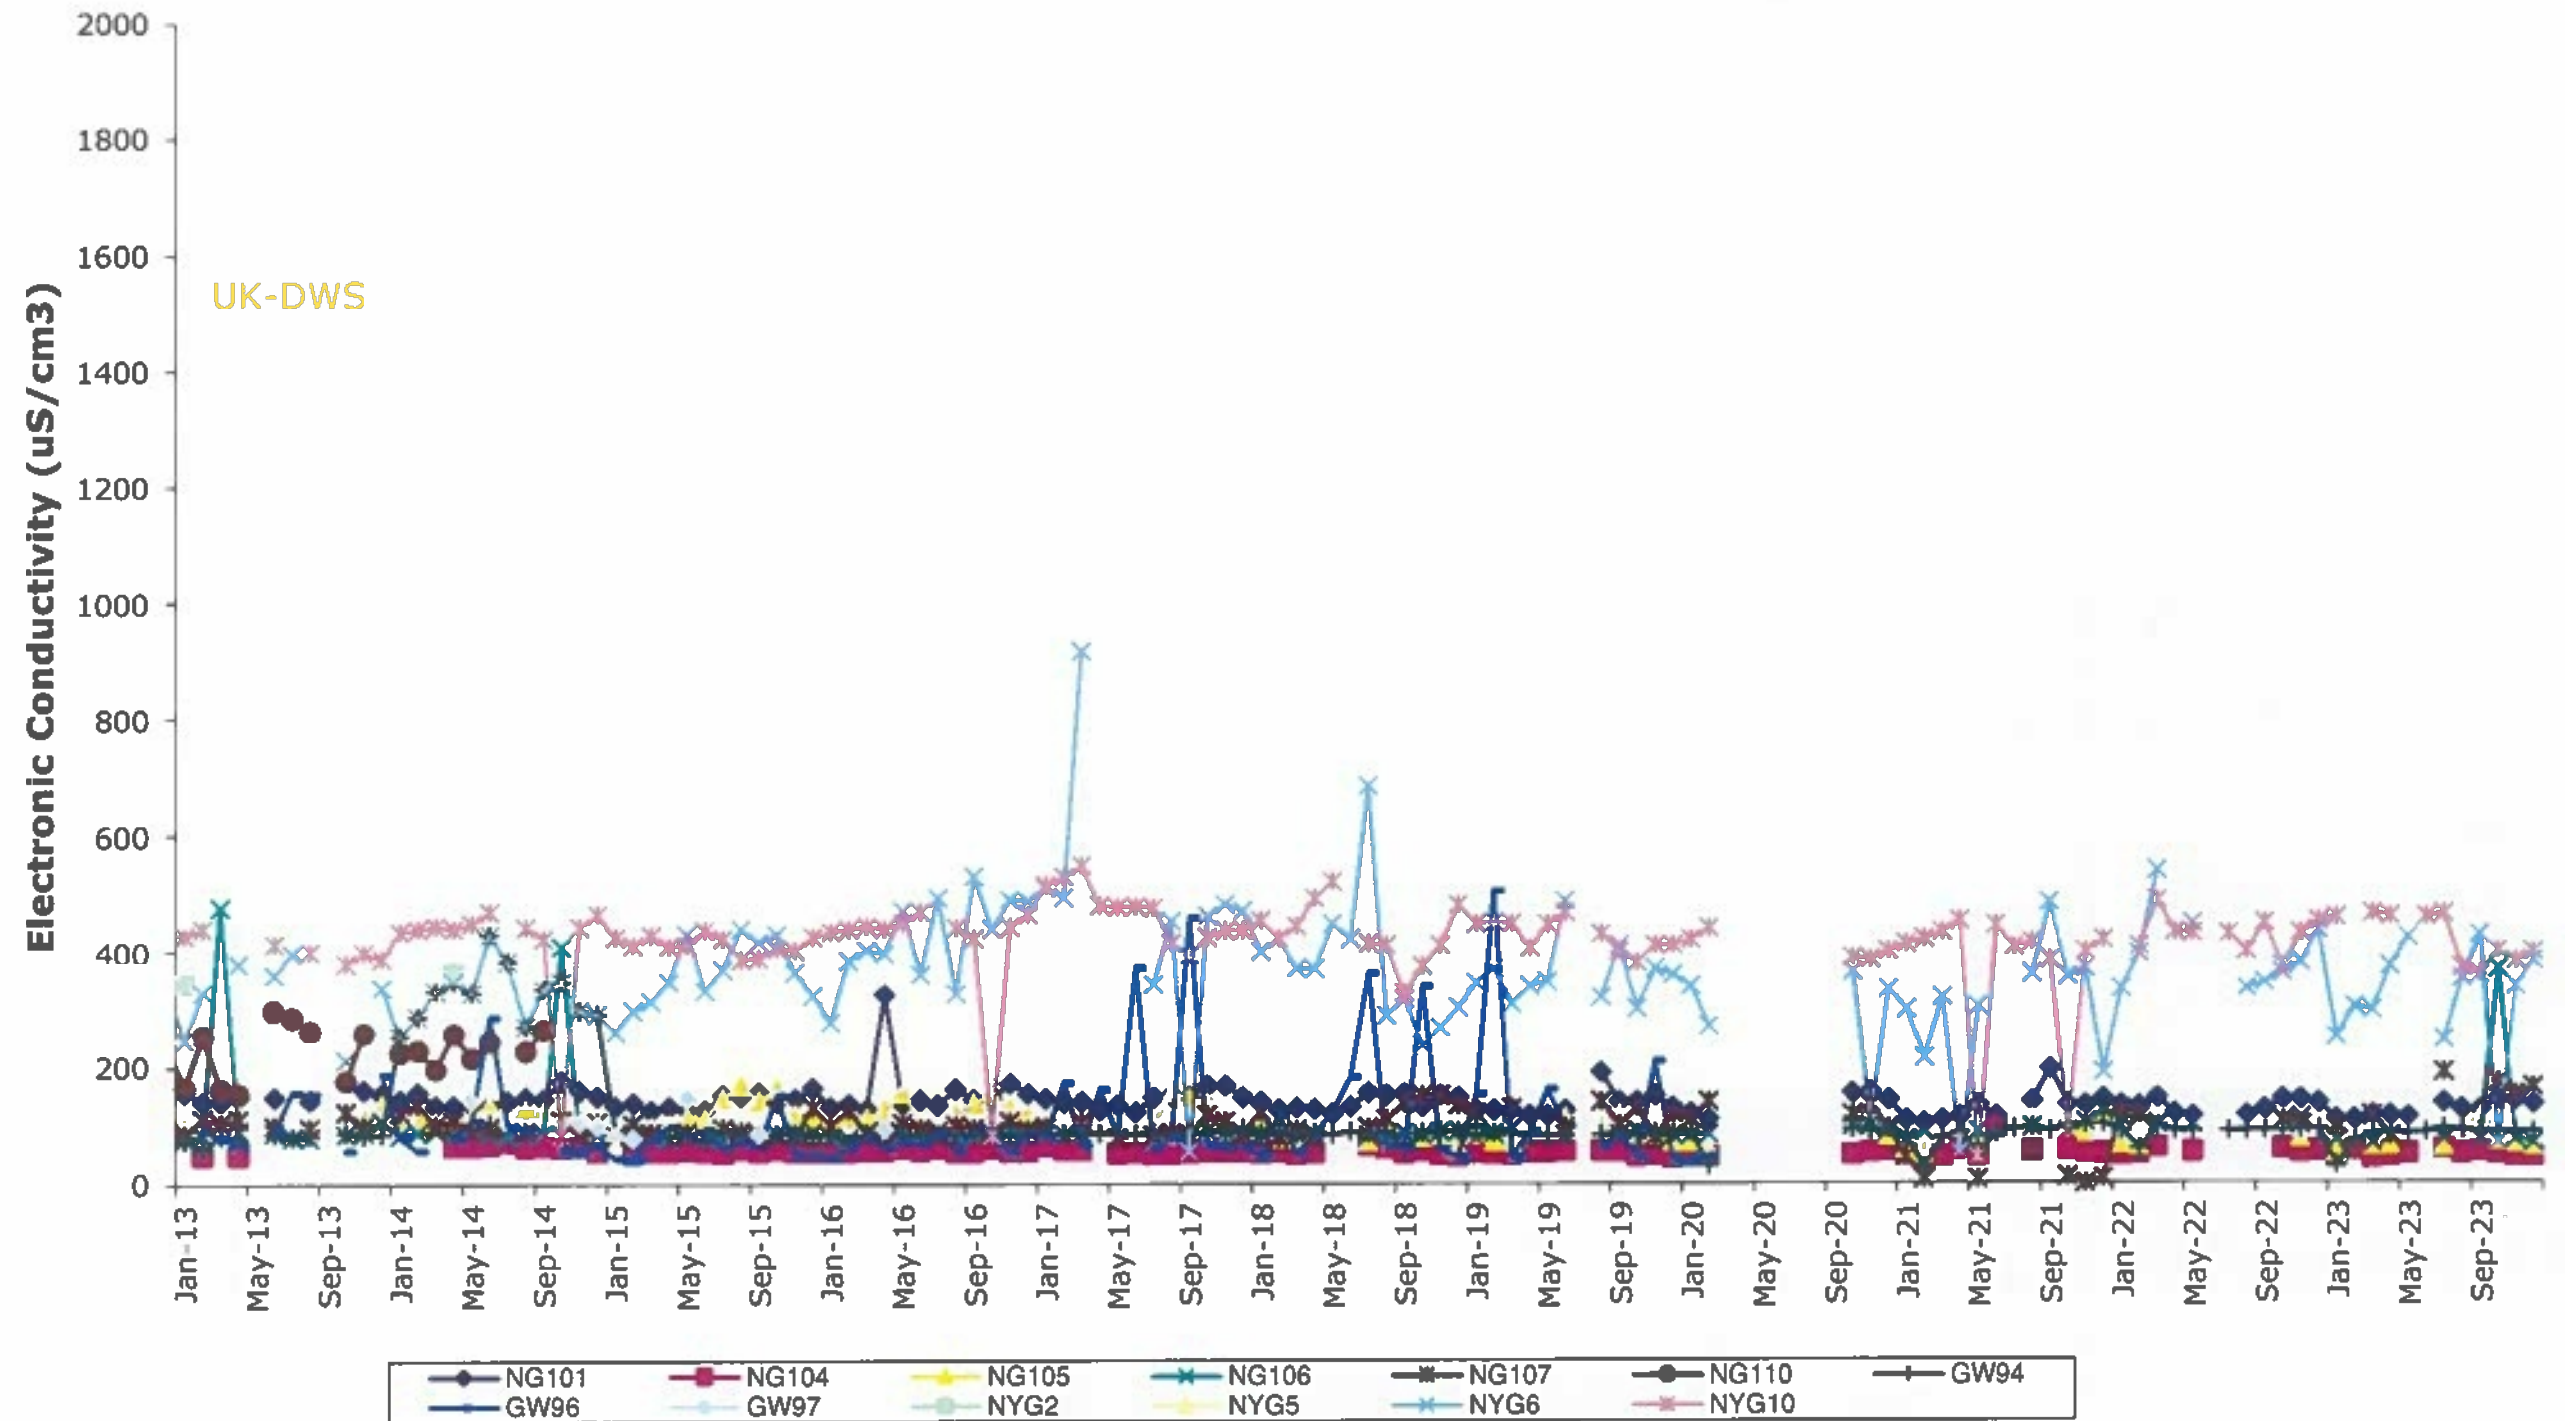
**Lab analysis of Electronic Conductivity levels in groundwater sampled by Amgen Rhondda Ltd at the Nant-Y-Gwyddon Landfill Site during the period Jan 2013 - Dec 2018.**

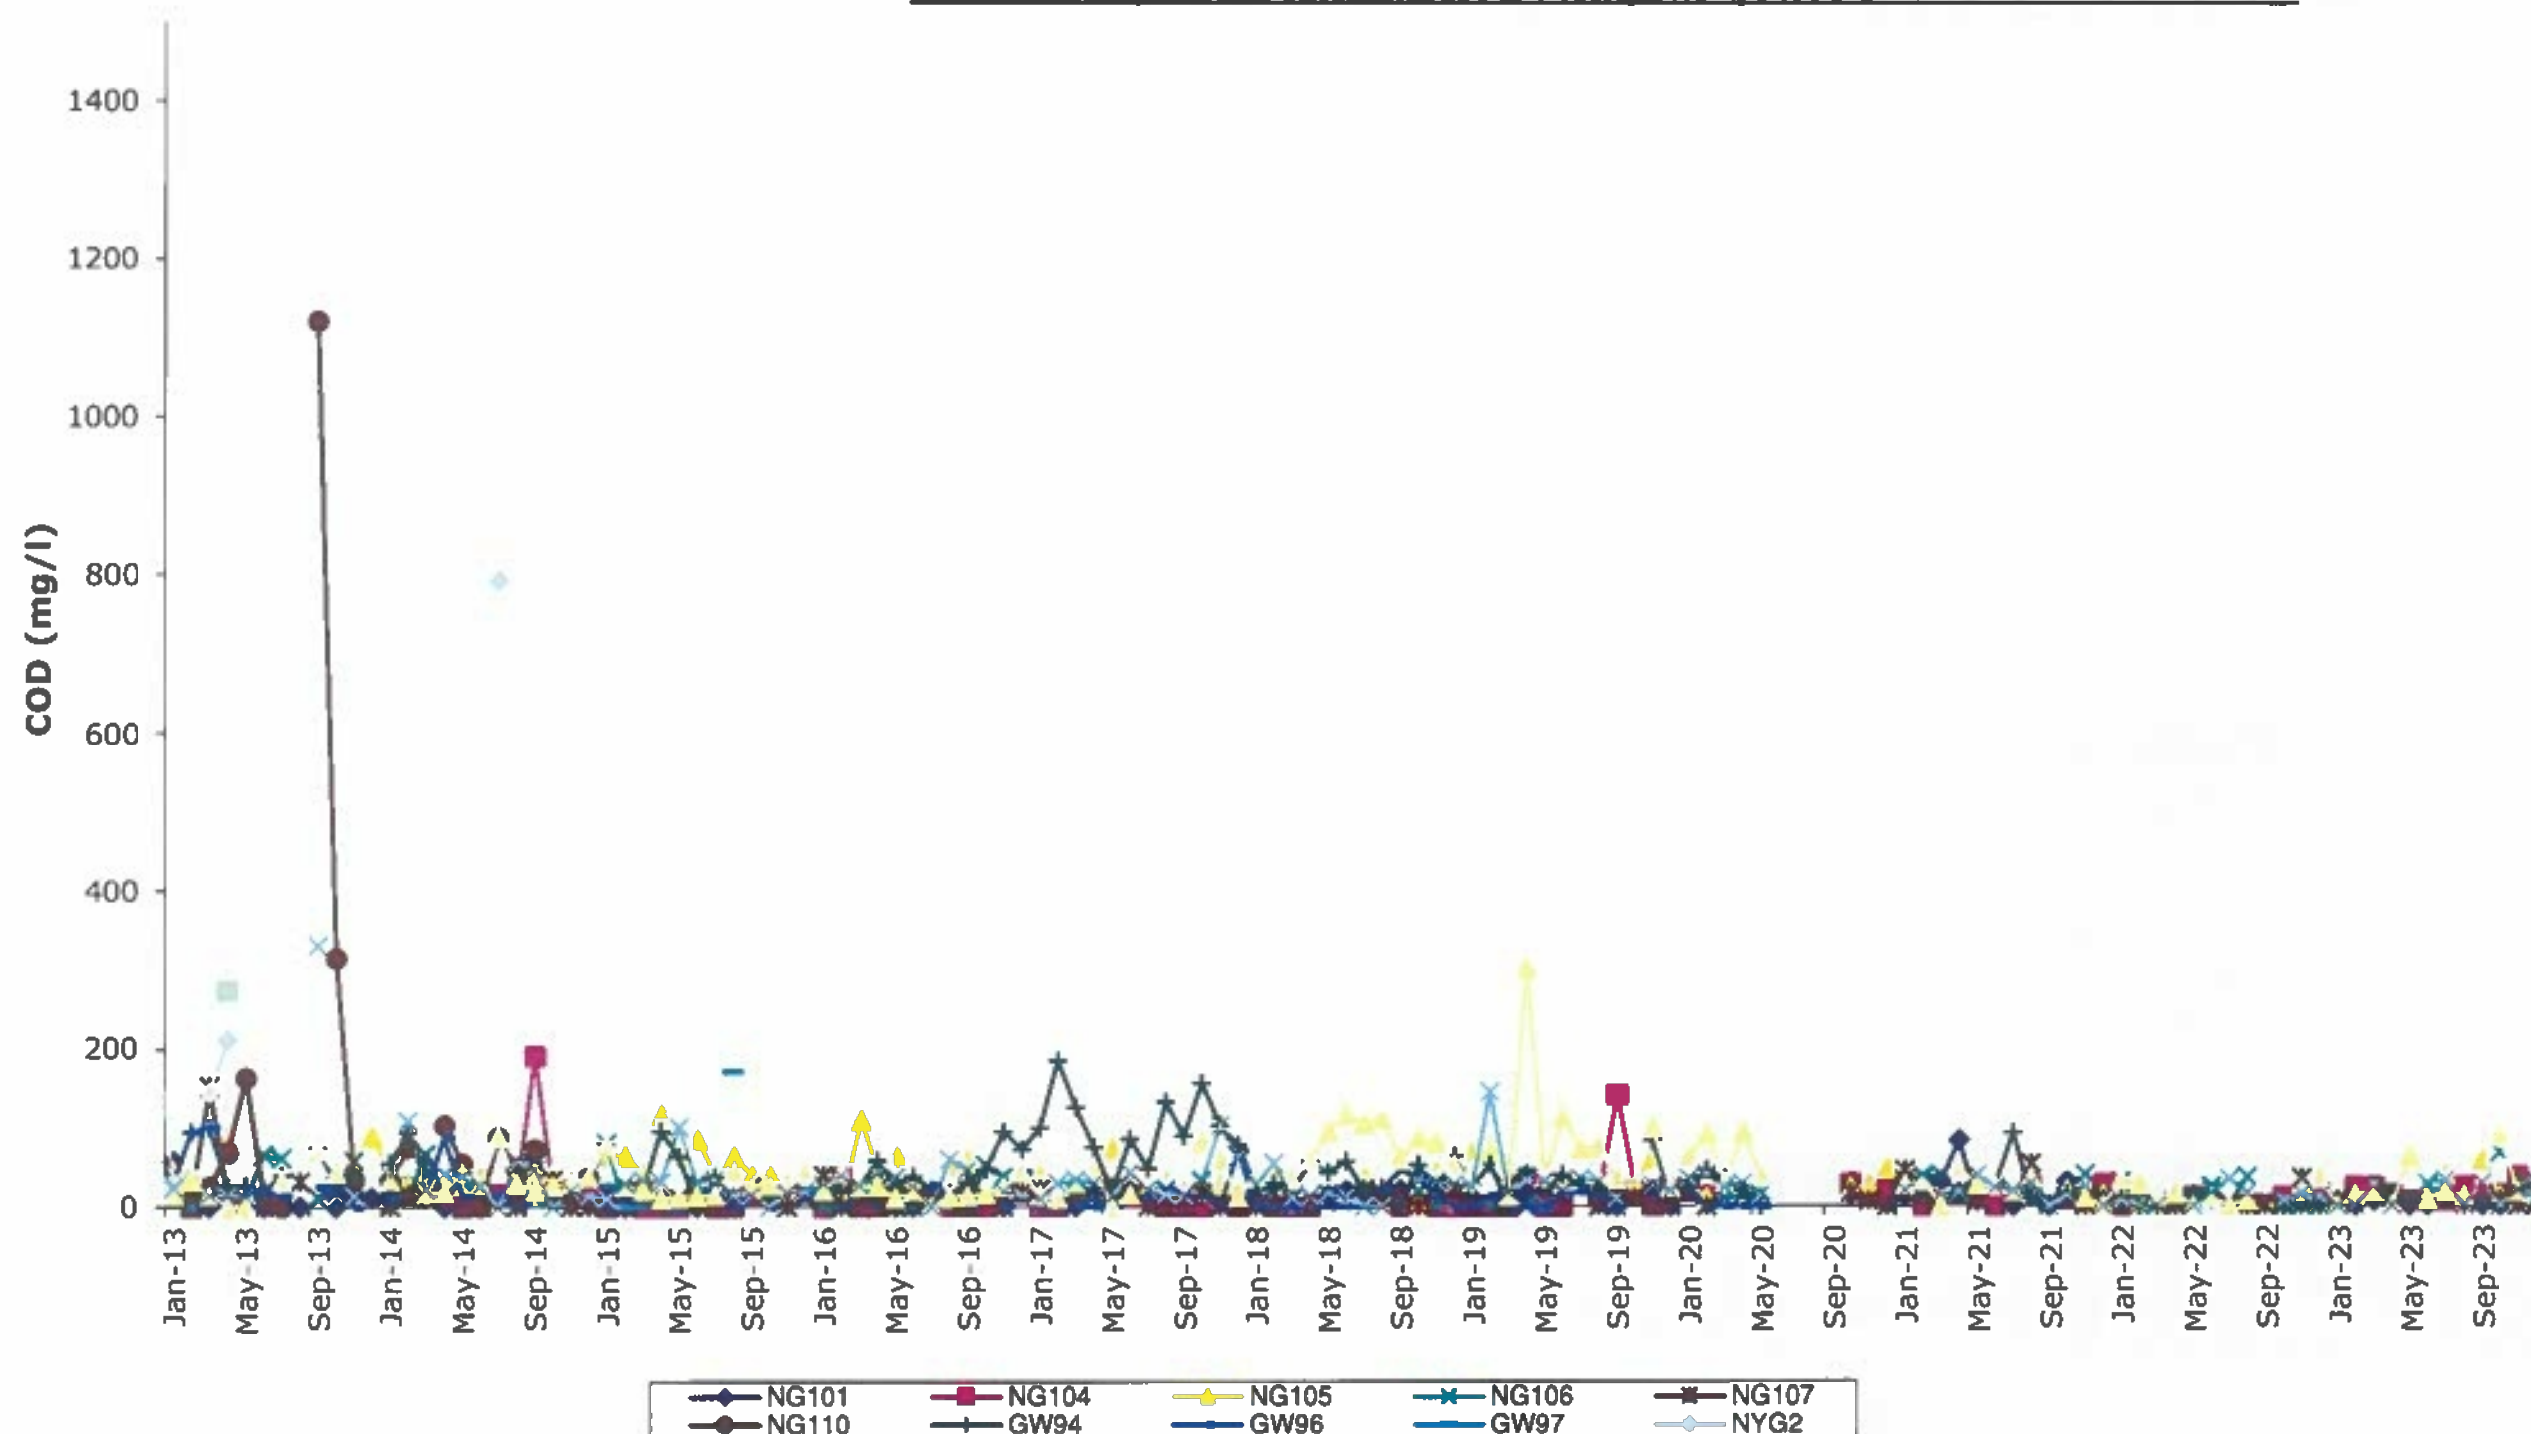
**Lab analysis of Chemical Oxygen Demand (COD) concentrations in groundwater sampled at the Nant-Y-Gwyddon Landfill Site during the period Jan 2013 - Dec 2023.**

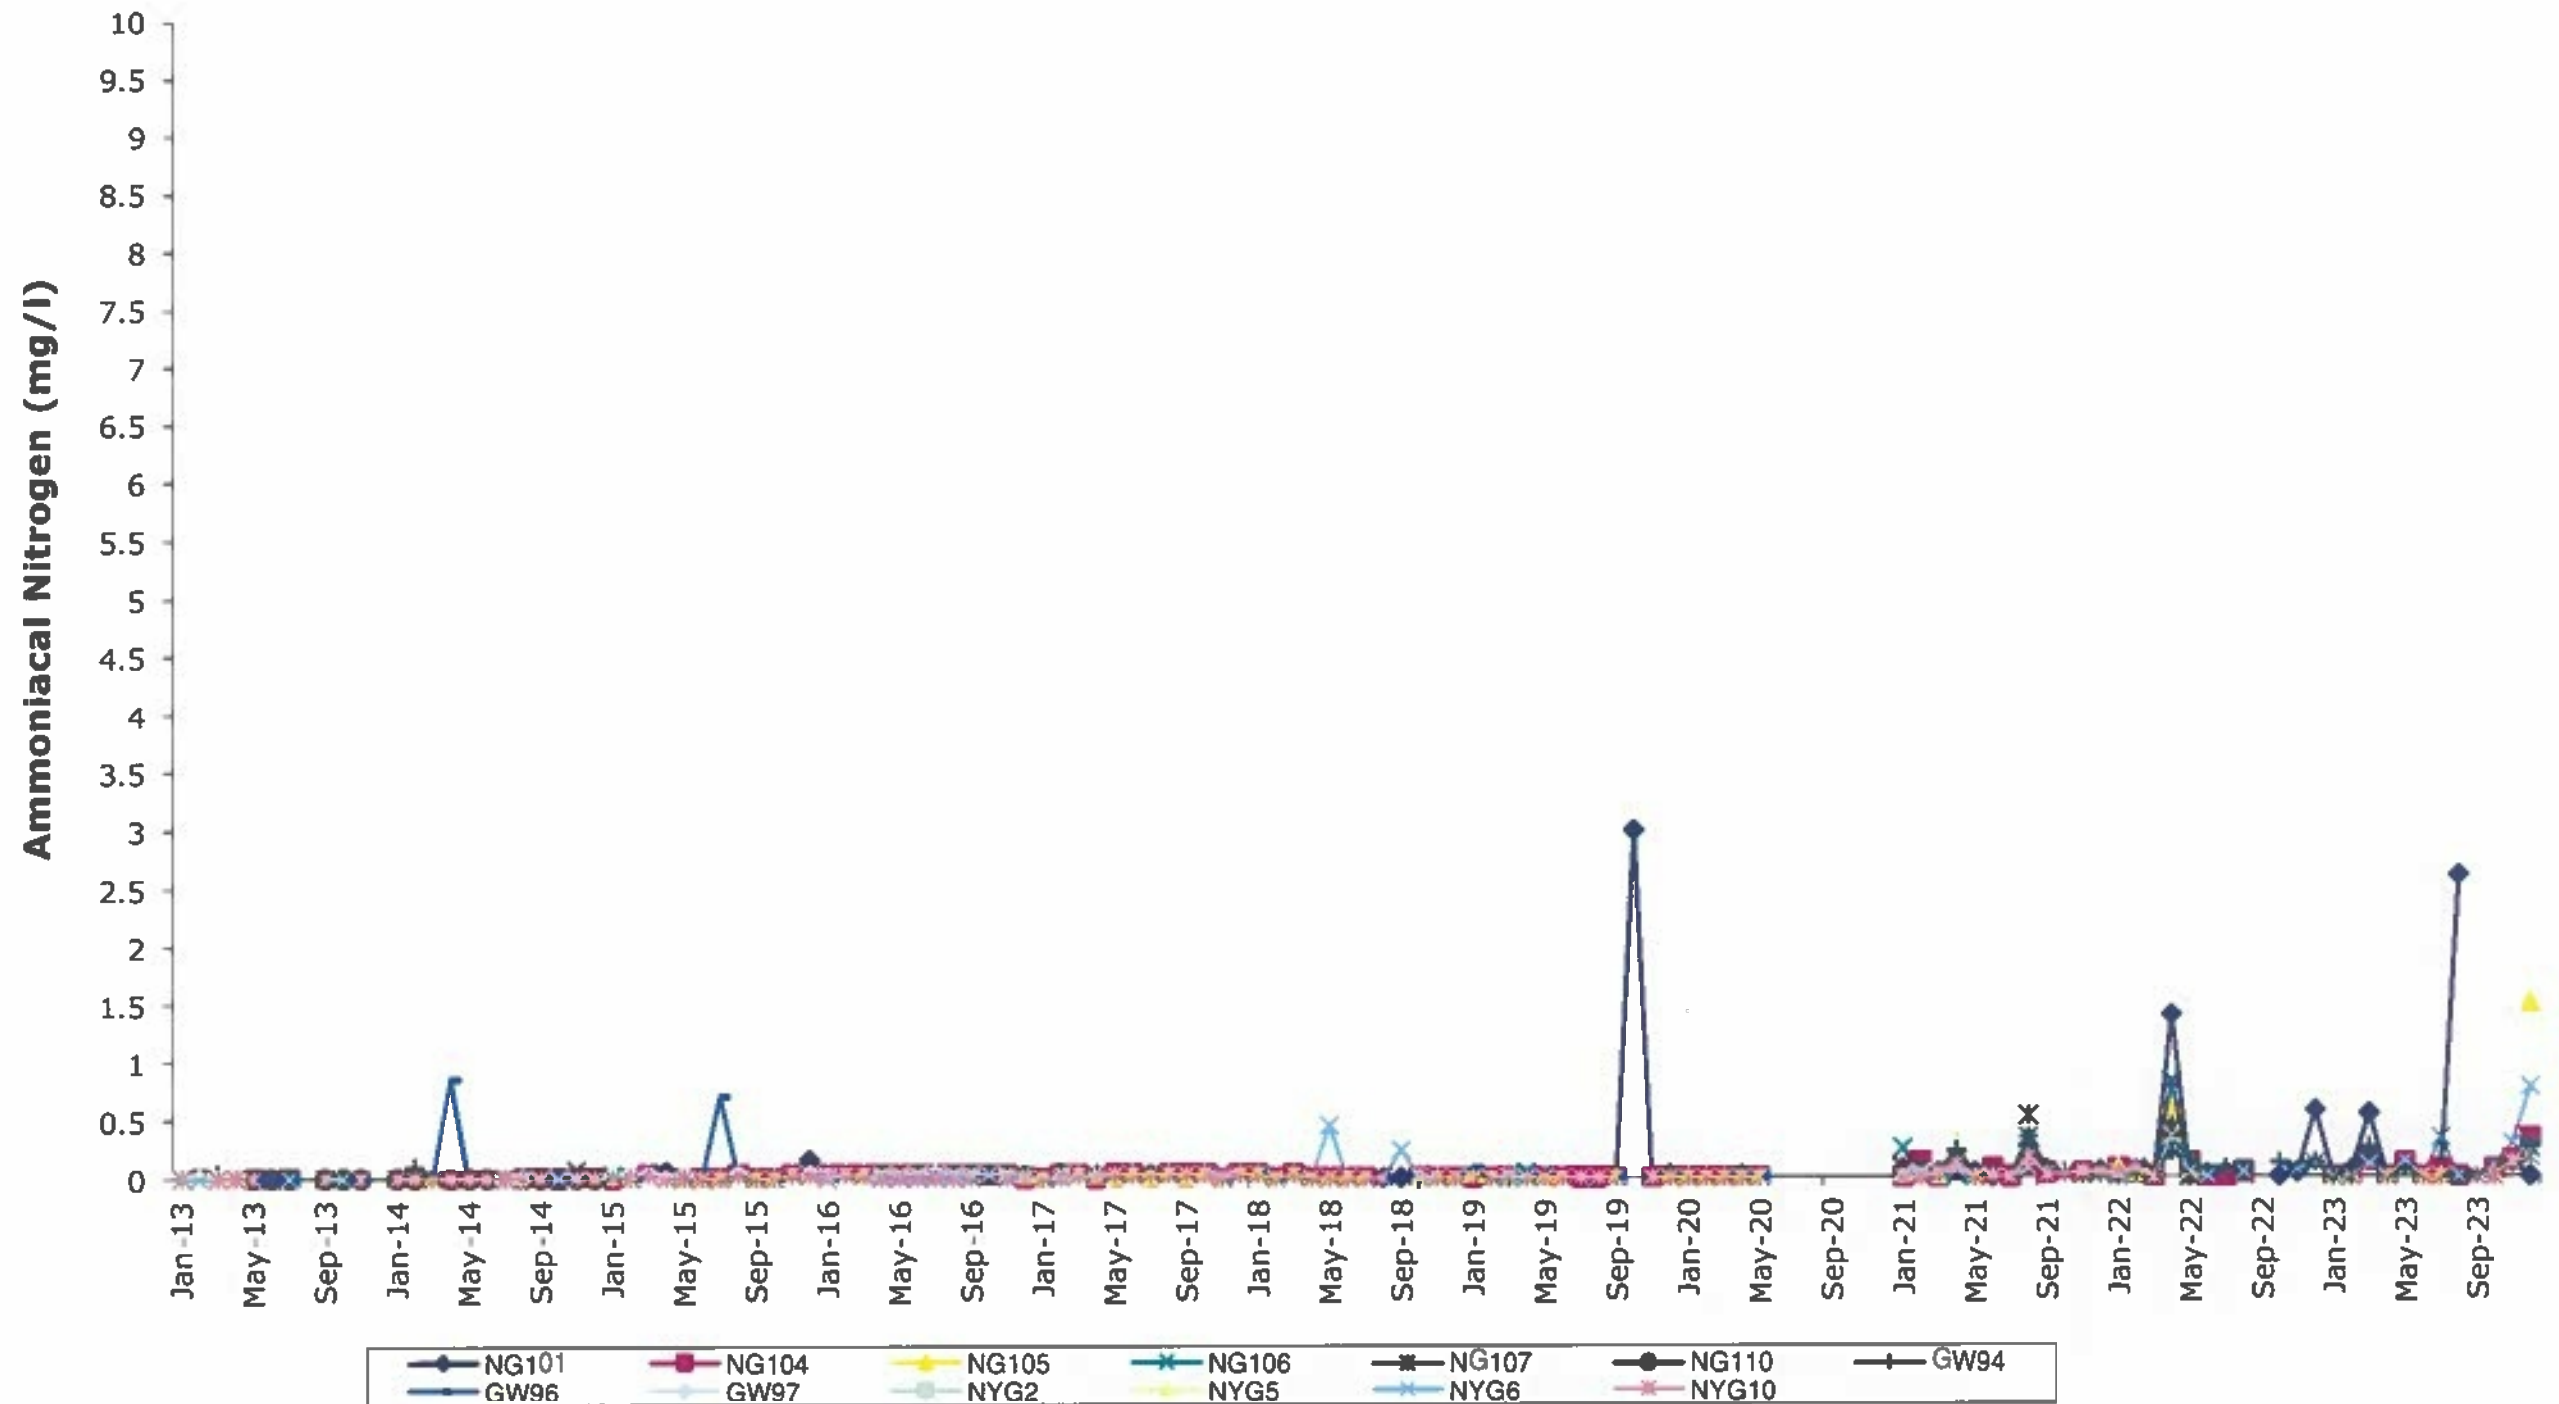
**Lab analysis of Ammoniacal Nitrogen levels in groundwater sampled by Amgen Rhondda Ltd at the Nant-Y-Gwyddon Landfill Site during the period Jan 2013 - Dec 2023.**

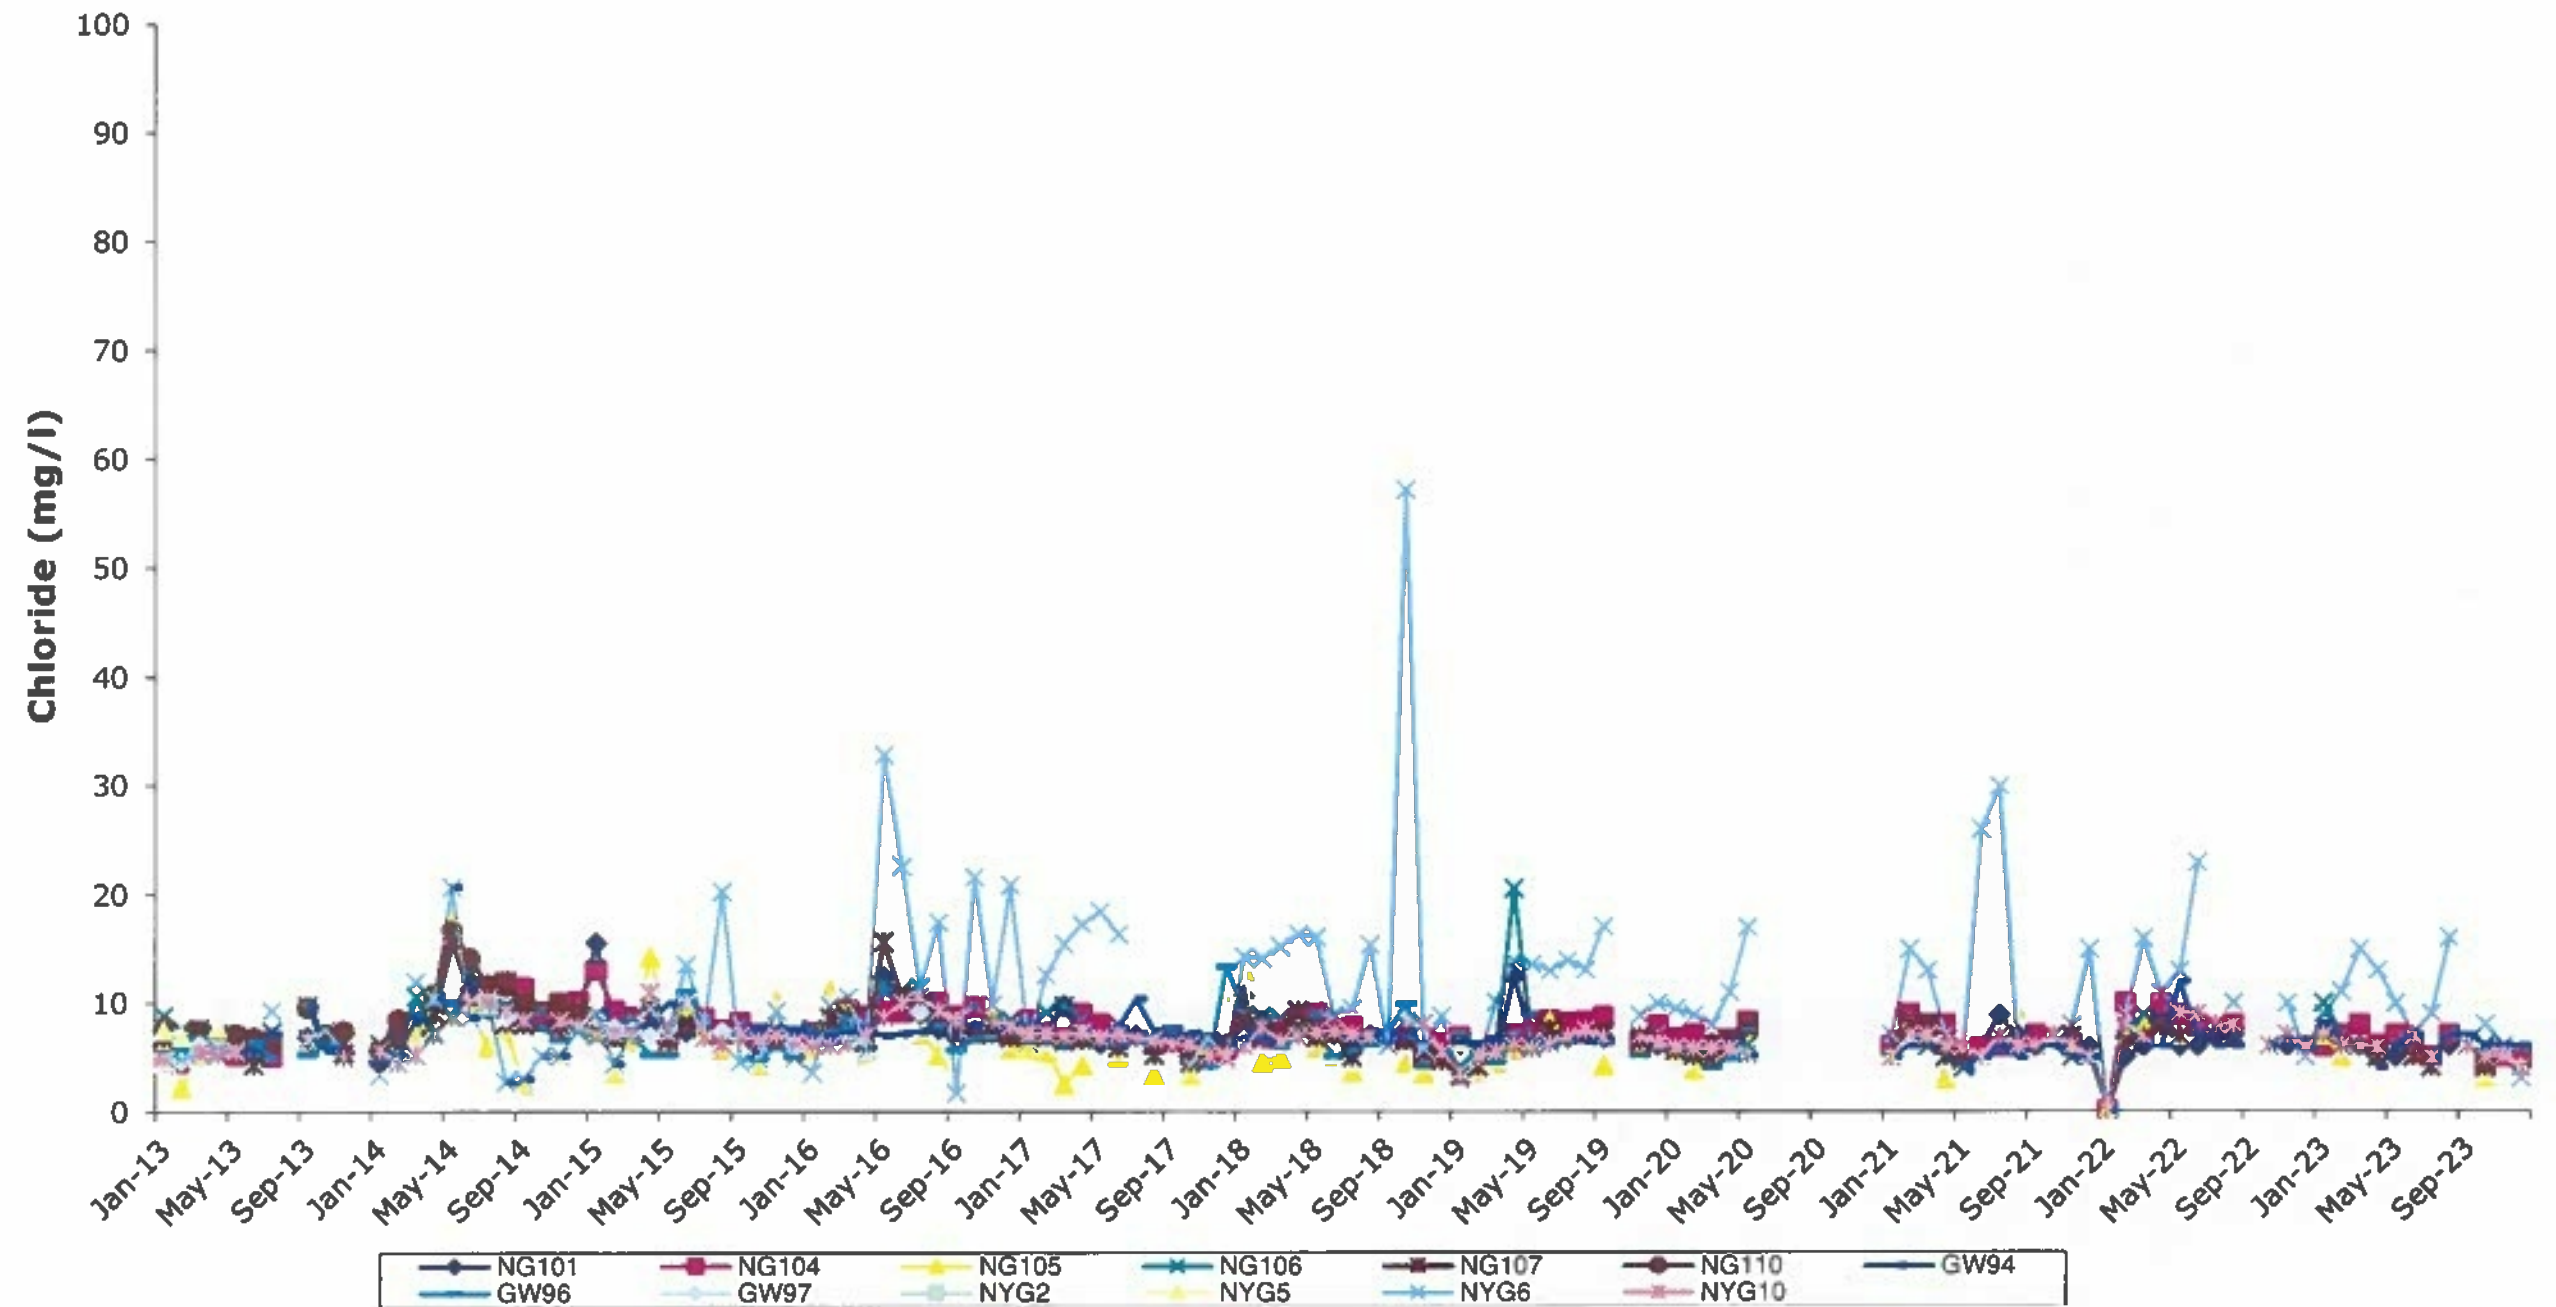
**Lab analysis of Chloride concentrations in groundwater sampled by Amgen Rhondda Ltd at the Nant-Y-Gwyddon Landfill Site during the period Jan 2013 - Dec 2023.**
