**Report No: ARL2024/ENV/01**  
**Apr-24**

**REVIEW OF ENVIRONMENTAL MONITORING  
RESULTS AT THE  
NANT-Y-GWYDDON LANDFILL SITE DURING THE  
PERIOD JAN 23 – DEC 23**

**Amgen Rhondda Ltd.  
Bryn Pica Landfill Site  
Llwydcoed  
Aberdare  
CF44 0BX**

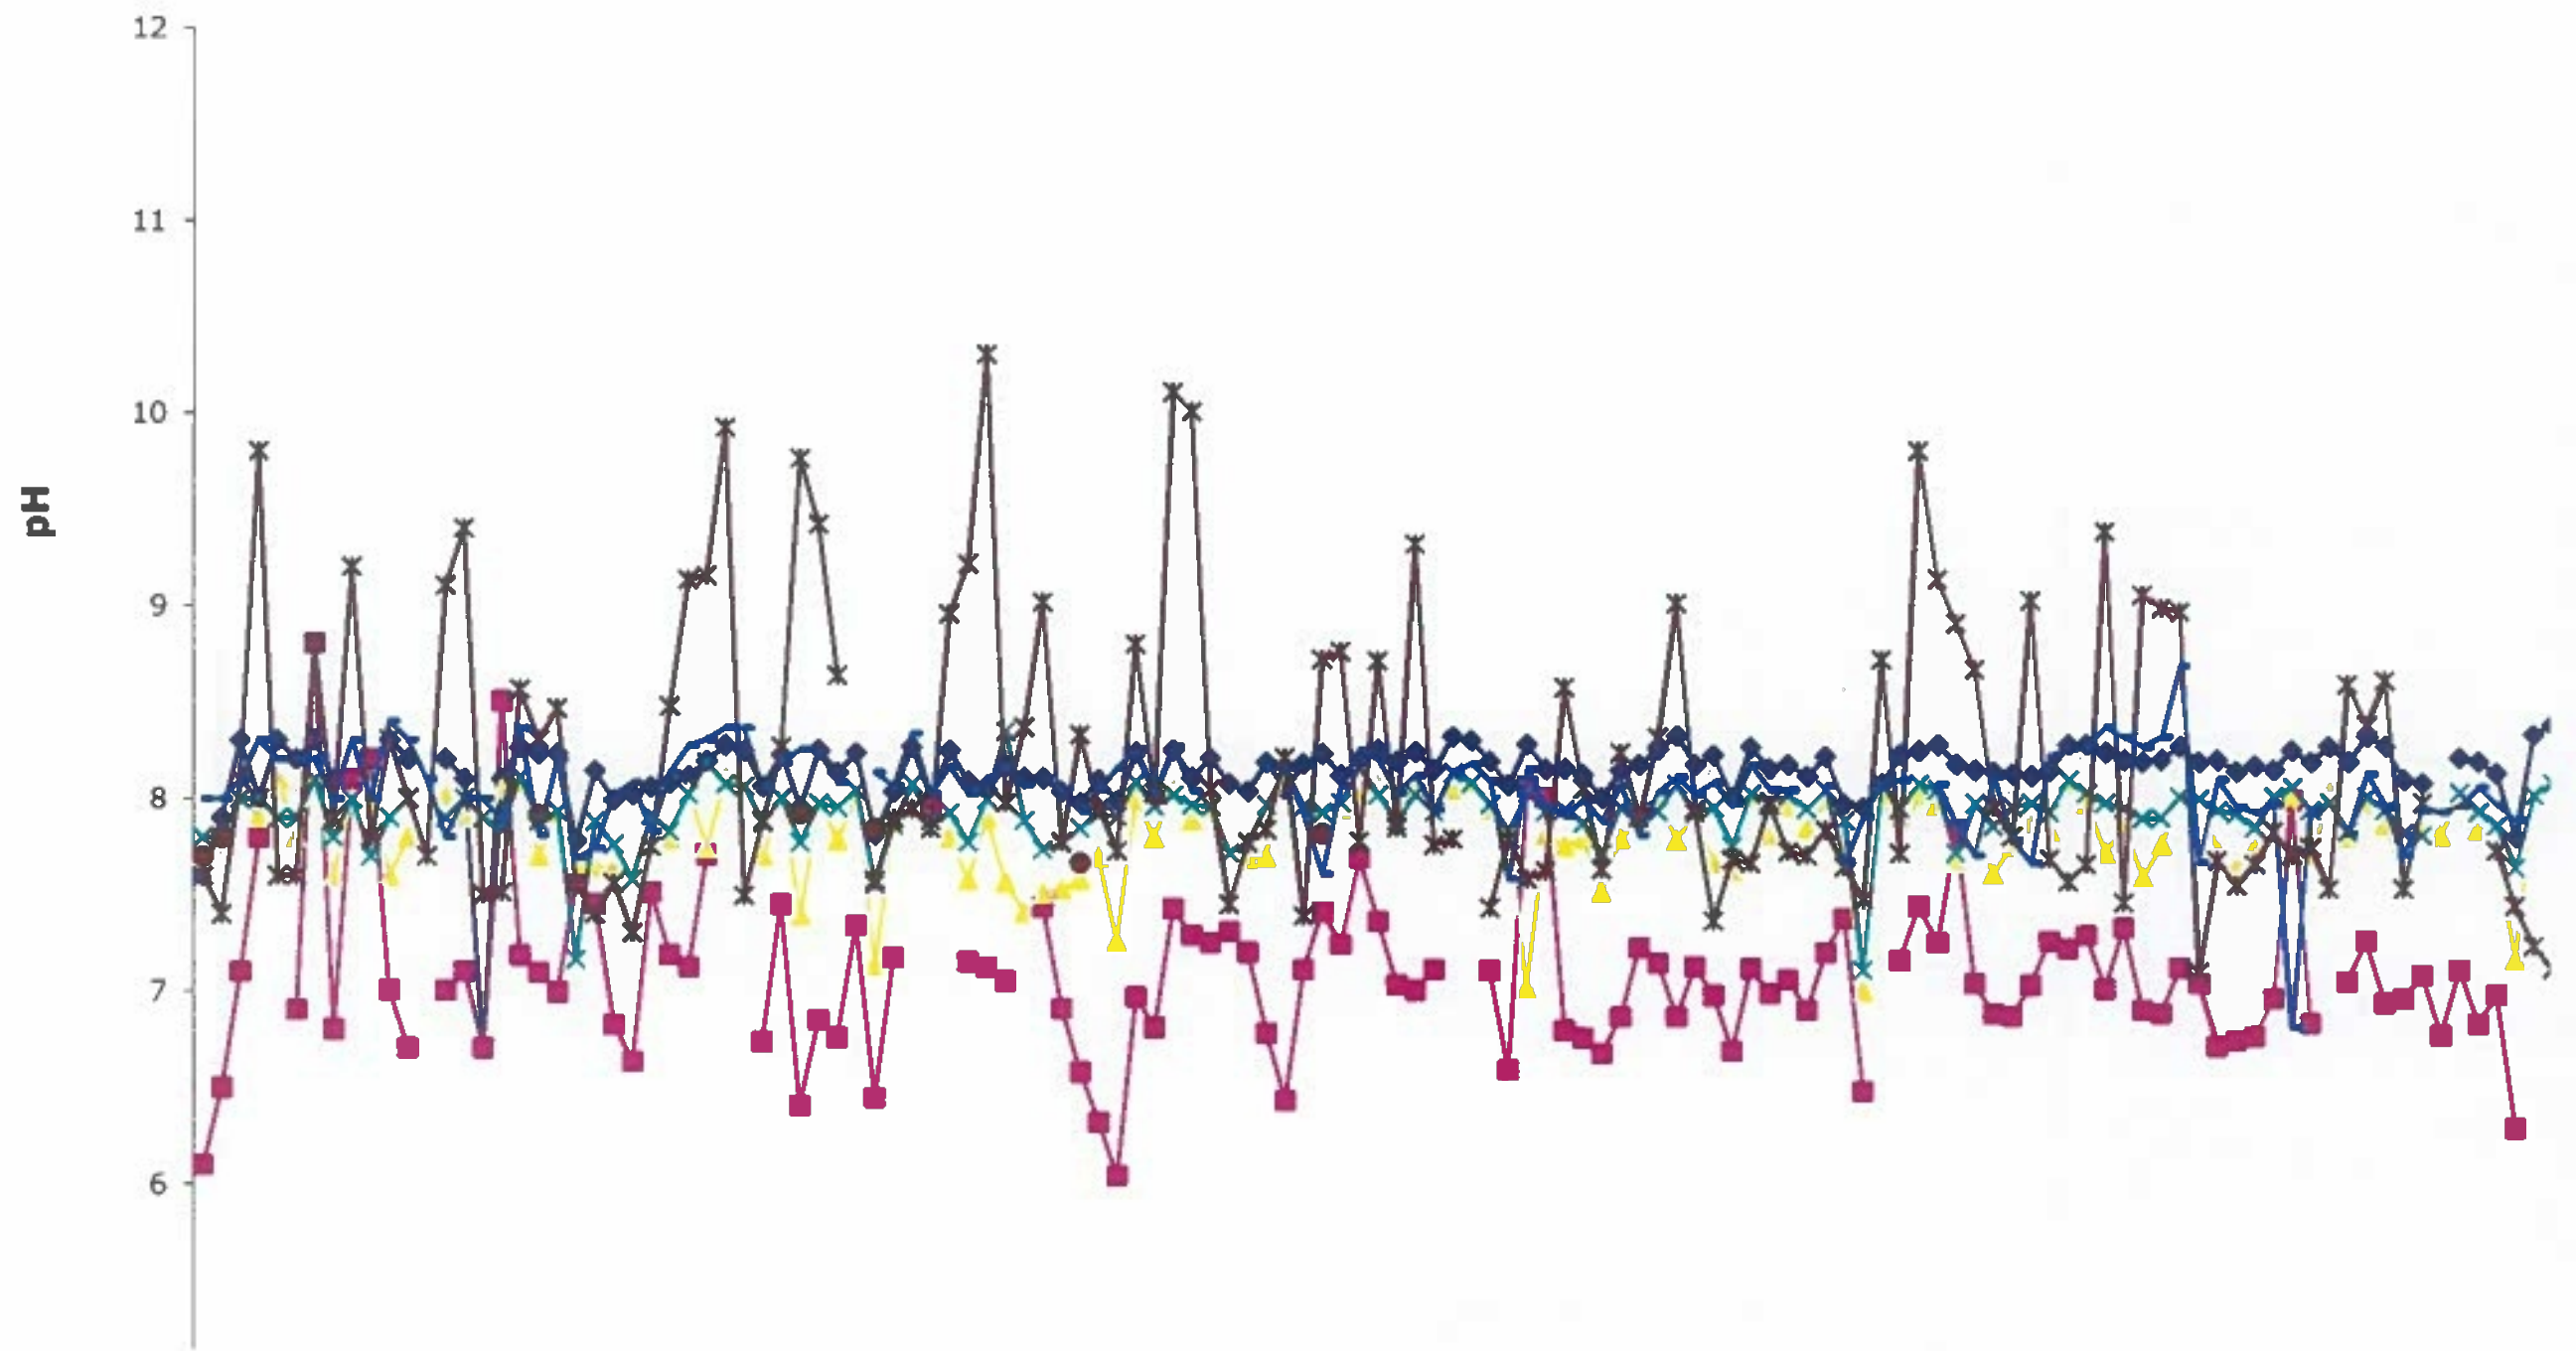
**Lab analysis of pH values in surface water sampled by Amgen Rhondda Ltd at the Nant-Y-Gwyddon Landfill Site**

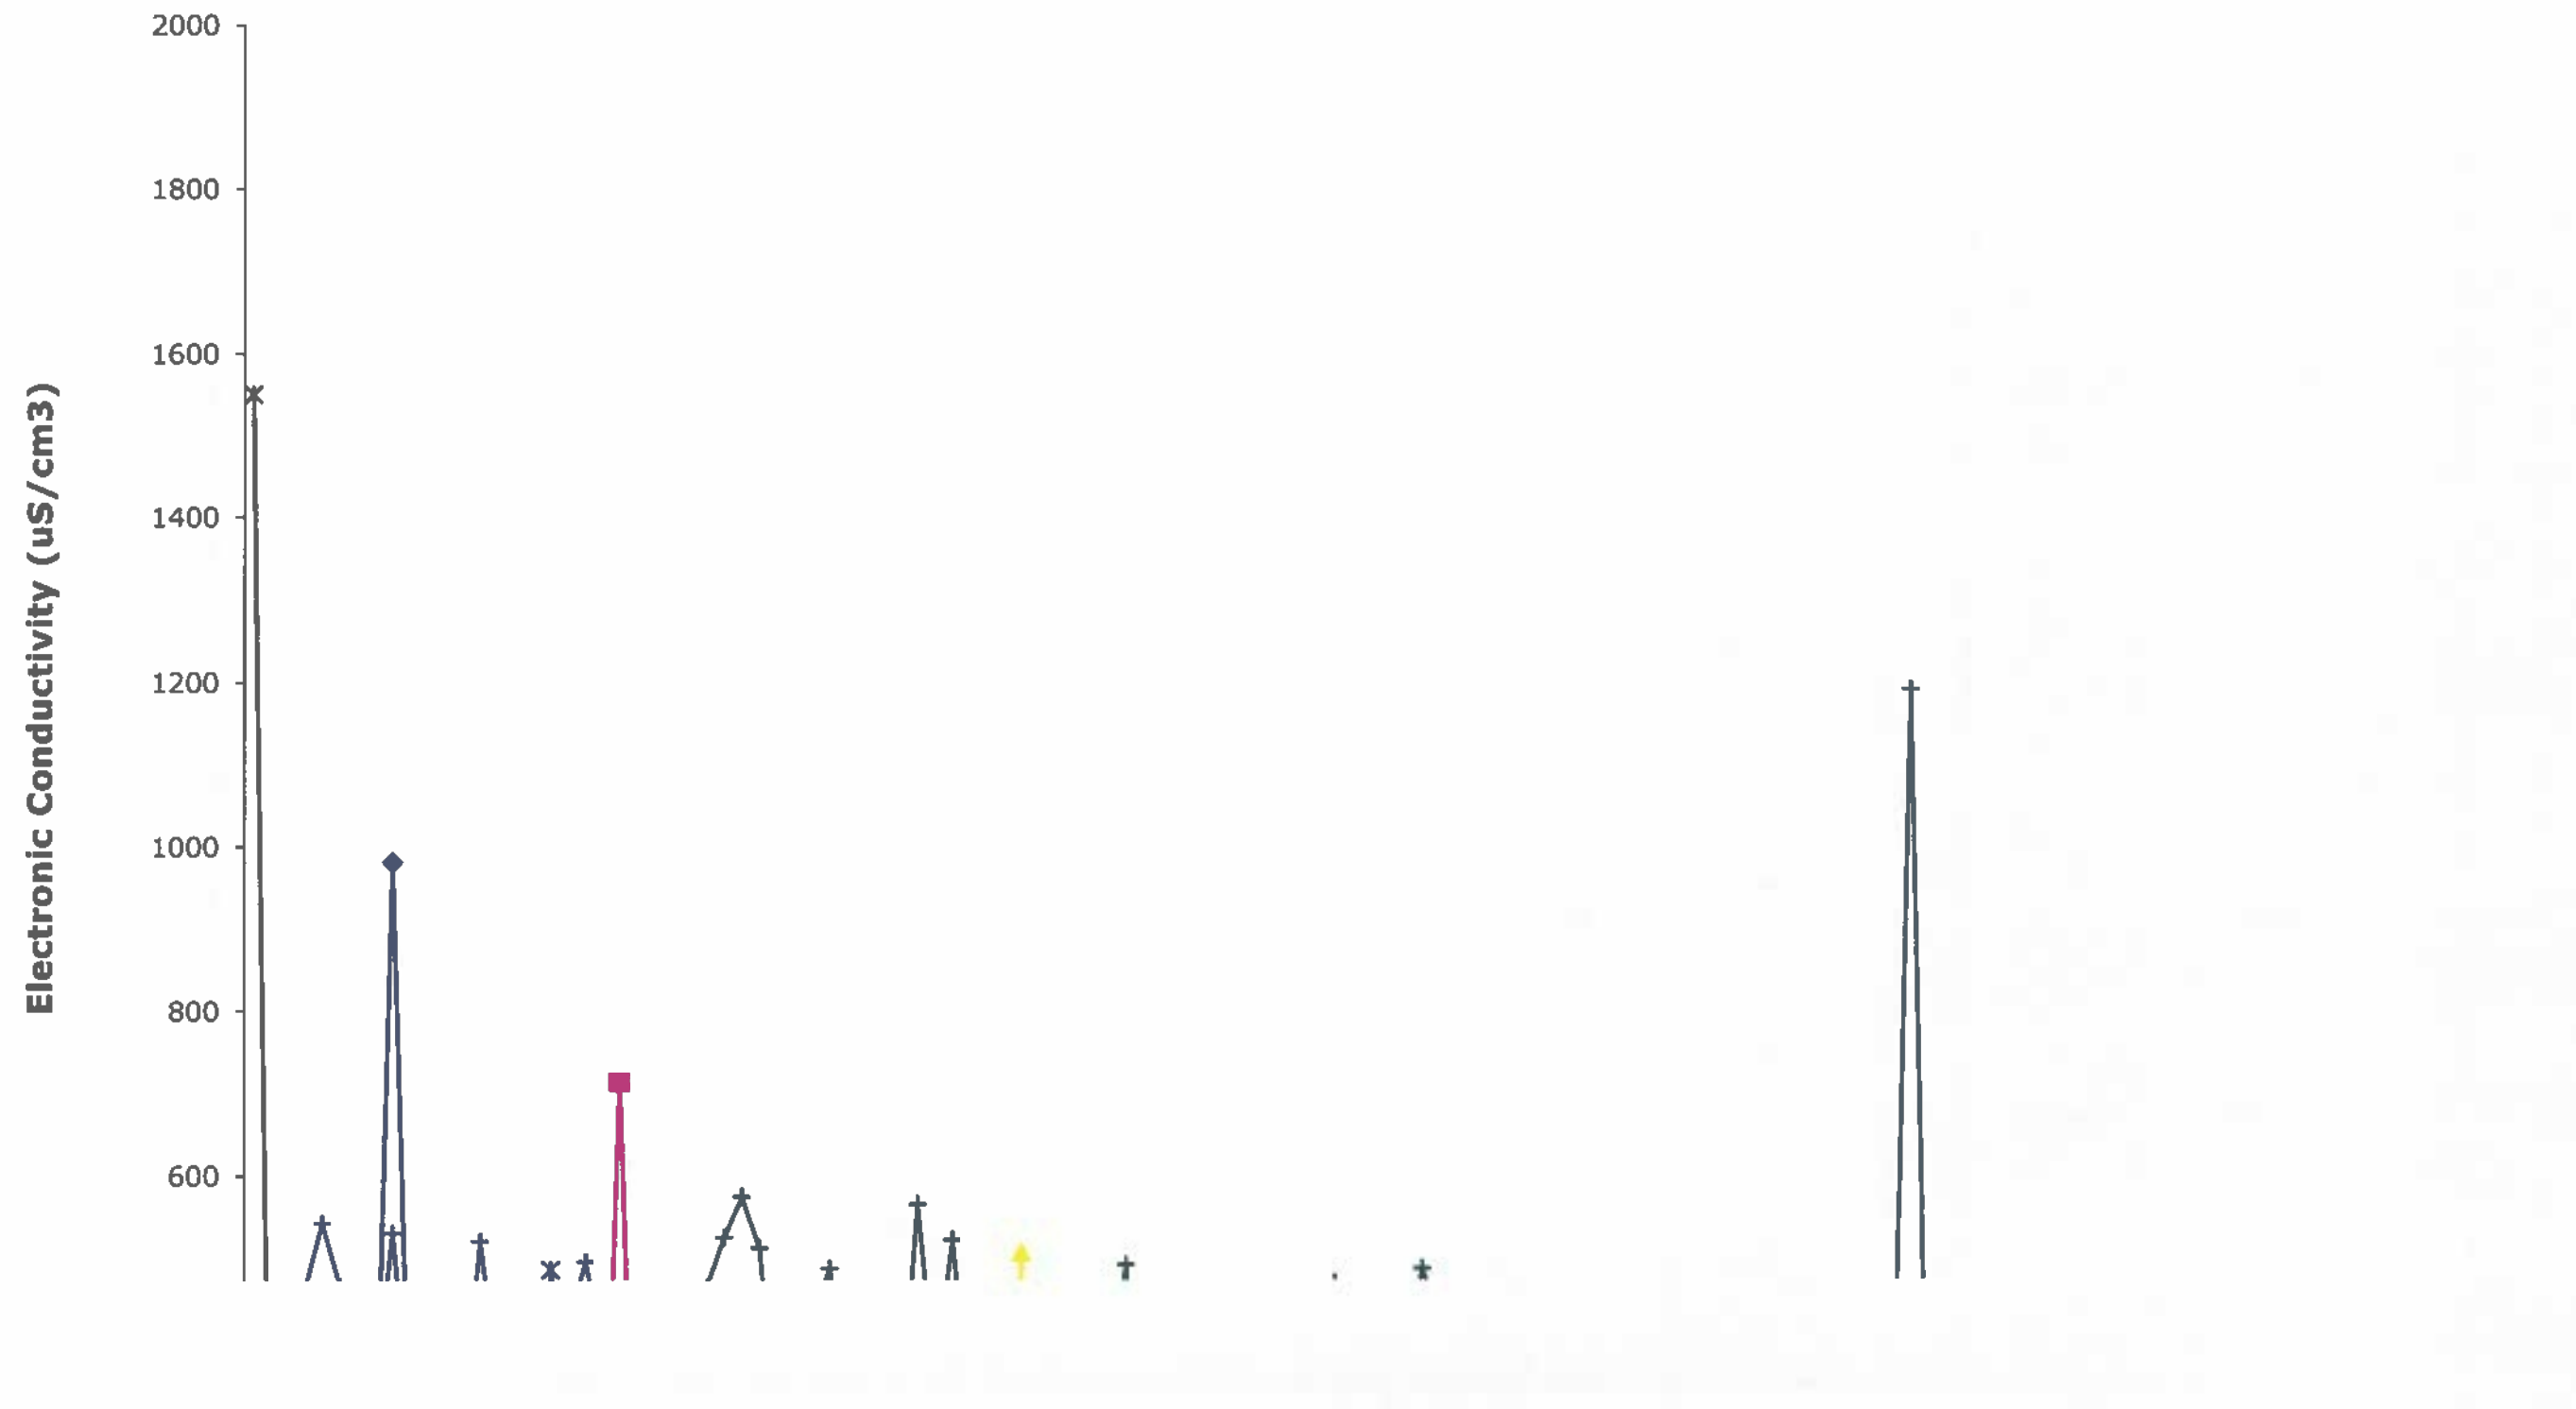
**Lab analysis of Electronic Conductivity levels in surface water sampled by Amgen Rhondda Ltd at the Nant-Y-**  
**2008 - Dec 2023.**

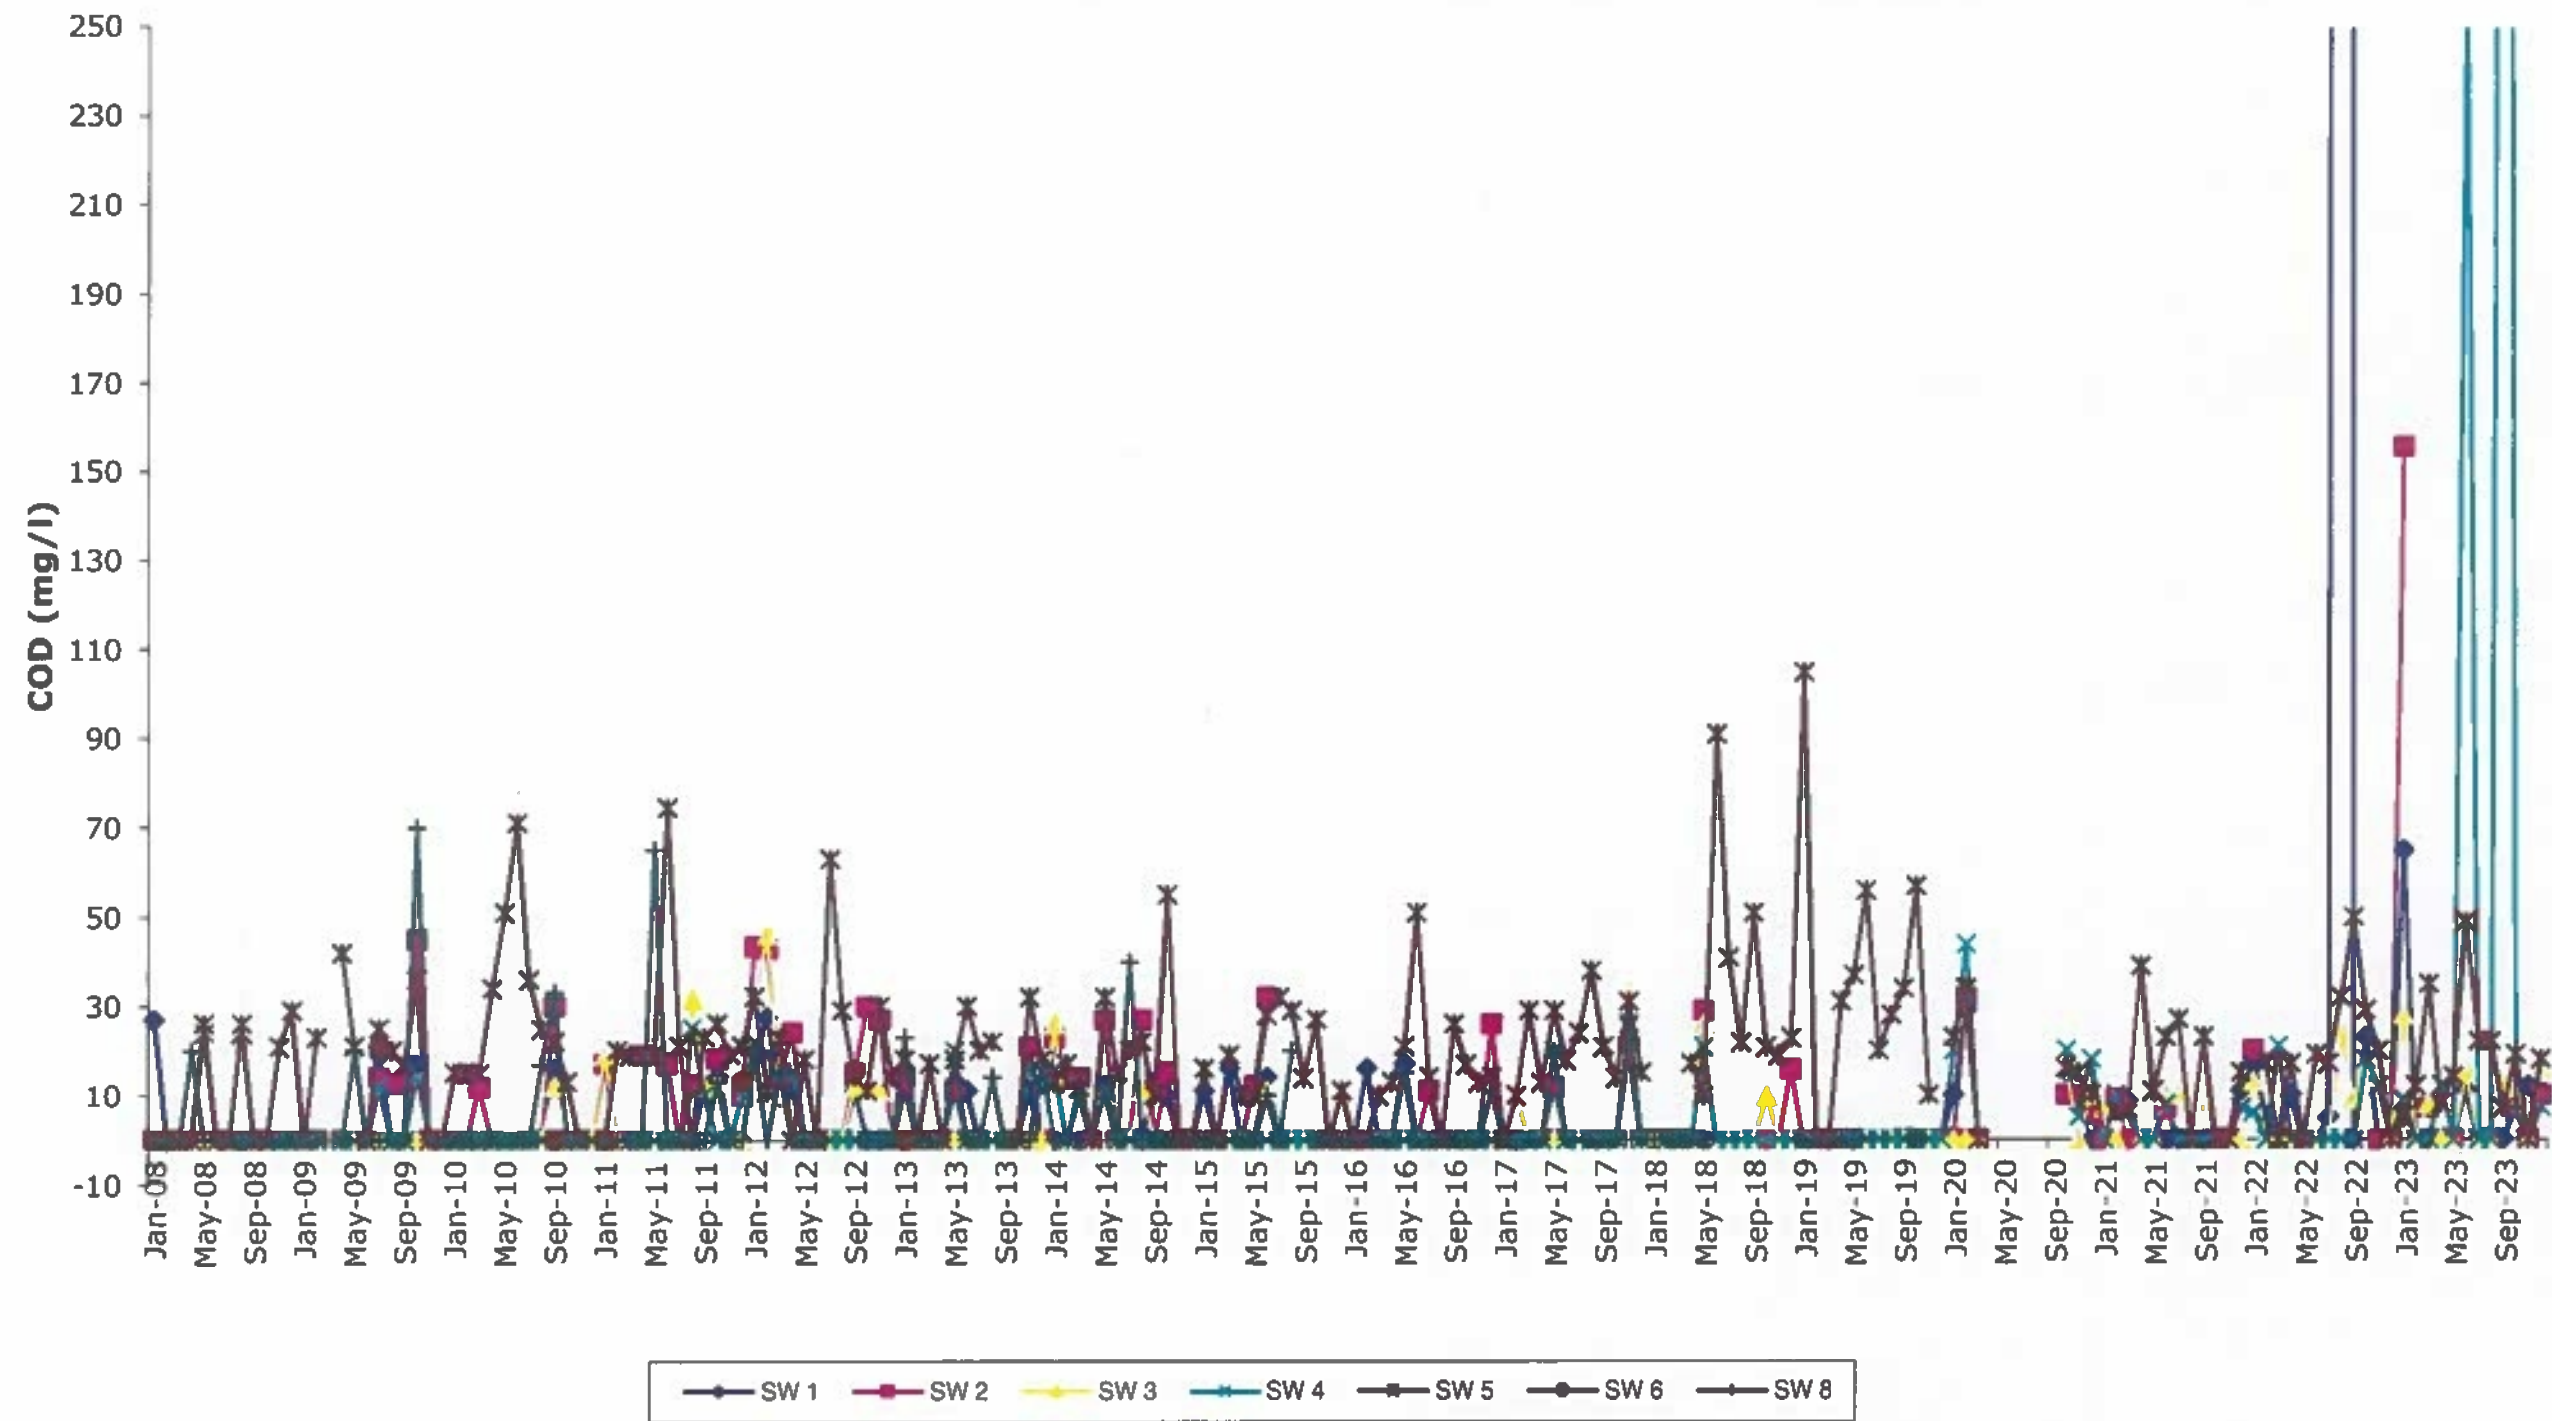
**Lab analysis of Chemical Oxygen Demand (COD) concentrations in surface water sampled by Amgen Rhondda Ltd at the Nant-Y-Gwyddon Landfill Site during the period Jan 2008 - Dec 2023.**

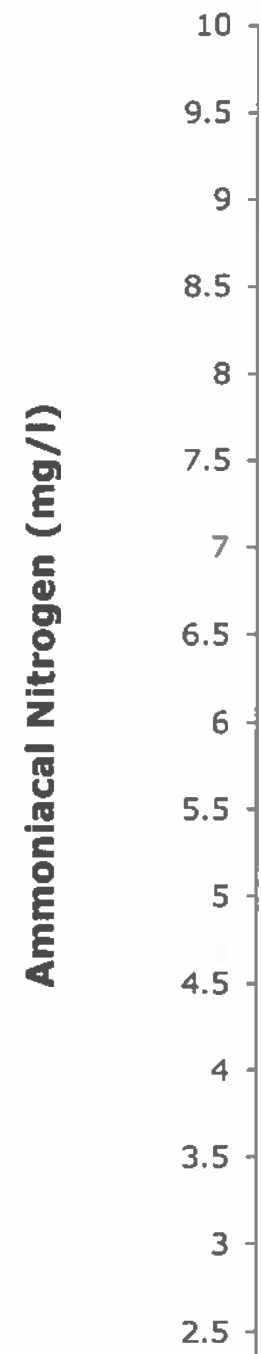
**Lab analysis of Ammoniacal Nitrogen levels in surface water sampled by Amgen Rhondda Ltd at the Nant-Y-G**  
**2008 - Dec 2023.**

Throughout 2023, it is noted that concentrations of ammoniacal nitrogen (ammonia  $\text{NH}_4$  as N) were very low, averaging less than 0.3 mg/l at each of the 6 surface water monitoring locations. Of the 56 water samples analysed for  $\text{NH}_4$  as N, a total 19 (34%) returned a positive result above the minimum reporting value of 0.05 mg/l  $\text{NH}_4$  as N. The maximum value recorded during 2023 was 1.85 mg/l, recorded at SW 2 in Apr-23.

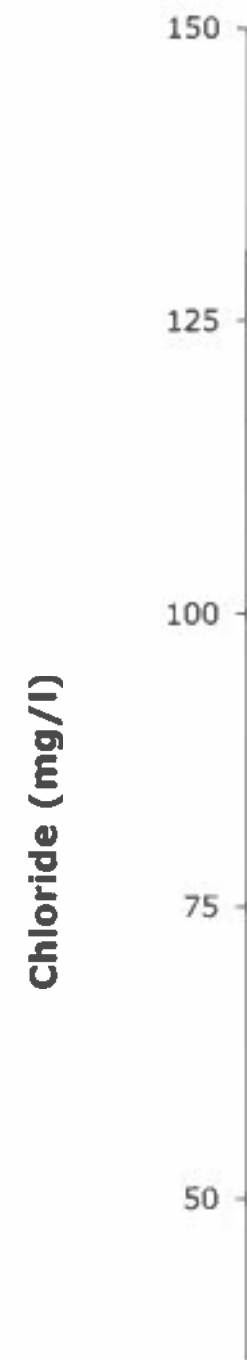
**Lab analysis of Chloride concentrations in surface water sampled by Amgen Rhondda Ltd at the Nant-Y-G**  
**- Dec 2023.**
