## Compliance Assessment Report CAR\_NRW0049055

For: LLECHWEN HALL HOTEL, held by LLECHWEN HALL HOTEL LIMITED

At: ., LLANFABON, NEAR PONTYPRIDD, CAERPHILLY, CF37 4HP.

**Type of assessment carried out:** Site Inspection, Reason: Routine.

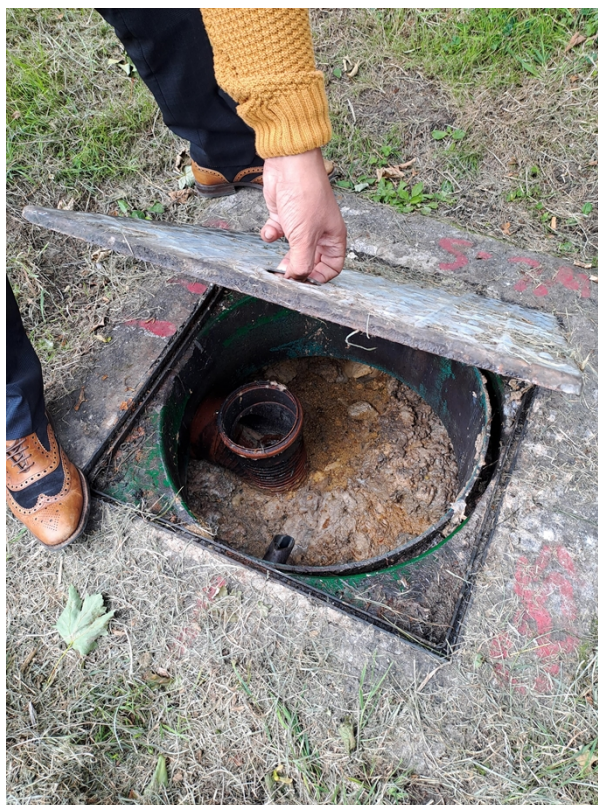
Chamber 1 – Mixed/untreated effluent input where solids/sludge settle out and effluent is carried forward for further treatment. This is also the point where sludge removal is undertaken. No issues were noted at the time of the visit, see Figure 1 as evidence of conditions.

Figure 1 – Chamber 1 of the treatment plant as observed during the visit.

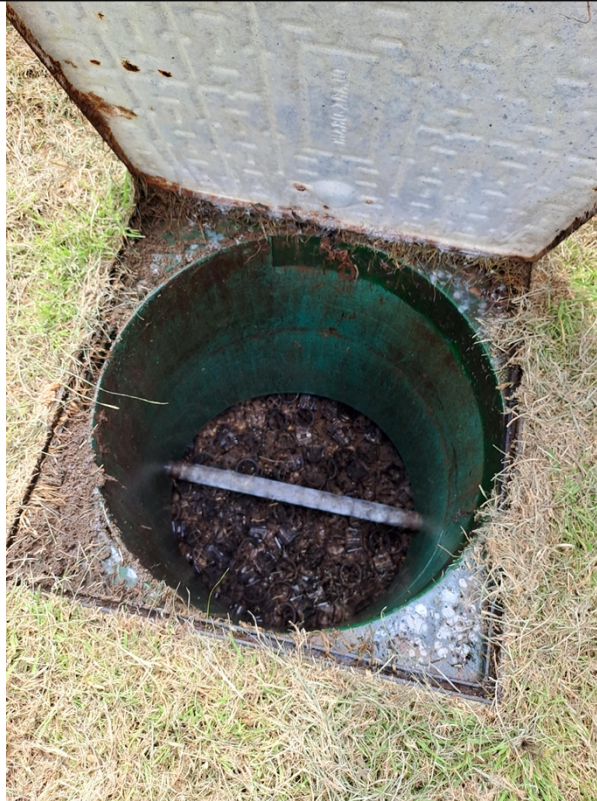
Chamber 2 – Further solids filtration and removal is undertaken here with bio media present to begin the biological treatment of the effluent. There were some solids present but no excessive buildup. No issues were present. Figure 2 shows evidence of these observations.

Figure 2 – Chamber 2 of the treatment plant as observed during the visit.

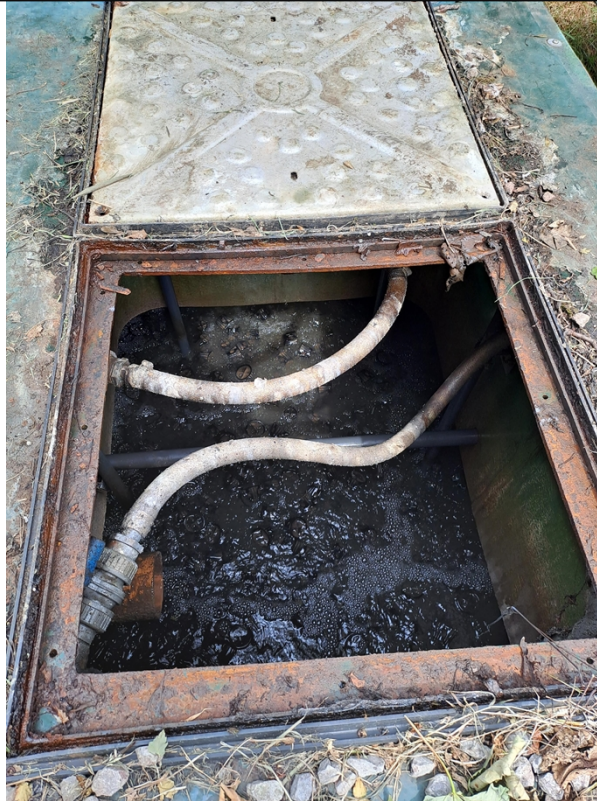
Chamber 3 – This is the aeration tank. The blowers were in operation and good circulation was present. There were minimal solids present in the effluent. No concerns were raised. This is evidenced in Figure 3.

Figure 3 – Chamber 3 of the treatment plant as observed during the visit.

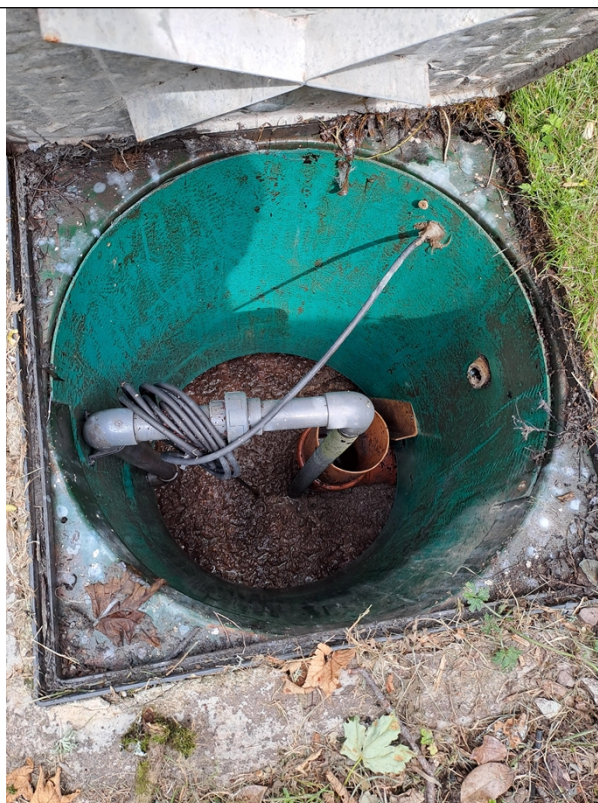
Chamber 4 – Further solids removal from the effluent is undertaken here and returned to the solids chamber for removal. The condition was as expected with no concerns raised. Figure 4 shows the condition at the time of the visit.

Figure 4 – Chamber 4 of the treatment plant as observed during the visit.

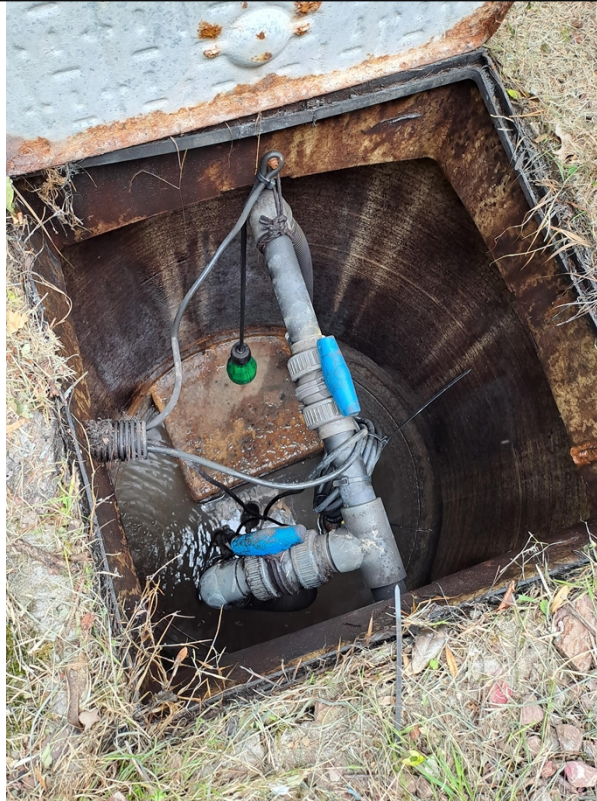
Chamber 5 – This is the final effluent chamber prior to discharge to the drainage field. It was noted that the pumps within this chamber were recently replaced due to issues with them burning out. It was stated that the system is now working effectively. The flow of effluent was good at the time of the visit with the effluent itself appearing clear and free of solids or debris. This is evidenced in Figure 5.

Figure 5 - Chamber 5 of the treatment plant as observed during the visit.

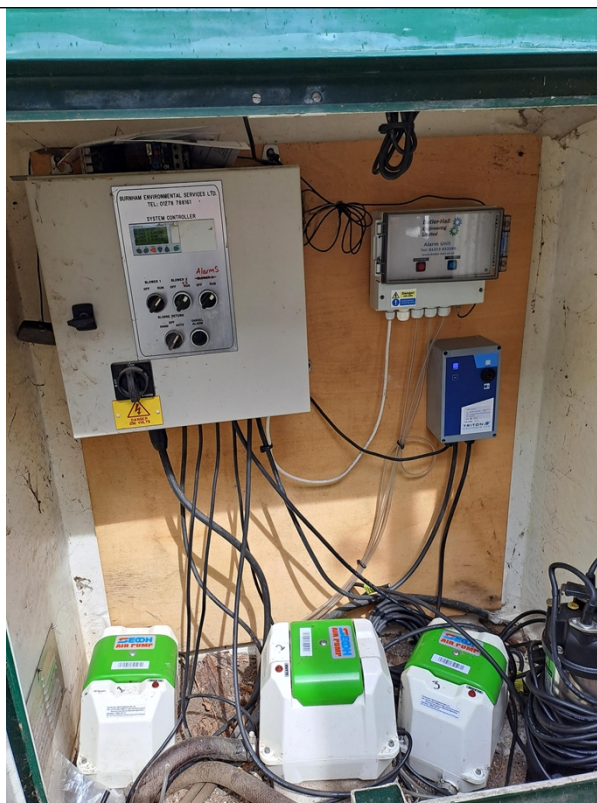
The control box was observed. All readouts showed the infrastructure was in operation with no error messages present, as seen in Figure 6.

Figure 6 – The treatment plant control box as observed during the visit.

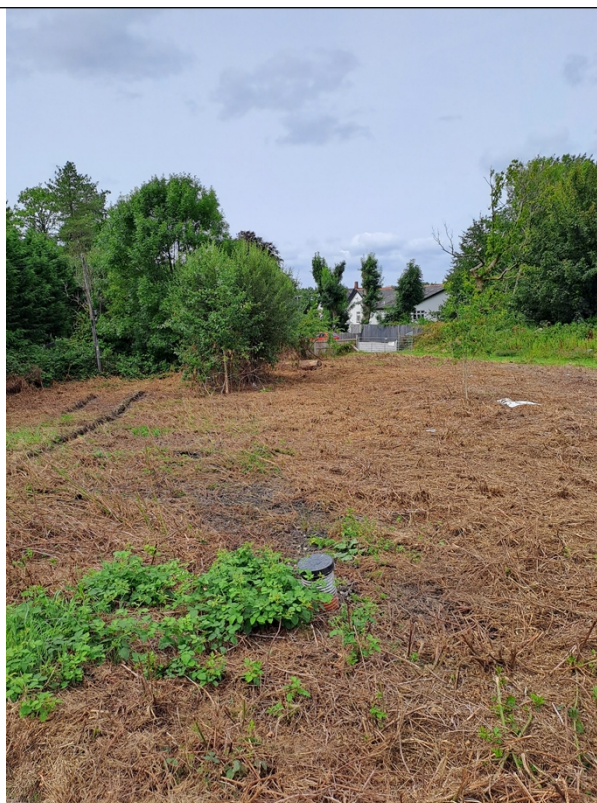
JB noted that the site is currently in the process of investigating the capacity of the filtration system to ensure it is continually fit for purpose. Percolation tests are scheduled for the 14/08/2025, where the results will dictate if an increase in size is required. Clearance of the field to undertake this testing had already taken place at the time of the visit, as seen in Figure 7.

Figure 7 – The drainage field area as observed during the visit.

I advised that if an increase in size is required that it should be undertaken in a manner to ensure that it does not breach the dimensions outlined in Condition 2.3.1(a-e), and does not stray outside of the permitted area listed in the site plan (Schedule 7) relating to Condition 2.2.1.

If any required amendments to the system will foreseeably breach either of these to ensure efficient filtration, NRW's permitting team will need to be consulted and a permit variation application will need to be submitted outlining the desired or required changes. Pending an assessment these changes will be approved via a variation if deemed acceptable and will not adversely impact the local environment. I advised that the permitting process is currently working at full capacity and lead times for new applications are extensive. I will provide information and guidance on this process separately to this report.
