## Compliance Assessment Report CAR\_NRW0049140

For: Site drainage under storm conditions at Hafod Quarry, held by TARMAC TRADING LIMITED

At: Hafod Quarry, Abercarn, Newbridge, Caerphilly, NP11 5LH.

**Type of assessment carried out:** Site Inspection, Reason: Routine.

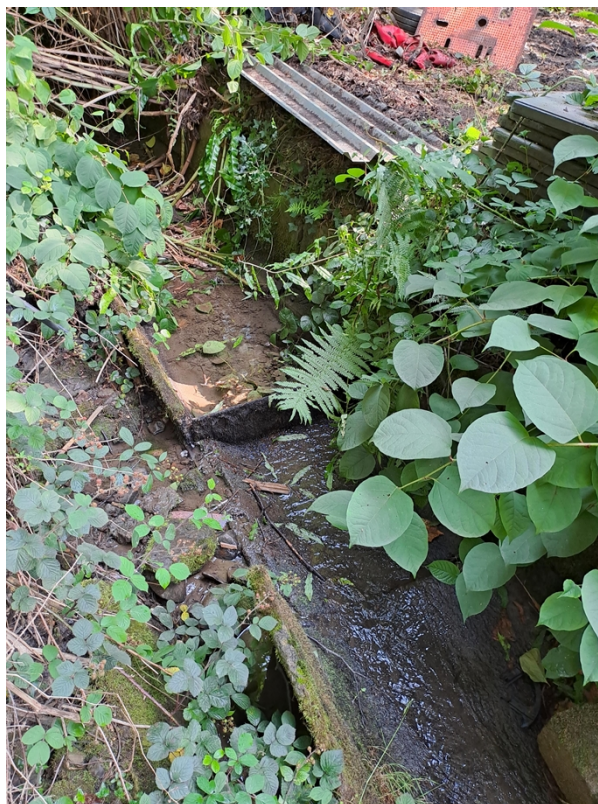
The sample/discharge point was checked and was confirmed to be in the correct position and accessible. As seen in Figure 1, there was minimal discharge at the time of the visit, and it was completely clear.

Figure 1 – The sample/discharge point as observed during the visit.

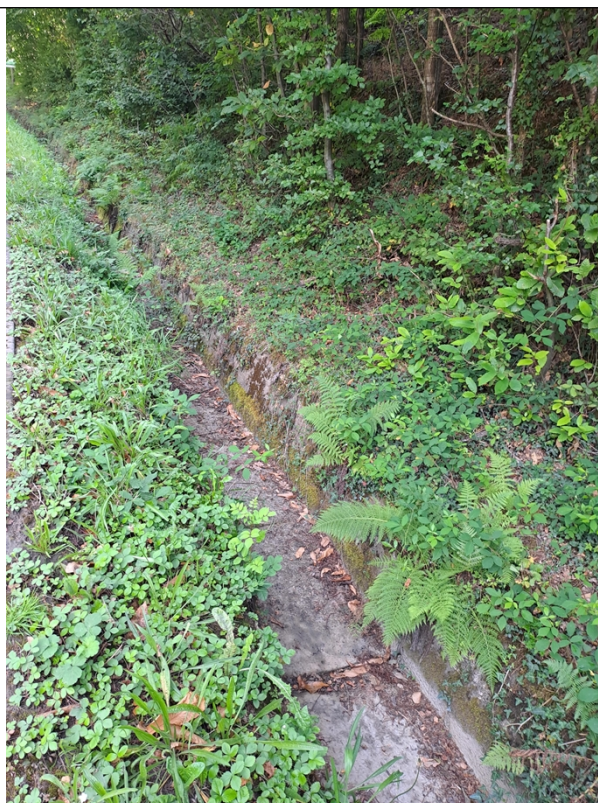
It was noted that there were no discharges from site the time of the visit, with the water present deriving from external sources outside of the site's boundary. This is evidenced in Figure 2 (dry leat/channel from site).

Figure 2 – Dry leat running from site ~100m upstream of the sample/discharge point at the time of the visit.

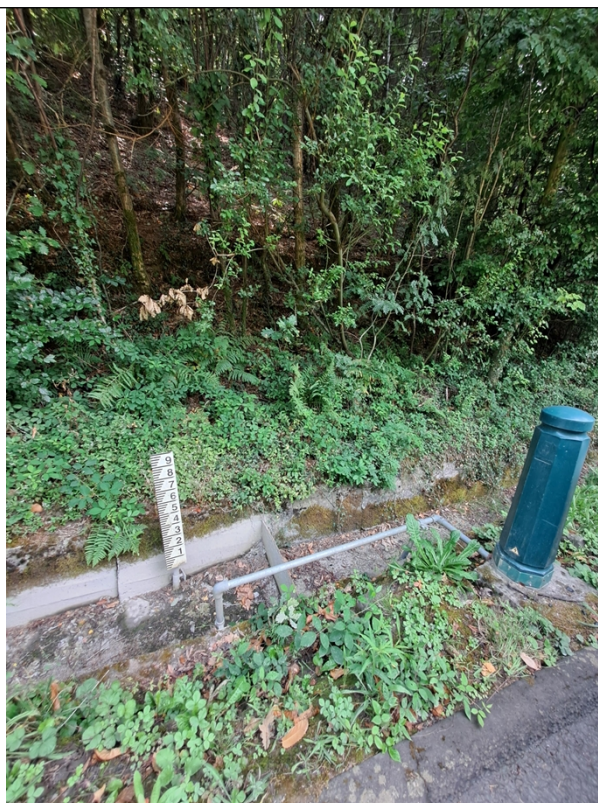
The flow monitoring point was observed and located at ST2213496184. As stated, this was upgraded in 2024. Figure 3 shows the infrastructure as it appeared at the time of the visit.

Figure 3 – The flow monitoring point as observed during the visit. No flows from site.

Due to no flows being present at the time of the visit, a visual assessment of discharges could not be made.

1. Provide records of flow monitoring data from February-August 2025 as evidence that the infrastructure is in good working order.

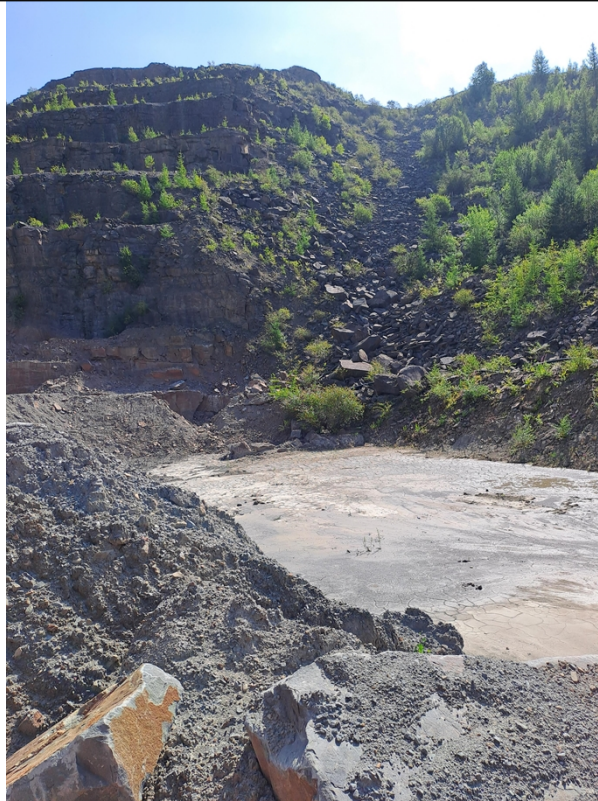
1. Lagoon 1 has been extended with ~800m<sup>3</sup> of material removed to do so. This will be the primary site storm water storage. The lagoon was dry at the timer of the visit, as seen in Figure 4.

Figure 4 – Lagoon 1 which has undergone extension.

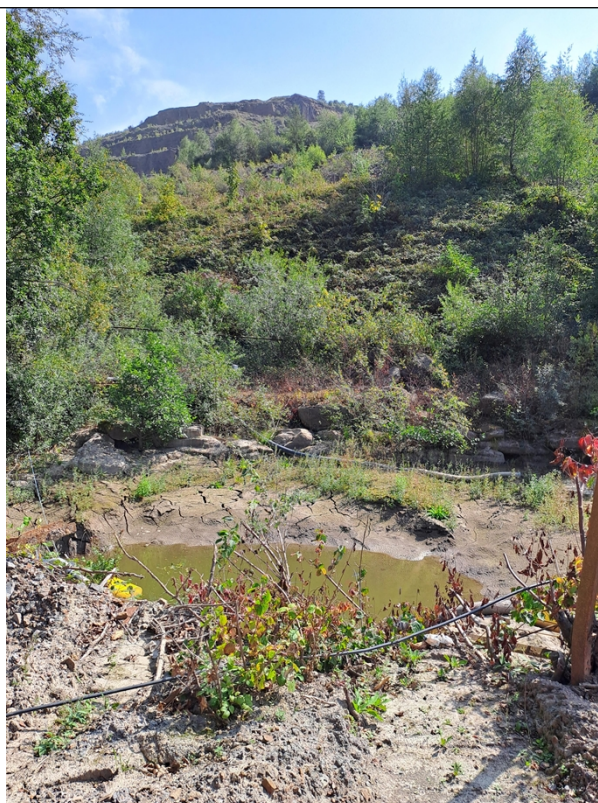
2. Lagoon 2 has been drained down, cleared and a pump installed to transport water to the treatment system (see notes below). This lagoon will be extended by a further 100m. This is evidenced in Figure 5.

Figure 5 – Lagoon 2 as observed during the visit.

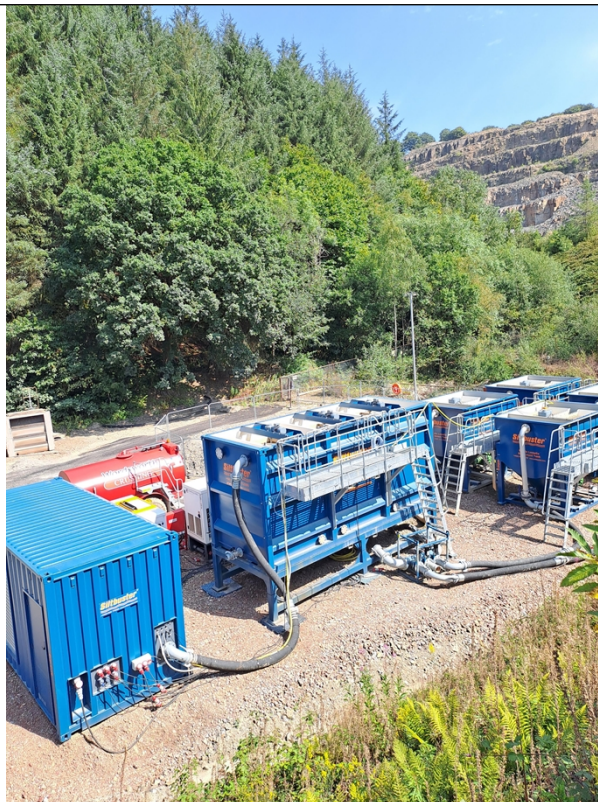
3. A water treatment system (Siltbuster) has been installed in preparation for the permit variation to be issued, as seen in Figure 6. It has been configured to treat site drainage for suspended solids. This system was inspected and appears to have been installed correctly, with LJ showing good knowledge and understanding of its operation and each stage's purpose. It is accompanied by a fully operational control room and material store, as seen in Figure 7.

Figure 6 – An overview of the water treatment system infrastructure.

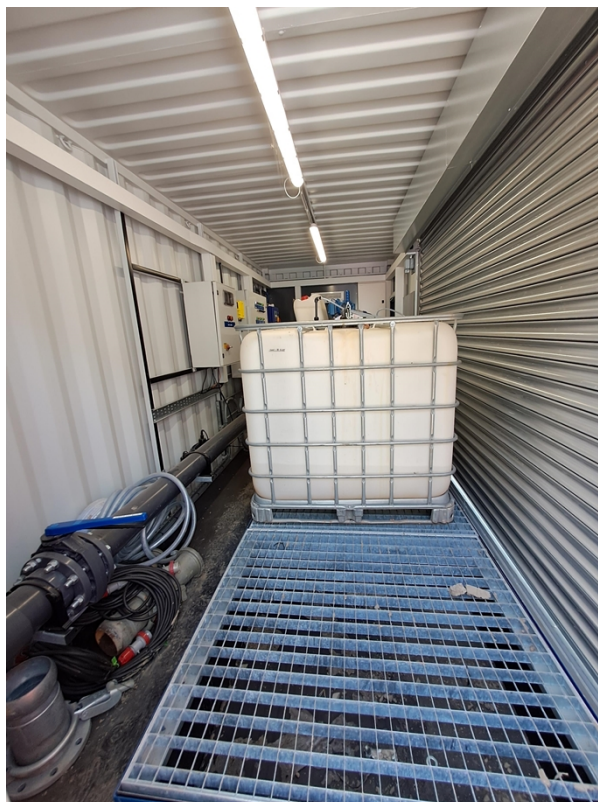
Figure 7 – The control room and material store in place.

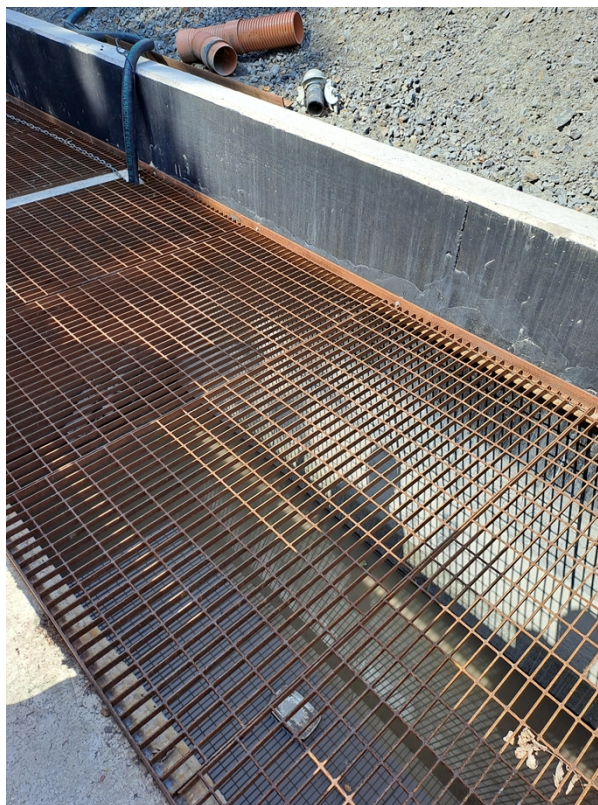
4. Two new wheel wash systems have been installed to ensure no sediments are tracked off site. Due to plant movements on site it was not possible to obtain a photo of this infrastructure at the time of the visit, but I witnessed its operation, and it is in good, effective working order.
5. A new final catchment weir has been constructed near the site entrance to capture any residual runoff before the boundary of the site. This is what was being constructed during the incident on the 05/06/2025, however it is now complete and appears to be working effectively, as evidenced in Figure 8. This effluent is then treated via a smaller treatment system and returned to the site discharge, as seen in Figure 9.

Figure 8 – The new final catchment weir as observed during the visit.

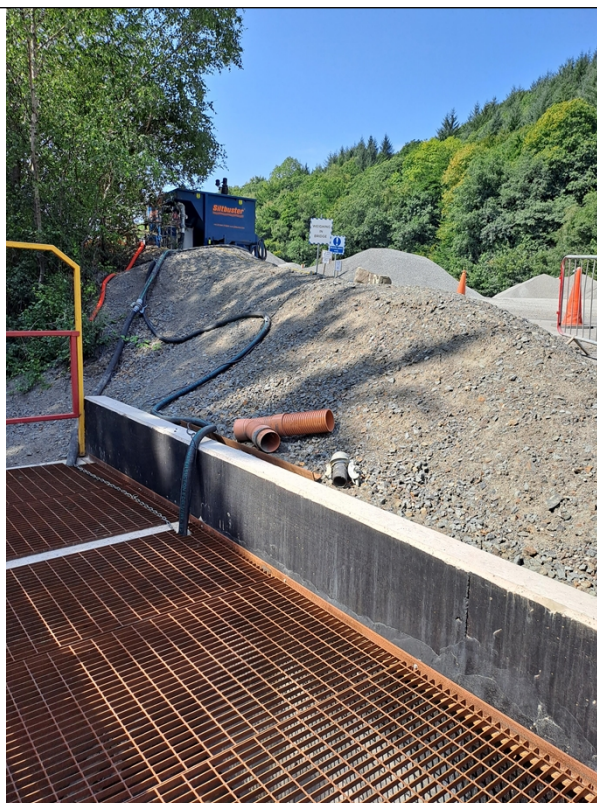
Figure 9 – The treatment system used to treat drainage effluent from the final catchment weir.
