## Compliance Assessment Report CAR\_NRW0049187

**Permit being assessed:** AC0121201

For: Trefil Quarry, held by Tarmac Trading Limited

**Type of assessment carried out:** Site Inspection, Reason: Routine.

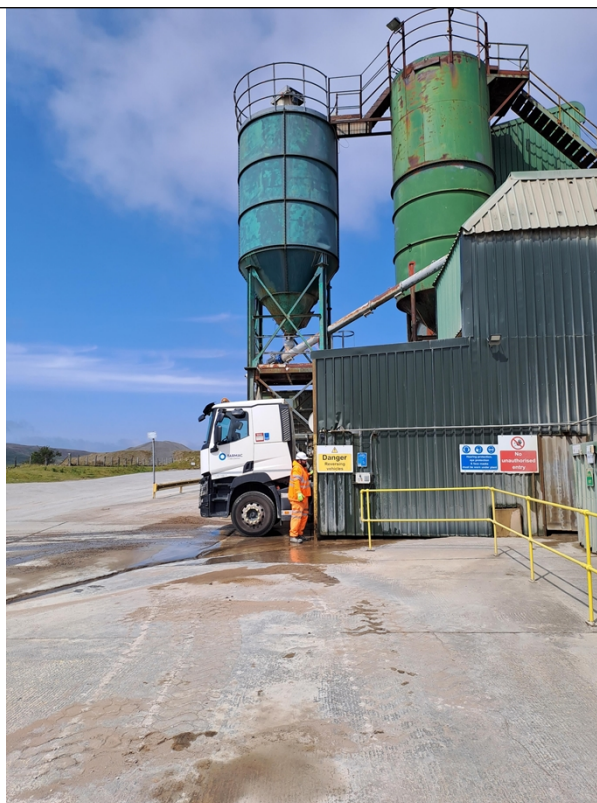
AH gave me a run through of site operations and where the associated site runoff emanates and flows. The majority of water on site is used during the concrete production process, the runoff of which enters on-site drainage channels which flow to the primary/dirty settlement pit. This is evidenced in Figures 1 & 2.

Figure 1 – The production area and water runoff as observed during the visit.

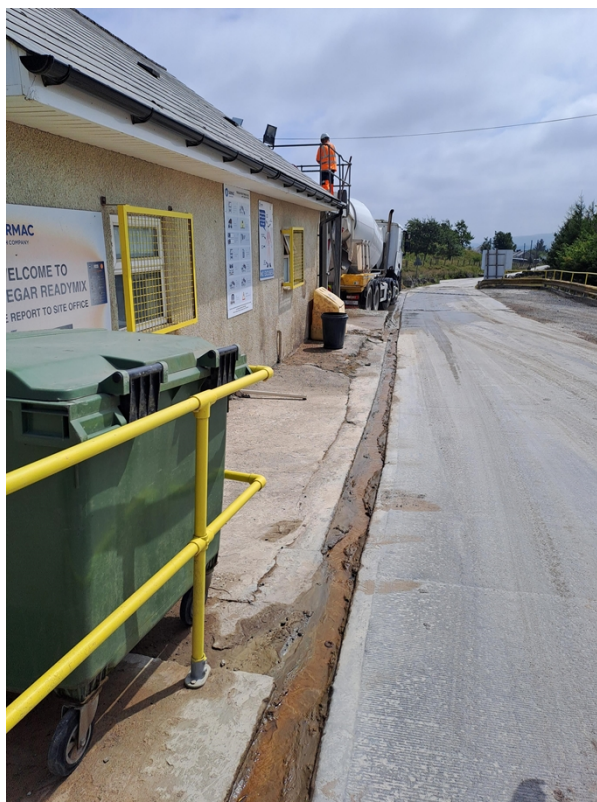
Figure 2 – Water from production flowing through drainage channels towards the settlement pits as observed during the visit.

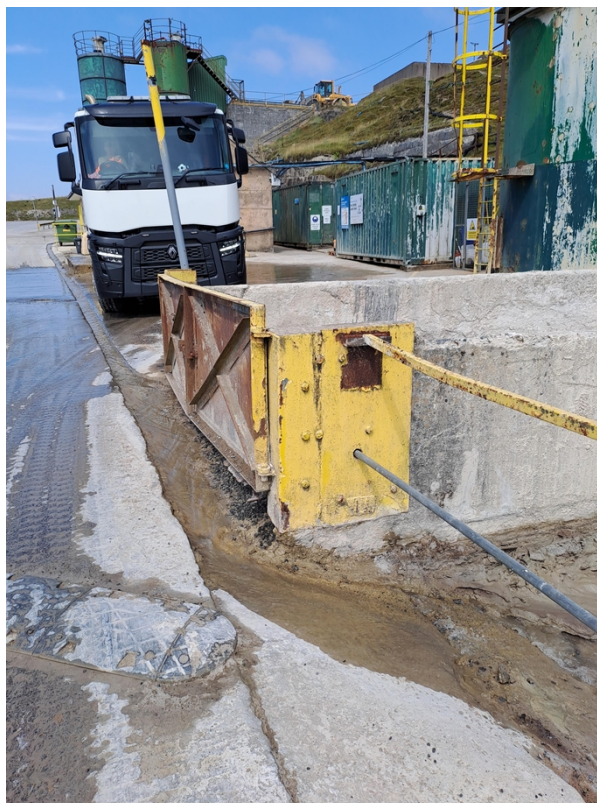
In addition to production runoff, further water is captured from the washing out of concrete mixers which is undertaken by operators on a hard, impermeable surface as seen in Figure 3. This water is also channelled into the settlement pits for re-use in the production process.

Figure 3 – Wash out water from a mixing vehicle entering the settlement pit via drainage channel as observed during the visit.

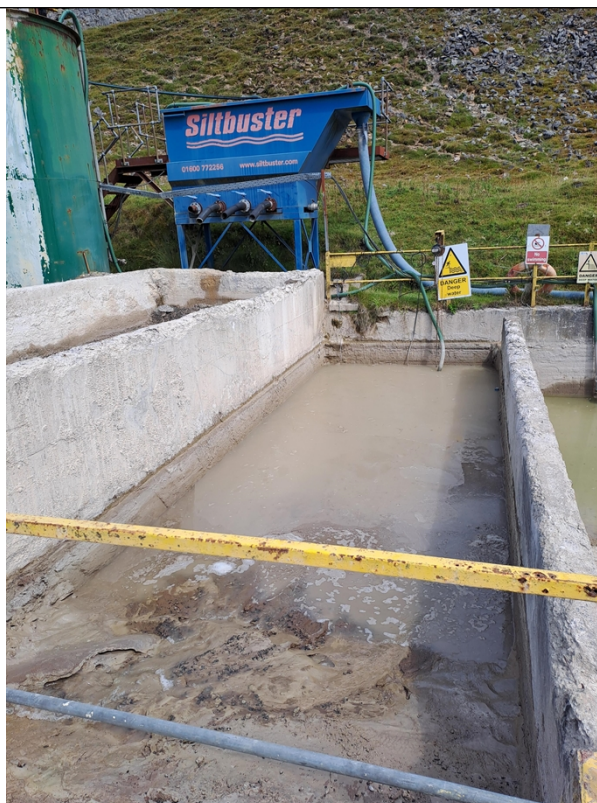
Water enters the dirty pit (Figure 4) before it is pumped back to the production area for re-use. While the water within this pit was heavily silted and discoloured at the time of the visit, AH stated the company attempts to recycle all water on site and only discharge via their consent point during periods of heavy rainfall. Water from the dirty pit can overflow into the end pit if needed.

Figure 4 – The dirty/primary settlement pit as observed during the visit.

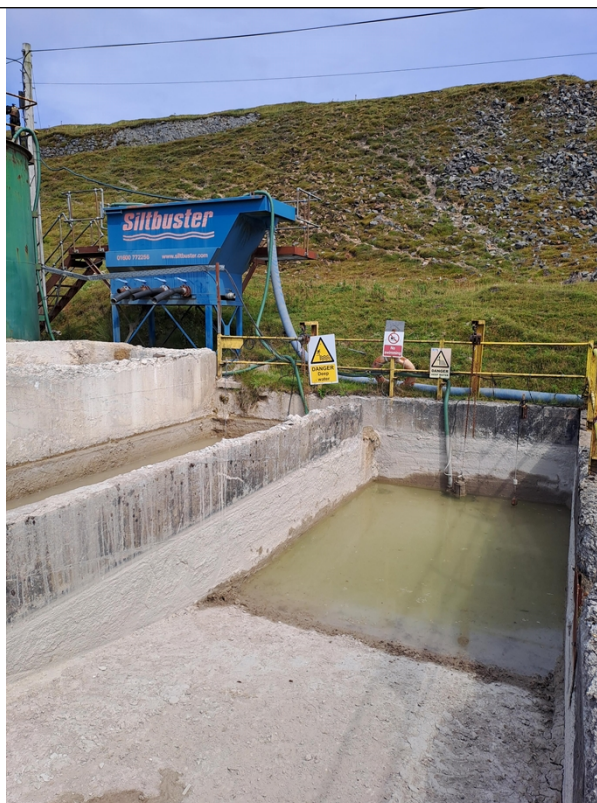
The end pit was observed, with no inputs from the dirty pit entering it at the time of the visit. As a result, the water within it was relatively clear, with a layer of settled sediments visible at the bottom of the pit. There were no discharges being made from this pit at the time of the visit. Evidence of these observations can be seen in Figure 5. It was noted that when the dirty pit receives increased input due to rainfall, it weirs over into this end pit with only the required volume being returned to the production process. The excess water is then treated via a small silt buster unit (which can be seen in Figure 5) which then discharges the water directly via the consent point and flows off site.

Figure 5 – The end settlement pit and silt buster system as observed during the visit.

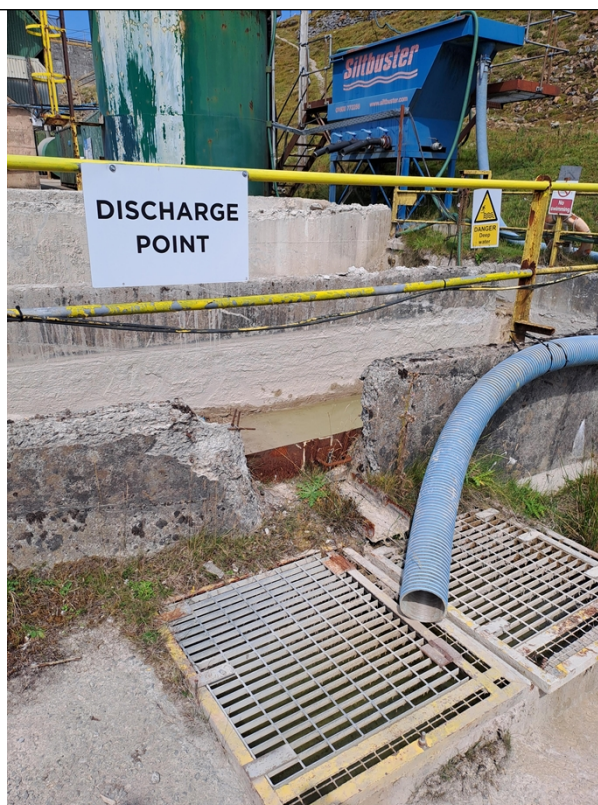
The discharge/sample point was observed to be located a ~SO1210413103 which is compliant with the consented location noted in the site plan. It was noted that this is where both the site and NRW undertake their routine water samples. There was no discharge at the time of the visit, as seen in Figure 6. Due to a period of prolonged dry weather, AH could not confirm when the last time a discharge was made from the site. No water was observed leaving the site at any other location.

Figure 6 – The discharge/sample point as observed during the visit.
