## Compliance Assessment Report CAR\_NRW0049208

**Permit being assessed:** AN0403501

For: RSPB VISITOR CENTRE NEWPORT, held by JEREMY POWELL - Trustee rspb

At: RSPB VISITOR CENTRE, NASH ROAD, NASH, NEWPORT, .

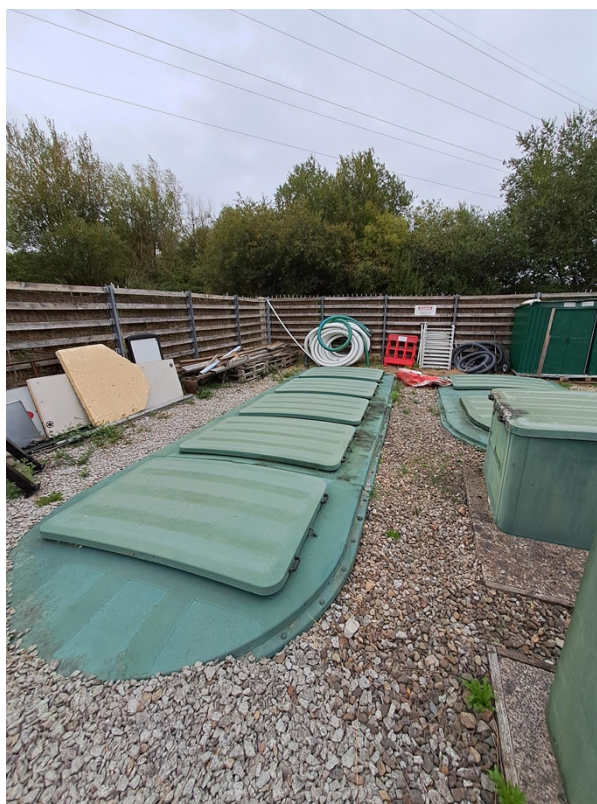
The system was observed to be located at ST3344083296, as specified in the site plan. Access to the chambers and control box was fine, however some trip hazards were noted in the form of various wates, pipes, wood etc. General site maintenance should be reviewed and any unnecessary/waste material should disposed of appropriately. This is evidenced in Figure 1.

Figure 1 – The sewage treatment infrastructure as observed during the visit.

1. Undertake general site maintenance to clear the area around the treatment system so that no excessive materials, debris or waste is present that could hinder any maintenance required.

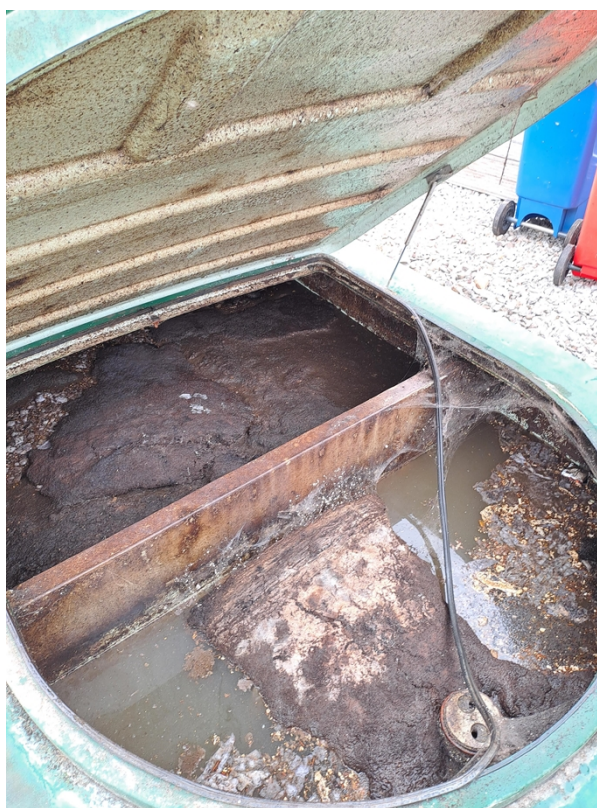
The primary solids settlement chamber (as seen in Figure 2) appeared very full at the time

of the visit. It was stated that the system had sufficient capacity to continue operating but I had concerns regarding its efficiency. While no excessive solids carry over was observed in subsequent chambers (as outlined below) I have actioned a de-sludge of the tank as a priority pertaining to condition 1.10.1(b) of the permit. It is also noted that the chamber seal has become dislodged and appears slightly perished (also seen in Figure 2). Please replace the seal to ensure a watertight seal and to prevent water ingress. Please see the actions list below for further details.

Figure 2 – The primary solids settlement chamber as observed during the visit.

Due to the large volume of solids present I have assessed the current status of the settlement tank as in need of maintenance as a priority, despite no current solids carry over occurring. Please see the action list below.

1. Undertake a desludge of the primary settlement tank to ensure sufficient capacity.

2. Replace perished and dislodged rubber seal on the primary settlement tank.

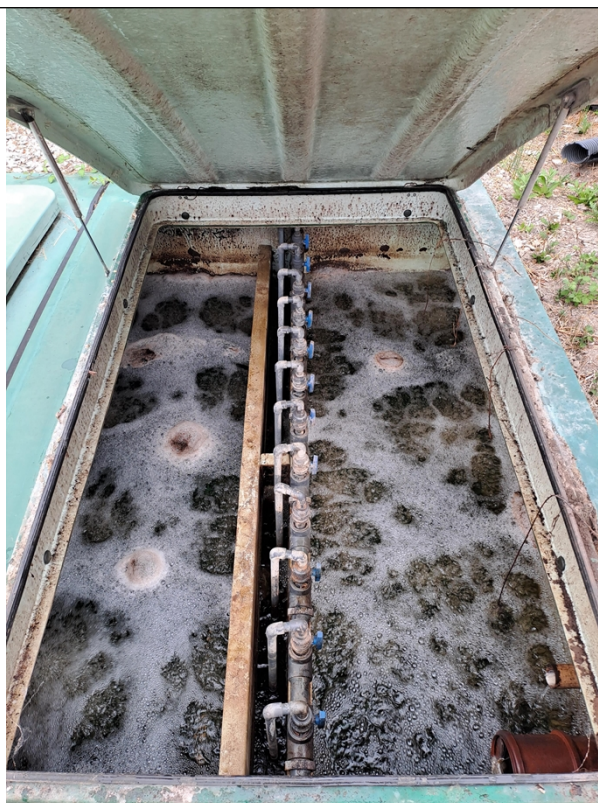
The aeration chambers were observed to be in operation and working as designed. Good aeration was present with no observable solids carry over and no excessive odour present. This is evidenced in Figure 3.

Figure 3 – The aeration chambers as observed during the visit.

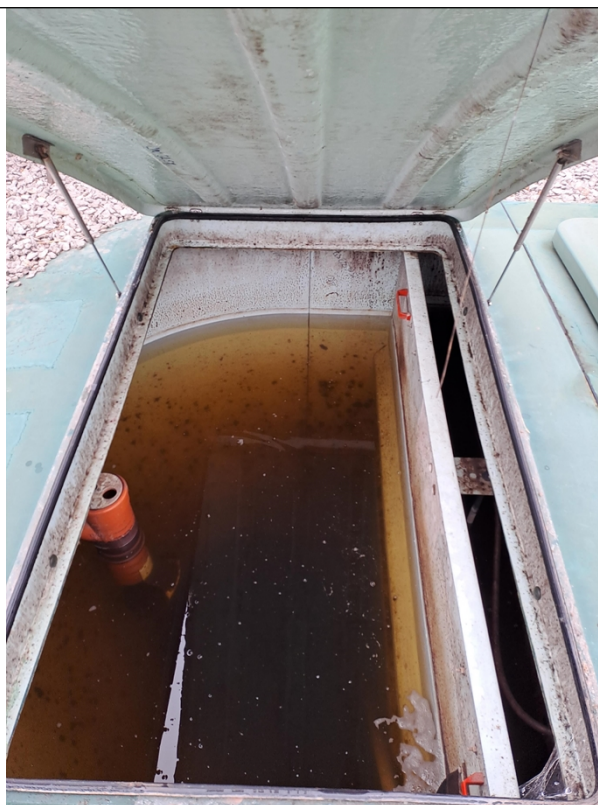
The final effluent chamber was inspected (Figure 4) and, while displaying a prominent brown colour/staining, there were no solids and no odour present. There was also no evidence of sewage fungus or untreated effluent present.

Figure 4 – The final effluent chamber as observed during the visit.

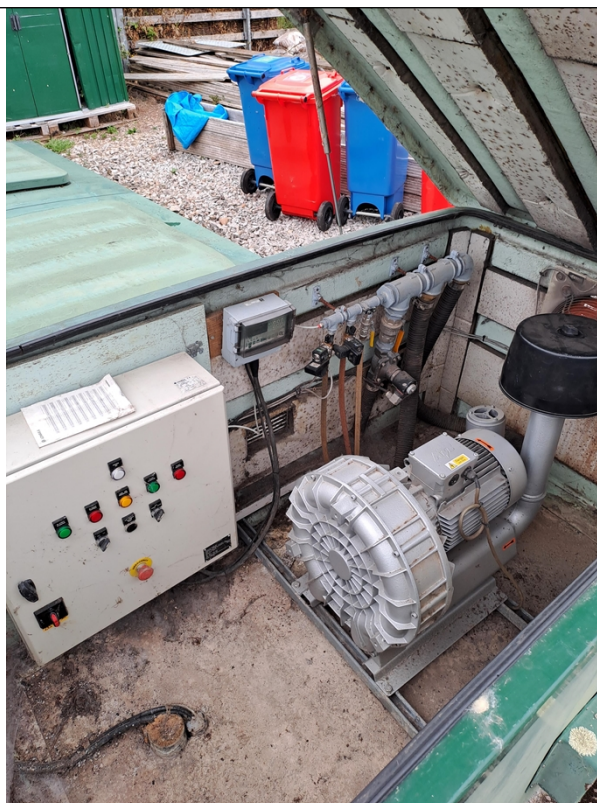
The pump and control box were observed to be working and in operation during the visit. There was no excessive wear, noise or damage present. Displays were clear and legible. This is seen in Figure 5.

Figure 5 – The pump and control box as observed during the visit.

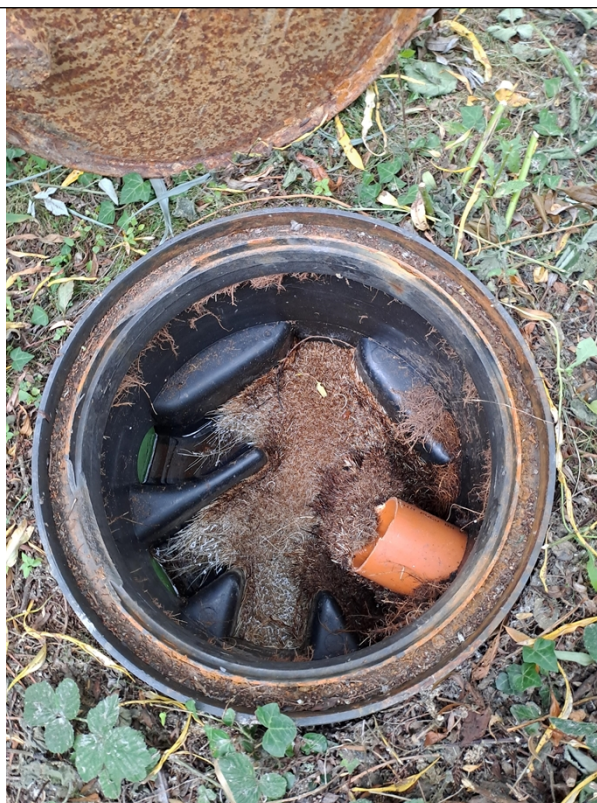
We then proceeded to the sample point. Access was good with a clear pathway cut (as managed by the site) and the location was accurate to that listed in the permit. The chamber lid of the sample point was easily located and opened. Within it was clear that no discharges were occurring at the time of the visit. However, as seen in Figure 6, there was significant root ingress present. It was requested that the chamber be cleared to ensure effective flow and discharge of treated effluent could occur. This is reflected in the actions list below.

Figure 6 – The sample point as observed during the visit.

3. Clear the sample point chamber of the root ingress observed during the visit.
