## Compliance Assessment Report CAR\_NRW0049274

**Permit being assessed:** LP3422XU

For: EO AT GLYN DERW SPS, held by DWR CYMRU CYFYNGEDIG

At: GLYN DERW SEWAGE PUMPING STATION, GLYN DERW, DERI, BARGOED, CF81 9GS.

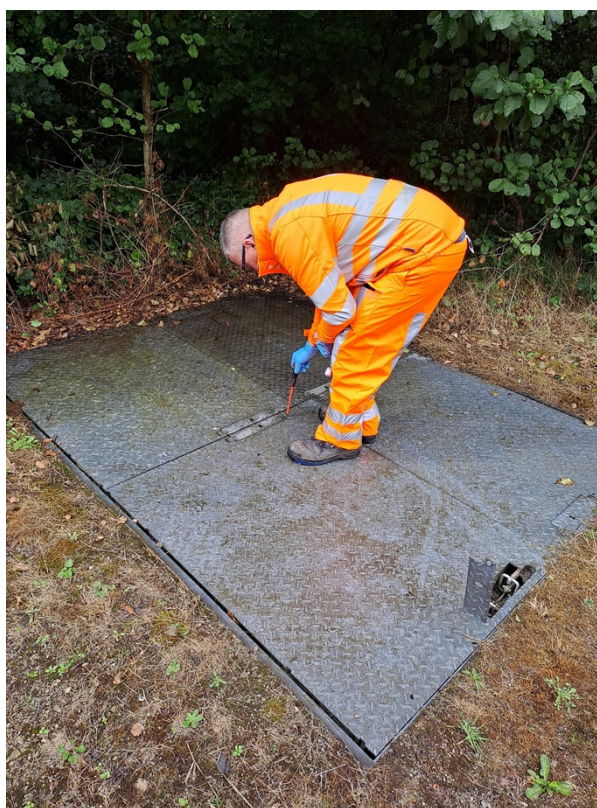
The site is completely accessible with no restrictions present. The wet well and valve chambers were secured with locked chambers and safety grates, as seen in Figure 1. The control box and infrastructure are all located within a locked and secure fenced area. MM stated no issues regarding vandalism or unauthorised access had occurred at the site.

Figure 1 – Chambers secured as observed during the visit.

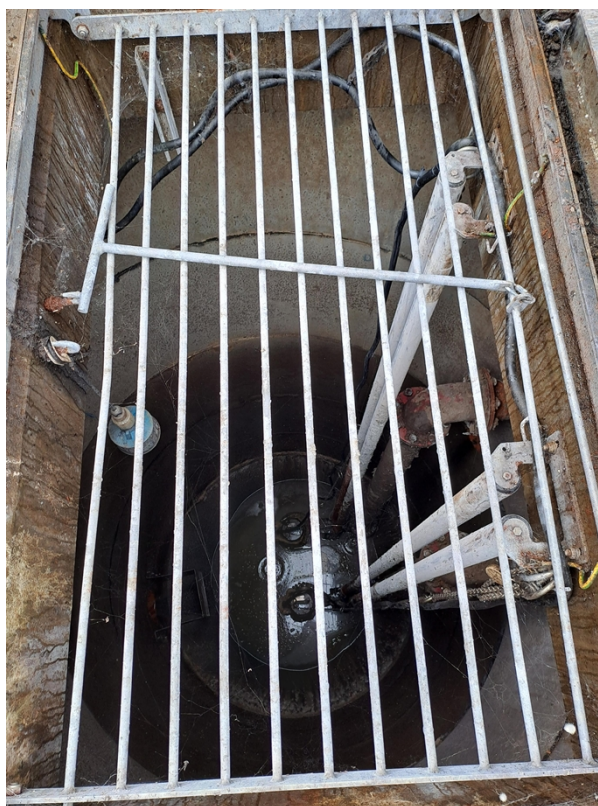
The wet well was inspected. It is of concrete construction and appeared to be in good condition with no observable cracks or defects. All pipework and internal infrastructure were free of excessive corrosion likely to inhibit operational effectiveness. There was no excessive odour present at the time of the visit and the site was not discharging to the watercourse. The cleaning schedule of the wet well was queried, to which MM was uncertain but stated that they could confirm this via communications at a later date. This is reflected in the actions list below.

A level head controller was in place which was also stated to be the site's EDM sensor. This is evidenced in Figure 2. When the sensor's servicing history was queried, MM did not know precisely when it was last serviced or calibrated but stated maintenance was undertaken in March 2025 which is part of routine maintenance and that there is a

Figure 2 – The wet well as observed during the visit.

It was noted that there are two pumps maintained on site, the main duty pump and a standby pump, both of which are located within the wet well and can be seen in Figure 2. There was no excessive or concerning noise coming from the pump during this visit, noting effective use and no excessive wear. MM noted that these pumps are serviced on a 2-yearly plan.

scheduled program to undertake this work. I requested that details of this maintenance be shared with NRW for references. See the actions list for further details.

2. Confirm the wet well cleaning/maintenance regime and when it was last cleansed.

3. Confirm the sensor/EDM monitor's maintenance history and when it was last calibrated.

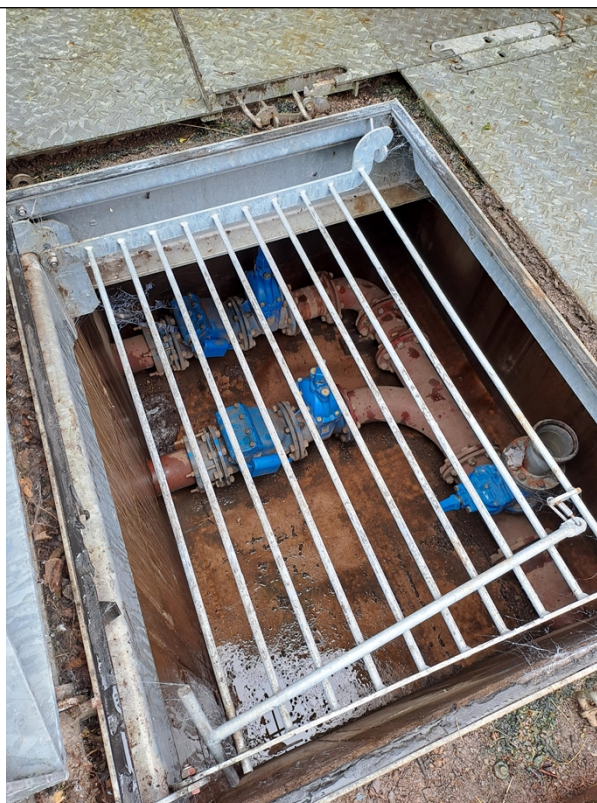
The valve chamber was inspected and was found to be secure, accessible and free of excessive corrosion as seen in Figure 3. This is also where the site's over pumping point is located.

Figure 3 – The valve chamber as observed during the visit.

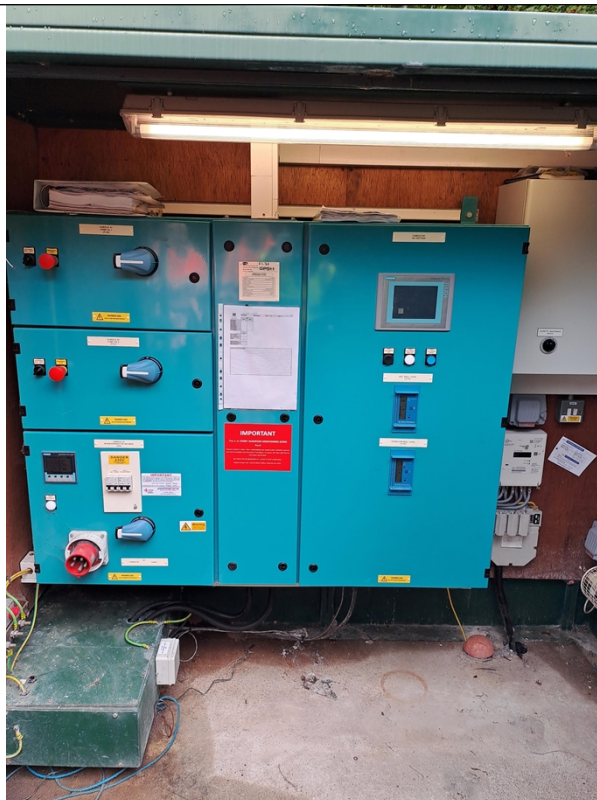
The control box and panel were inspected and found to be clean and dry with no condensation build-up or signs of damage. This is evidenced in Figure 4. While there is no on site generator to be implemented in times of power loss, the facilities to install a mobile/temporary generator are present and accessible. This is seen in Figure 5 (large red socket). The emergency stop function was located and confirmed to be operational, although DCWW have never had to use it at this site. When details on emergency response plans for the site were requested, MM stated that DCWW operate a standardised response plan for all SPS assets. I requested that a copy of this plan be shared for reference and is reflected in the actions list below.

Figure 4 – The control box and panel as observed during the visit.

4. Provide NRW with a copy of DCWW's standardised emergency response plan for SPS assets.

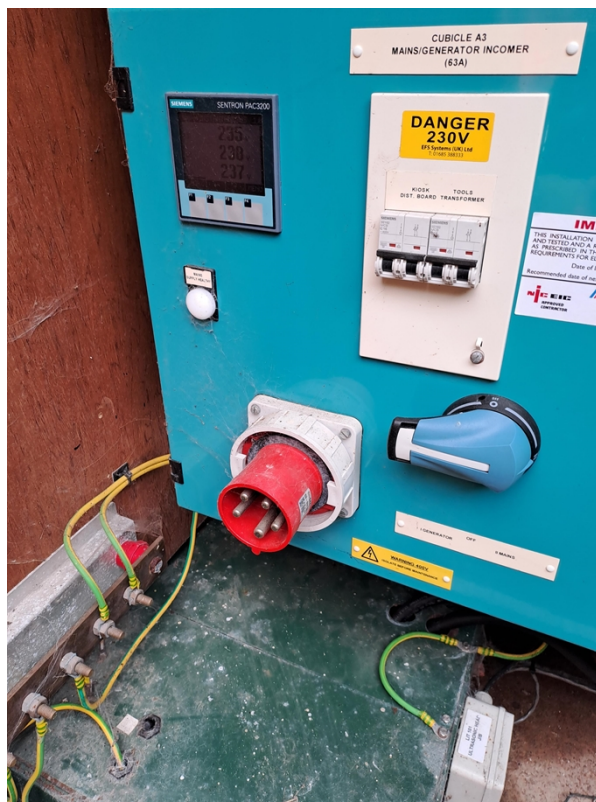
Figure 5 – The point where an external backup generator can be plugged in.

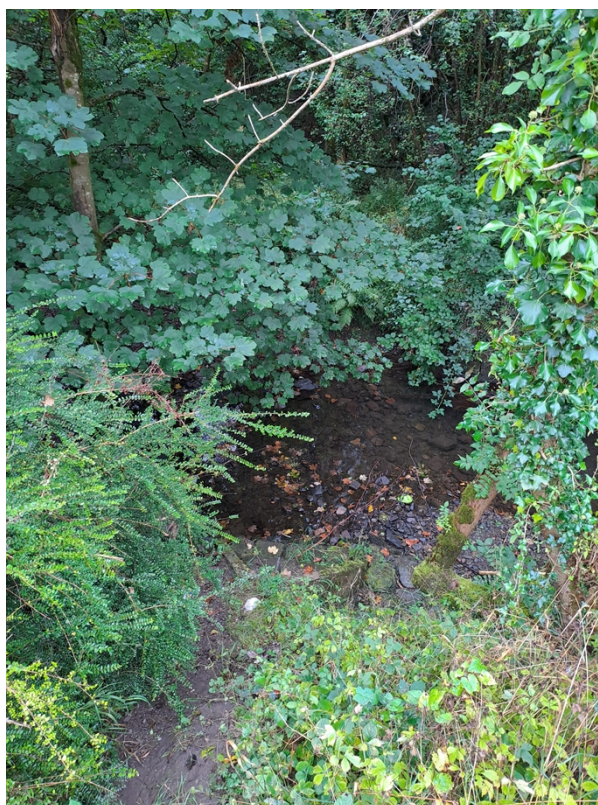
The discharge/monitoring point was confirmed to be situated in the listed location (~SO1267102129) and was accessible if required. There was no discharge at the time of the visit with no evidence of sewage debris or fungus present indication very infrequent spills. MM noted that DCWW were not aware if the site has ever experienced a spill which has impacted the watercourse. These observations can be seen in Figure 6.

Figure 6 – The discharge/monitoring point as observed during the visit.
