## Compliance Assessment Report CAR\_NRW0049093

**Permit being assessed:** BP0230101

**For:** DEVILS BRIDGE STW NEAR ABERYSTWYTH, held by DWR CYMRU CYFYNGEDIG

**Type of assessment carried out:** Site Inspection, Reason: Routine.

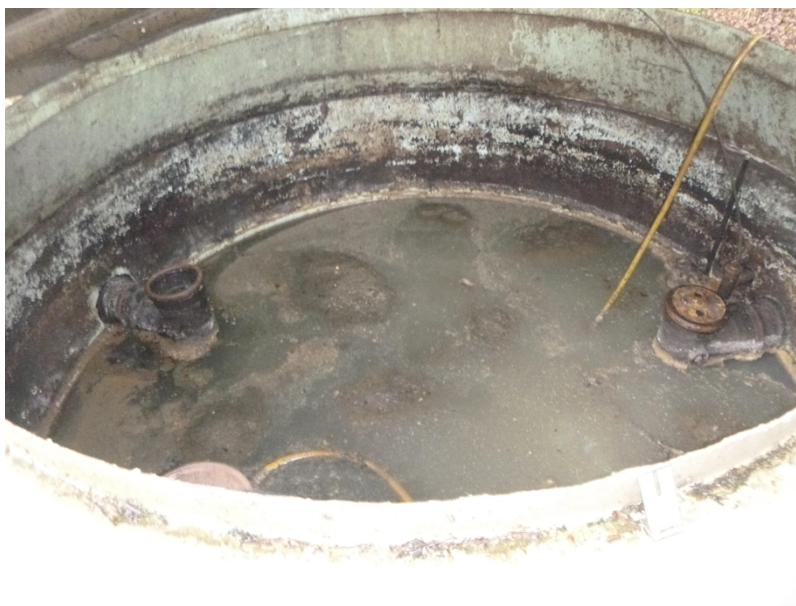
The inlet to Devil's Bridge STW consists of a tank used for primary settlement. This tank is shown in photograph 1 below. Sludge from the inlet tank is removed to a nearby sludge holding tank as shown in photograph 2 below. The sludge holding tank is emptied as and when required.

*Photograph 1: Inlet tank used for primary settlement*

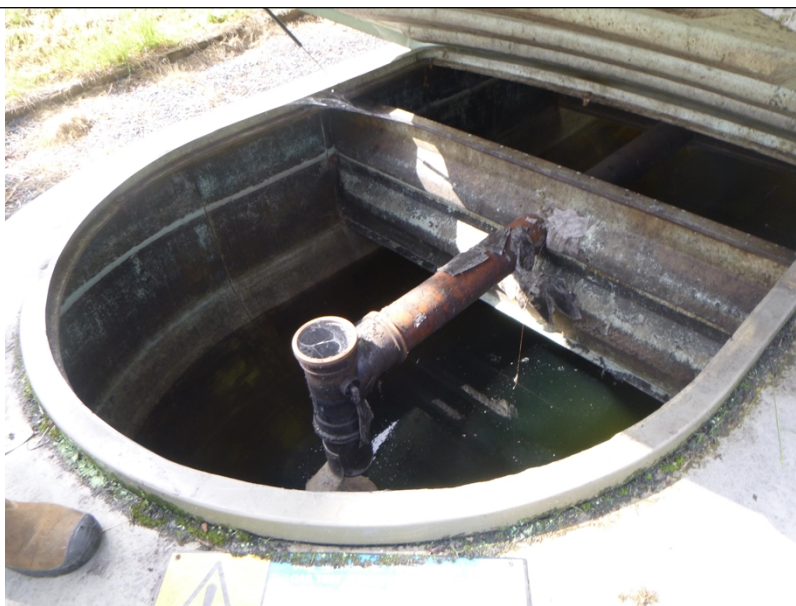
*Photograph 2: Sludge holding tank*

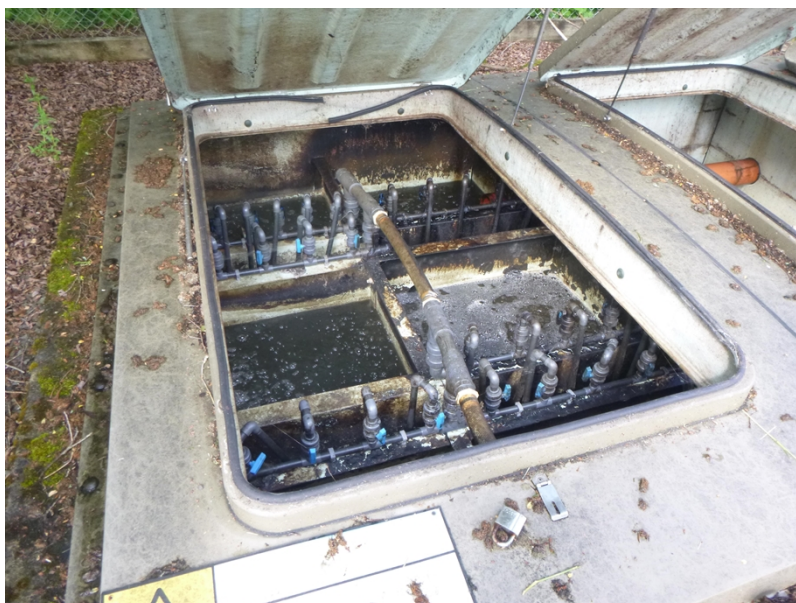
Following primary settlement, sewage enters a Biological Aerated Filter (BAF) as shown in photograph 3 below. The BAF consists of several compartments, with sewage passing from one compartment to the next. Flows subsequently enter a secondary settlement tank as shown in photograph 4 below.

*Photograph 3: Biological Aerated Filter (BAF)*

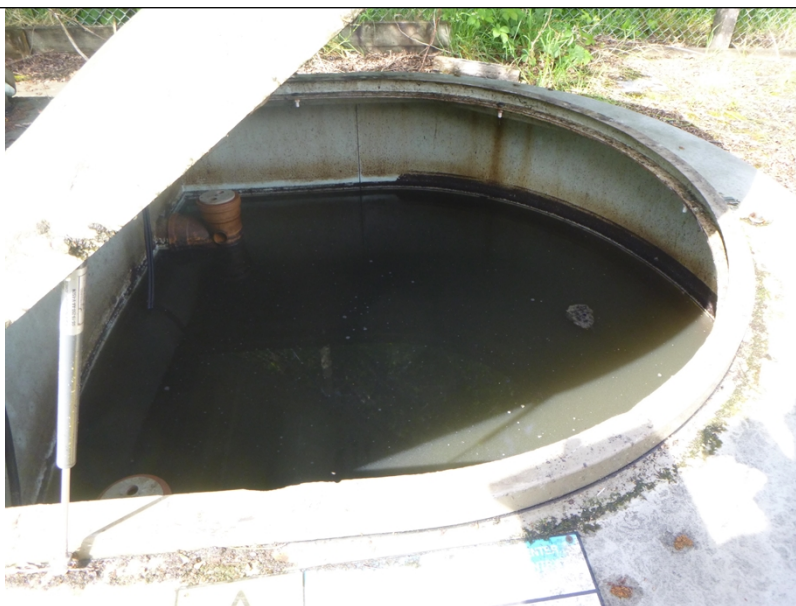
*Photograph 4: Secondary settlement tank*

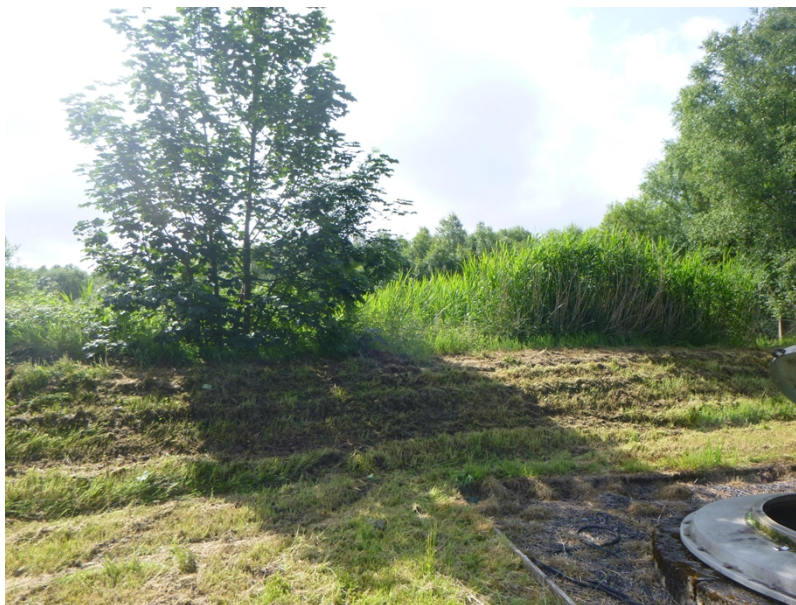
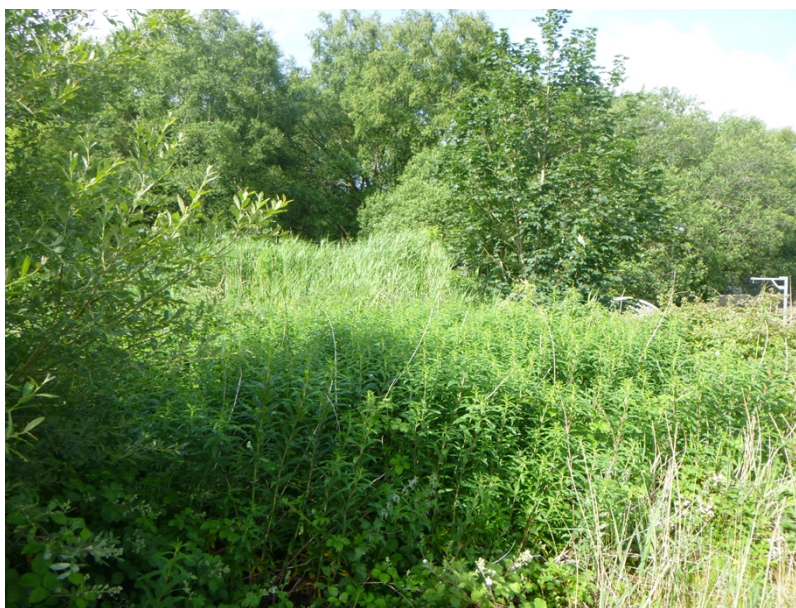
Following secondary settlement, flows are discharged to a reedbed as shown in photograph 5 and 6 below. The reedbed at Devil's Bridge STW currently covers an area of approximately 250 square metres. This is a breach of condition 1 of Devil's Bridge STW's permit which states that the discharge shall have "*passed through a reedbed of at least 426 square metres*". At the time of the site inspection, the reedbed at Devil's Bridge STW consisted of approximately 40% reeds (*Phragmites*), with the remainder comprising of a willow tree, a sycamore tree, bramble and rosebay willowherb. This is a breach of condition 9(d) of Devil's Bridge STW's permit which states that "*the works shall be operated and maintained in accordance with good operational practice such that reed growth is established and maintained to cover at least 75 percent of the bed*". In response to these two breaches, two category 2 non-compliances have been recorded above for non-compliances which have the potential to have a significant impact or effect on the environment, people and/or property.

NRW deem that the non-compliances with regards to both the total dimension of the reedbed and percentage cover of *Phragmites* has the potential to have a significant impact on the Coedydd a Cheunant Rheidol Site of Special Scientific Interest (SSSI) and Special Area of Conservation (SAC). The Coedydd a Cheunant Rheidol SSSI/SAC is an internationally important old sessile oak woodland. It is both categorised by and expresses a particularly rich assemblage of hyper-oceanic mosses and liverworts. These bryophytes require high humidity and as a result many of them are concentrated in and around the watercourses and streams that flow through the site. There are a number of rare and more unusual species that are very sensitive to increased nutrient levels within the Nant Lletys, the watercourse that Devil's Bridge STW discharges into, as well as within the "mist-zone" of the stream. As Devil's Bridge STW's reedbed is not functioning to its full capacity, there may be increased nutrients entering the Nant Lletys. As increased nutrient levels has the potential to directly impact on these species, NRW deem that the permit breaches in relation to the reedbed should be categorised as category 2 non-compliances. To rectify the non-compliances, DCWW are asked to extend the reedbed to cover an area of at least 426 square metres, or apply for a permit variation or new Environmental Permit to enable them to discharge sewage effluent from a reedbed of less than 426 square metres. DCWW are also asked to ensure that reed growth covers at least 75% of the reedbed. DCWW must complete these actions by no later than the **21 February 2026**.

*Photograph 5: Reedbed*

*Photograph 6: Reedbed*

| Criteria | Action needed | Complete by |
|---|---|---|
| WQ-B2 | Extend the reedbed to cover an area of at least 426 square metres, or apply for a permit variation or new Environmental Permit to enable you to discharge sewage effluent from a reedbed of less than 426 square metres. | 21/02/2026 |
| WQ-B2 | Ensure that reed growth covers at least 75% of the reedbed. | 21/02/2026 |

As DCWW no longer carry out their own ground maintenance, contractors working on behalf of DCWW currently attend Devil's Bridge STW once a year to manage the reedbed. Given the non-compliance recorded against condition 9(d) above, it may be advisable for DCWW to increase the frequency of the contractors' visits to ensure that reed growth is maintained appropriately.

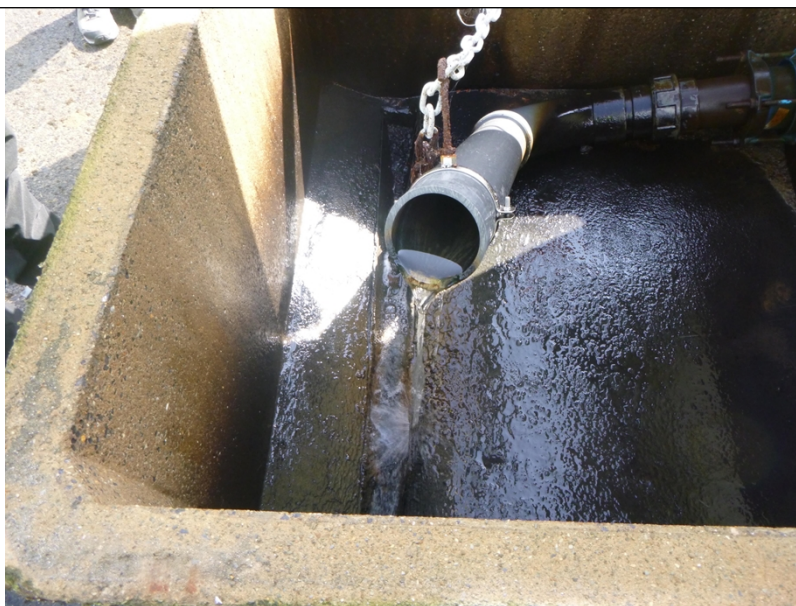
Flows discharge from Devil's Bridge STW's reedbed via a pipe as shown in photograph 7 below. The angle of this pipe can be adjusted to control the volume of effluent retained within the reedbed. This enables DCWW to manage final effluent quality. As shown in photograph 7, flows discharging from the reedbed appeared clear at the time of the inspection.

*Photograph 7: Discharge from reedbed*

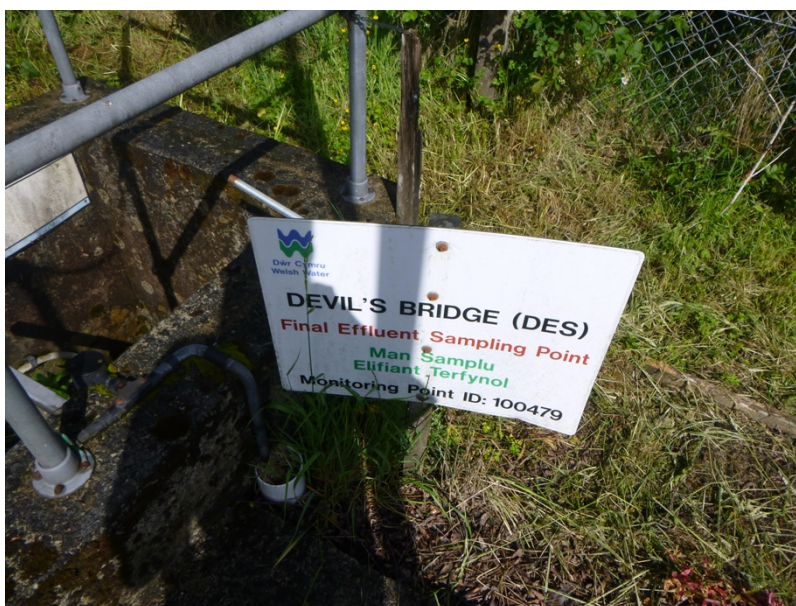
Final effluent at Devil's Bridge STW passes through an appropriately labelled final effluent sampling point as shown in photographs 8 and 9 below.

*Photograph 8: Final effluent sampling point signage*

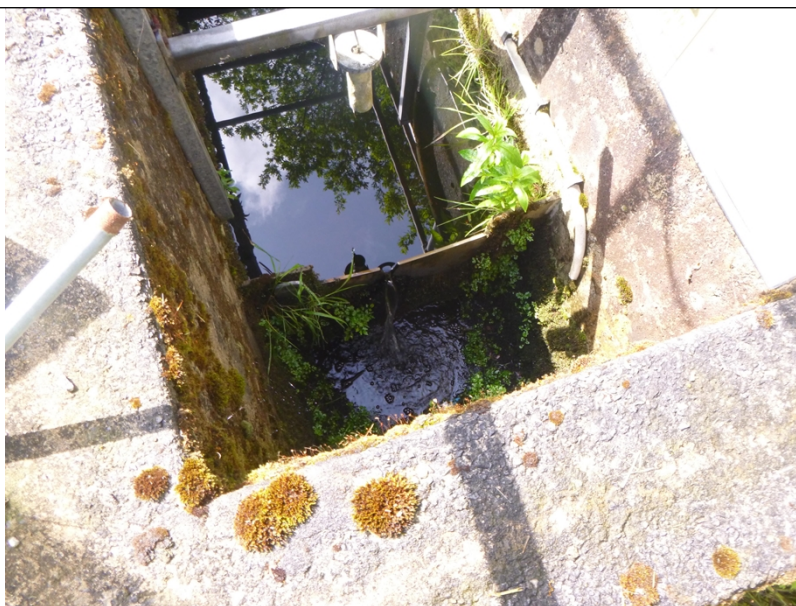
*Photograph 9: Final effluent sampling point*

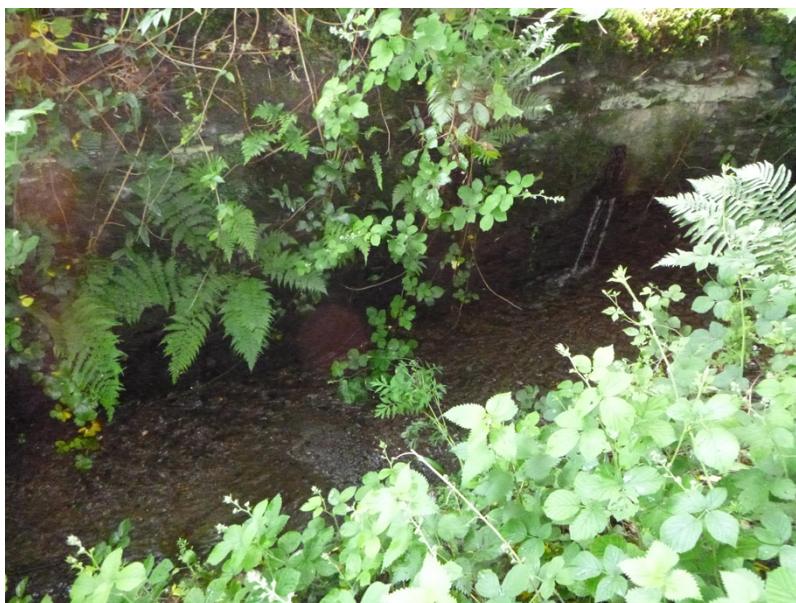
Final effluent from Devil's Bridge STW eventually discharges into the Nant Lletys at SN 73680 77001. The discharge point is shown in photograph 10 below. The discharge into the Nant Lletys was clear and odourless at the time of the site inspection with no signs of sewage fungus at the outfall.

*Photograph 10: Final effluent outfall into the Nant Lletys*
