Compliance Assessment Report CAR_NRW0049763

Permit being assessed: AN0031701

For: Pill North PS North Octopus Rdbt, held by DWR CYMRU CYFYNGEDIG

Type of assessment carried out: Site Inspection, Reason: Routine.

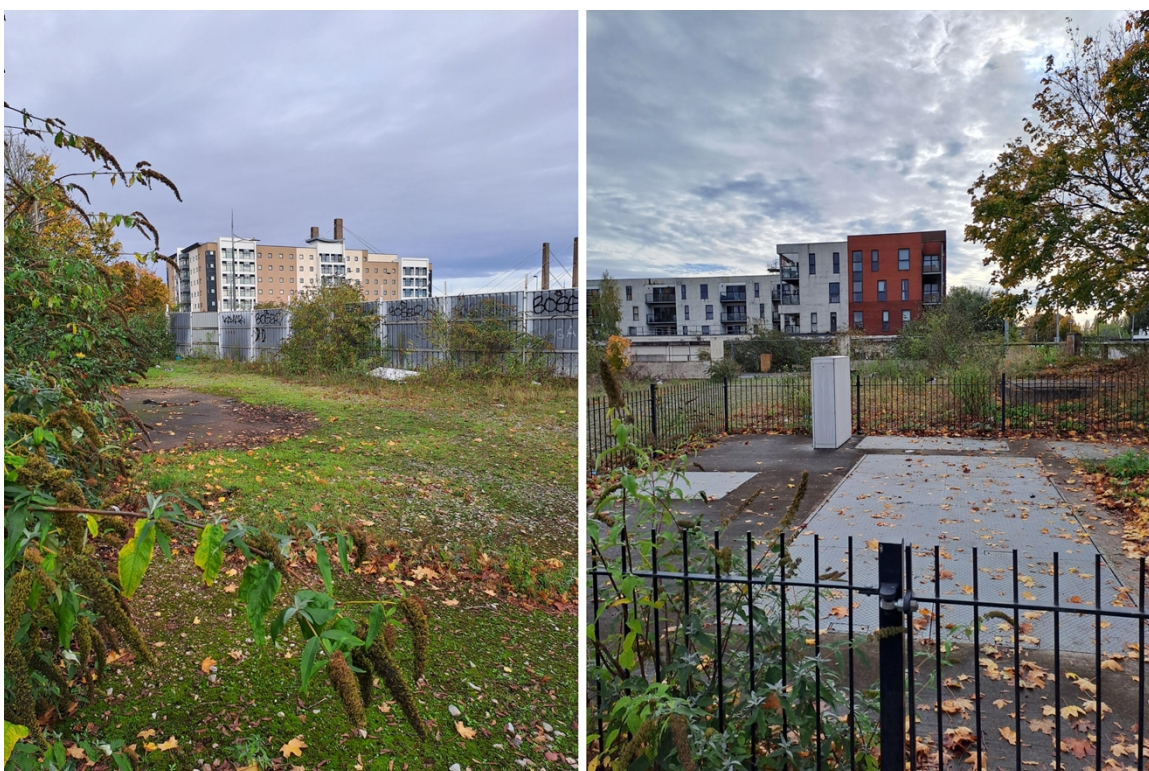
On entry to the site, it was clear that access was adequate, with the compound itself secure, but there was a significant amount of litter with a risk of contaminated sharps and biological wastes present (as advised by SB). As such it is noted that a high degree of care will be needed for subsequent visits, with all appropriate protective equipment a necessity. The nature of the site and access route (being relatively accessible to the public) means that this issue is likely to continue, however I advise a general site clean-up would be a benefit and improve the health and safety standards for operators. These observations can be seen in Figure 1.

Figure 1 – General site conditions at the time of the visit.

1. Undertake a clean-up of the site to remove any residual litter and potentially hazardous items (sharps, biological waste etc) for the benefit of all operators and visitors/regulators.

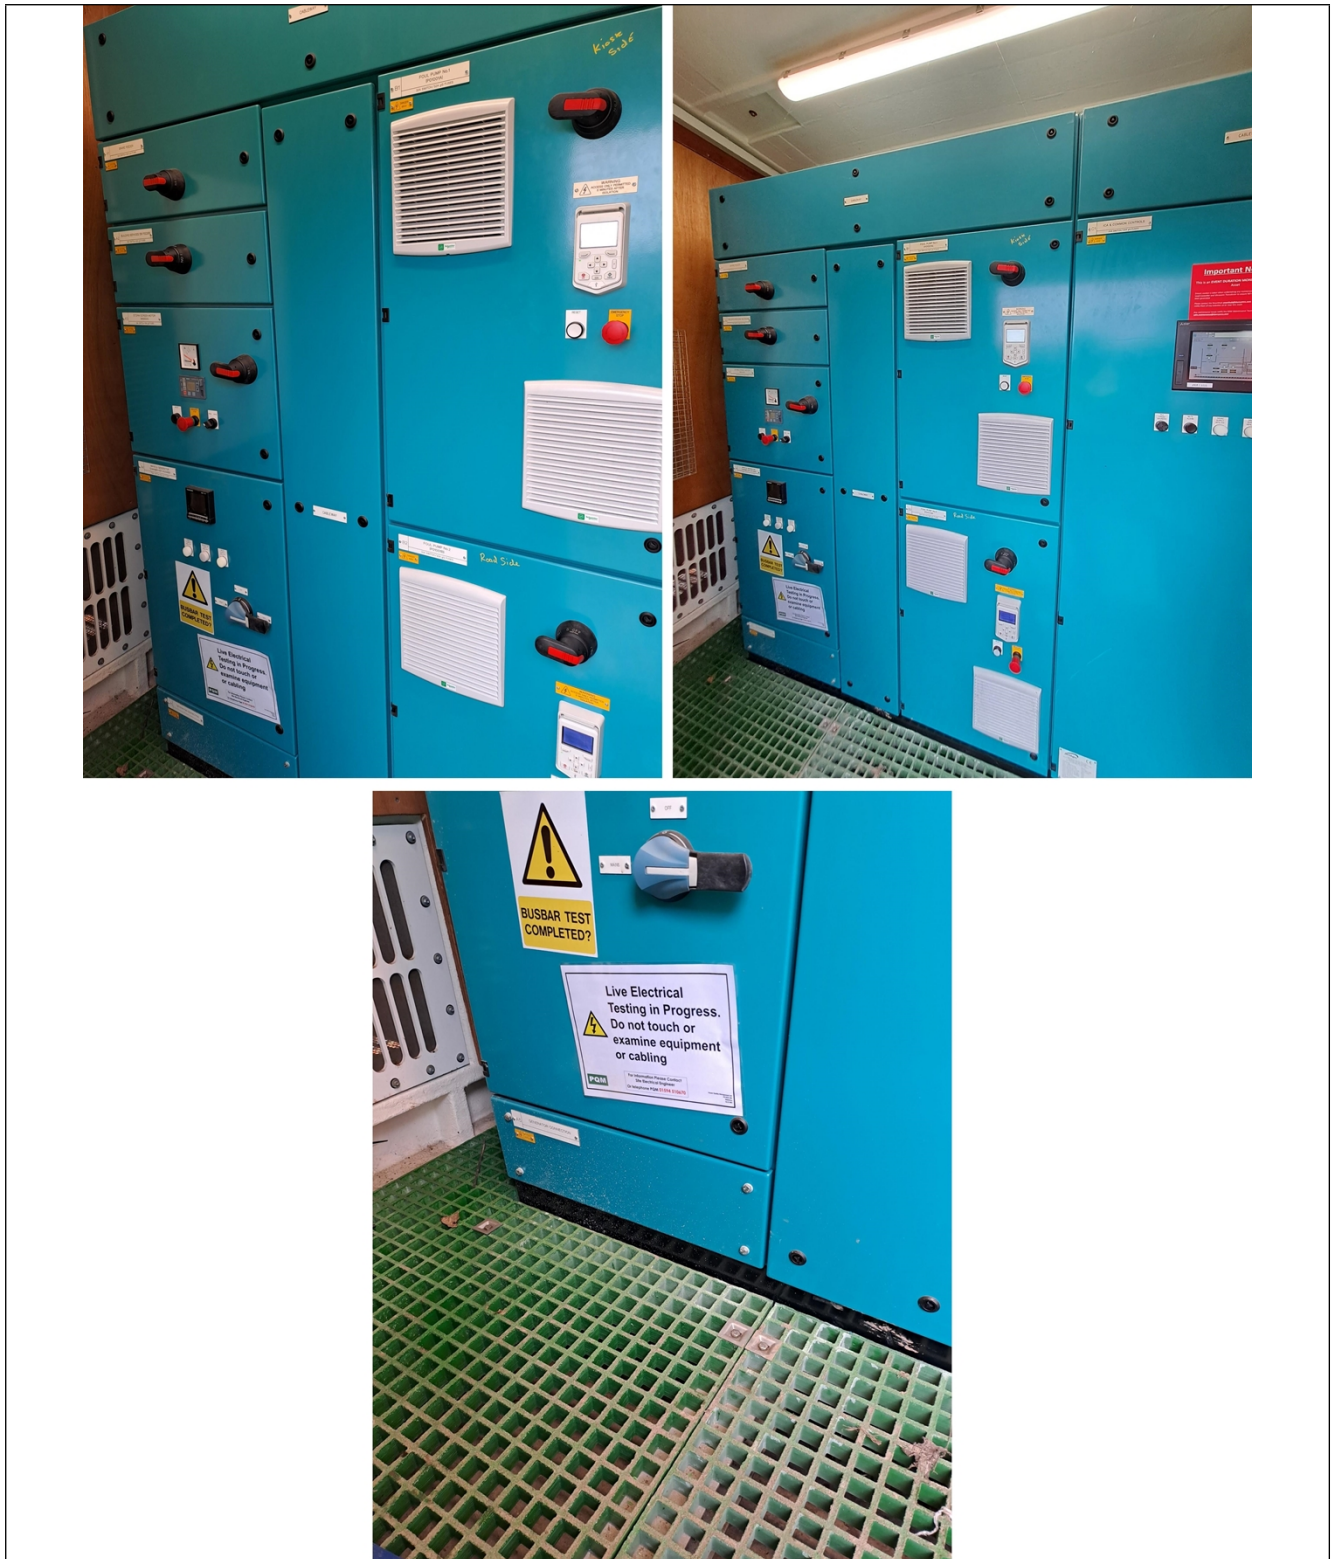
The control room was observed, with all control panels appearing clean and dry with no cracks or condensation present. An emergency stop function was present as well as a generator plug in point which requires a panel to be removed to access. Evidence of these conditions are seen in Figure 2.

Figure 2 – The control panel and associated infrastructure as observed during the visit.

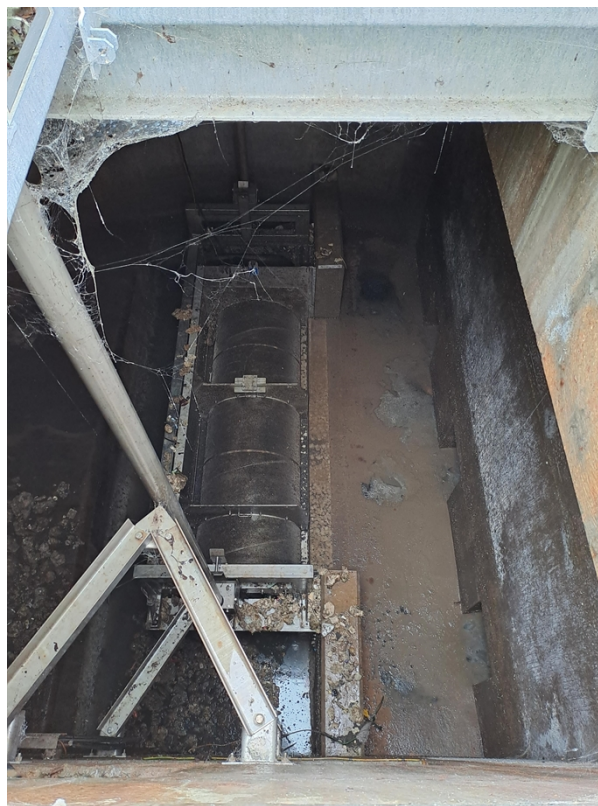
Despite including a CSO, this site does not have a wet well, with the screen and overflow channel within the sewer itself. The chamber was lifted and the overflow channel observed to be clean with the screen free of debris. The aperture size appeared appropriate. There was no noxious odour present. This is evidenced in Figure 3. I have requested maintenance records and cleaning regimes for both the screen and overflow channel, please see the actions list.

Figure 3 – The screen and CSO channel as observed during the visit.

3. Provide details (with evidence) on the maintenance and cleaning regimes associated with the screen and overflow channel.

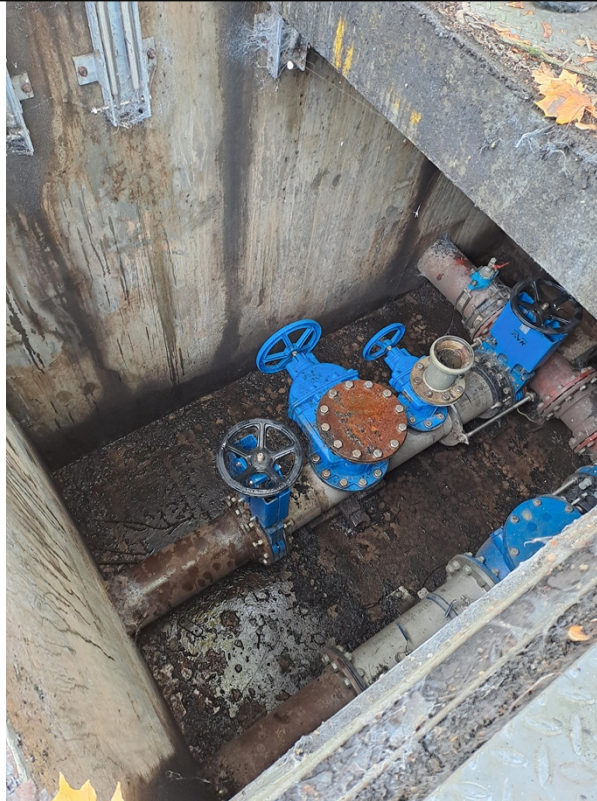
The valve chamber was lifted and observed to be in a good condition with no corrosion present and a tanker point in place. This is evidenced in Figure 4.

Figure 4 – The valve chamber as observed during the visit.

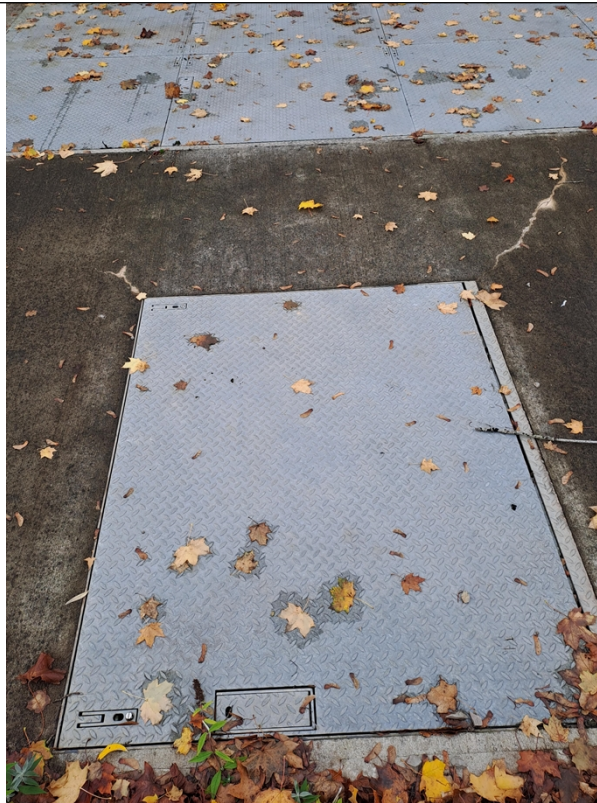
SB noted that the sample point as well as the EDM and flow monitoring sensors are located within the chamber at ST3185487408. While the location of the sample point is compliant (within the acceptable distance discrepancy) an assessment was not possible at the time of the visit due to the operators not being able to lift the chamber cover. While this is technically a breach of Condition 3.1.3 (accessible monitoring point) I am happy to issue a C4 breach (no environmental impact) due to the area in question being accessible (as seen in Figure 5) and with the correct equipment would have been able to be inspected. As such, I have requested photographic evidence of the open chamber and internal infrastructure to be provided as evidence of its appropriate condition. This includes the sensor heads for flow and EDM recording. I have also requested data for flow and EDM records for the 12 months prior to the visit. See the actions list below for further details.

Figure 5 – The sample point chamber which was not able to be lifted at the time of the visit.

Due to the incorrect lifting equipment available at the time of the visit I was unable to gain access to the sample point. However, the location was accessible and with the correct equipment would be able to take a sample if needed. As a result a C4 breach is justified.

4. Provide photographic evidence of the sample point chamber and the infrastructure within for visual assessment.

5. Provide flow and EDM data for the 12 month period prior to the inspection (October 2024 - October 2025).

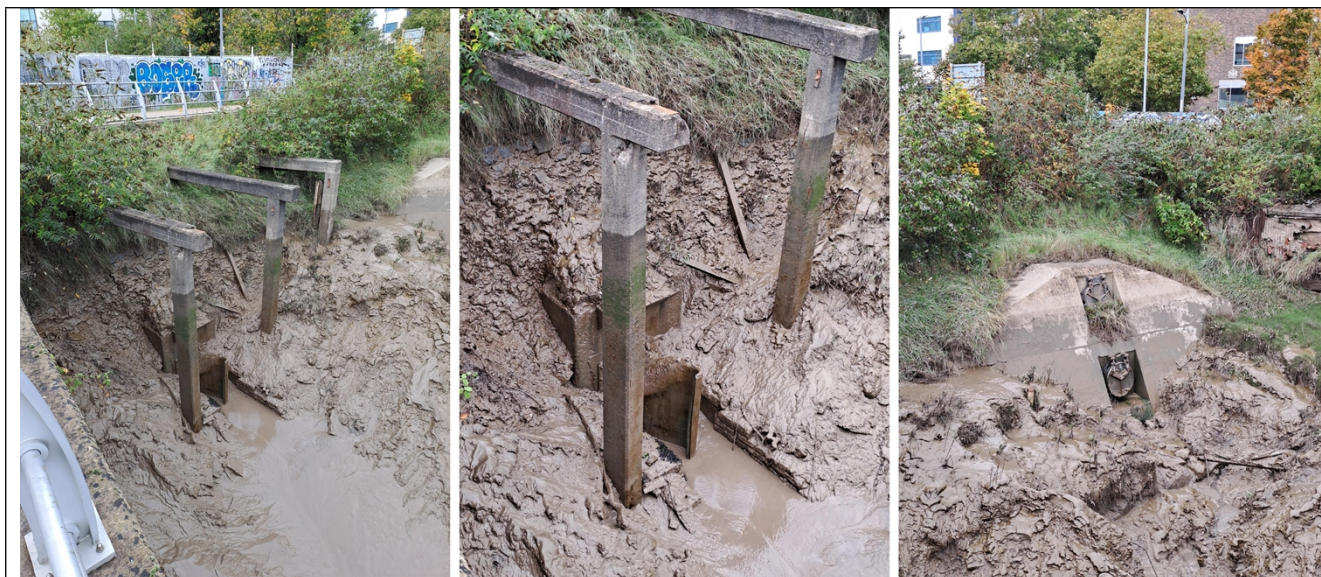
The outfall (described as a Duck's Foot outfall by SB) was observed and confirmed to be located at ST3185387445, as stipulated by the permit. There was no evidence of pollution, debris or staining around the outfall, as evidenced in Figure 6. There were two secondary outfalls directly adjacent to the consented discharge point (at ST3184587455) characterised by flap valves rather than the Duck's Foot on the CSO outfall. It was noted by SB that these were not a DCWW assets and are likely components of Newport City Council's surface water system. Regardless, these outfalls did not appear to be discharging polluted material, with the higher outfall being heavily vegetated, indicating infrequent discharges. I had no concerns of misconnections or inappropriate usage.

Figure 6 – The outfall as observed during the visit.

Left to right: CSO outfall, CSO outfall, Surface water outfall.
