Compliance Assessment Report CAR_NRW0050240

For: Nantycaws Landfill EPR/CP3735PB, **held by:** CWM Environmental Ltd

At: Nantycaws Landfill Site Llanddarog Road , Nantycaws, Carmarthen, Carmarthenshire, SA32 8BG.

Type of assessment: Site Inspection,

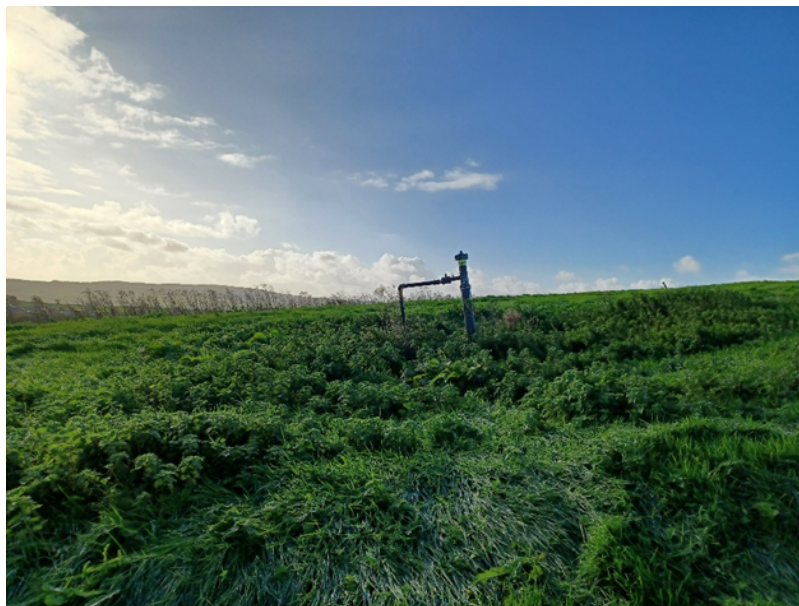
Image 1: Example of subsidence around NYCW1103.

During the visit, NRW observed minor subsidence around a number of monitoring assets. CWM

Environmental informed NRW that these areas will be reinstated and reprofiled in the future in order to facilitate routine maintenance (i.e. grass-cutting activities).

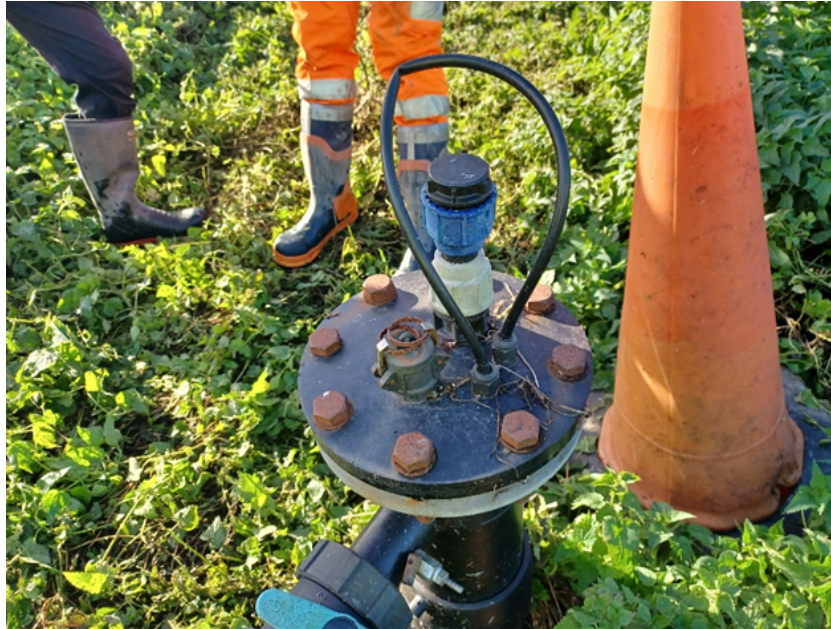
Image 2: Loss of Landfill Gas from redundant cable coupling points associated with NYCL0013

To facilitate the inspection, a Gazomat Inspectra® Max Methane Gas Analyzer was utilised during the walkover in order to identify losses of Landfill Gas from the Artificial Capping Liner (ACL) and gas/leachate infrastructure associated with the Landfill Complex. The following losses were recorded during the visit:

- 13.4ppm recorded from rubber seal associated with NYCL0005.
- >2000ppm detected from inadequate sealing around redundant coupling points (from a previous pump) associated with NYCL0013.

Representatives of INFINIS whom were in attendance marked up the assets which required remediation, and provided an in-situ explanation to NRW on how they would remediate these losses of Landfill Gas (i.e. installation of blanking plugs on redundant coupling points).

INFINIS/CWM Environmental Ltd is to confirm to NRW that the Landfill Gas losses noted on NYCL0005 and NYCL0013 have been remediated.

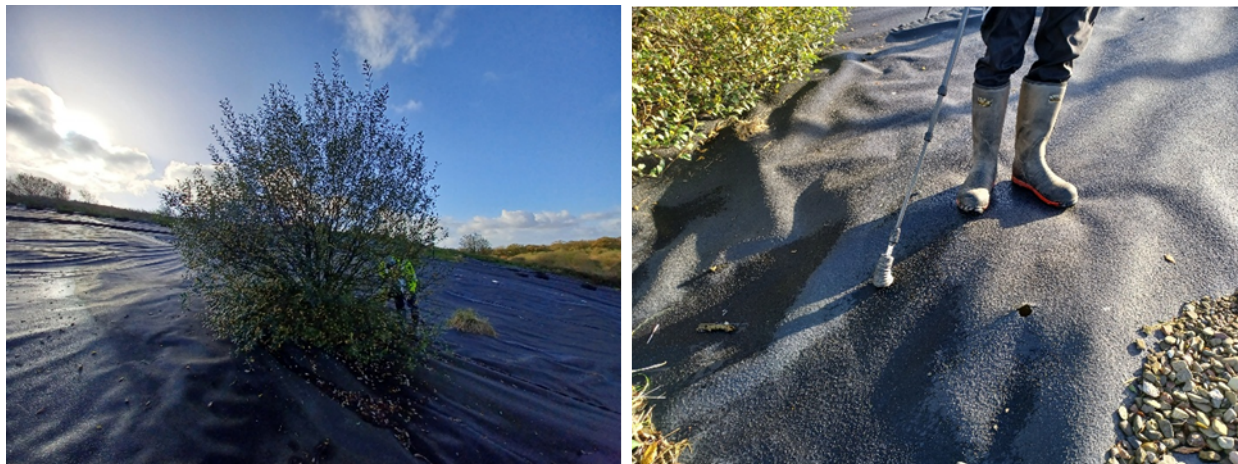
Images 3 & 4: Examples of observed failures on the Landfill Cap

During the inspection, the landfill cap was found to be compromised in a number of locations throughout the Landfill Complex. These failures can lead to increased release of surface emissions to air from the Landfill, which is a contravention of permit condition 3.3.1. Although these failures were not found to be gassing at the time of the inspection.

Review of previous Surface Emission Surveys in conjunction with onsite observations indicate repeated failures of the Landfill Cap. This is primarily due to the increased risk of degradation of temporary capping, which has been left exposed to the elements (e.g., UV damage, impact damage, vermin). The Landfill Complex has been mothballed, with no waste deposited since 2016 which has resulted in large sections of the Landfill benefitting only from temporary capping measures.

In light of the above, and given the prolonged deterioration of the temporary capping liner, particularly from UV exposure and vermin, NRW cannot consider it compliant with permanent capping standards. The Operator must implement necessary improvements before any restoration works can commence.

The Operator has failed to ensure that the Artificial Capping Liner (ACL) associated with the landfill remains uncompromised, particularly by allowing vegetation (specifically trees/shrubs) to penetrate through the temporary capping liner. NRW considers this a contravention of permit condition 1.1.1 and therefore has allocated a non-compliance score of C2 against non-compliance criteria IR1A – General Management.

CWM Environmental Ltd must address all breaches of the landfill cap's integrity, including the removal of vegetation (such as trees) growing through the temporary liner. Once completed, evidence is to be submitted to NRW for our records.

CWM Environmental Ltd must commission works to cap the Landfill to a permanent standard, these works must be undertaken in accordance with CQA requirements with a CQA Validation Report submitted to NRW for review.

Until the landfill is permanently capped to the required standard, CWM Environmental Ltd must increase the frequency of the Surface Emissions Survey from annually to every six months. This measure is intended to ensure that any fugitive releases are identified and addressed at the earliest possible stage.

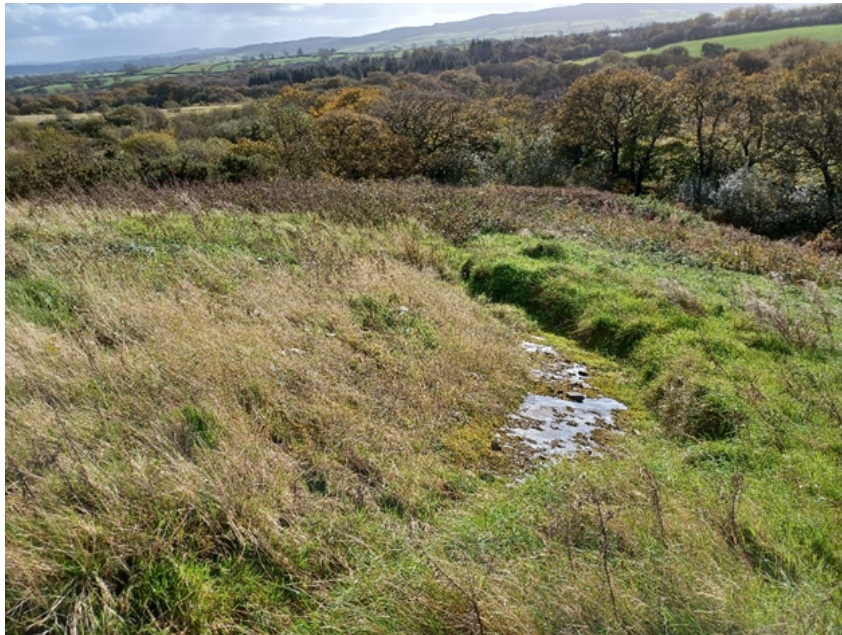
Image 5: Evidence of slope failure noted on SW flank of Cell 4.

During the visit, NRW Officers observed evidence of a slope failure on the flank adjacent to the southwest corner of Cell 4. Inspection of the exposed liner between the two soil masses revealed an unspecified smooth plastic sheeting placed over the Artificial Capping Liner (ACL). NRW is currently uncertain about the extent of this plastic sheeting along the flank and whether it may have contributed to the slope failure. No odours were detected in the area, and no damage to the visible section of the ACL was noted. A review of historical records indicates a previous slope failure in the area in 2010, which resulted in catastrophic damage to the ACL. Review of previous annual topographical surveys submitted by the Operator suggest that the current failure has been present for several years.

Following the visit, an email was sent to the Operator on 29th of October 2025 requesting that a competent person undertake an investigation to determine the cause of the slope failure in this area and assess whether there is any further risk of slippage.

CWM Environmental Ltd must commission an investigation into the slope failure and surrounding area, using a competent person and determine whether there is risk of further soil movement. Upon completion, a detailed report must be submitted to NRW as evidence. In addition, CWM Environmental Ltd are required to review and update its Stability Risk Assessment (SRA) accordingly.

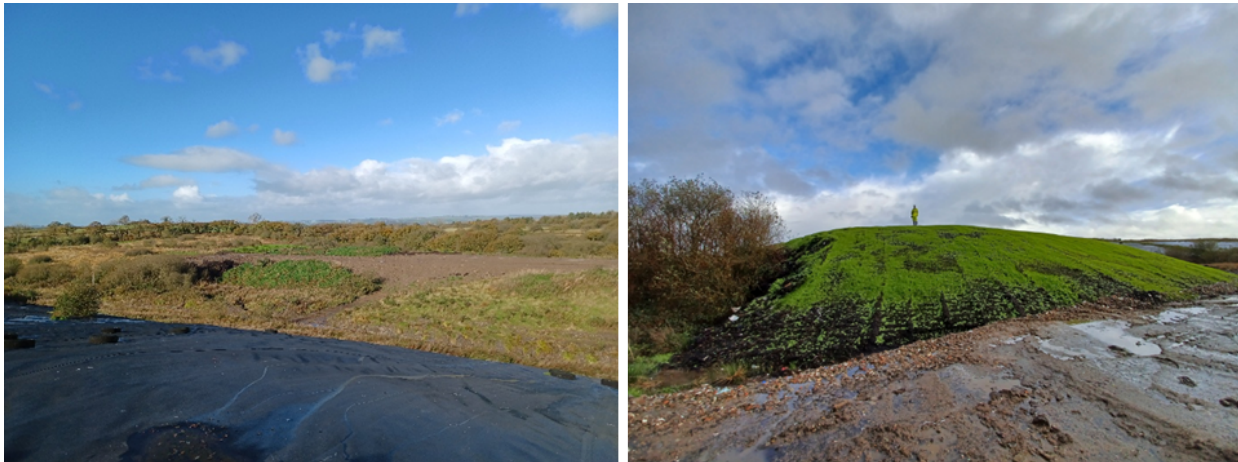
Images 6 & 7: View of material stockpile from Cell 6 (left) and stockpile of composting material received from adjacent permitted Site (right)

NRW Officers inspected the material stockpile which is situated within the adjacent Phase 3 area to the North of Cell 6. NRW were informed that the soils have been sourced from onsite works, including the construction of the new Materials Recycling Facility (MRF) which is scheduled for commissioning in the near future. It is proposed that this material is to be used within the restoration works for the Phase 2 Landfill.

On review of the permit (CP3735PB), it has been identified that currently there are not necessary mechanisms to allow the use of deposited uncontaminated waste for recovery purposes (in this case, restoration). CWM Environmental will need to submit a permit variation application to incorporate the required provisions into their EPR permit, subject to determination and approval by NRW's Permitting Team.

During the visit, NRW officers observed a significant accumulation of material resembling compost within the soil stockpile area. Compliance implications have not yet been assessed, as further investigation is currently underway. This matter may be subject to future inspections and subsequent CAR Forms.

CWM Environmental Ltd must submit a permit variation application to incorporate the necessary mechanisms for landfill restoration activities. Please note that approval is not guaranteed and will be subject to determination by NRW's Permitting Team.

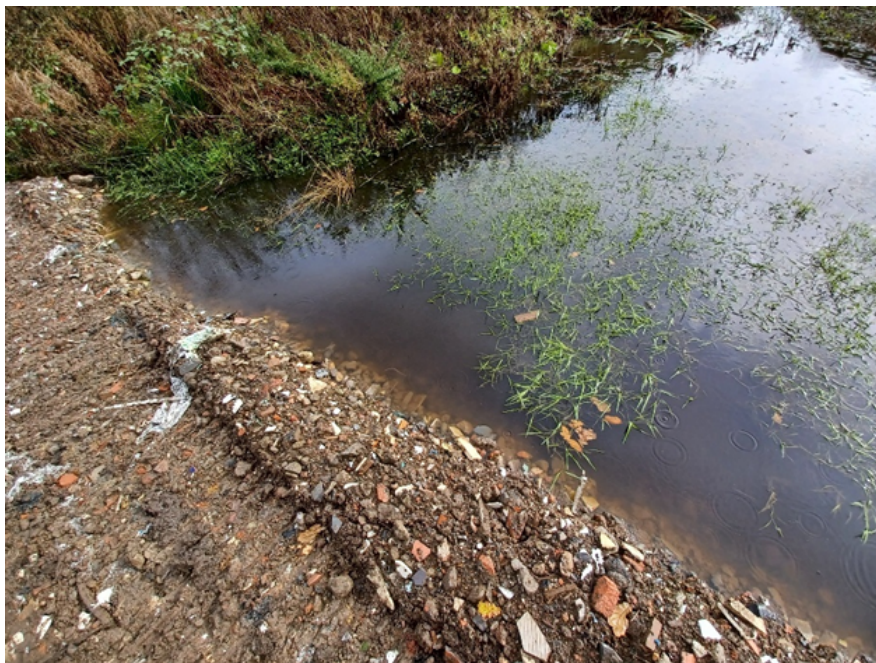
Image 8: Visually poor surface water situated adjacent to the accumulations of compost material

NRW Officers observed a body of visually contaminated surface water adjacent to the compost stockpiles and considered that surface water management in this area may be inadequate. At the time of inspection, NRW were unable to confirm the discharge point for this water, and further investigation was required.
