## Compliance Assessment Report CAR\_NRW0050925

**Permit being assessed:** BN0015601

**For:** PENNANT STW, **held by:** DWR CYMRU CYFYNGEDIG

**Type of assessment carried out:** Site Inspection,

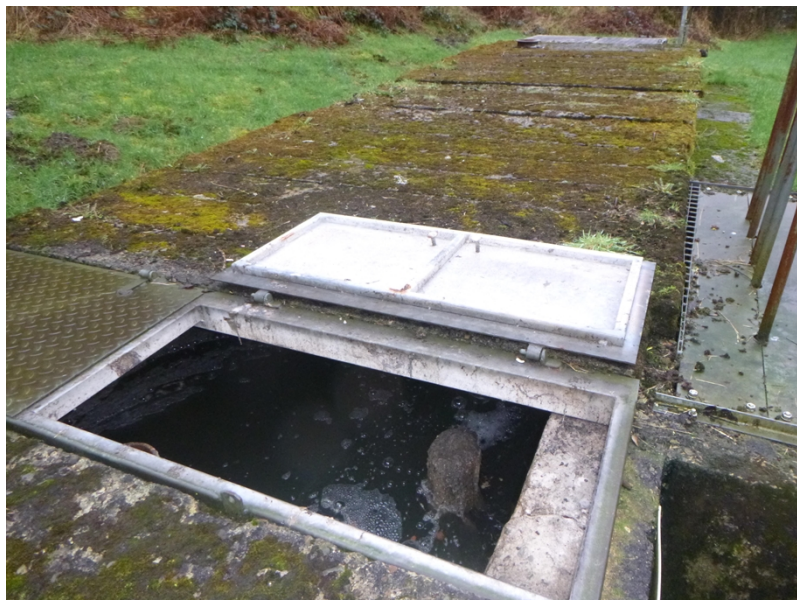
*Photograph 1: Septic tank*

Flows at Pennant STW are first treated by a septic tank as shown in photograph 1 below. The septic tank is desludged every few months, as and when required.

As has been mentioned in previous Compliance Assessment Reports (see CAR\_NRW0037449), infrastructure at Pennant STW, namely the septic tank and filter bed, appear old and in a poor state of repair. The DCWW operatives mentioned that Pennant STW is part of an AMP 8 (Asset Management Period 8) scheme looking at reducing the number of storm spills from the site. As part of this scheme, it is possible that the site's infrastructure may be improved.

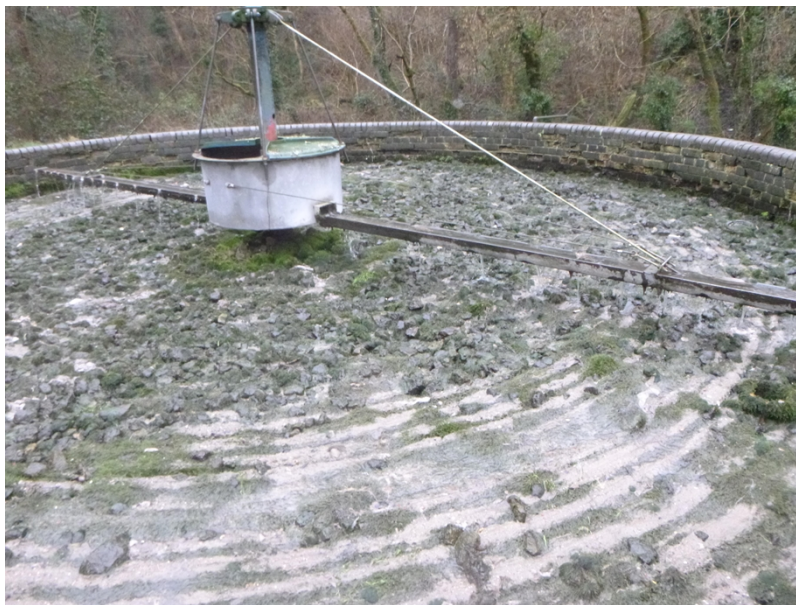
*Photograph 2: Filter bed*

Flows discharging from the septic tank reach a stone media filter bed as shown in photograph 2 below. The arms of the filter bed were rotating unhindered at the time of the inspection. Effluent was being evenly distributed across the surface of the filter bed.

Given Pennant STW's location, a covering of moss was present at the surface of the filter bed. This was also noted during NRW's last inspection of Pennant STW on the 18 September 2020 as detailed in Compliance Assessment Report (CAR) CAR\_NRW0037449. At the time of the most recent inspection, the DCWW operatives explained that moss can cause a deterioration in final effluent quality if cleared too frequently, or infrequently. Given the quantity of moss observed at the surface of the filter bed at the time of the most recent inspection, it was stated that DCWW would arrange for the moss to be cleared to avoid a deterioration in final effluent quality and to avoid effluent ponding at the surface of the filter bed.

As no screen exists at the inlet to Pennant STW, rags also accumulate at the surface of the filter bed. Rags are periodically cleared by hand from the surface of the filter bed.

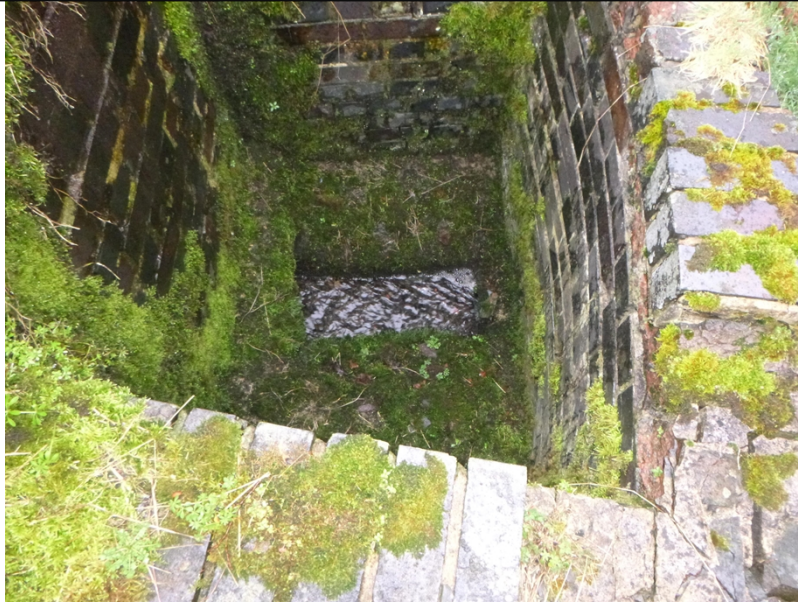
*Photograph 3: Outflow from filter bed*

Photograph 3 below shows the outflow from the filter bed. The outflow appeared clear at the time of the inspection with no evidence of rags or other matter discharging from the filter bed.

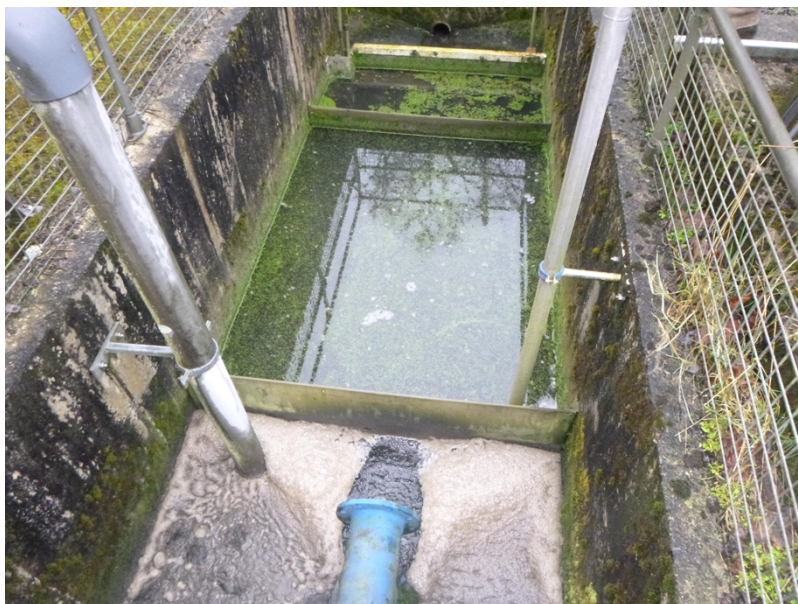
*Photograph 4: Final settlement tank*

After discharging from the filter bed, effluent discharges to a final settlement tank as shown in photograph 4 below. Flows exiting the final settlement tank appeared clear at the time of the inspection. The final settlement tank is desludged every three months. When incoming flows are low, flows are recirculated from the final settlement tank back to the filter bed to keep the filter bed wet. The recirculation flow is monitored by an MCERTS flow meter.

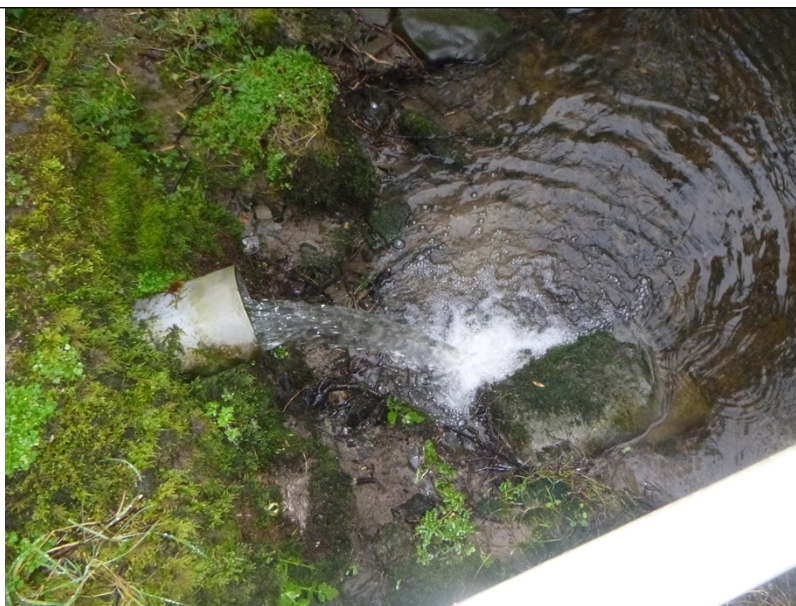
*Photograph 5: Final effluent discharge point into the Afon Arth*

Final effluent from Pennant STW subsequently discharges into the Afon Arth as shown in photograph 5 below. The final effluent outfall acts as the site's final effluent sampling point as shown in photograph 6 below. Final effluent discharging at the outfall appeared clear and odourless at the time of the inspection. The NRW officer did not notice a discoloured plume or evidence of sewage fungus within the Afon Arth at the final effluent discharge point.
