Compliance Assessment Report CAR_NRW0051694

Permit being assessed: AB3092FR.

At: Llantrisant Recycling, Pantybrad Lane, Llantrisant, Pontyclun, CF72 8YY.

Type of assessment: Site Inspection,

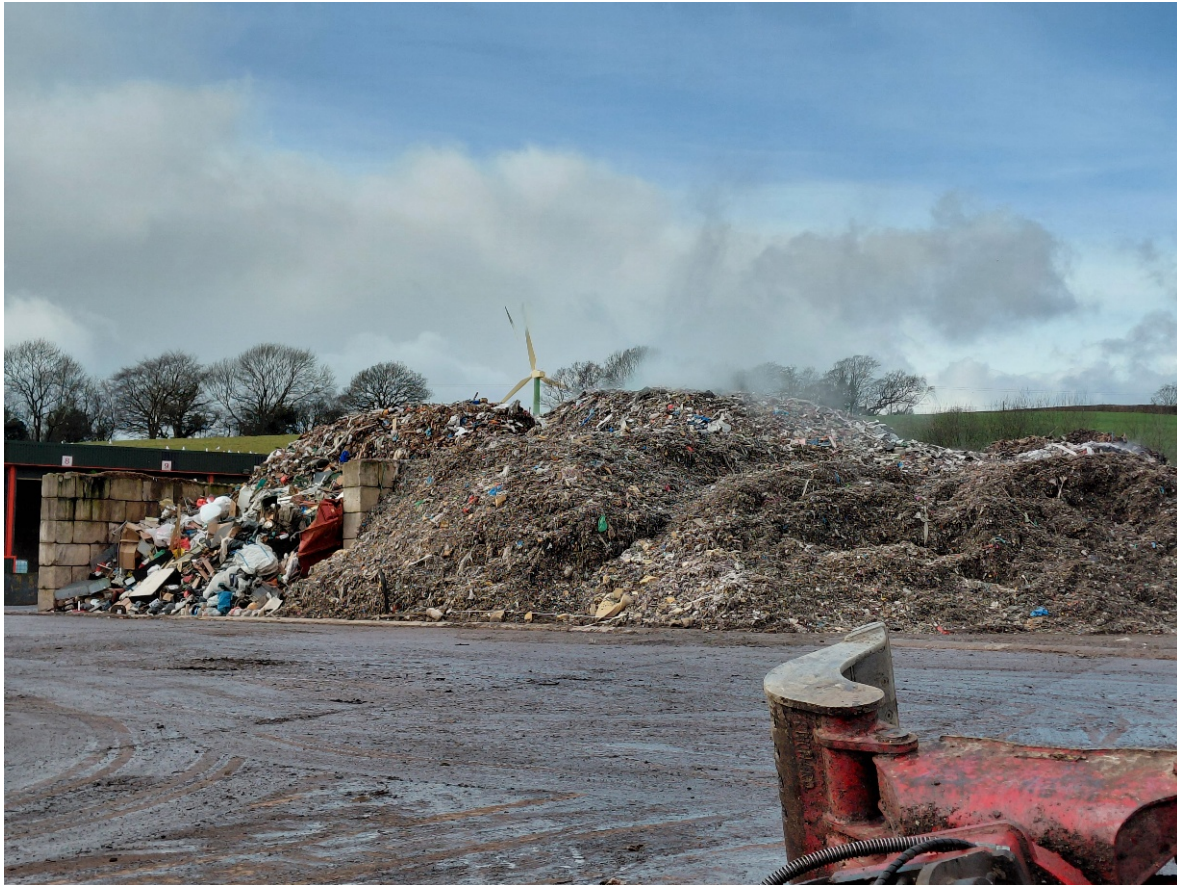
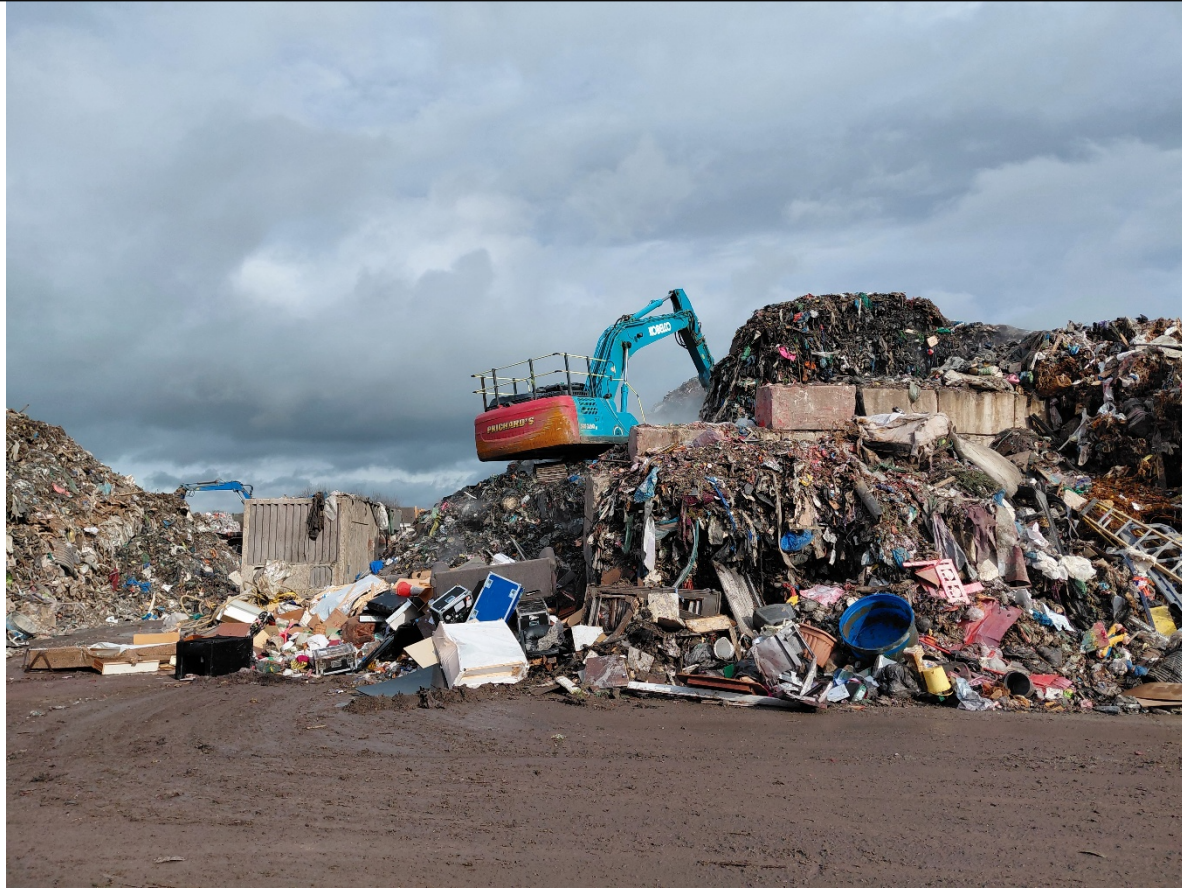
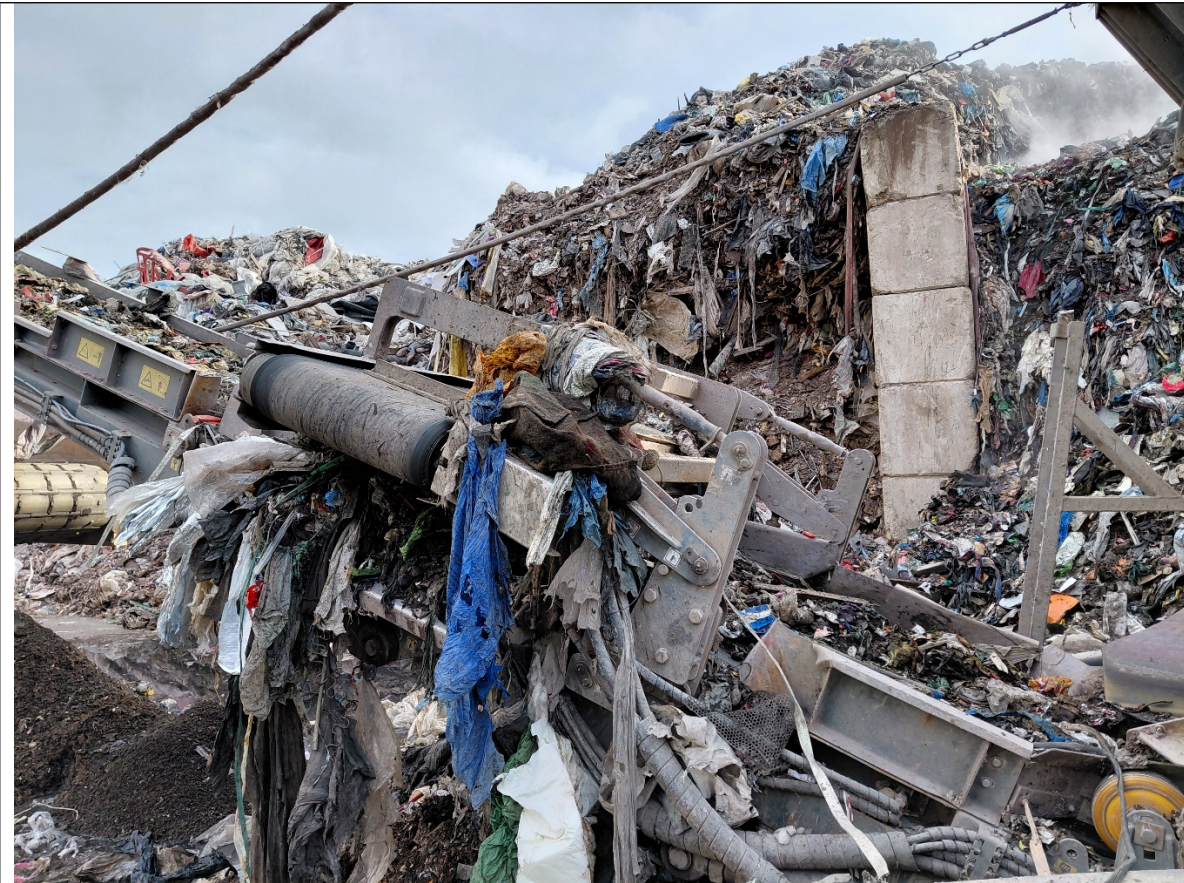
During the site inspection, we observed mixed waste stockpiles exceeding the permitted maximum height of 4 metres. Several stacks were approximately 5 - 6 metres in height, as shown in photograph 1, 2 and 3. Waste was being stored higher than the concrete block walls. These walls are required to maintain a minimum 1 metre freeboard above the waste

to prevent fire spread between stockpiles. There were also insufficient fire breaks between the open sides of the stockpiles, with waste spilling out of the bays, the FPMP guidance and the FPMP on site stipulates a minimum of 10 metres. Due to the inadequate fire breaks, the waste in this area would be considered a single large stockpile. In the event of a fire, rapid spread across the pile would be likely. NRW have issued you with this breach in the past in CAR_NRW0041920.

The waste was visibly seen steaming in several areas, the FPMP states visual monitoring will be undertaken daily and states, *'The visual monitoring will look for signs of heating within the waste piles such as accumulations of condensation within plastic materials, steam being produced from the stockpiles and scorch marks on material brought out from within the piles. If any of these signs of heating are noted, then the waste pile will be split into smaller piles, cooled down with clean water sprays (if required) and removed from site.'*

Your FPMP also states, *'If steam or condensation is noticed or even if signs of melting or charred material is seen within the waste, this would initiate a review of the policies and procedures set out within this FPMP. The sections of the plan that would be reviewed in this type of situation would be stack sizes and separation distances, the waste storage time, frequency of monitoring, the type of monitoring being undertaken (i.e. would more extensive equipment be needed) and the preventing fire section to ensure that the measures being taken are still adequate. If these signs are noticed within the daily site checks, the environmental manager will be informed and will contact NRW. At this point waste inputs are to be stopped until the waste has been safely removed from site and NRW are in agreement for waste to be imported once more.'* This has been identified as a risk but the measures within the plan have not been carried out.

Action: Ensure all waste is being stored and managed in accordance with your permit and FPMP.

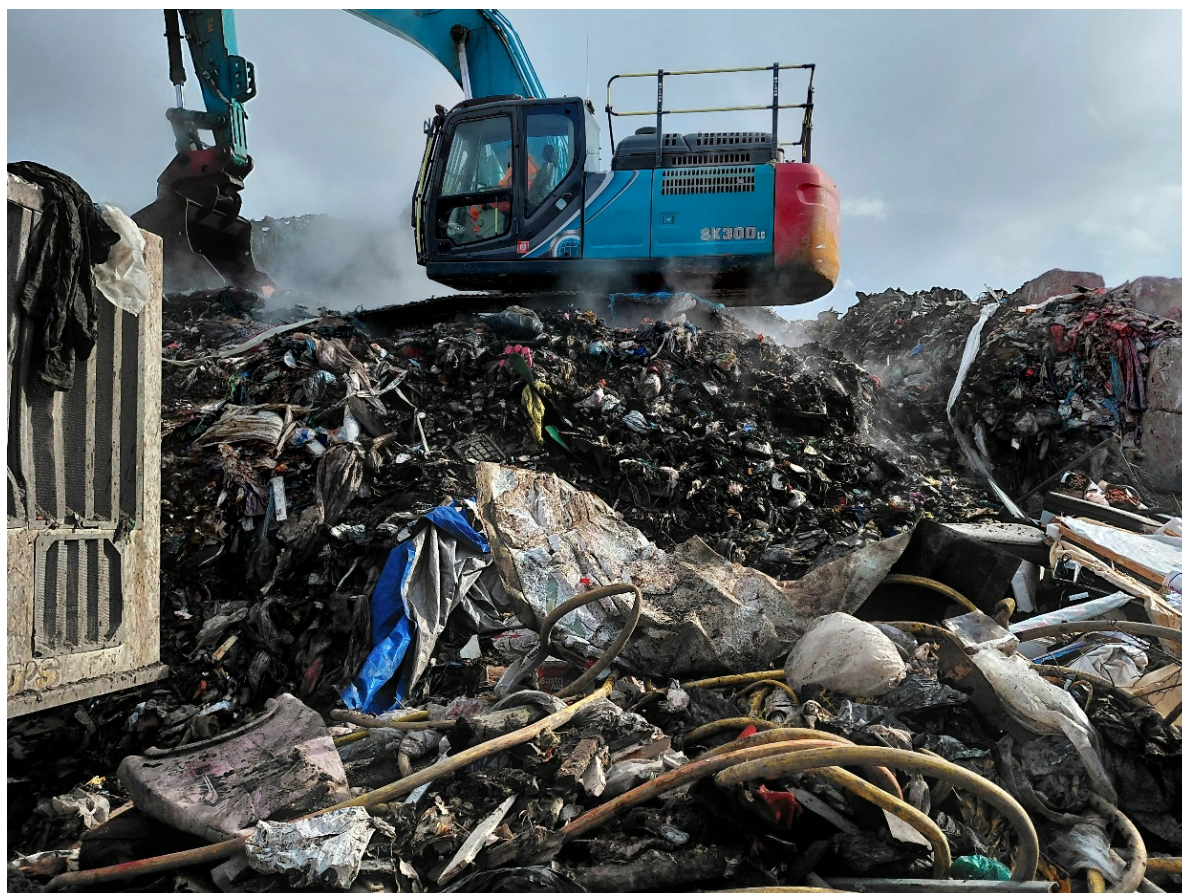
Photo 4

We also witnessed plant operating directly on top of the waste compacting it down (photo 4 below). Vehicles working on top of a waste pile increases fire risk acting as an ignition point. The FPMP on site identifies hot exhausts as a fire risk and states:

Using machinery to compact material down has not been included in the sites FPMP or other management system and in which case, consideration of the associated risk, additional waste volumes within the bays and the potential impacts that will have on fire prevention and mitigation has not been considered. This would, as a minimum, have likely implications on the amount of water required to fight a fire as well as the capacity of the quarantine area.

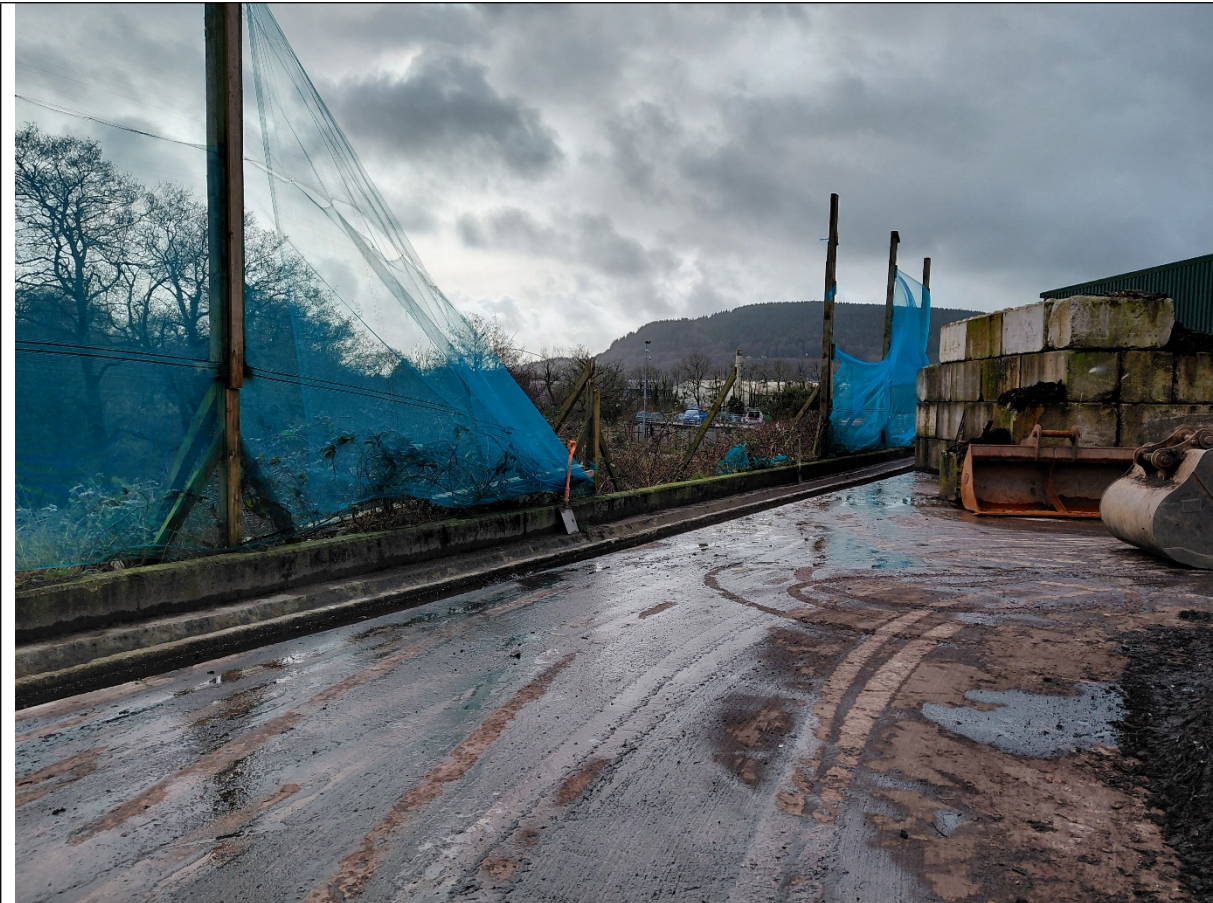
Photo 5

Additionally, during the inspection, we discussed the damaged boundary netting (see photo 5 below). We understand that Llantrisant Recycling Centre plans to construct a new building that will fully contain waste across the site. However, until this is completed, the boundary netting must remain intact and maintained to prevent any waste from leaving the site, particularly during periods of high winds.

The *How to Comply with Your Environmental Permit* guidance (Waste Operations, page 44) states under *Dust, Mud and Litter* that operators should erect litter fences around the site - which you have already done. It is therefore important that these measures are maintained to ensure they continue to be effective.

Action: Please repair the site boundary netting to avoid any litter leaving site.

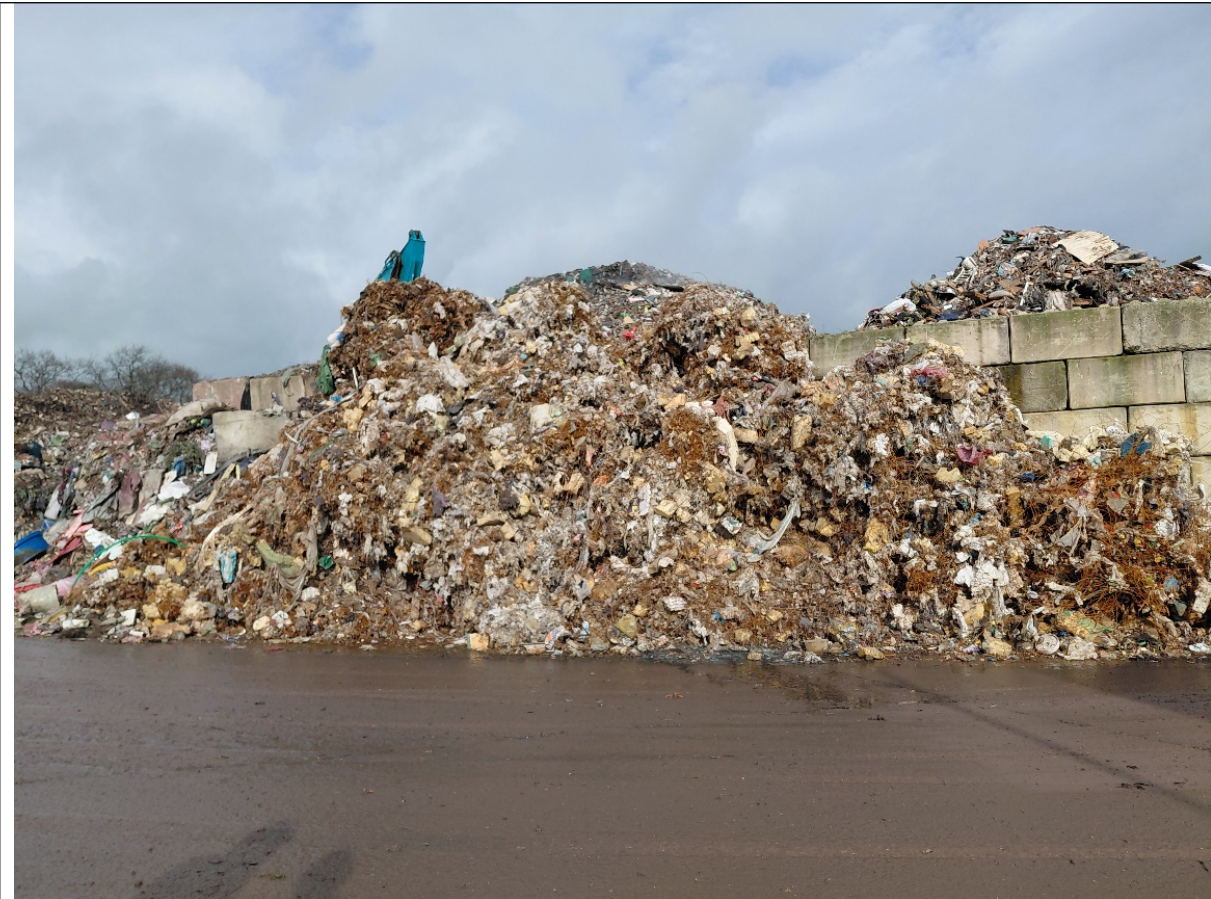
Photo 6

We have issued you with a C3 breach of your permit under sub-criteria W2A Permitted Activities, due to the ongoing processing of mattresses at the site.

During the inspection we discussed the shredded mattresses on site (photo 6 below), you told us that mattress shredding is done almost daily. This is not a permitted activity within your permit. This has been explained to the operator in previous Compliance Assessment Forms, I have added the information below.

Action: You must cease shredding of mattresses on the site immediately. Should you wish to shred mattresses you will need to apply for a permit variation to include these activities.
