**REVIEW OF ENVIRONMENTAL MONITORING  
RESULTS AT THE  
NANT-Y-GWYDDON LANDFILL SITE DURING THE  
PERIOD JAN 25 – DEC 25**

**Amgen Rhondda Ltd.  
Bryn Pica Landfill Site  
Llwydcoed  
Aberdare  
CF44 0BX**

*Amgen Rhondda Ltd. has carried out a review of the results of environmental monitoring activities undertaken at the Nant-y-Gwyddon landfill site, during 2025.*

## **REVIEW OF ENVIRONMENTAL MONITORING AT THE NANT-Y-GWYDDON LANDFILL SITE, GELLI, RHONDDA.**

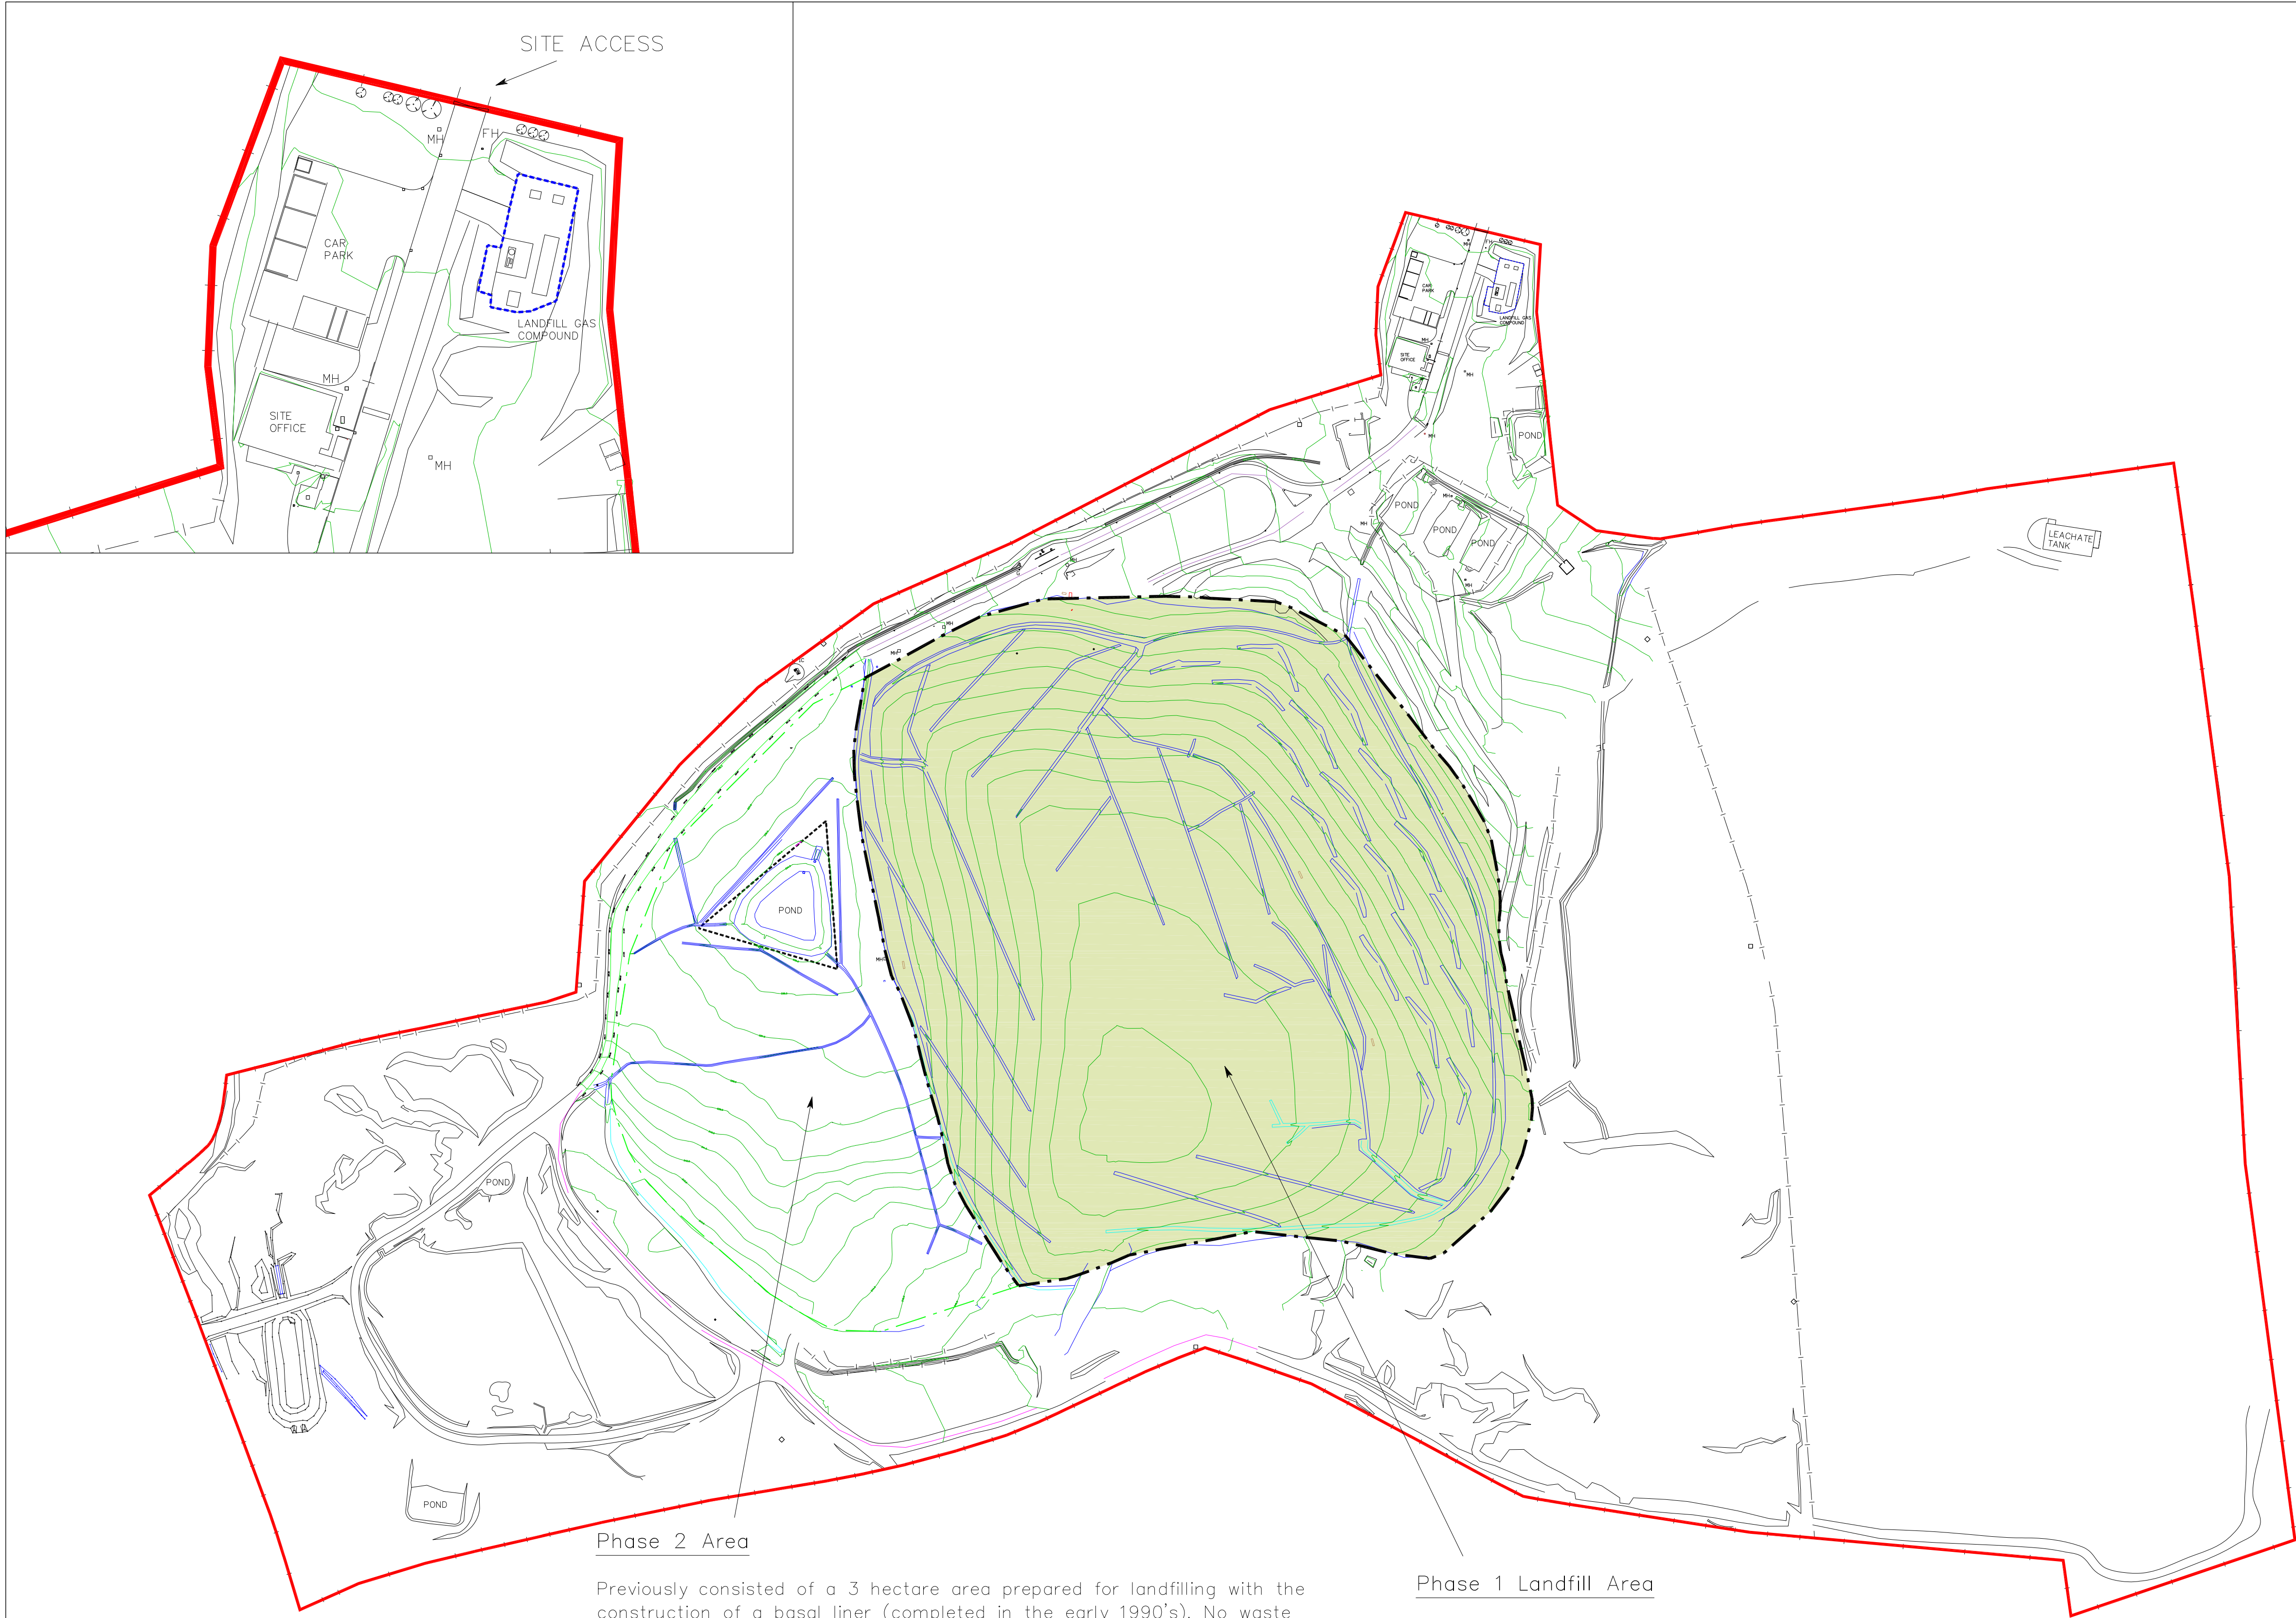
| SCALE | SHEET | DRAWING NO. | REVISION |
|---|---|---|---|
| 1: 2500 | A2 | AARL2026/ENV/01/002 | — |

Previously consisted of a 3 hectare area prepared for landfilling with the construction of a basal liner (completed in the early 1990's). No waste was ever deposited within this area.

The Phase 1 landfill covers an area of approximately 9.5 hectares and was operated during the period November 1987 – March 2002. It contains approximately 1.25 million tonnes of Household, Commercial and Non-Hazardous Industrial Waste.

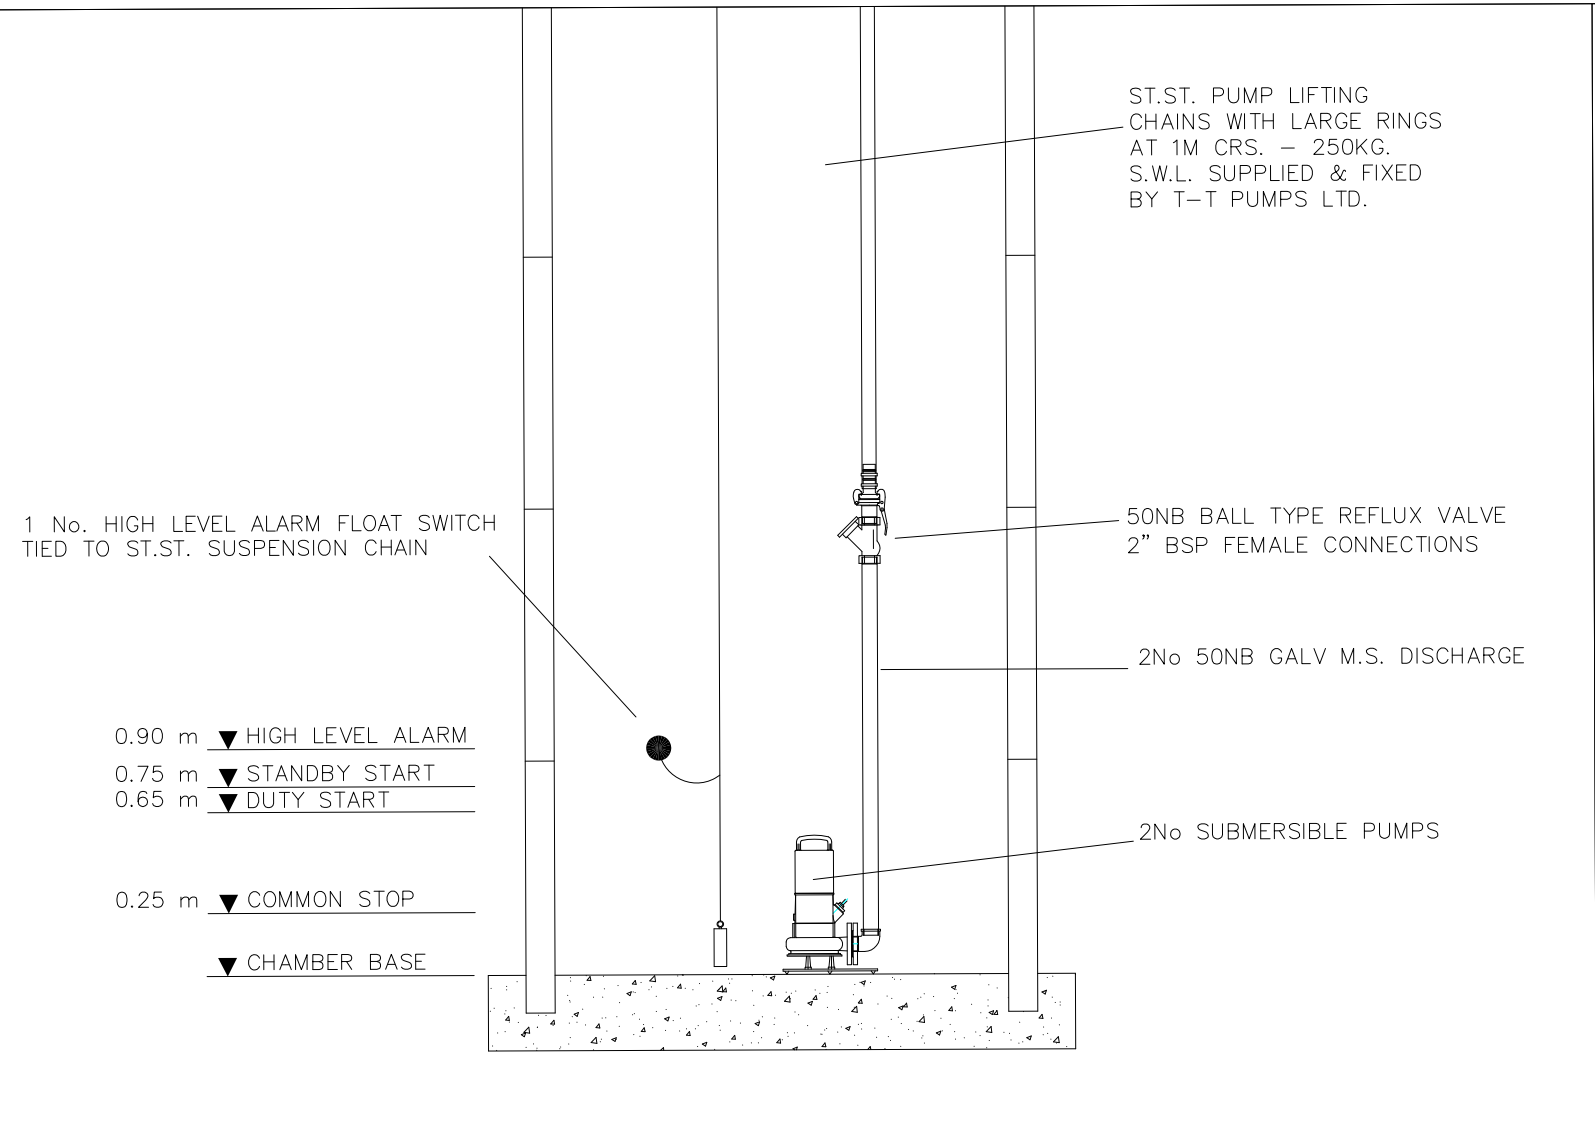
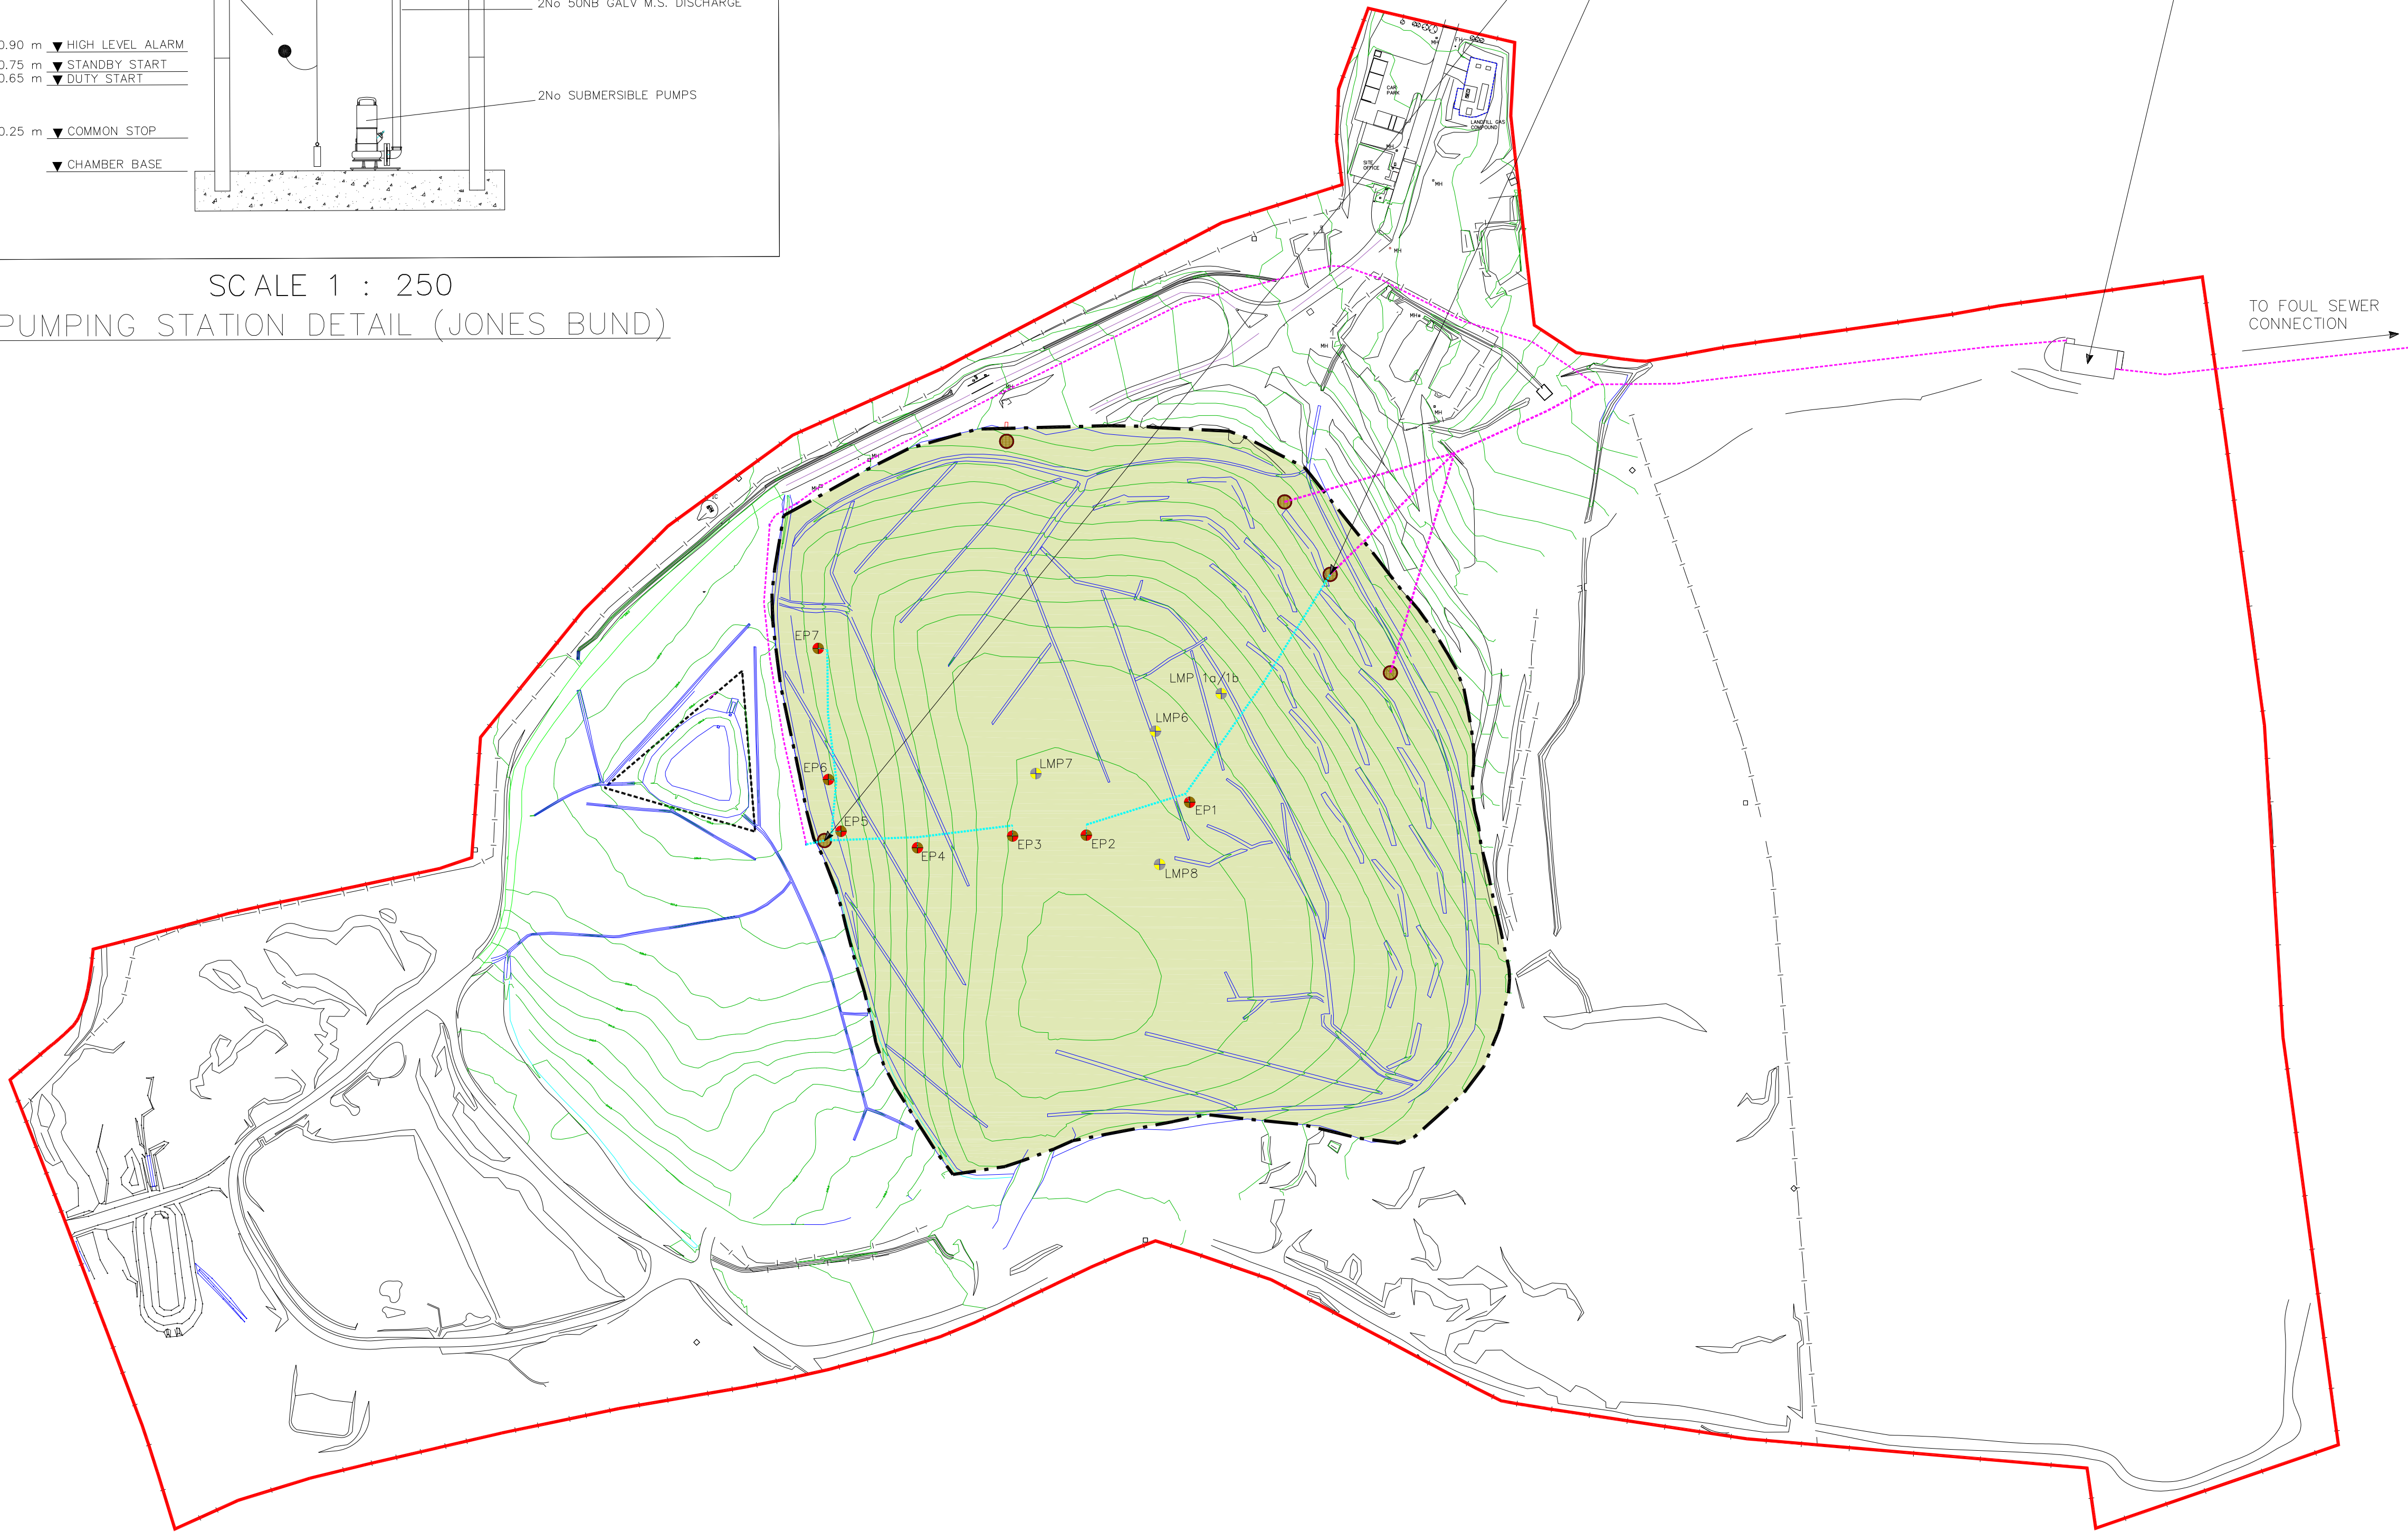
| 1: 2500 | A2 | A20264/ENV/01/003 | — |

- LPS1 (LEACHATE PUMPING STATION JONES BUND)
- L5a (INSPECTION MANHOLE)
- L5 (LEACHATE HOLDING TANK)

SCALE 1 : 250  
PUMPING STATION DETAIL (JONES BUND)

Leachate level monitoring is carried out monthly, involving dip measurement, undertaken by a suitably qualified landfill technician. The location of the 2 monitoring points currently used is illustrated in Drawing No. ARL2026/ENV/01/003 and a description provided below:

- **L5a (leachate inspection manhole L5a)** – L5a is a leachate inspection chamber located within the landfill immediately adjacent to the Inert Bund retaining the eastern margin of the waste. This chamber is linked directly to the basal drainage system, at a location considered to be the lowest point in the landfill. Leachate collected by the basal drainage system flows to this point under the influence of gravity - prior to exiting the landfill via an underground pipeline.

Monthly monitoring of Leachate Inspection Chamber L5a has shown it to be consistently dry over the previous 12 months. This observation has been confirmed by visual inspection of the installation. A very small basal flow is observed within the drainage channel and this is freely escaping the landfill (under gravity) into the external leachate management pipe-work.

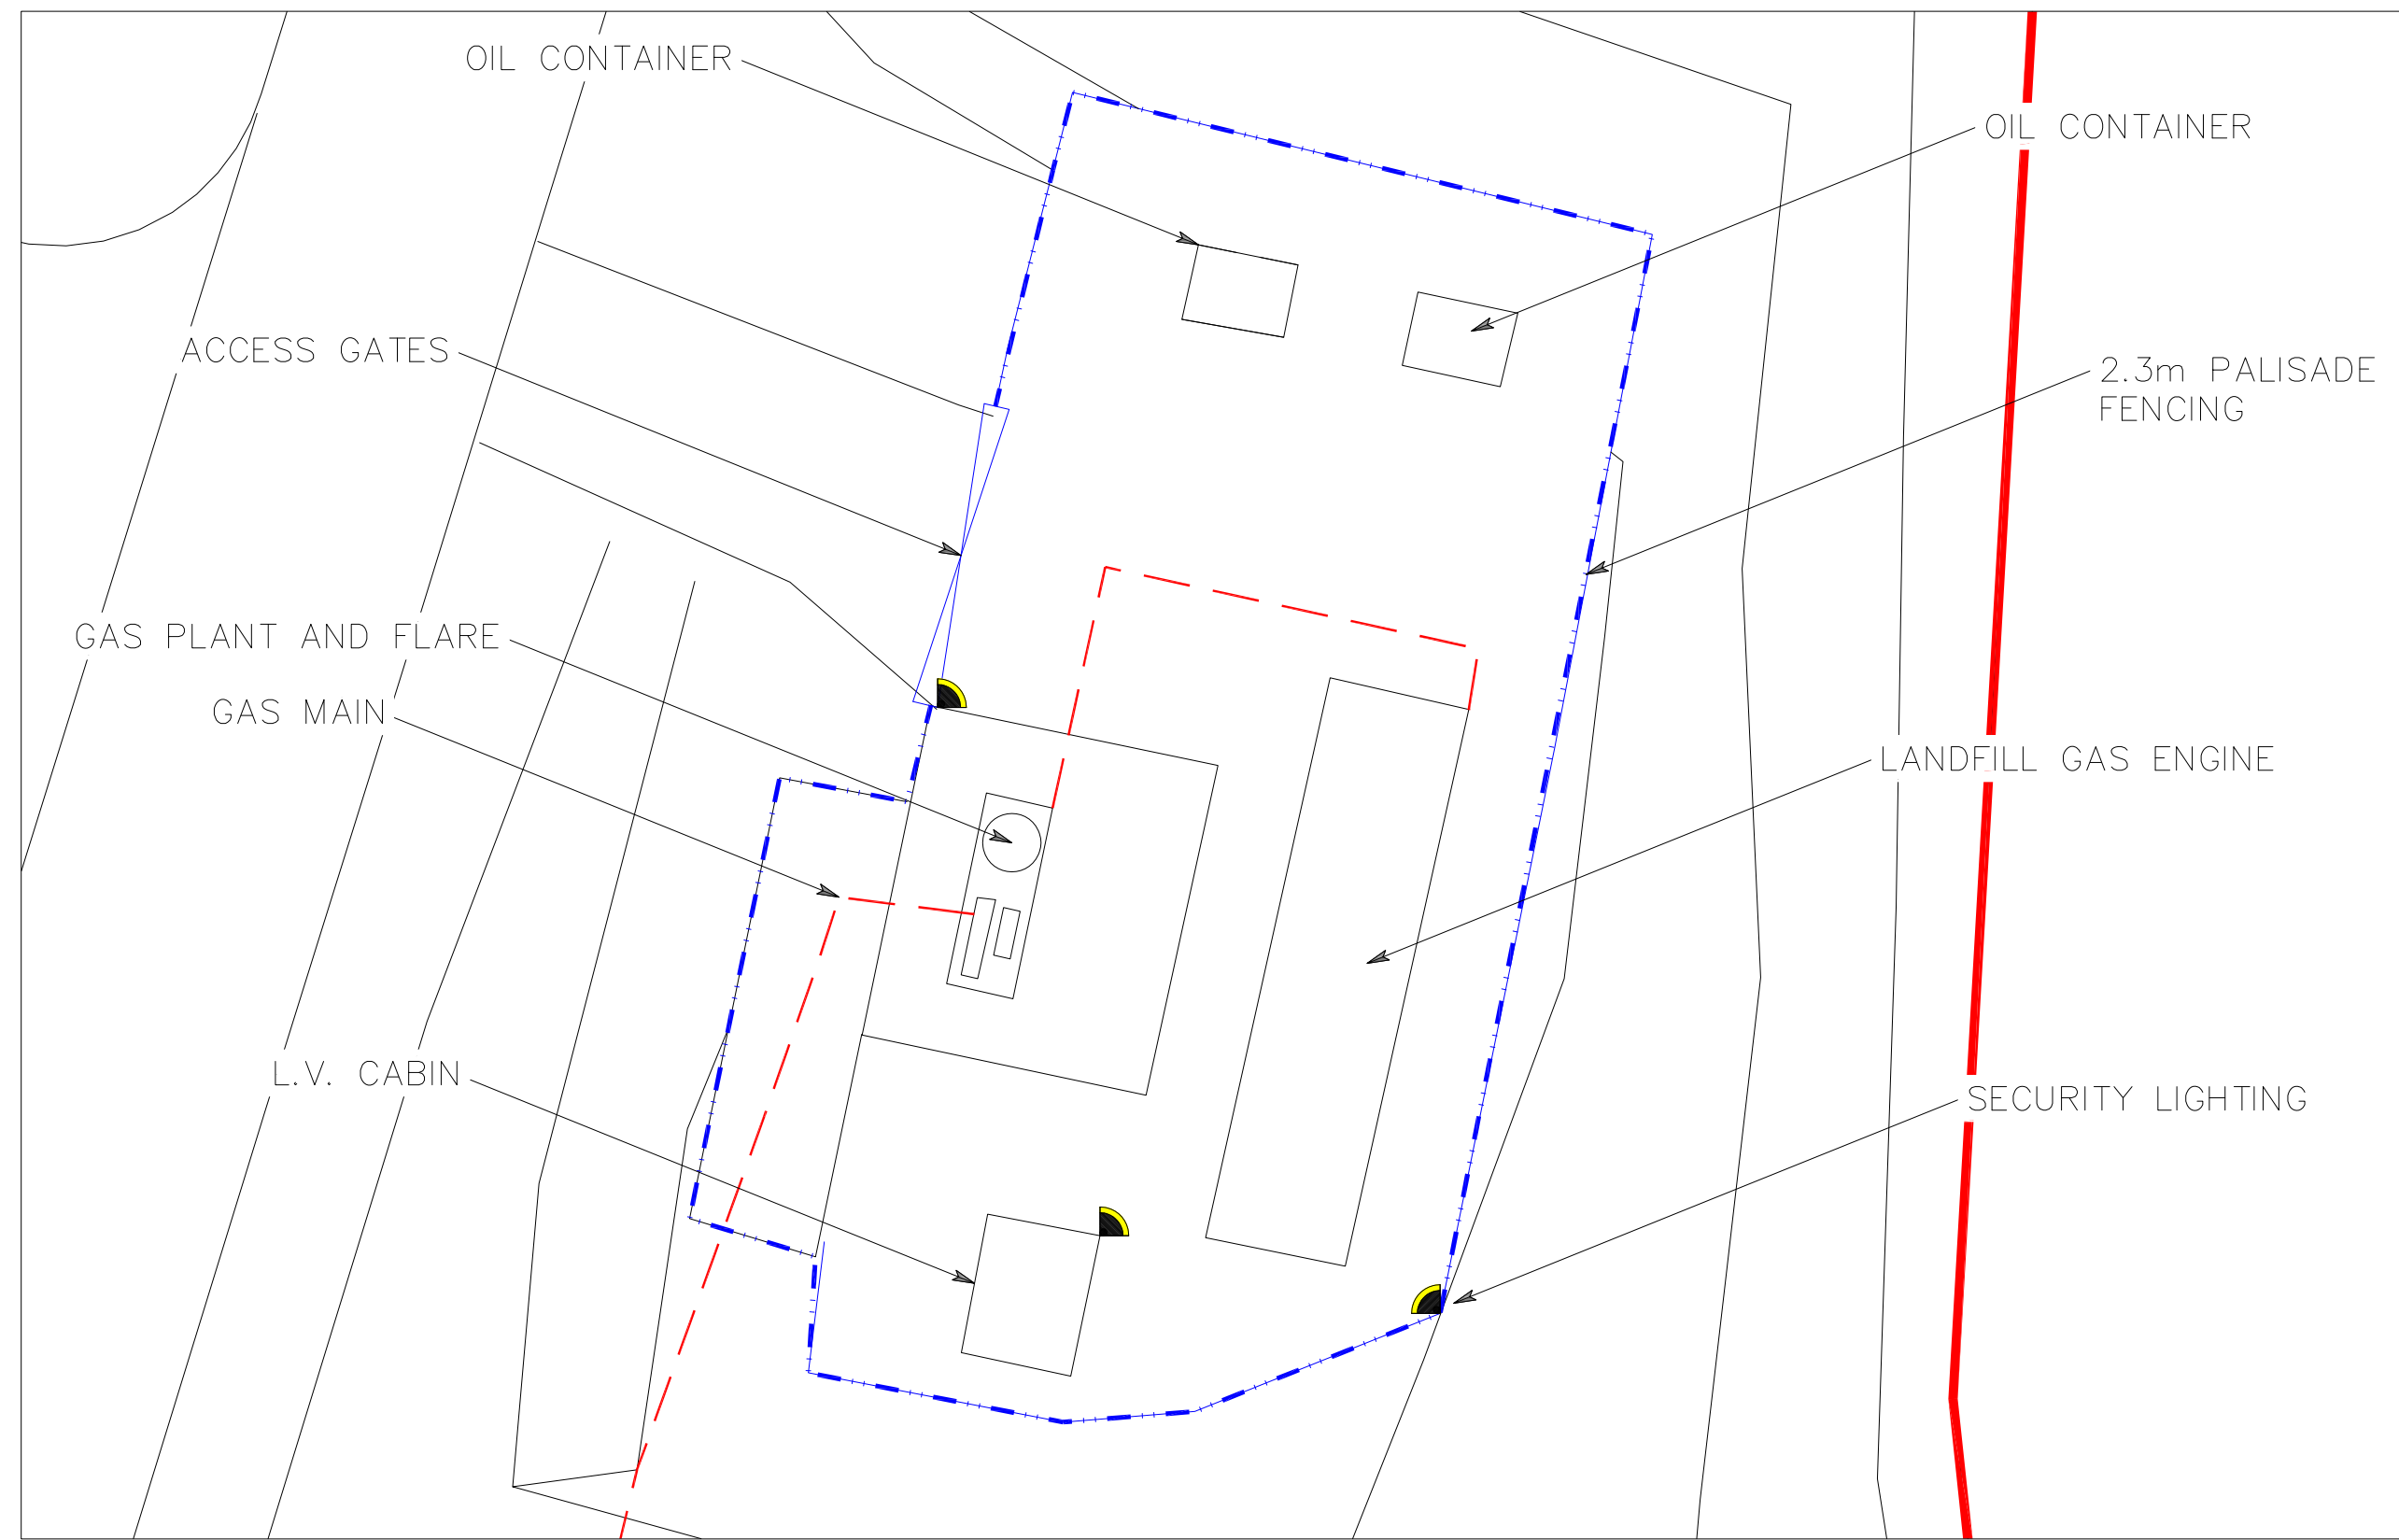
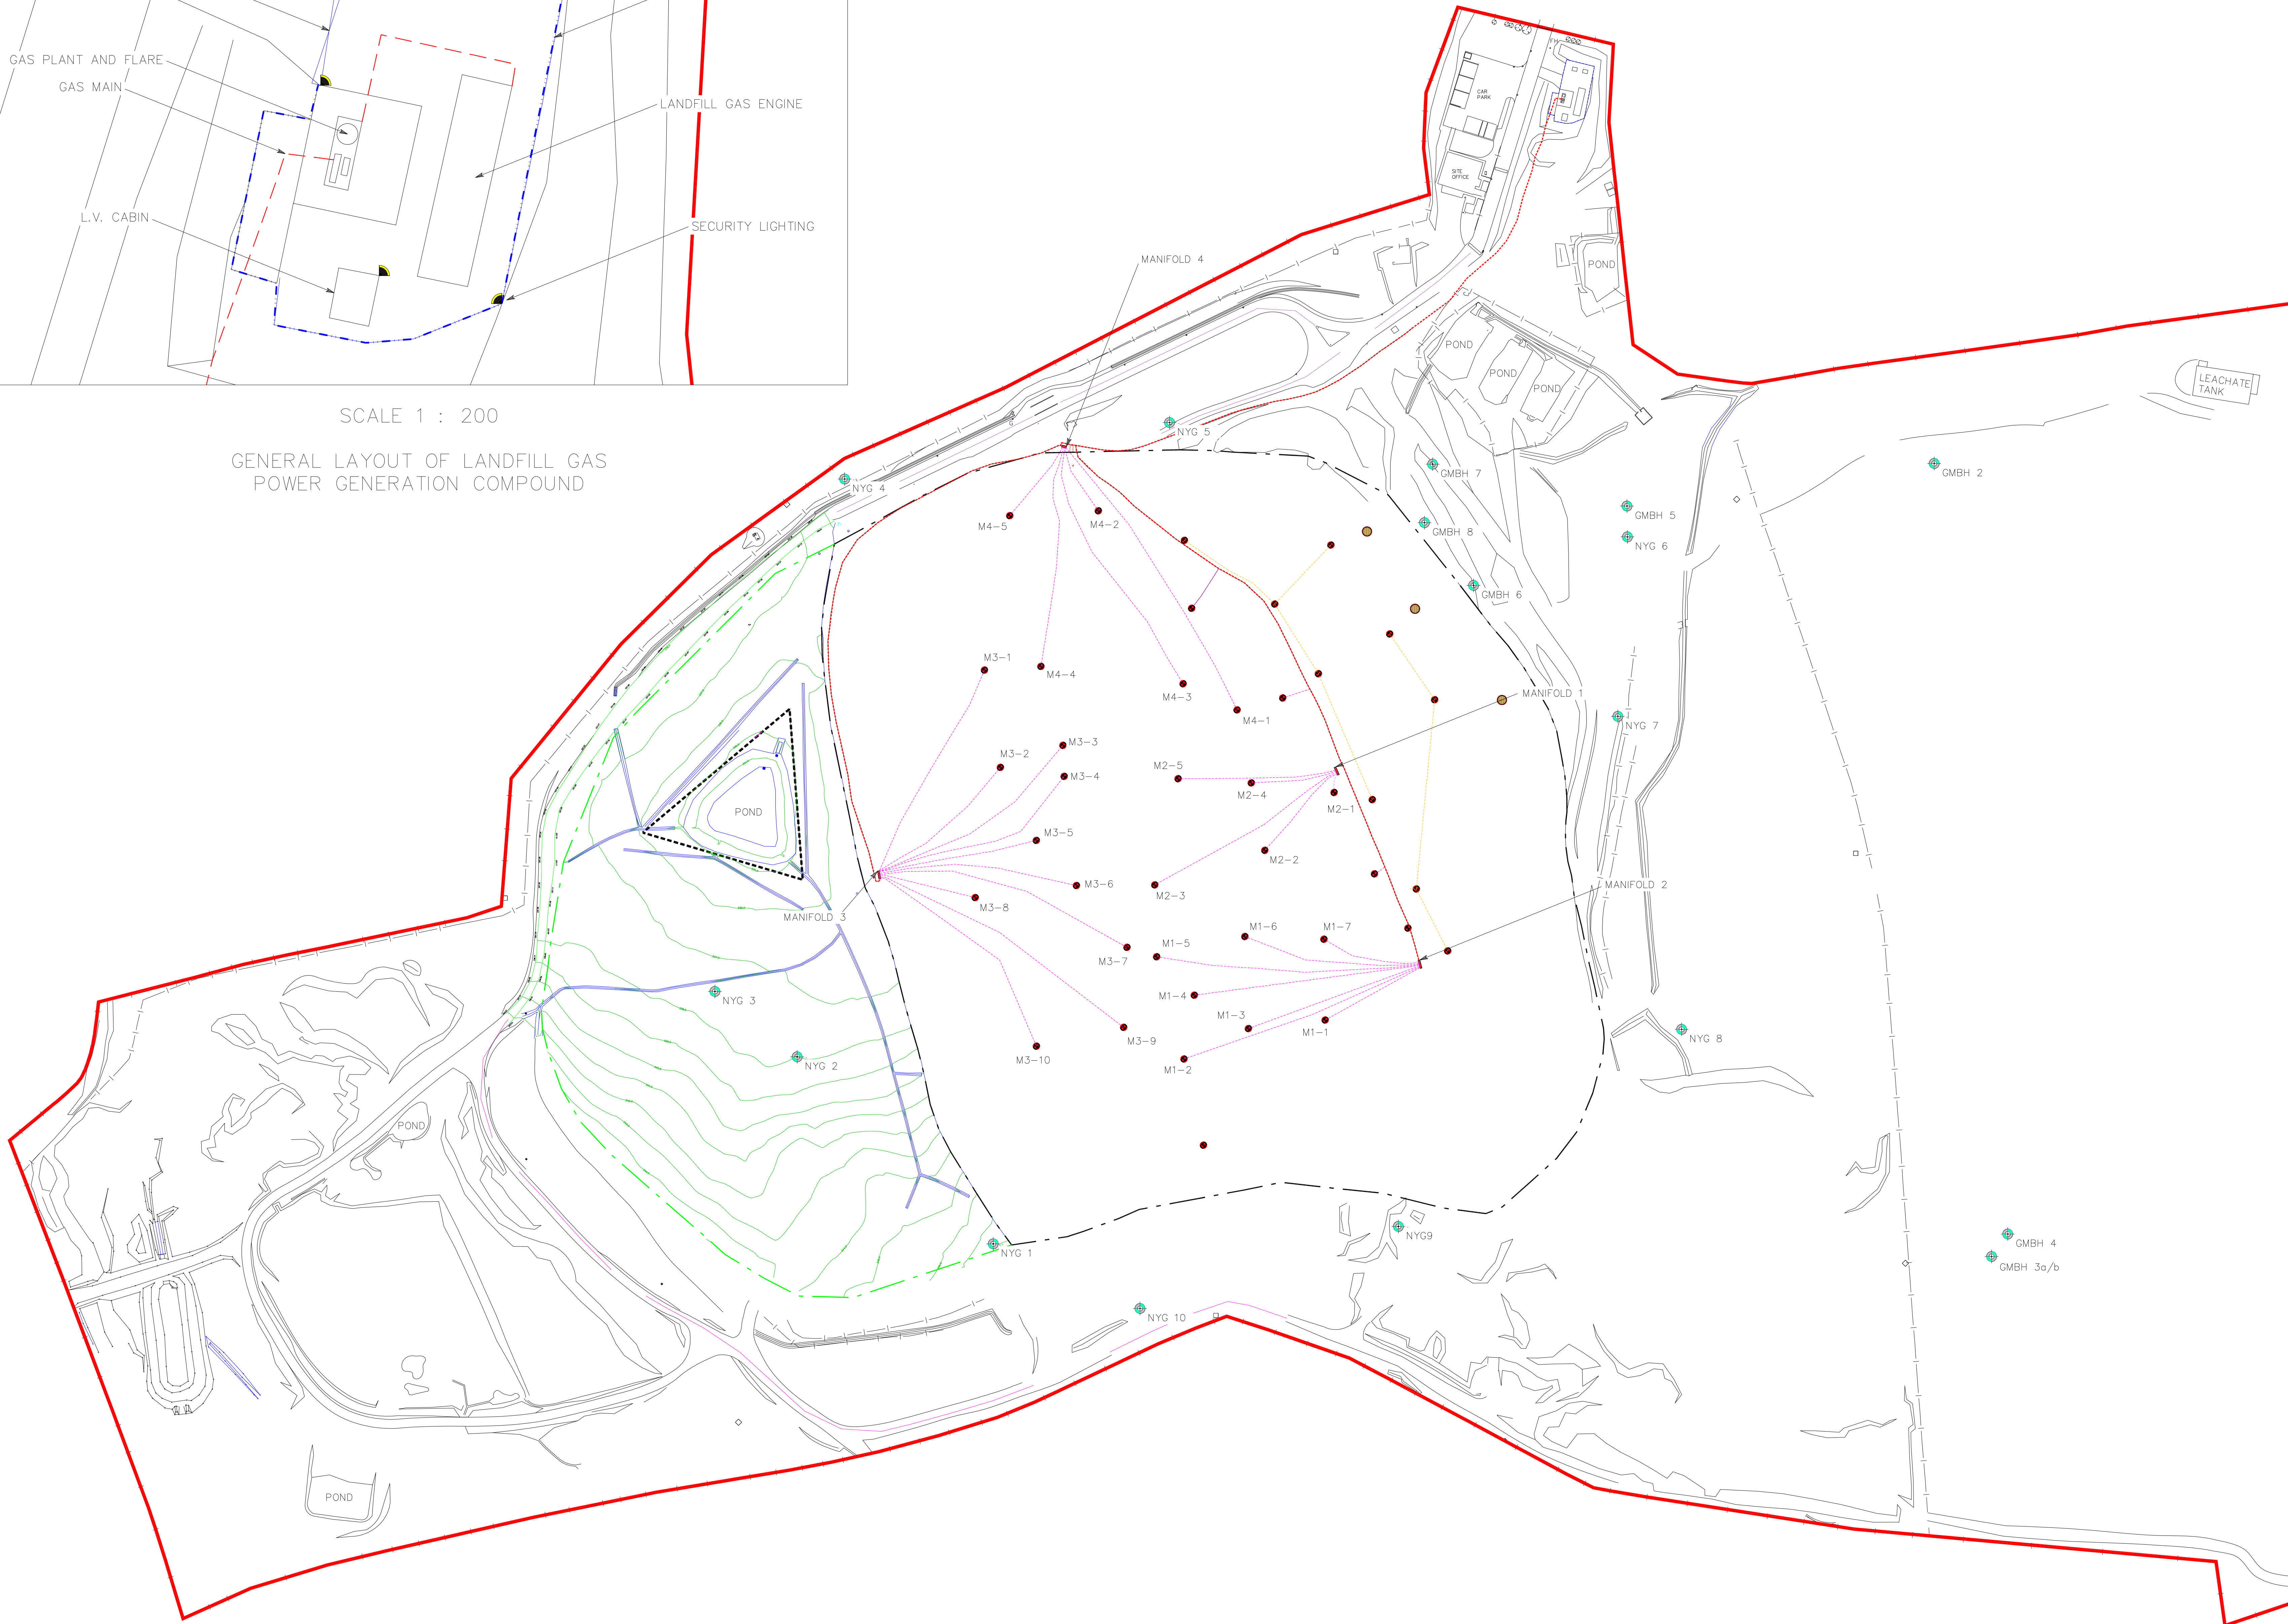
GENERAL LAYOUT OF LANDFILL GAS  
POWER GENERATION COMPOUND

- WML BOUNDARY
- PHASE 1 LANDFILL AREA
- GAS MAIN
- GAS LINE (UNDERGROUND)
- GAS LINE (SURFACE)
- GAS EXTRACTION WELL WITH MONITORING POINT
- SUBSURFACE LANDFILL GAS MONITORING BOREHOLE
- LEACHATE INSPECTION CHAMBER
- LANDFILL GAS CONTROL MANIFOLD AND DEWATERING KNOCKOUT POT

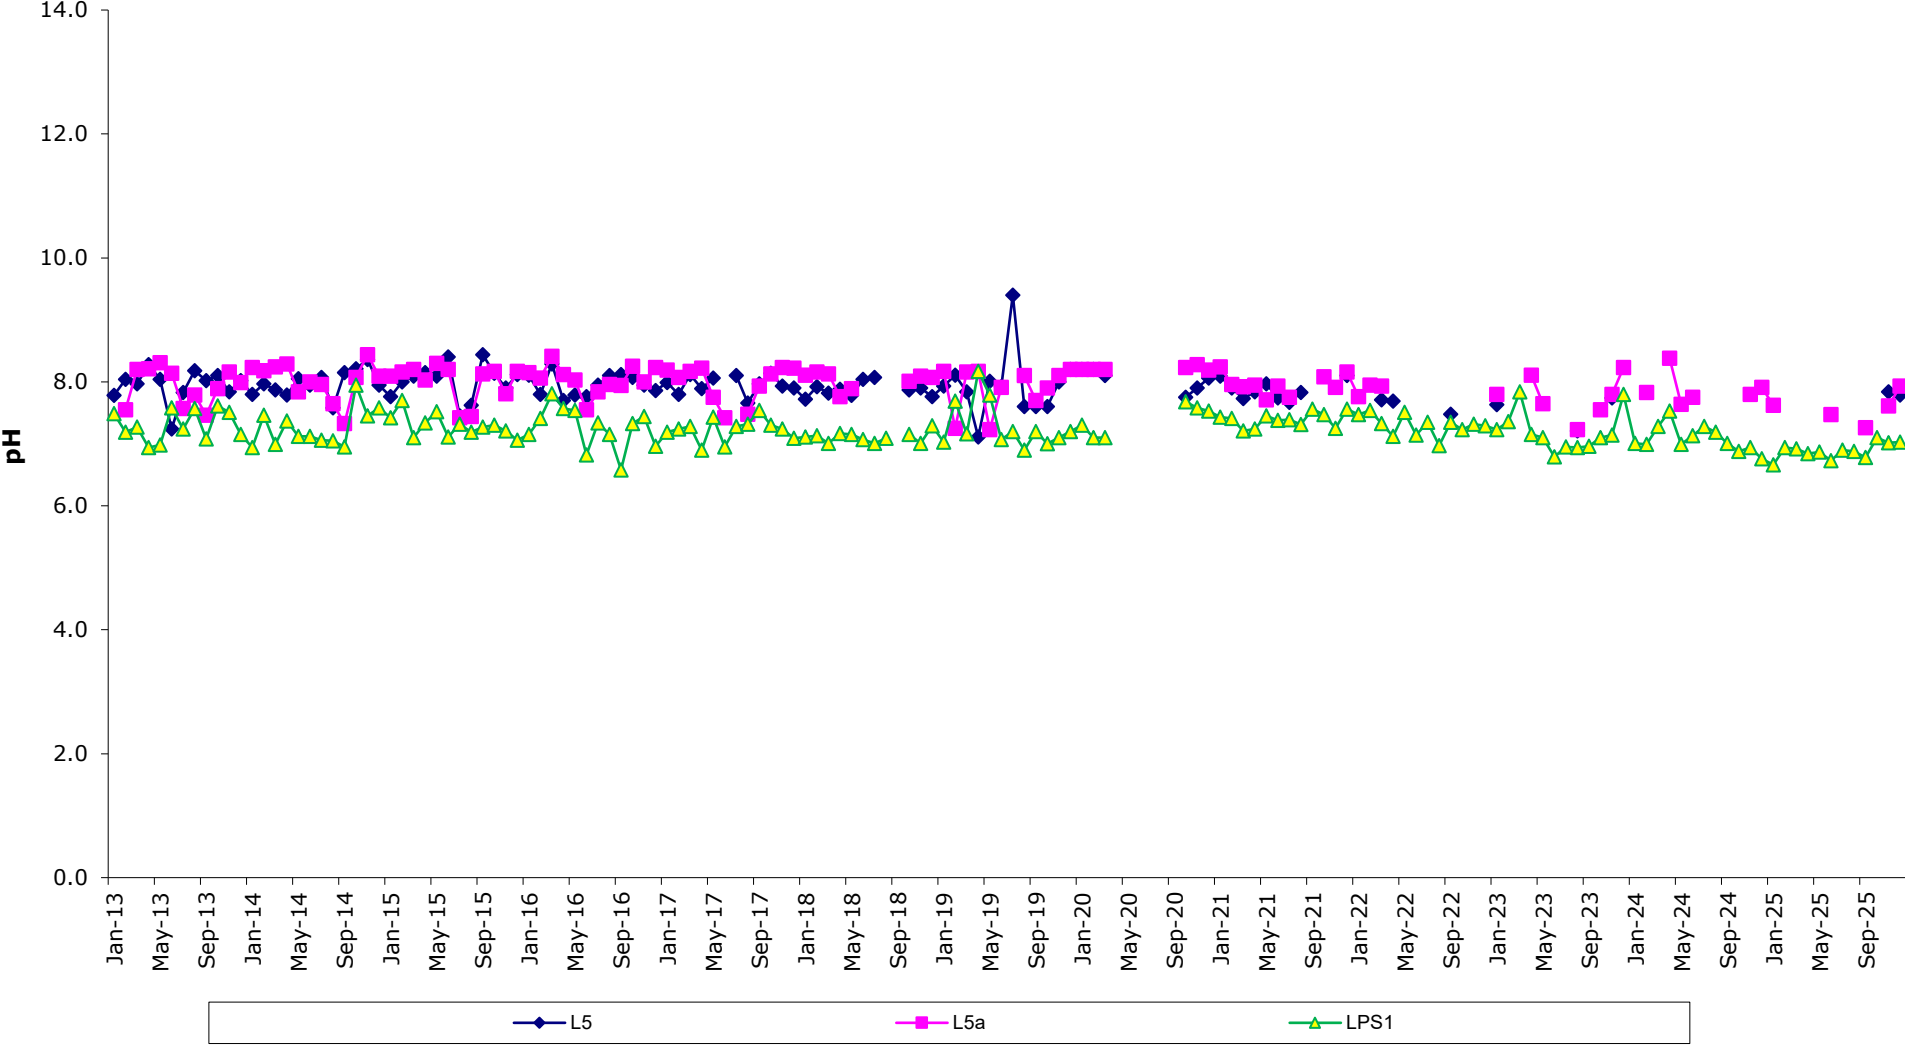
**Lab analysis of pH levels in leachate sampled by Amgen Rhondda Ltd at the Nant-Y-Gwyddon Landfill Site during the period Jan 2013 - Dec 2025.**

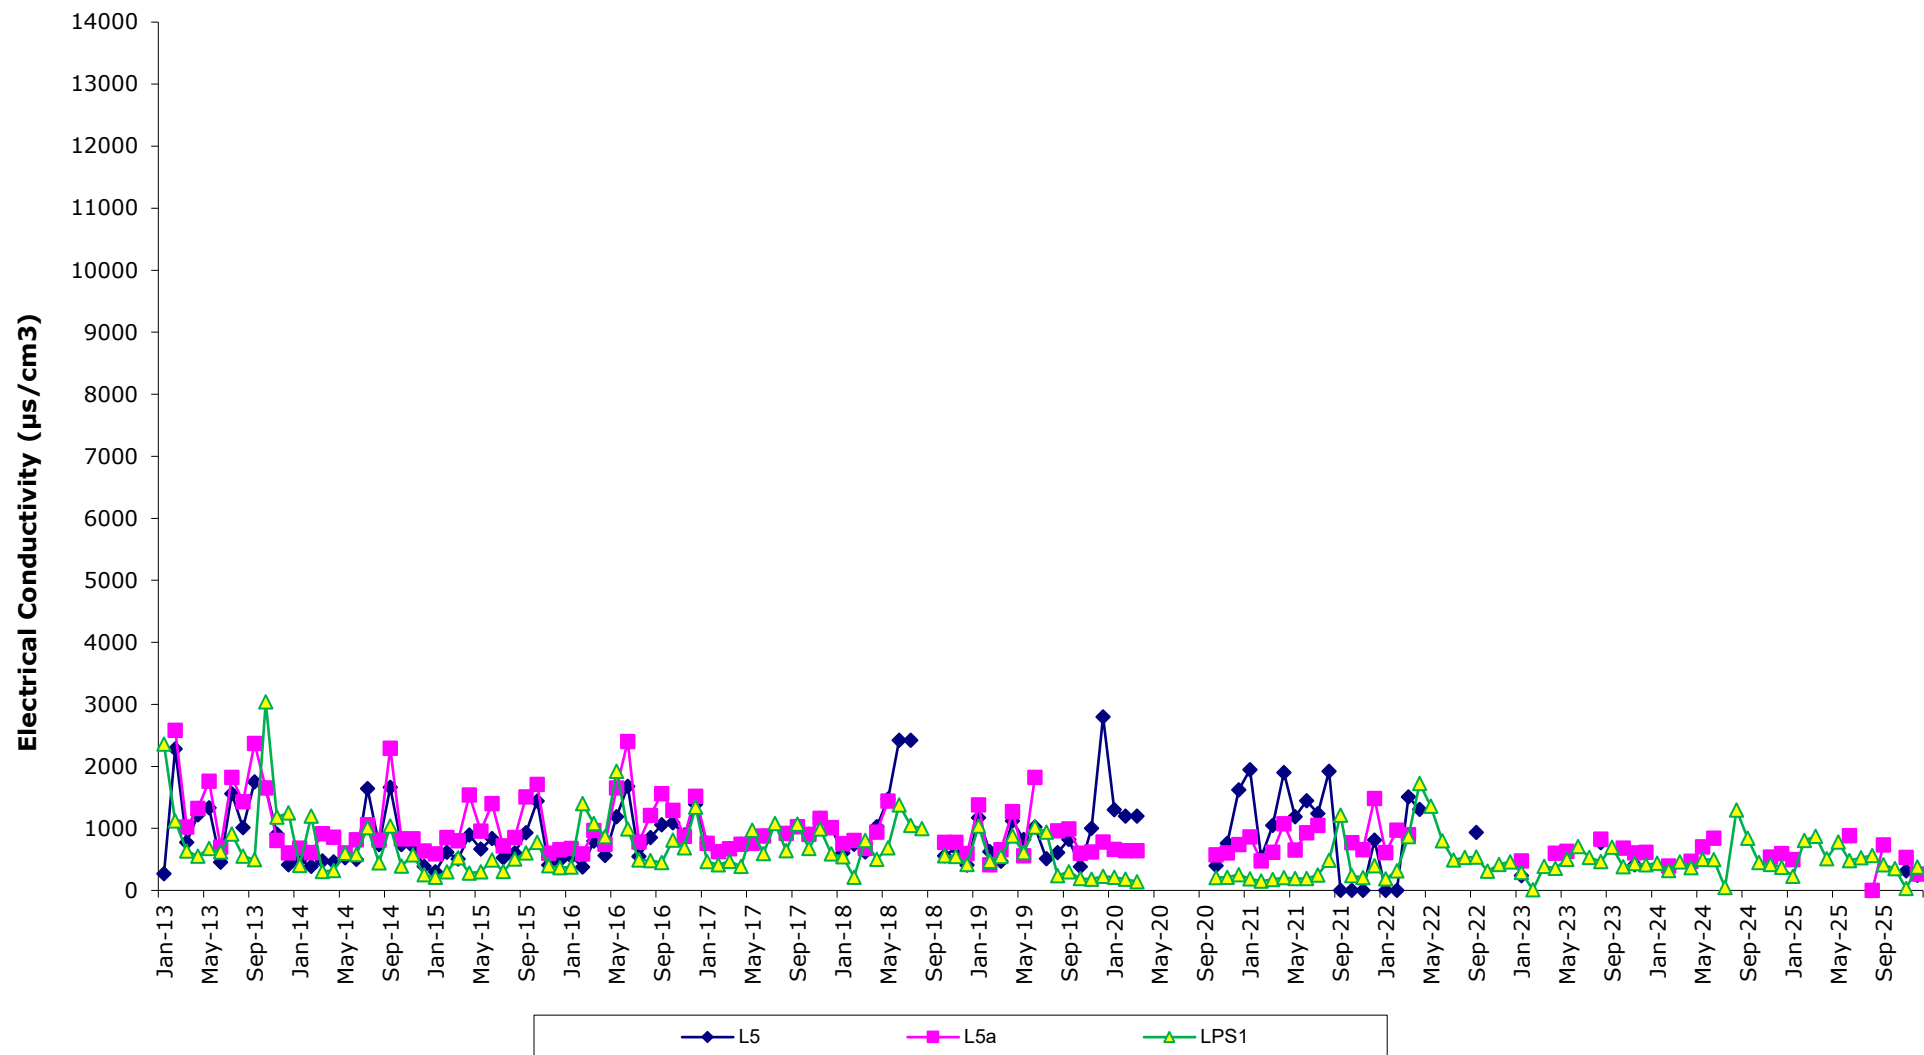
**Lab analysis of Electrical Conductivity levels in leachate sampled by Amgen Rhondda Ltd at the Nant-Y-Gwyddon Landfill Site during the period Jan 2013 - Dec 2025.**
