**REVIEW OF ENVIRONMENTAL MONITORING  
RESULTS AT THE  
NANT-Y-GWYDDON LANDFILL SITE DURING THE  
PERIOD JAN 25 – DEC 25**

**Amgen Rhondda Ltd.  
Bryn Pica Landfill Site  
Llwydcoed  
Aberdare  
CF44 0BX**

*Amgen Rhondda Ltd. has carried out a review of the results of environmental monitoring activities undertaken at the Nant-y-Gwyddon landfill site, during 2025.*

## **REVIEW OF ENVIRONMENTAL MONITORING AT THE NANT-Y-GWYDDON LANDFILL SITE, GELLI, RHONDDA.**

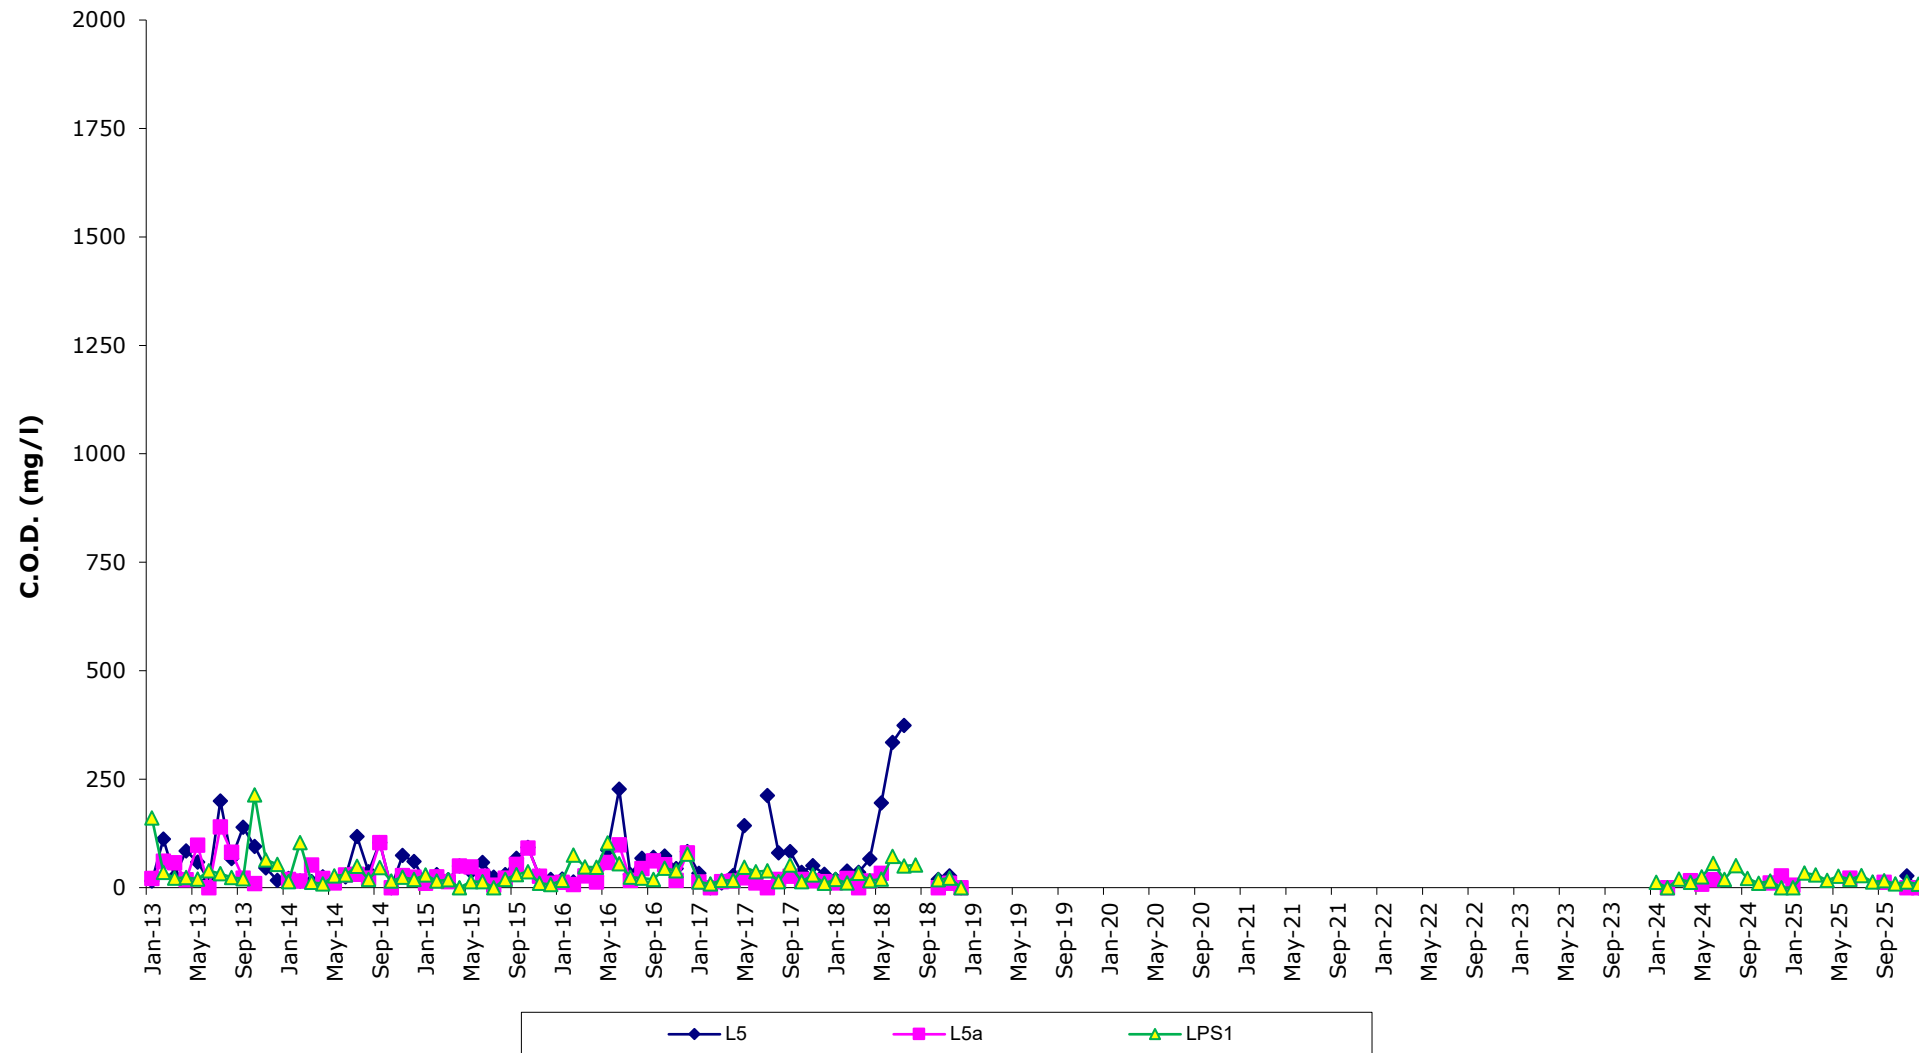
**Lab analysis of C.O.D. in leachate sampled by Amgen Rhondda Ltd at the Nant-Y-Gwyddon Landfill**  
**Site during the period Jan 2013 - Dec 2025.**

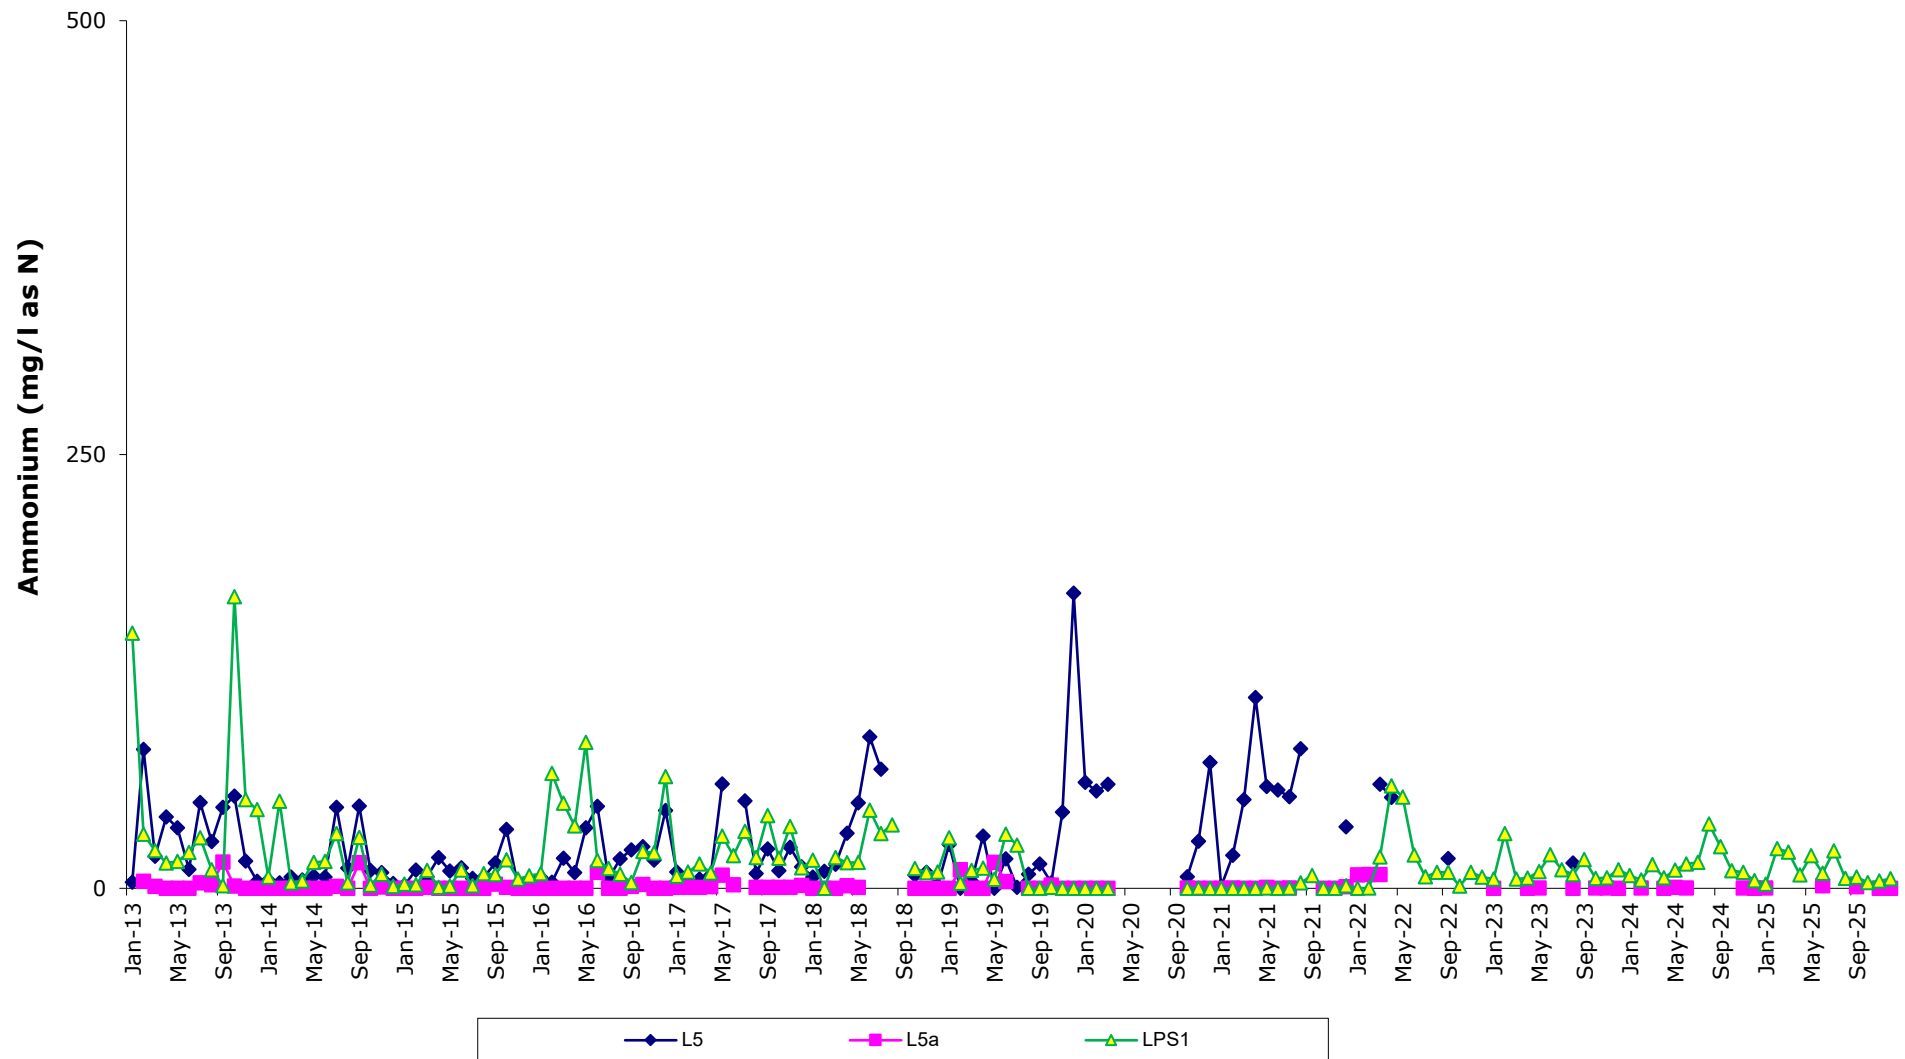
**Lab analysis of Ammonium (as N) in leachate sampled by Amgen Rhondda Ltd at the Nant-Y-Gwyddon Landfill Site during the period Jan 2013 - Dec 2025.**

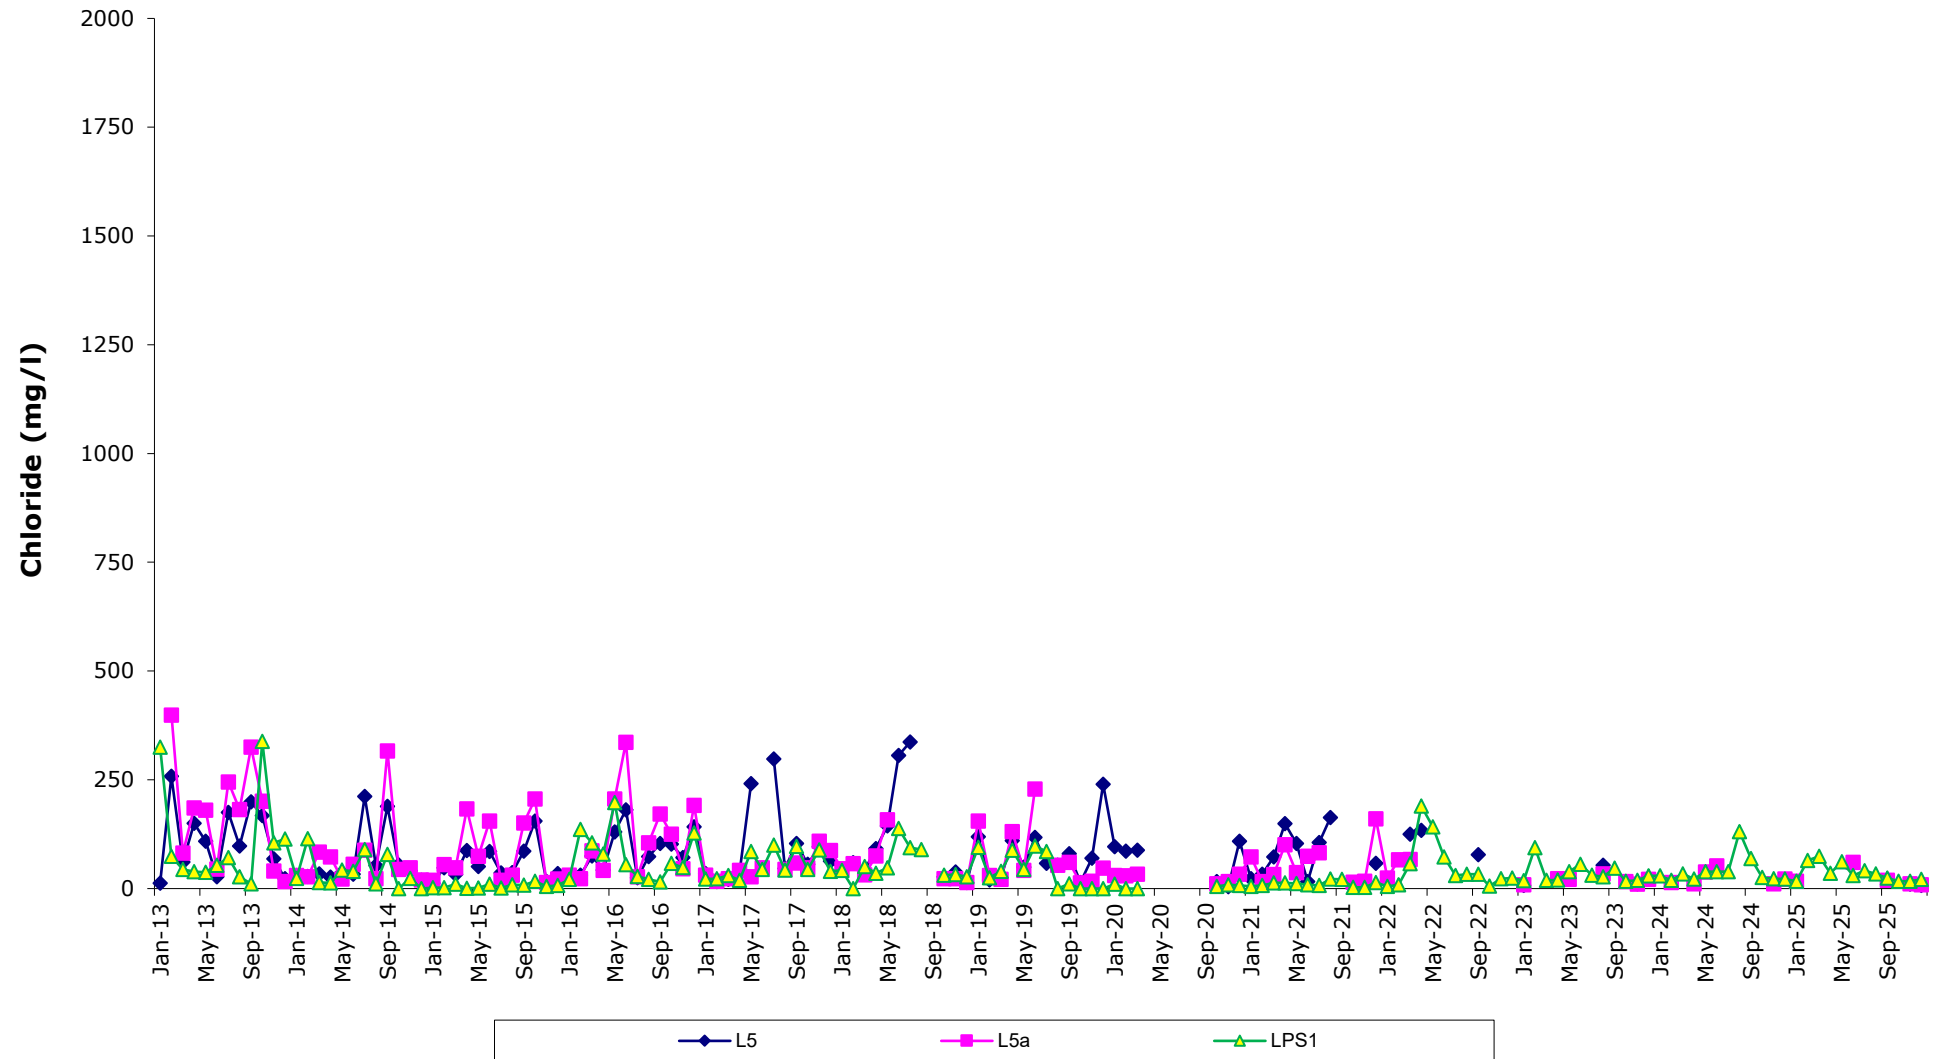
**Lab analysis of Chloride in leachate sampled by Amgen Rhondda Ltd at the Nant-Y-Gwyddon Landfill Site during the period Jan 2013 - Dec 2025.**

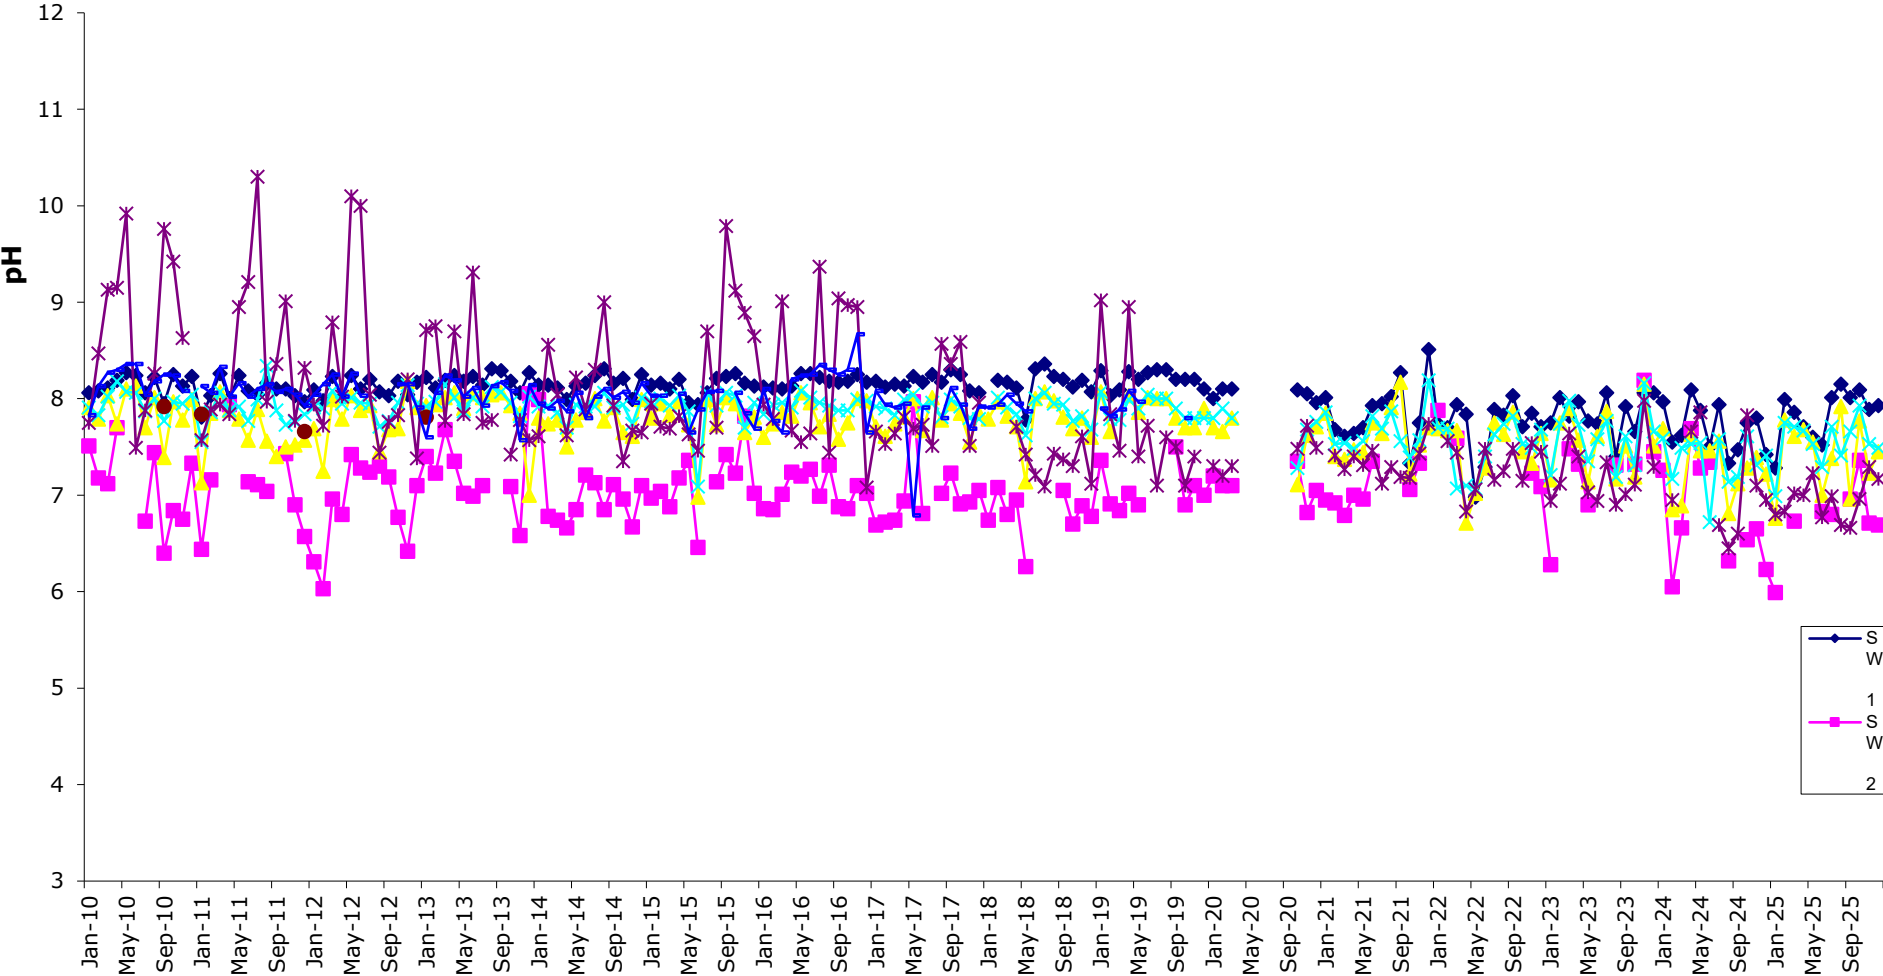
**Lab analysis of pH values in surface water sampled by Amgen Rhondda Ltd at the Nant-Y-Gwyddon  
Landfill Site during the period Jan 2010 - Dec 2025.**

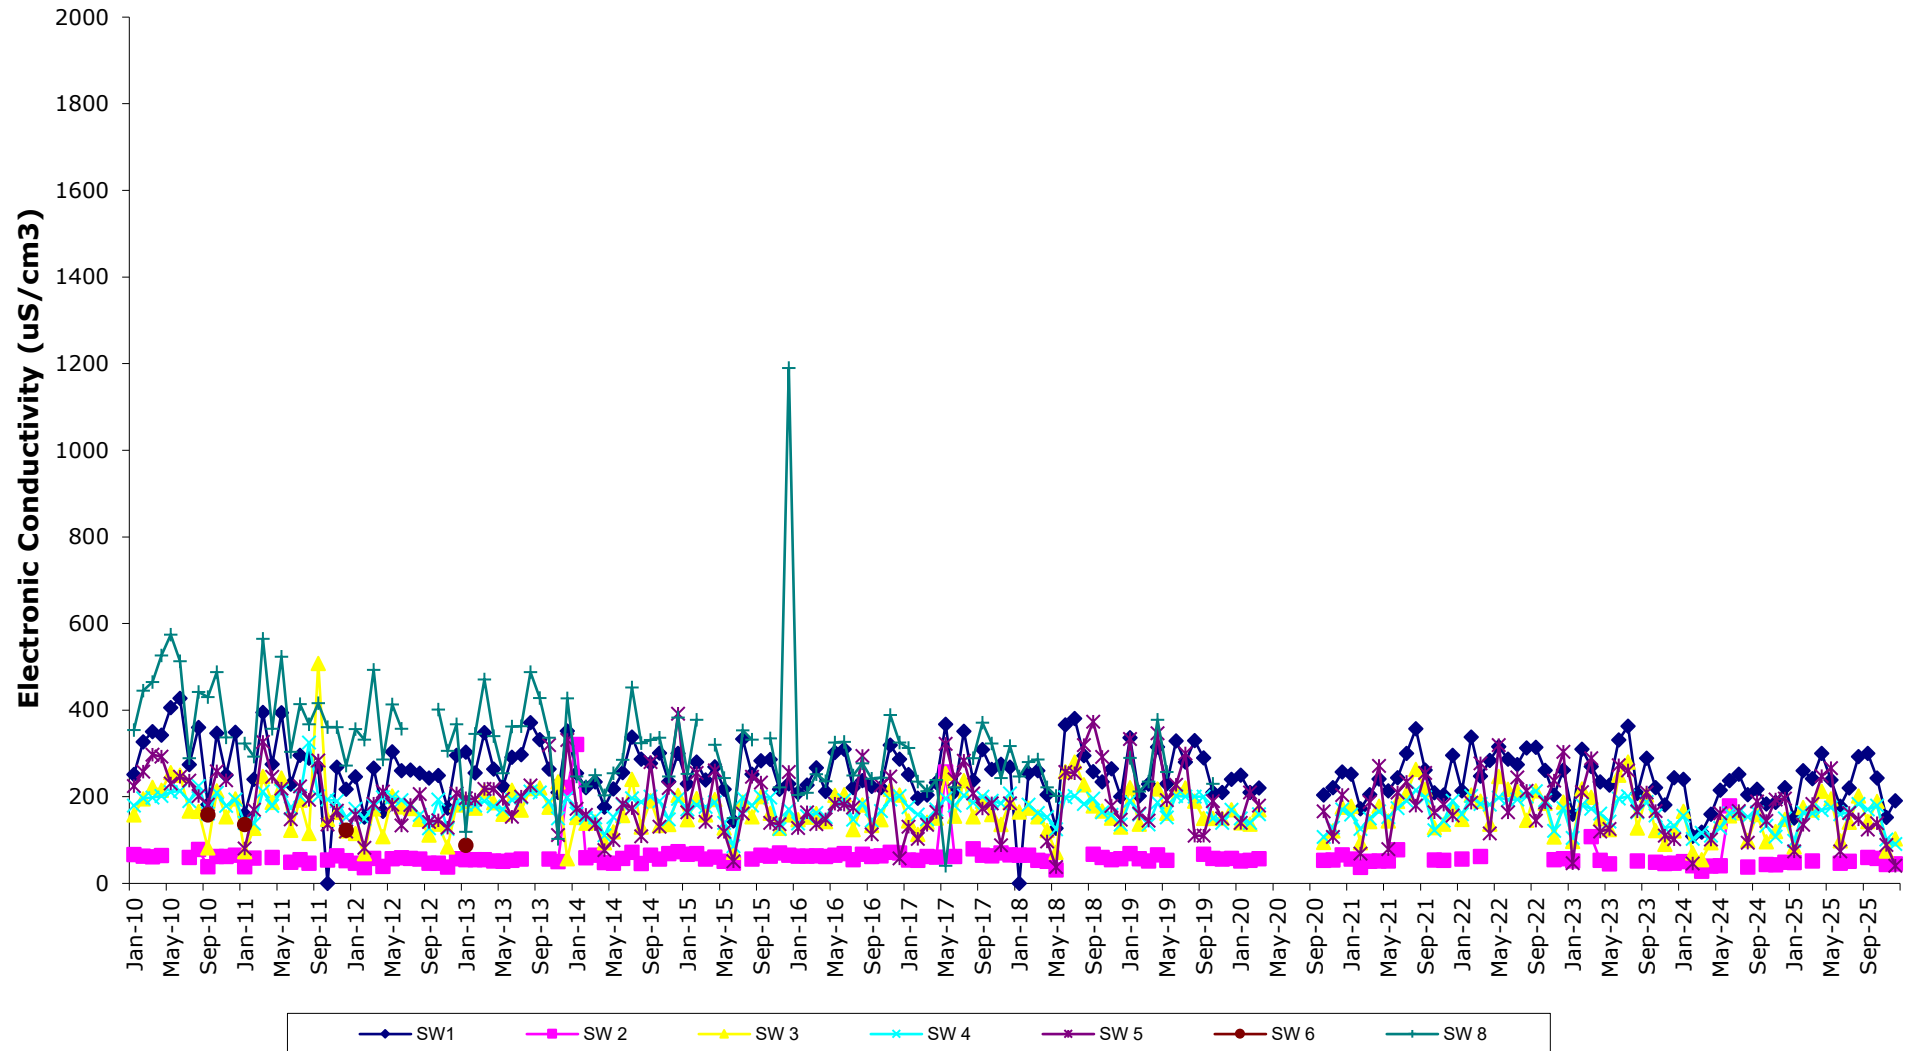
**Lab analysis of Electronic Conductivity levels in surface water sampled by Amgen Rhondda Ltd at the Nant-Y-Gwyddon Landfill Site during the period Jan 2010 - Dec 2025.**

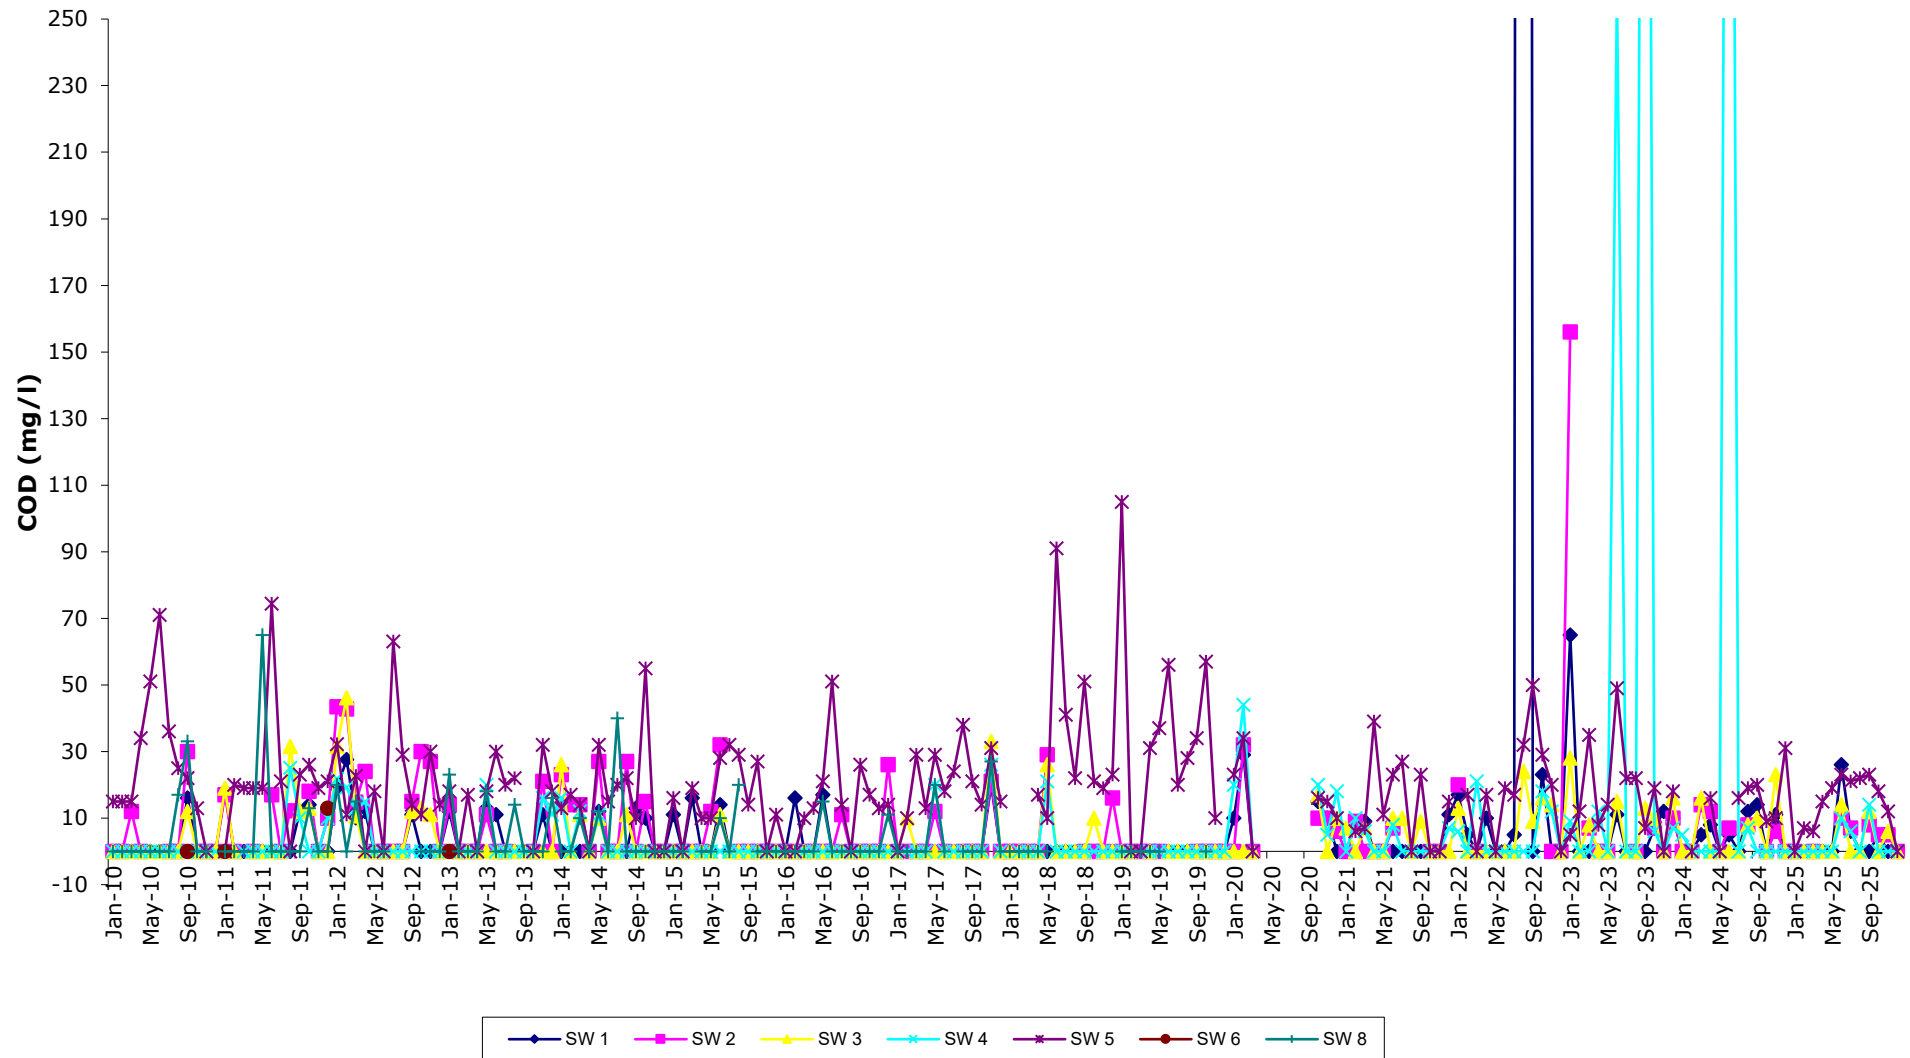
**Lab analysis of Chemical Oxygen Demand (COD) concentrations in surface water sampled by Amgen Rhondda Ltd at the Nant-Y-Gwyddon Landfill Site during the period Jan 2010 - Dec 2025.**

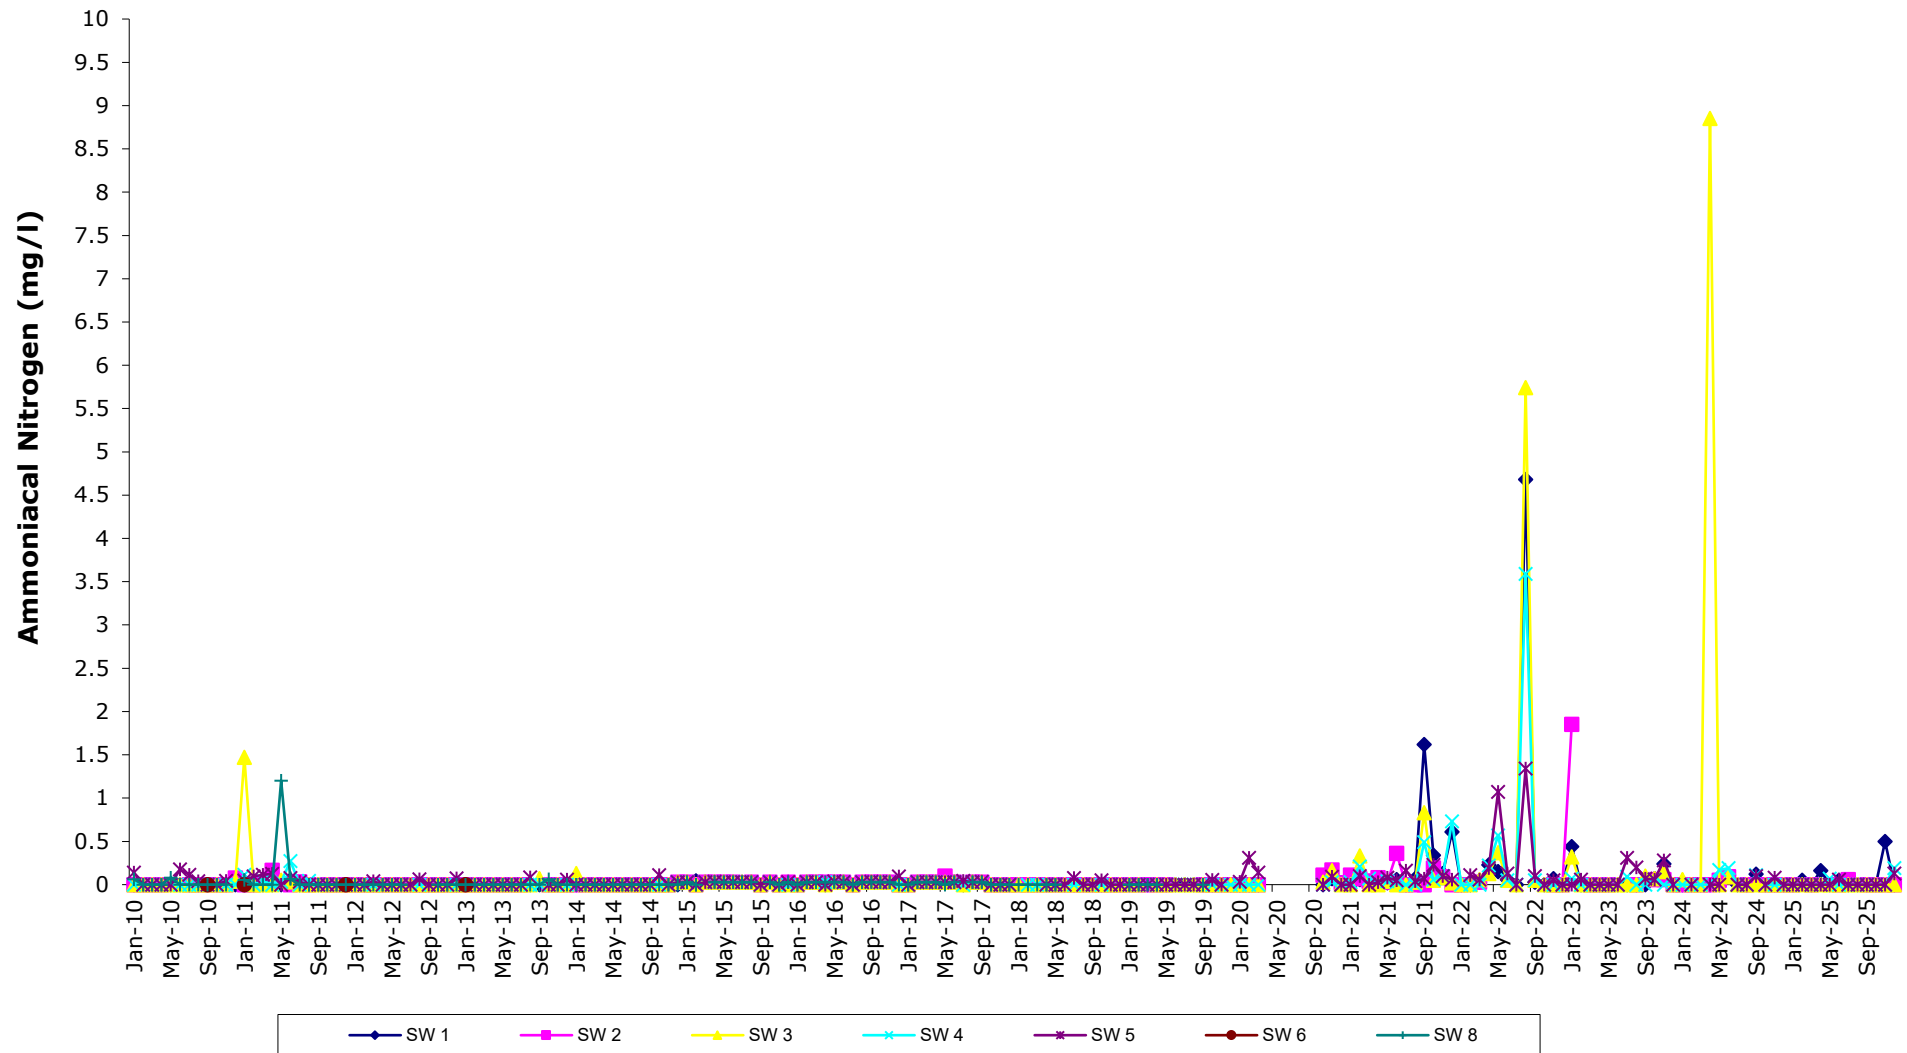
**Lab analysis of Ammoniacal Nitrogen levels in surface water sampled by Amgen Rhondda Ltd at the Nant-Y-Gwyddon Landfill Site during the period Jan 2010 - Dec 2025.**

Throughout 2025, it is noted that concentrations of ammoniacal nitrogen (ammonia  $\text{NH}_4$  as N) were very low, averaging less than 0.3 mg/l at each of the 6 surface water monitoring locations. Of the 56 water samples analysed for  $\text{NH}_4$  as N, a total of 8 (14%) returned a positive result above the minimum reporting value of 0.05 mg/l  $\text{NH}_4$  as N. The maximum value recorded during 2025 was 0.5 mg/l, recorded at SW 1 in Nov-25.

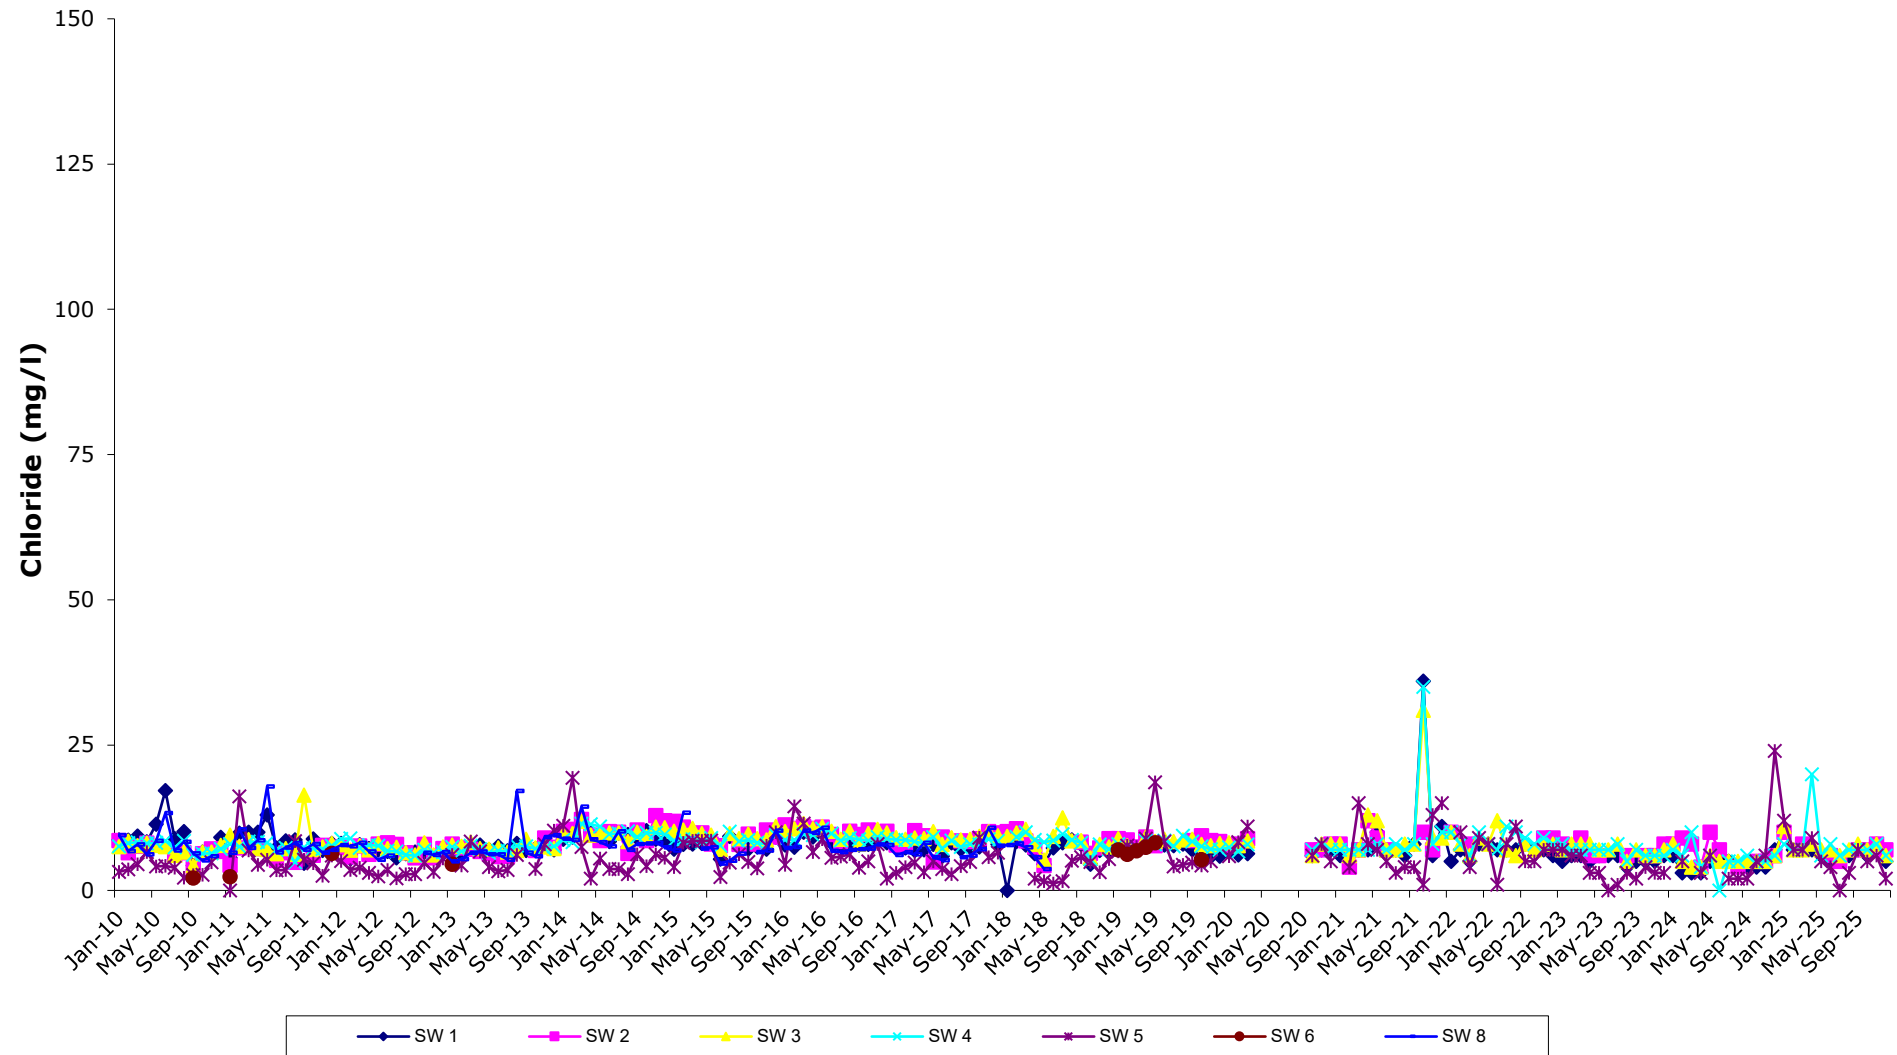
**Lab analysis of Chloride concentrations in surface water sampled by Amgen Rhondda Ltd at the Nant-Y-Gwyddon Landfill Site during the period Jan 2010 - Dec 2025.**

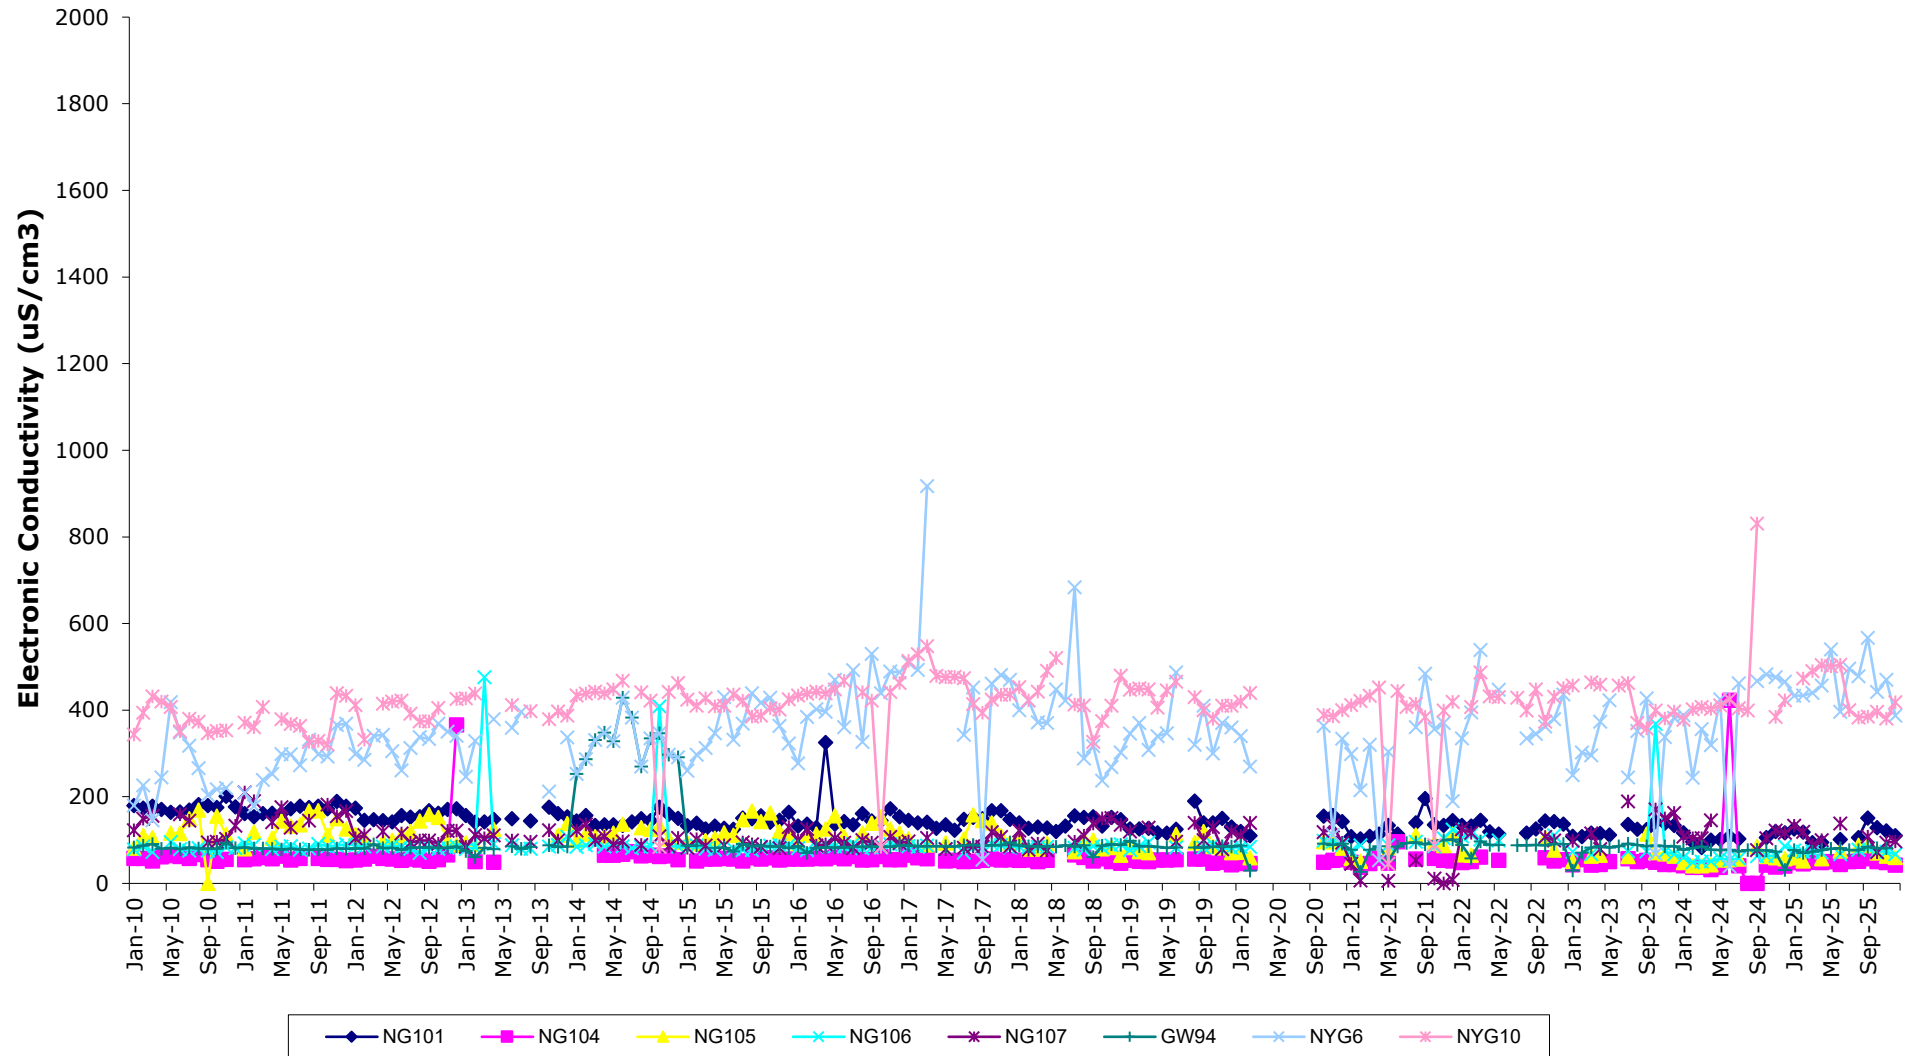
**Lab analysis of Electronic Conductivity levels in groundwater sampled by Amgen Rhondda Ltd at the Nant-Y-Gwyddon Landfill Site during the period Jan 2010 - Dec 2025.**

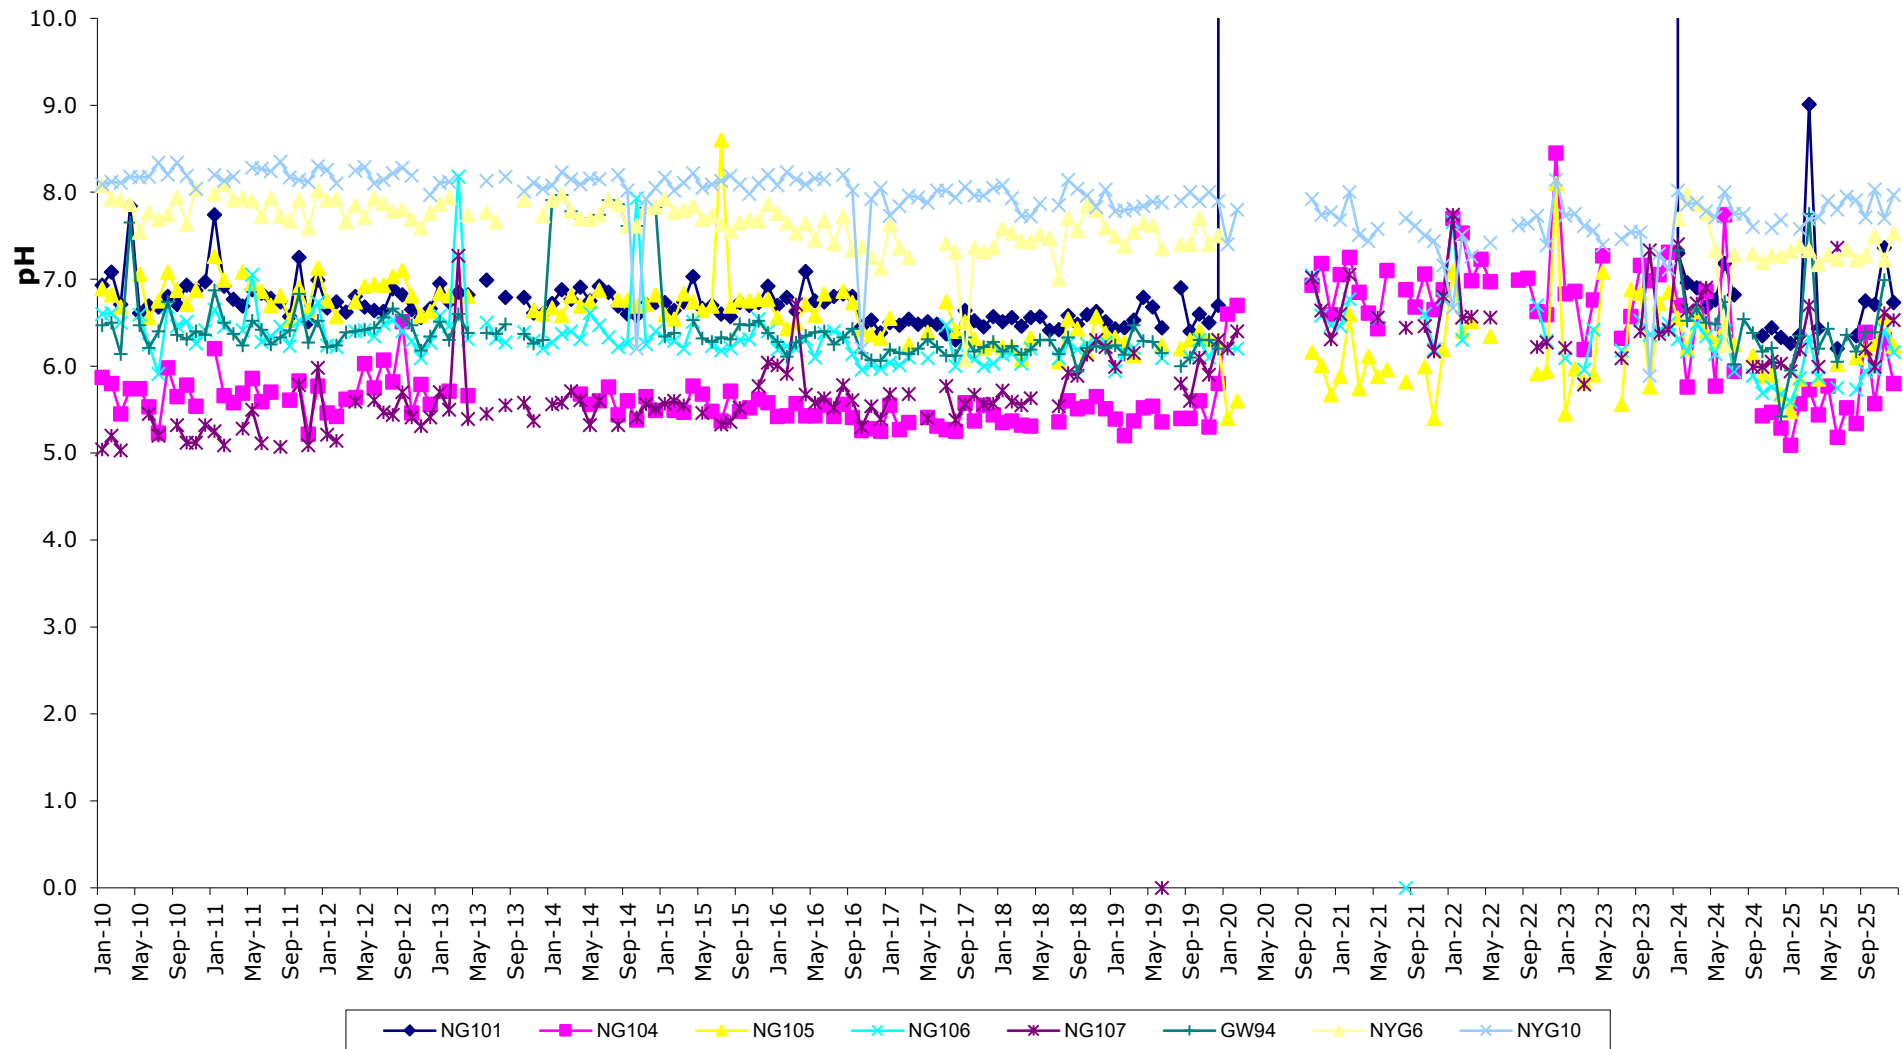
**Lab analysis of pH values in groundwater sampled by Amgen Rhondda Ltd at the Nant-Y-Gwyddon  
Landfill Site during the period Jan 2010 - Dec 2025.**

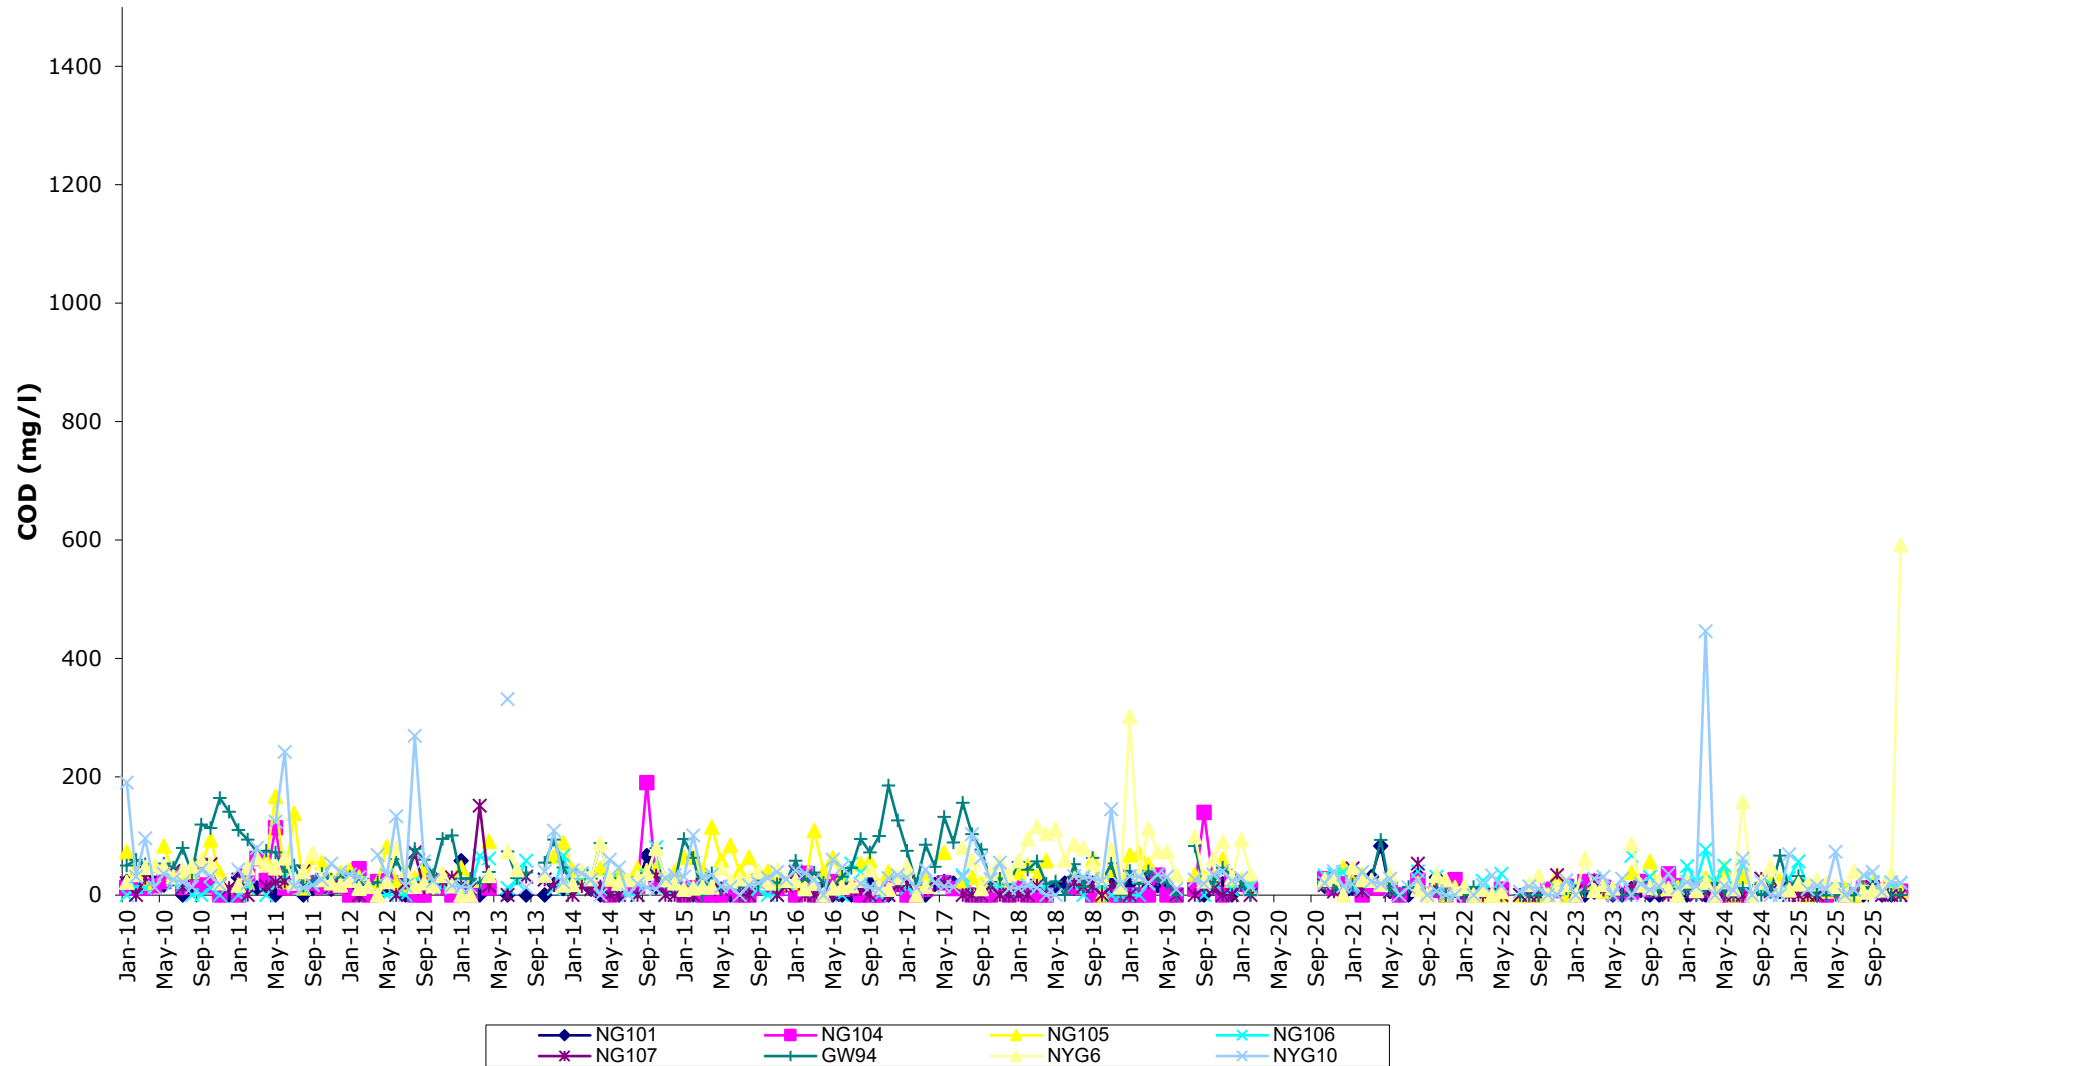
**Lab analysis of Chemical Oxygen Demand (COD) concentrations in groundwater sampled at the Nant-Y-Gwyddon Landfill Site during the period Jan 2010 - Dec 2025 (Scale 0-1500 mg/l).**
