**REVIEW OF ENVIRONMENTAL MONITORING  
RESULTS AT THE  
NANT-Y-GWYDDON LANDFILL SITE DURING THE  
PERIOD JAN 25 – DEC 25**

**Amgen Rhondda Ltd.  
Bryn Pica Landfill Site  
Llwydcoed  
Aberdare  
CF44 0BX**

*Amgen Rhondda Ltd. has carried out a review of the results of environmental monitoring activities undertaken at the Nant-y-Gwyddon landfill site, during 2025.*

## **REVIEW OF ENVIRONMENTAL MONITORING AT THE NANT-Y-GWYDDON LANDFILL SITE, GELLI, RHONDDA.**

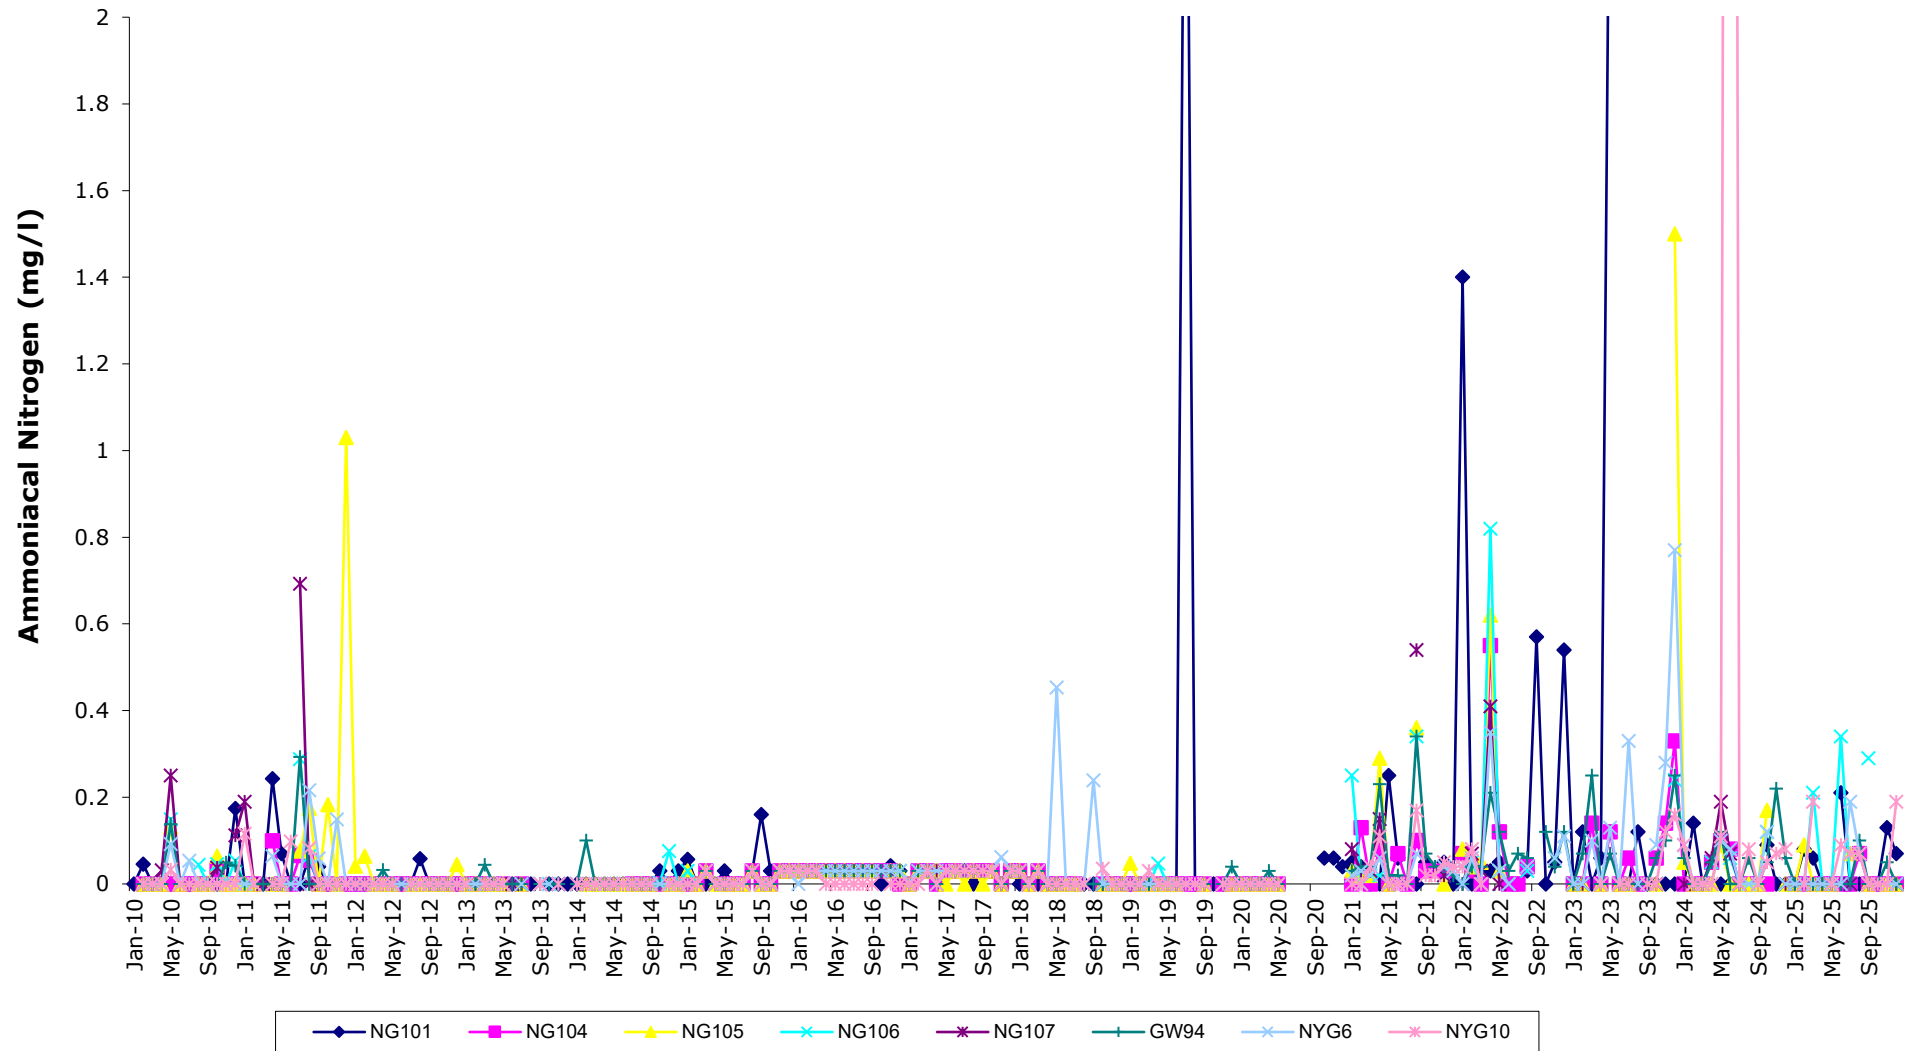
**Lab analysis of Ammoniacal Nitrogen levels in groundwater sampled by Amgen Rhondda Ltd at the Nant-Y-Gwyddon Landfill Site during the period Jan 2010 - Dec 2025.**

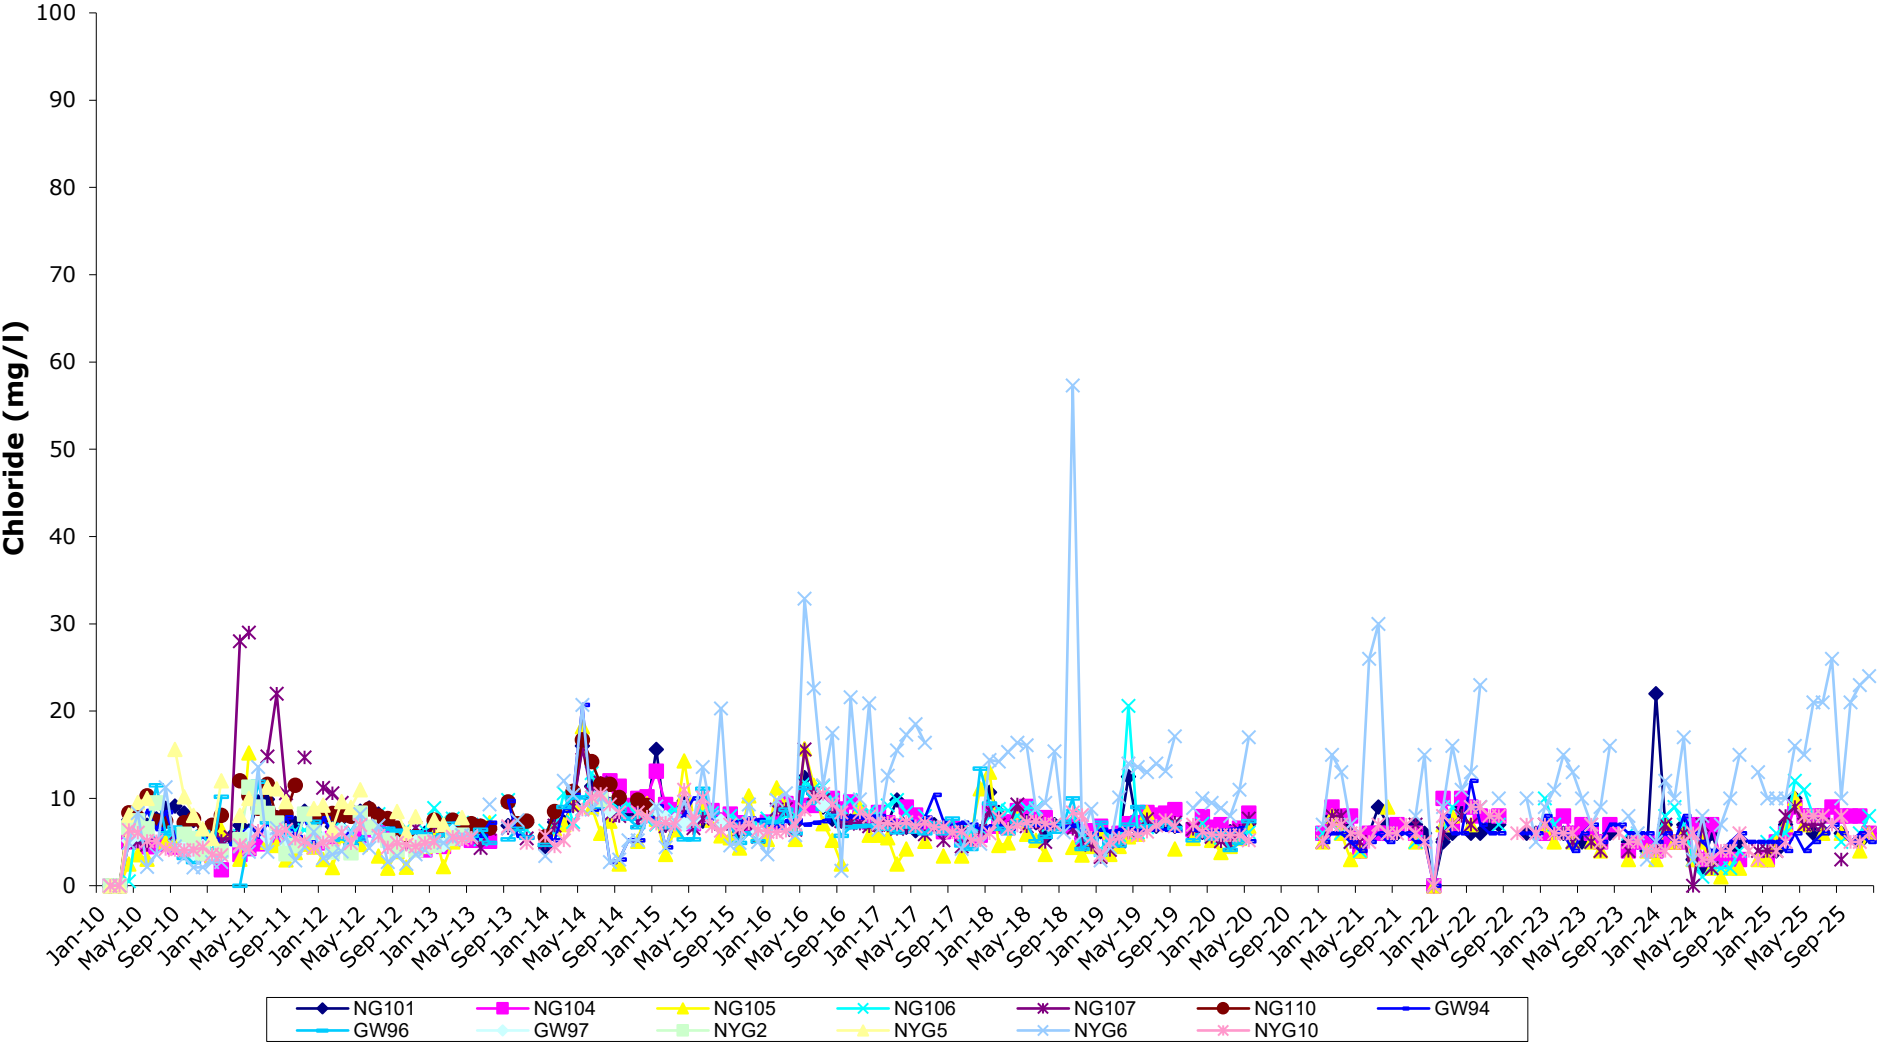
**Lab analysis of Chloride concentrations in groundwater sampled by Amgen Rhondda Ltd at the Nant-Y-Gwyddon Landfill Site during the period Jan 2010 - Dec 2025.**
