**REVIEW OF ENVIRONMENTAL MONITORING  
RESULTS AT THE  
NANT-Y-GWYDDON LANDFILL SITE DURING THE  
PERIOD JAN 24 – DEC 24**

**Amgen Rhondda Ltd.  
Bryn Pica Landfill Site  
Llwydcoed  
Aberdare  
CF44 0BX**

## **REVIEW OF ENVIRONMENTAL MONITORING AT THE NANT-Y-GWYDDON LANDFILL SITE, GELLI, RHONDDA.**

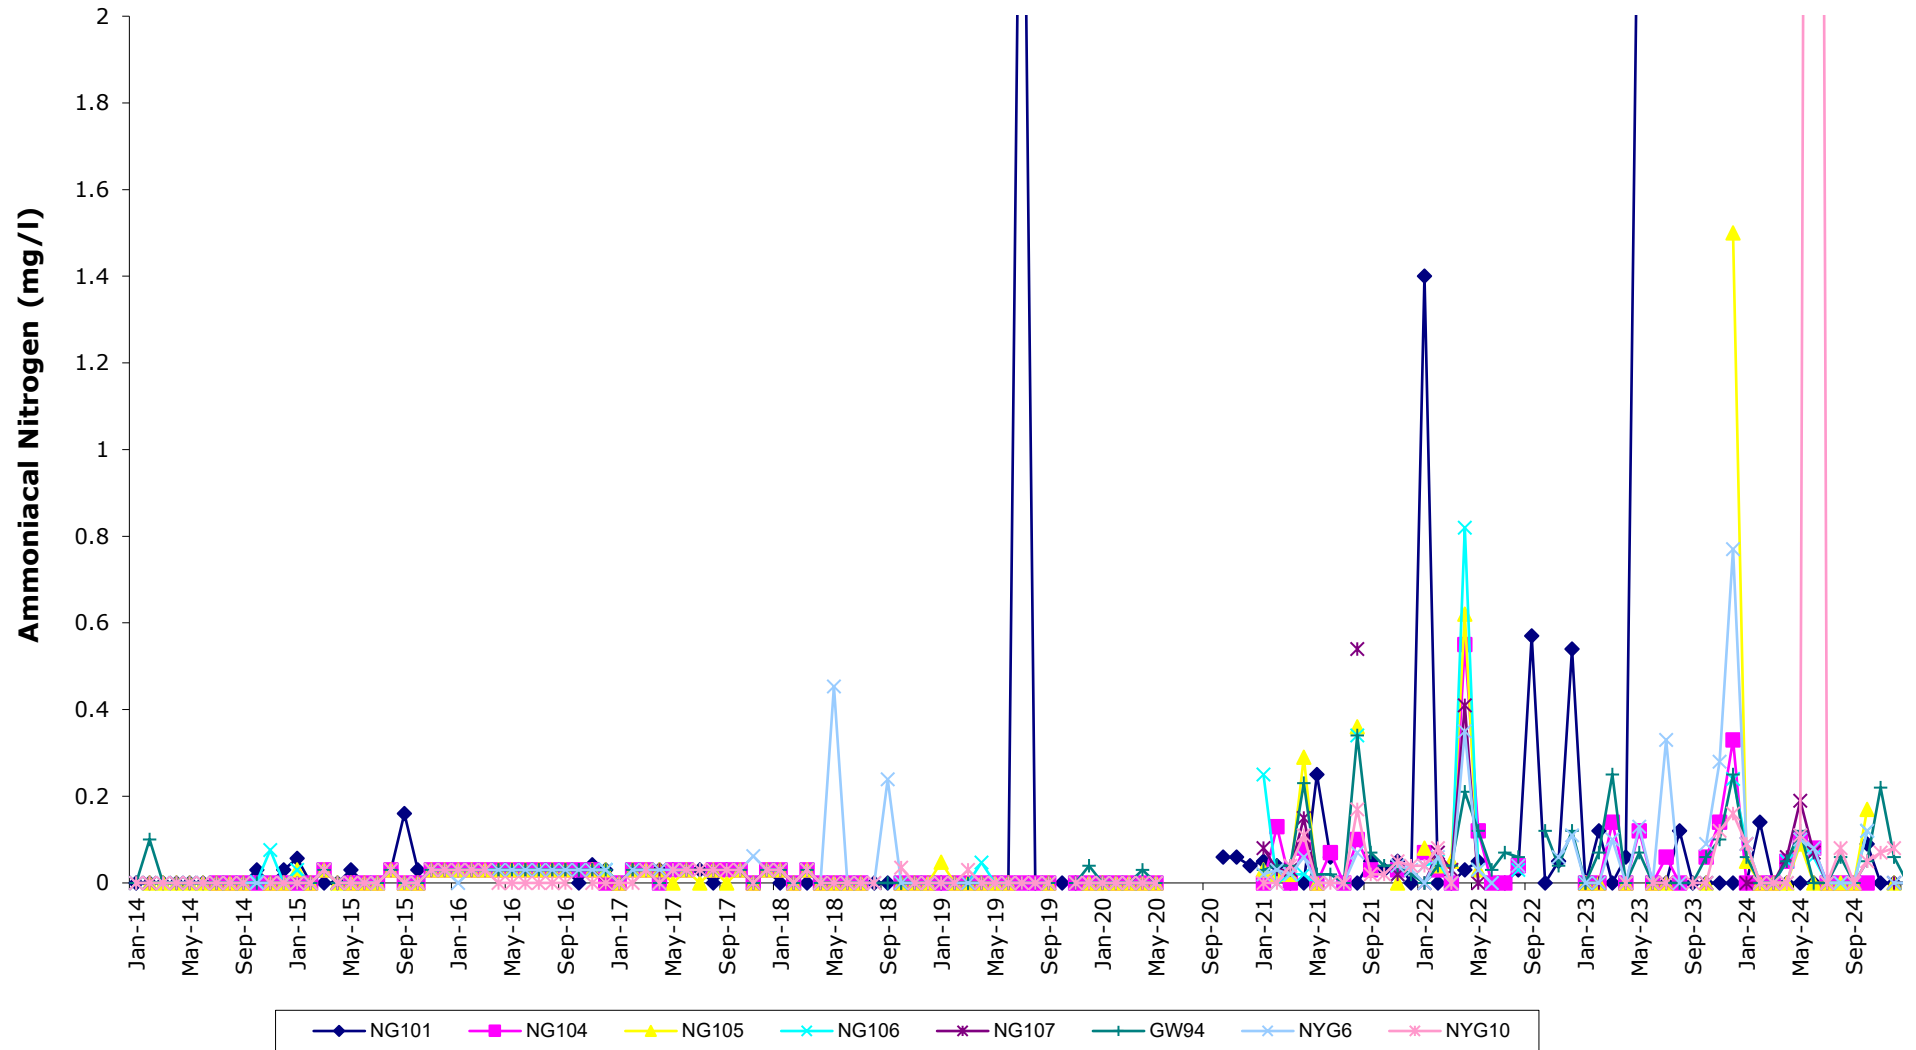
**Lab analysis of Ammoniacal Nitrogen levels in groundwater sampled by Amgen Rhondda Ltd at the Nant-Y-Gwyddon Landfill Site during the period Jan 2014 - Dec 2024.**
