## Compliance Assessment Report CAR\_NRW0052828

**Licence being assessed:** WA/064/0006/0032.

**For:** Blaen Tafolog, **held by:** Richard Anthony Roose & Ann Dominique Carpenter.

**Type of assessment:** Site Inspection,

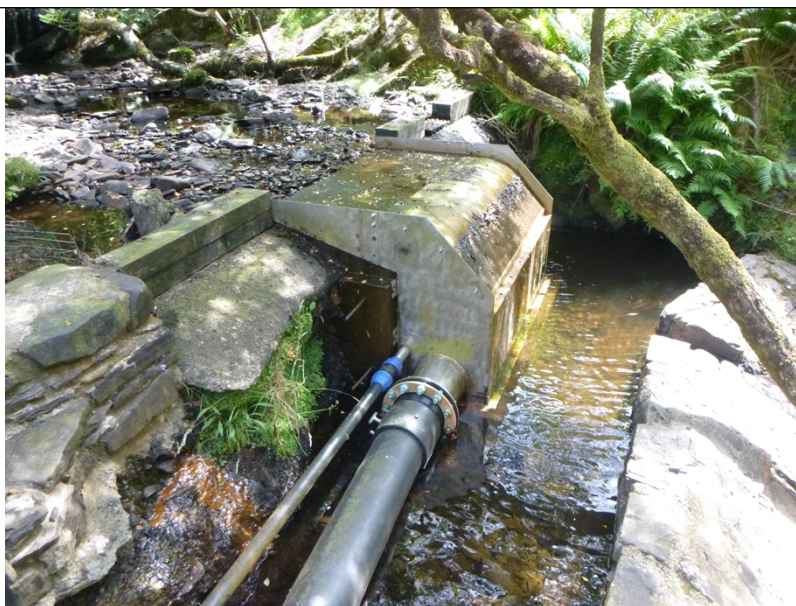
*Photograph 1: Abstraction point*

Water is abstracted from an unnamed tributary to the Afon Tafolog at Blaen Tafolog, Mallwyd, Machynlleth at National Grid Reference SH 89529 09326. The abstraction point is shown in photograph 1 below.

No issues were identified.

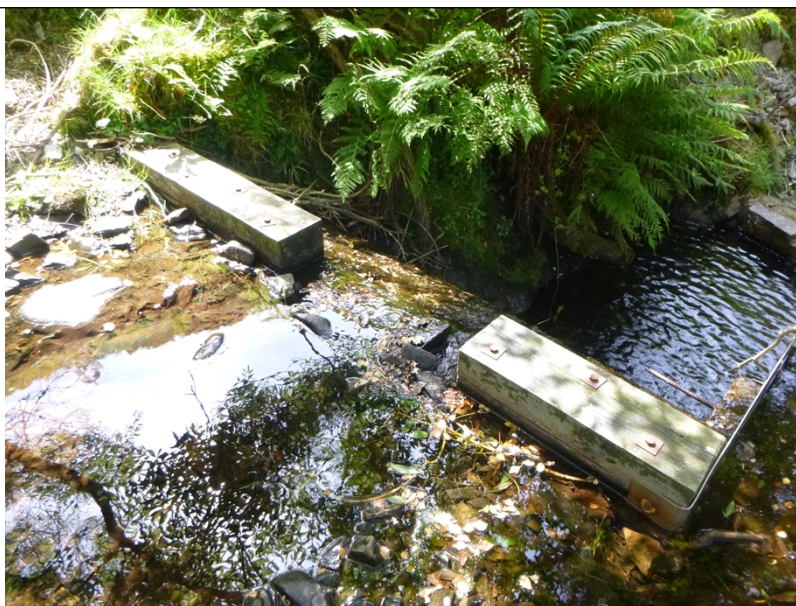
*Photograph 2: Stones blocking HoF notch*

On the day of the inspection, stones within the Hands off Flow (HoF) notch restricted flows downstream, causing a small amount of water to be directed over the Coanda screen, allowing abstraction to take place. The stones are shown in photograph 2 below.

The blockage of the HoF notch on the 03 August 2026 represents a breach of condition 9.5(i). The breach has been scored as a category 3 non-compliance above. A category 3 non-compliance represents a non-compliance that has the potential to have a minor or minimal impact or effect on the environment, people and or property. Whilst the Licence Holder has already rectified the breach, NRW ask that they continue to clear stones from the HoF notch and residual flow notch as and when necessary to avoid a recurrence of this breach.

| Criteria | Action needed | Complete by |
|---|---|---|
| WR-C1 | Clear stones from Hands off Flow (HoF) notch. | Already completed |

The Licence Holder cleared the stones whilst the NRW officers were on site. This stopped further abstraction over the Coanda screen. Photograph 3 below shows the HoF notch after the stones had been cleared.

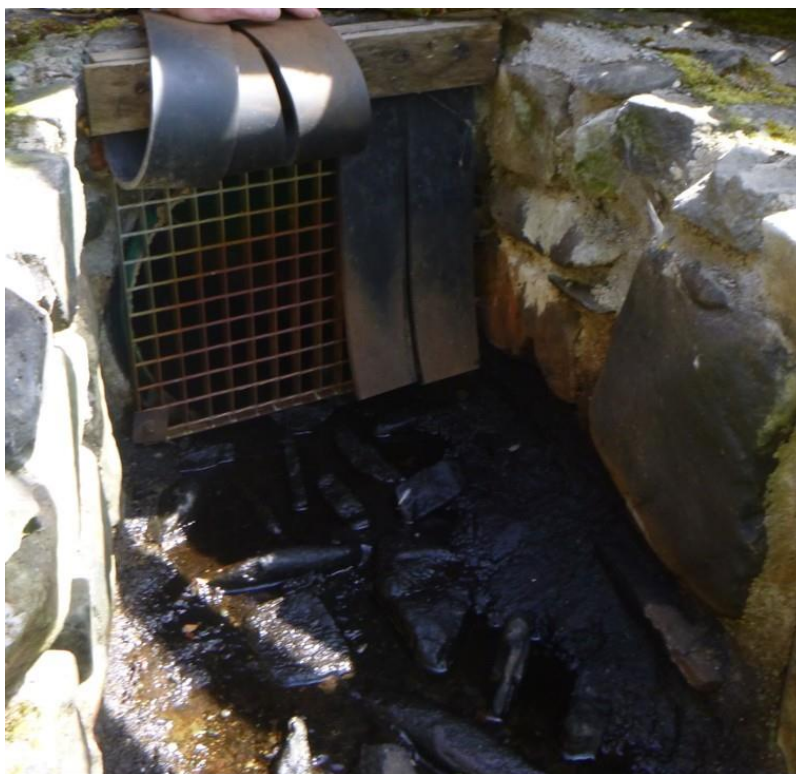
*Photograph 4: Discharge outlet pipe*

All abstracted water is returned to the unnamed tributary to the Afon Tafolog at National Grid Reference SH 89360 09405. The discharge outlet pipe is shown in photograph 4 below.

Condition 9.7(i) of the licence states that *"no abstraction shall take place unless the Licence Holder has installed a Vertical flat bar screen with spacing no greater than 20 millimetres to the discharge outlet pipe to prevent the entrapment, entrainment or impingement of fish"*. As can be seen in photograph 4 above, a screen has been installed on the discharge outlet pipe, however measurements taken during the inspection indicated that the spacings were 30mm rather than 20mm. This represents a breach of condition 9.7(i) and has been scored as a category 3 non-compliance above. To rectify the non-compliance, the Licence Holder is asked to install a vertical flat bar screen with spacing no greater than 20mm to the discharge outlet pipe and to provide NRW with photographic evidence that this has been completed by the **19 October 2026**.

The Licence Holder confirmed that no power was being generated at the time of the inspection, however as can be seen in photograph 4 above, a small trickle of water was observed discharging at the discharge outlet pipe. This represents a breach of condition 9.3

| Criteria | Action needed | Complete by |
|---|---|---|
| WR-F2 | Install a vertical flat bar screen with spacing no greater than 20mm to the discharge outlet pipe and provide NRW with photographic evidence that this has been completed. | 19/10/2026 |
| WR-A8 | Ensure that no water flows through the turbine if power is unable to be generated. | 28/09/2026 |

and has been scored as a category 3 non-compliance above. To rectify the non-compliance, the Licence Holder is asked to ensure that no water flows through the turbine if power is unable to be generated. A deadline of the **28 September 2026** has been set for this.
