## Compliance Assessment Report

**Report ID:**  
**CAR\_NRW0035752**

Site	The Old Transport Yard		Permit Ref	XP3694FN		
Operator/Permit holder	Mr M R Jackson					
Regime	Waste Operations					
Date of assessment	16/09/2019	Time in	13:50	Out	14:30	
Assessment type	Site Inspection					
Parts of the permit assessed	Specified by permit; Containment of stored materials; Management system and operating procedures; Storage, handling, labelling and segregation					
Lead officer's name	White, Steven					
Accompanied by	Henderson, Amy					
Recipient's name/position	Mike & Steve Jackson/ Directors		Date issued	26/11/2019

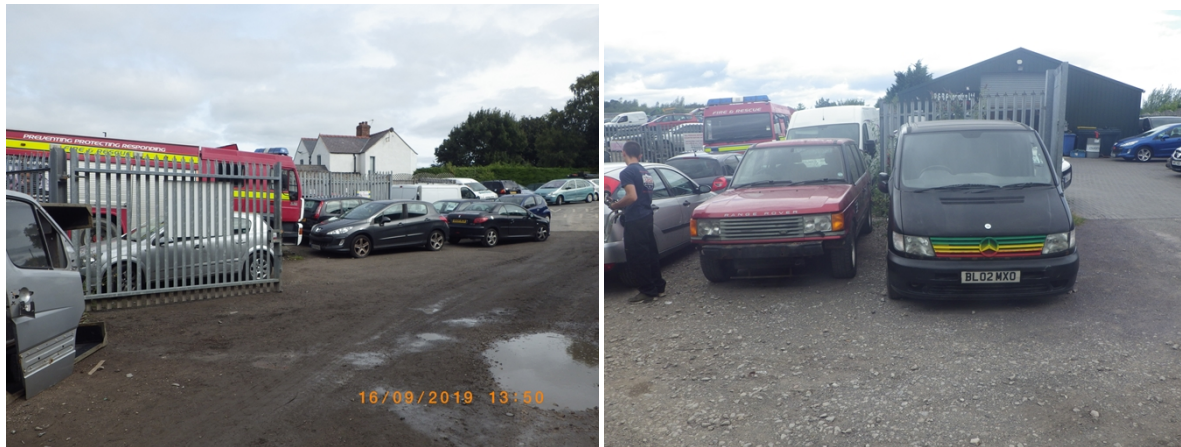
There were a number of vehicles parked outside the permitted boundary (see photo 1 below), you must ensure that all ELV are stored within the permitted boundary of the site; on inspection of these vehicles we were unable to prove that they were ELV for MR Jacksons or if they were customer/employee vehicles for this or other businesses in the area - this will be followed up in the next inspection. However, there is a Fire Engine that has been parked outside the site boundary for a number of months (see photo 2 below), previous discussions with site have ascertained that this is still used as a 'classic' vehicle and is not yet a ELV. You must ensure that all vehicles that are destined to be depolluted and are classed as 'waste' are stored within the permitted boundary as per condition 2.2.1 of the site permit. For clarification the legal definition of waste that Natural Resources Wales adheres to is *'A material is considered to be waste when the producer or holder discards it, intends to discard it, or is required to discard it'*

Photo 1: Vehicles stored outside permitted boundary(16/09/19). Photo 2: Fire engine visible on 31/07/18

There were a number of vehicles stored outside the permitted boundary adjacent to the entrance gate, waste vehicles can only be stored within the permitted boundary of the site. As we were unable to prove that they were ELV for MR Jacksons or if they were customer/employee vehicles for this or other businesses in the area. This has subsequently been logged as an 'action' to ensure that all waste ELV are stored within the permitted boundary and will not show up as a score against the permit.

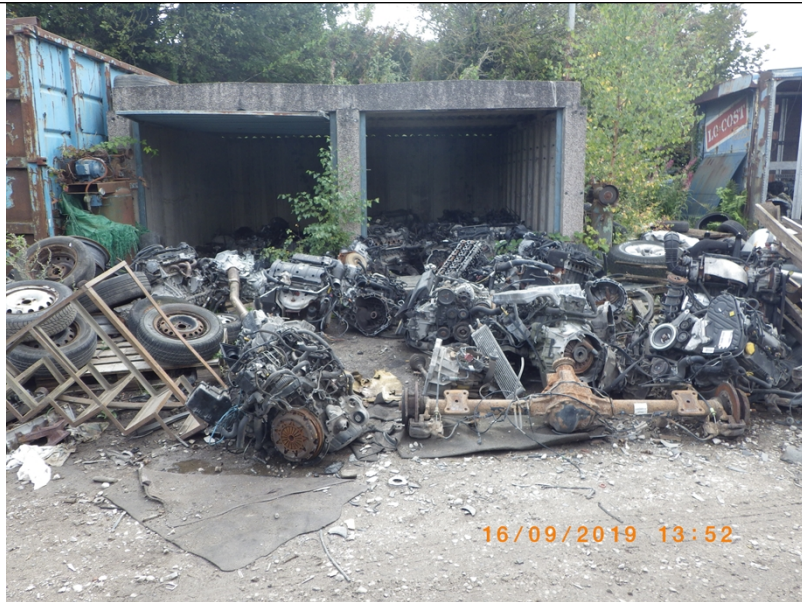
As officers entered the yard we observed approx. 10 vehicles stored in an area adjacent to the entrance gates, these vehicles were stored here prior to being depolluted. This area drains to the site interceptor, there is a concrete slab in this area which is where engines are stored post-depollution to drain the residual oils into the interceptor. Following depollution there are usually some residual fluids left in the engine; engines and oily parts are required to be stored on the concrete slab that drains to the interceptor. Further into the yard a large number (approx. 15) engines were observed stored outside on hardstanding (see photo below) with no weatherproof covering or separate, sealed storage area. This goes against the relevant part of the ELV Directive (The treatment of a waste motor vehicle shall only be carried out at a site... provided with storage facilities that are appropriate for dismantled spare parts, including impermeable storage facilities for spare parts that are contaminated with oil) and is a breach of Working Plan condition 4.2 which states that engines are to be stored on a concrete slab in the designated area that shall drain to an oil interceptor. Engines stored on hardstanding in this area cannot drain to the interceptor; this contributes as a permit breach and is discussed with other permit breaches below.

Engines stored outside on hardstanding with no weatherproof

Action: ELVs must be fully depolluted before being stored on permeable ground in the yard. Batteries and all fluids must be

removed and stored separately in suitable containers and oily parts must be stored in suitable weatherproof containers. All un-depolluted (hazardous) ELVs must be removed and fully depolluted prior to returning to the yard. Deadline for this action is Friday 8th November 2019.

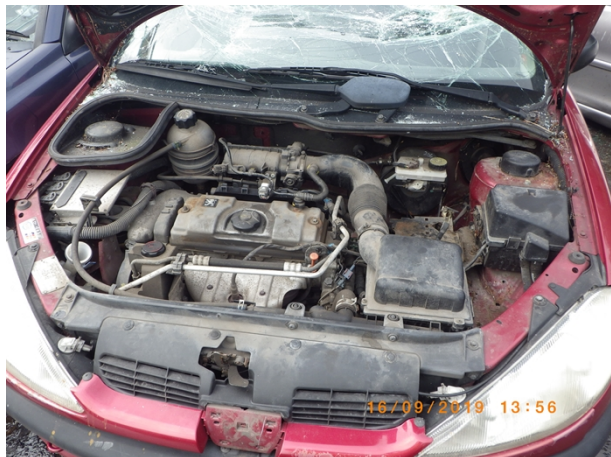
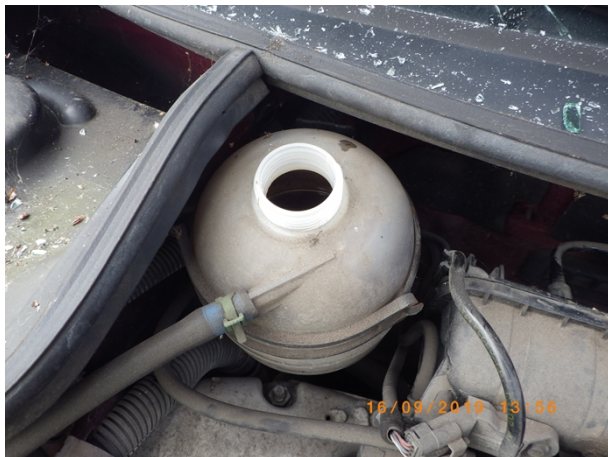
We inspected the vehicle crushing area where ELV are crushed prior to being removed from site, ELV in this area should be completely depolluted prior to crushing. On inspection there were at least three vehicles in this area that still had fluids in them (see photos below)

Red Peugeot with fluids observed in crushing area

Action: ELVs must be fully depolluted before being stored on permeable ground in the yard. Batteries and all fluids must be removed and stored separately in suitable containers and oily parts must be stored in suitable weatherproof containers. All un-depolluted (hazardous) ELVs must be removed and fully depolluted prior to returning to the yard. Deadline for this action is Friday 8th November 2019..

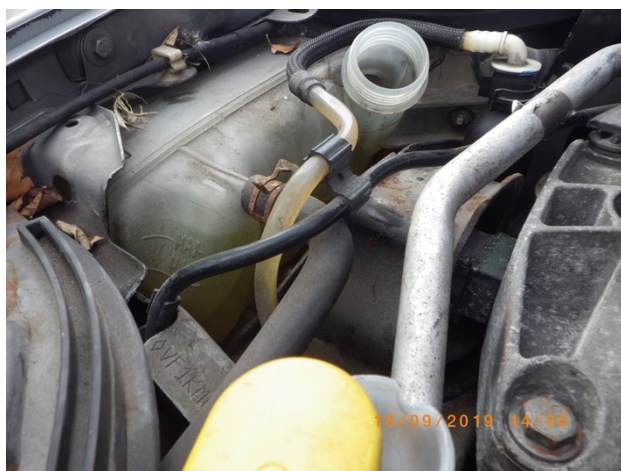
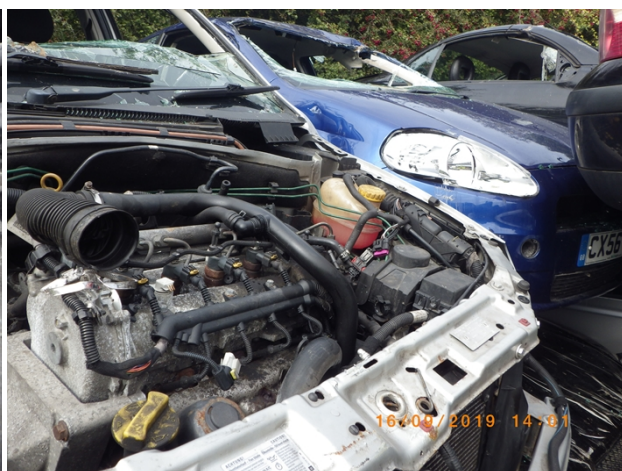
Fluids observed in vehicles in crushing area

During the inspection we checked approximately 20 vehicles to see if they were fully depolluted prior to being stored in the main yard, an estimated 3/4 of these (~15) were found to have various fluids, un-depolluted engines and batteries still in them. Permit condition 2.4.1 states that the 'storage and treatment of waste motor vehicles shall meet the requirements of article 6(1) of the End-of-life Vehicles Directive' as detailed below:

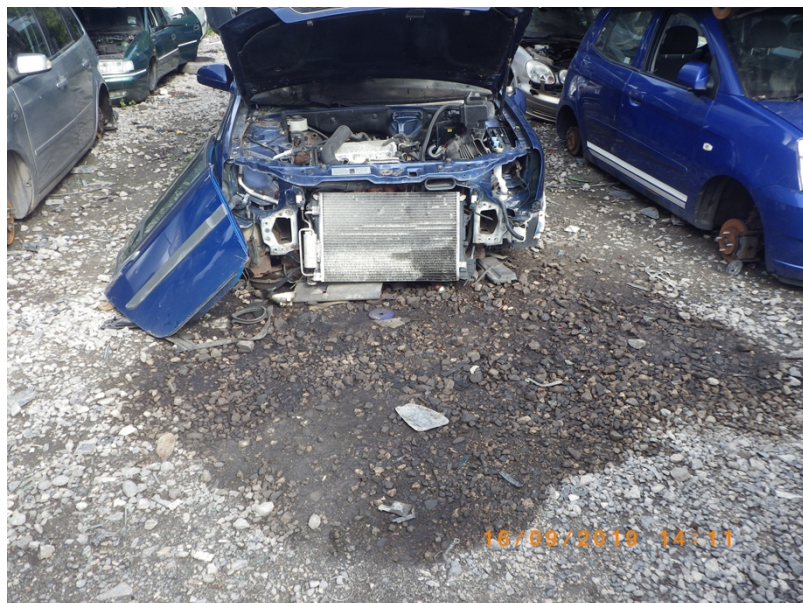
Not fully depolluting the vehicles prior to storage on the hardstanding can have a significant impact on the ground, this is shown in the photo below where a large patch of oil is visible below a not-fully depolluted vehicle.

Large oil spill below ELV on hardstanding

Action: ELVs must be fully depolluted before being stored on permeable ground in the yard. Batteries and all fluids must be removed and stored separately in suitable containers and oily parts must be stored in suitable weatherproof containers. All un-depolluted (hazardous) ELVs must be removed and fully depolluted prior to returning to the yard. Deadline for this action is Friday 8th November 2019.
