## Compliance Assessment Report

Report ID:  
CAR\_NRW0035854

Site	Bryn Posteg Landfill	Permit Ref	BU77661C			
Operator/Permit holder	Sundorne Products (Ilanidloes) Ltd					
Regime	Installations					
Date of assessment	25/09/2019	Time in	10:25	Out	15:00	
Assessment type	Audit					
Parts of the permit assessed	All mentioned below					
Lead officer's name	Ellis, Rhys					
Accompanied by						
Recipient's name/position	David Williams / Tony Webber/ Technical manager/ Site manager	Date issued	24/10/2019

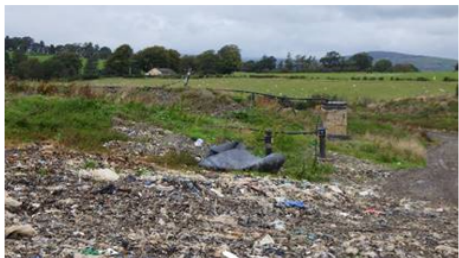
Photograph 1

- It was observed that many gas collection lines contained a large amount of condensate, particularly in areas of slumping which will inhibit gas extraction (slugging noises was heard on a number of gas lines). Examples of low points in pipework can be seen in photograph 1. Some of these contained condensate.

**ACTION 3** Site to ensure that low spots within the gas collection infrastructure are designed out and that appropriate methods of dewatering are installed across the site in all cases. Please provide NRW with timescales for these investigations no later than 1st November 2019.

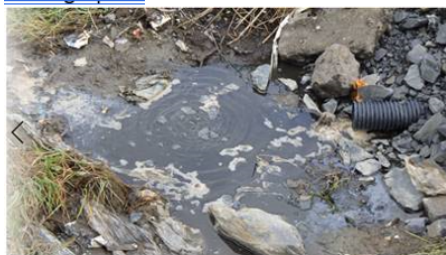
Photograph 7

- Gas bubbling was observed on certain surface areas of Cell 9D and around the site entrance to Cell 9D (particularly on the haul road). A reading of up to 25% methane was noted in the haul road on the GAZOMAT. See photos 7 and 8. This is a very high reading and should be addressed by reference to the efficiency of the landfill gas extraction system in this area.

**ACTION 2** It was discussed that the operator should review gas well coverage and zone of influence particularly in the northern part of Cell 9D and update NRW of the outcome of these investigations. This should follow a gas well survey of all wells in this area for perching with leachate. The well spacing should be presented as no area greater than 40m centres (20m overlapping radius). Please provide NRW with timescales for this work no later than 1st November 2019.

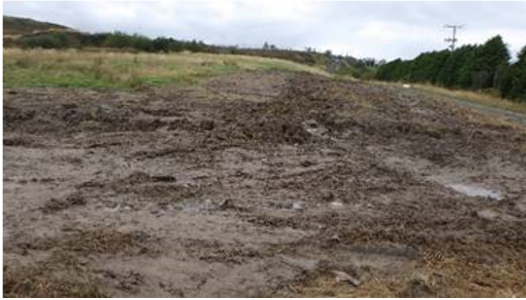
It was advised that this trench has now been installed. Leachate connection from this sump has also been installed and is now pumping. However the gas line remains unconnected and is currently venting. As discussed this should be connected as a matter of urgency. You advised that this work will be completed within the next week.

**Photograph 9** - Gas and Leachate Intervention Trench

**ACTION 7.** An action from the visit was for the operator to connect the gas line from this Intervention Trench and inform NRW when this has been completed. Please could you respond no later than 1st November 2019 on this matter.

**ACTION 8.** Operator to monitor this unconnected gas line closely in the interim. If elevated gas emissions are detected then site should take necessary measures to alleviate these emissions and this pipe should under no circumstances act as a conduit for oxygen ingress into the extraction system. The operator should also monitor the effectiveness of the new trench in collecting contaminated water within phase 1 and 2.

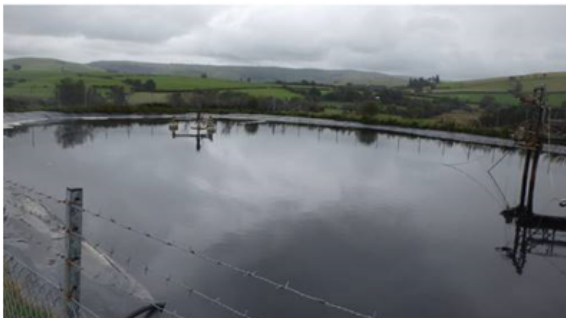
**Photograph 10**

Both lagoons appeared to have some free board during the visit. The marker boards on the lagoons have not been installed as per Leachate management plan. Please keep NRW updated on this outstanding matter.

It was also explained that given the polluting nature of the substance being stored within this lagoon, previous containment failures and incidents NRW deem this lagoon a high risk and therefore extra safeguards are necessary on site. For example (but not limited to) the operator should consider measures such as high-level alarm and automatic shut offs etc. This will be covered in more detail in response to the operator's response to CAR form NRW 0035577.

Operator to confirm the timescales for the installation of the marker board and address further comments raised in correspondence

CAR form NRW 0035577 regarding the implementation of extra safeguards etc . Operator to provide an update to NRW by 1st November 2019.
