Site	Rees Metals	Permit Ref	LP3098FJ		
Operator/Permit holder	Rees Metals Ltd				
Regime	Waste Operations				
Date of assessment	27/02/2020	Time in	10:30	Out	11:20
Assessment type	Audit				
Parts of the permit assessed	See Below				
Lead officer's name	Ellar, David				
Accompanied by	Kinkead, James				
Recipient's name/position	Len Davies/ Permit holder	Date issued	06/03/2020

**Report ID:  
CAR\_NRW0036408**

Site	Rees Metals	Permit Ref	LP3098FJ
Operator/Permit holder	Rees Metals Ltd	Date	27/02/2020

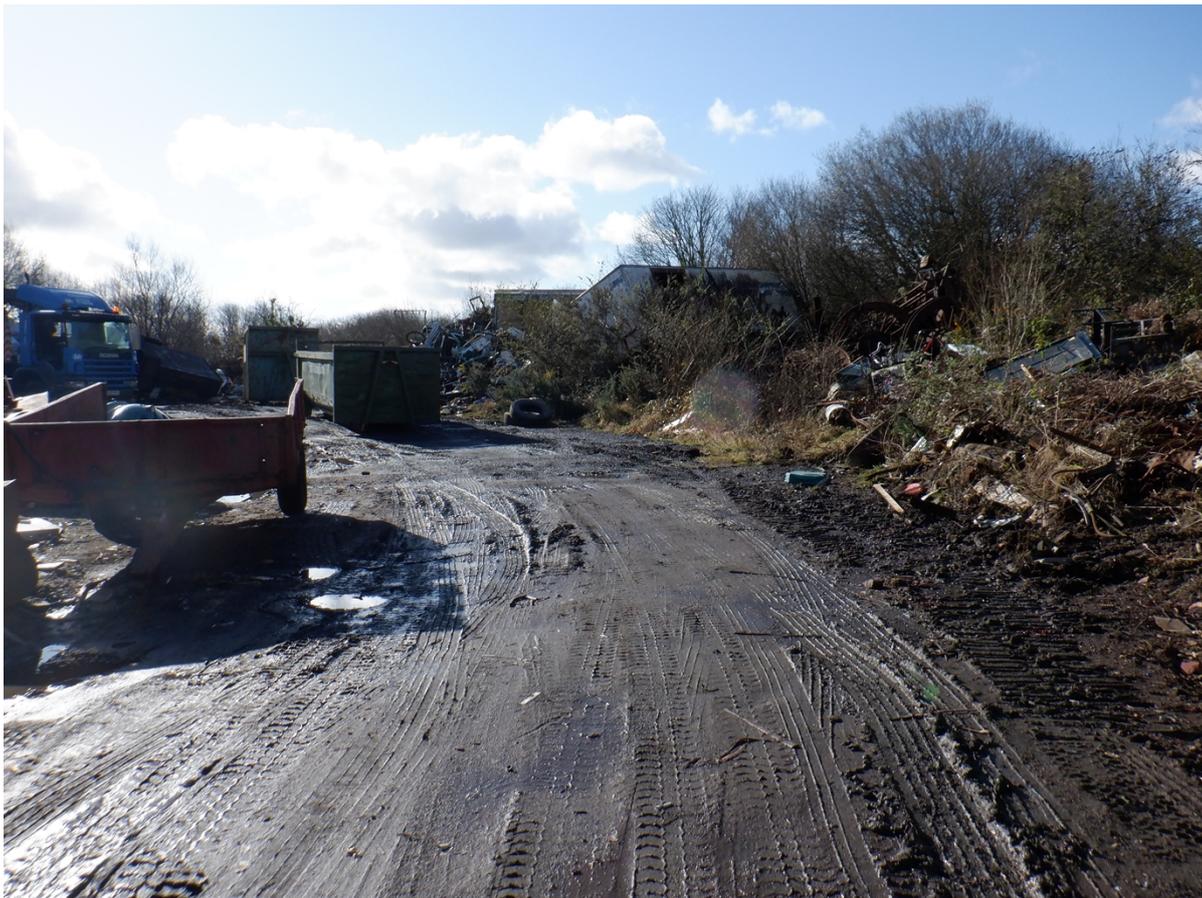
The recent improvements to the hardstanding and tracks though the site had generally held up despite the recent wet weather. There was some pooling of water visible, but this was to be expected given the recent rainfall. The area leading up to and around the shears does need some attention though. The tracks should be cleared of waste and any build up of slurry should be removed.

Photograph showing good hardstanding:

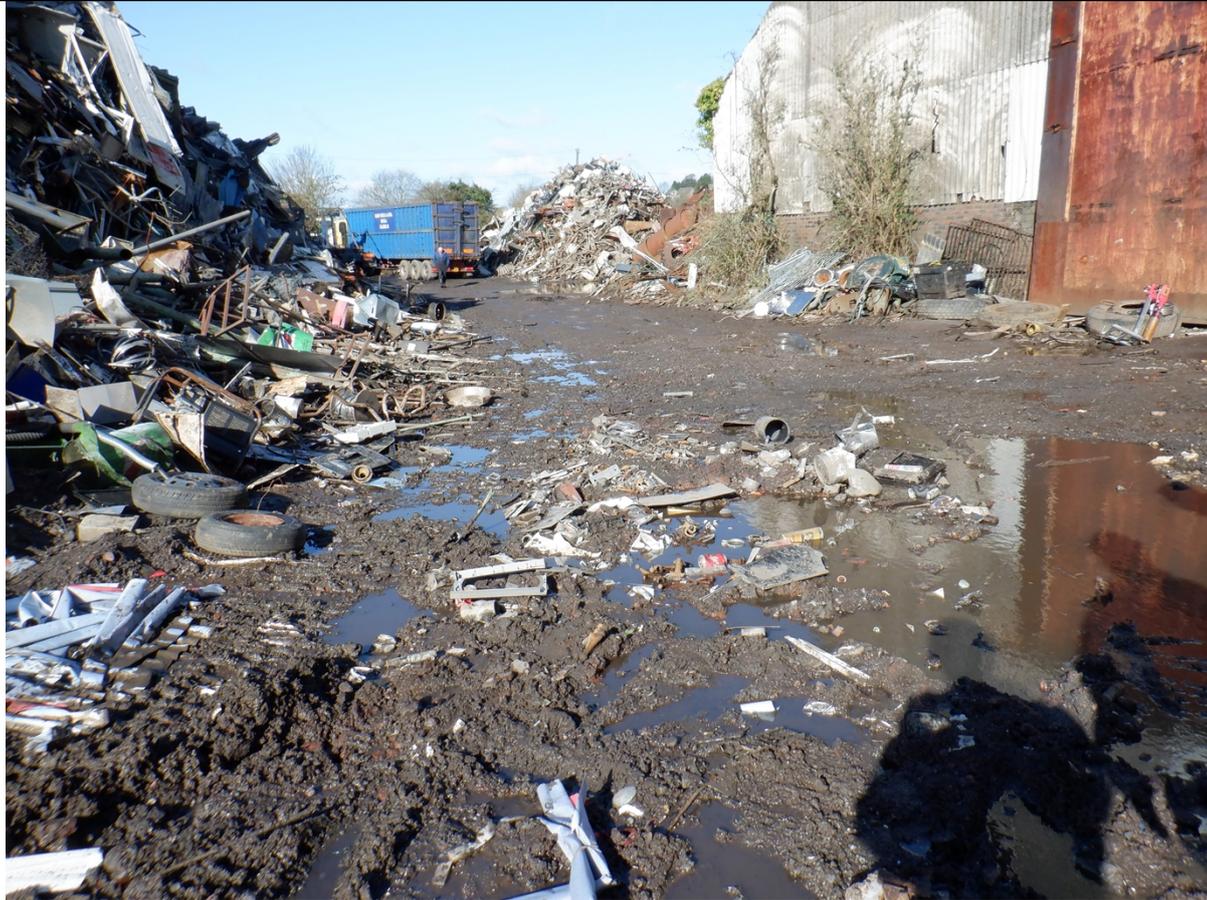
Photograph showing hardstanding area in need of attention:

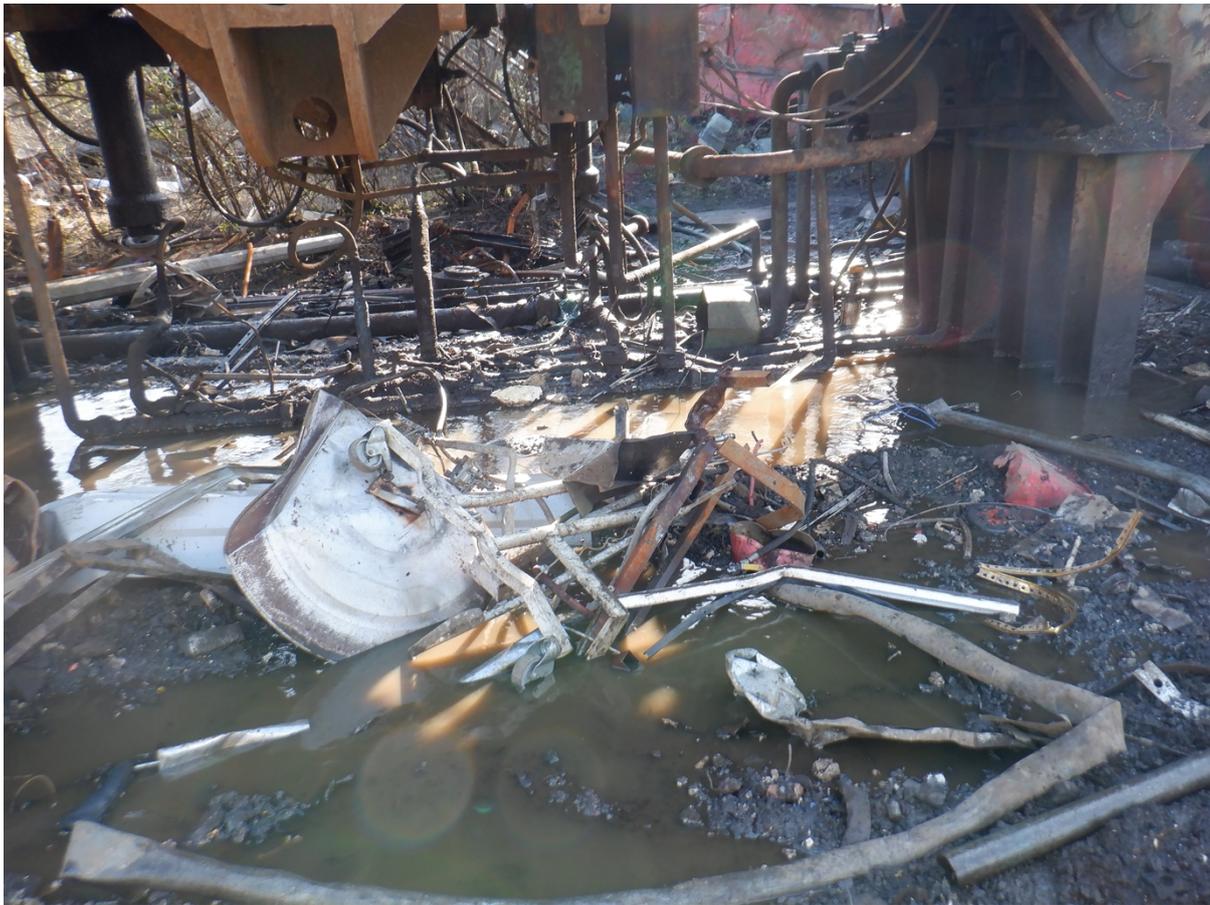
**B3 (Engineering for the prevention and control of emissions) Category 2 Non - Compliance of permit condition 2.1.1.** The site has a history of issues regarding the metal shears area. During this visit the area in and around the shears and its bund was full of scrap metal and rain water. This makes the bund unable to capture and retain any fluids that could potentially leak from the shears and given the age and condition of the equipment this is highly likely. This is a breach of condition 2.1.1 of your permit. Please clear (and keep clear) the bunded area pump out the water (removing it to a suitably authorised facility) and repair the bund as necessary. Table 2.1 of your permit details the need for daily inspection of the bund and keeping it free from contaminated water.

Photograph showing banded area under shears:

**ACTION: Empty, inspect and improve inspection regime to insure bund is kept free from waste and rain water.**

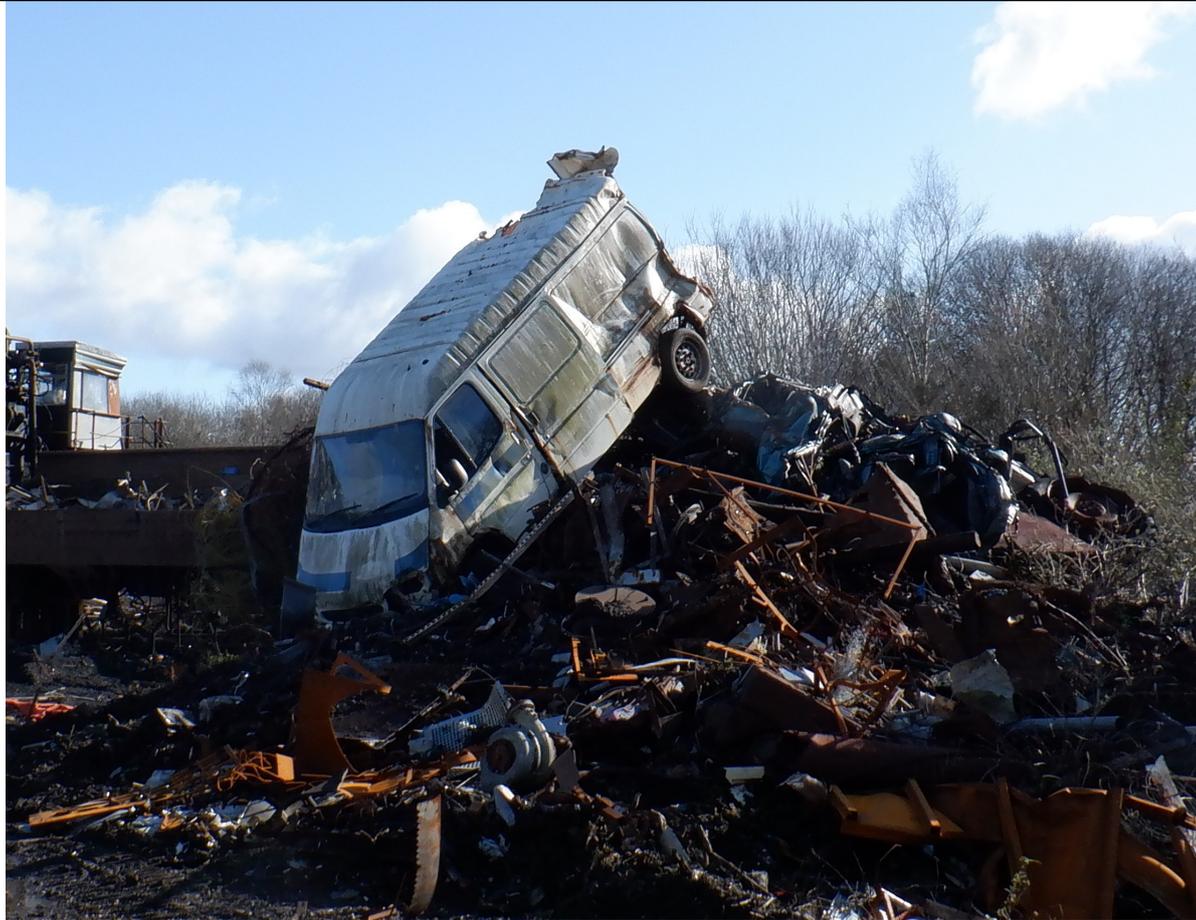
**A1 (Specified by permit) – Category 3 non-compliance of permit conditions 1.2.1 and 1.2.2: Excluded and non-permitted waste types.** Non-permitted and excluded waste types were identified during the visit. Whilst walking around the site we saw; gas cylinders, tyres and two End of life vehicles. These waste types are not allowed to be accepted at the site. Table 1.2.A of your permit states what permitted waste types are e.g ferrous and non-ferrous metals. Table 1.2.B of your permit states what the excluded or non-permitted waste types are. Len Davies explained that none of these waste had recently been brought onto the site and they had been uncovered whilst reducing the stock piles. All excluded and non-permitted waste must be removed from site as detailed in table 4.4 of the permit.

Photograph showing an unpermitted ELV:

**Action: Remove all excluded or non-permitted waste to quarantine area and then arrange removal off site as per permit conditions. (see table 4.4)**
