## ENVIRONMENTAL SETTING AND SITE DESIGN

White Rock Geo Environmental Limited were instructed by Mold Investments Limited (MIL), the Operator, to prepare an application for an Environmental Permit for Parry's Quarry Inert Landfill in Mold, Flintshire under the Environmental Permitting (EP) (England and Wales) Regulations 2016.

The site is situated within the existing Parry's Quarry in Alltami, Flintshire and bounded by the A494 to the south, A55 to the north and Pinfold Road to the west. The National Grid Reference (NGR) for the entrance to the site is SJ 27478 66278, presented at Figure 1 below and is detailed at Drawing ESSD 1.

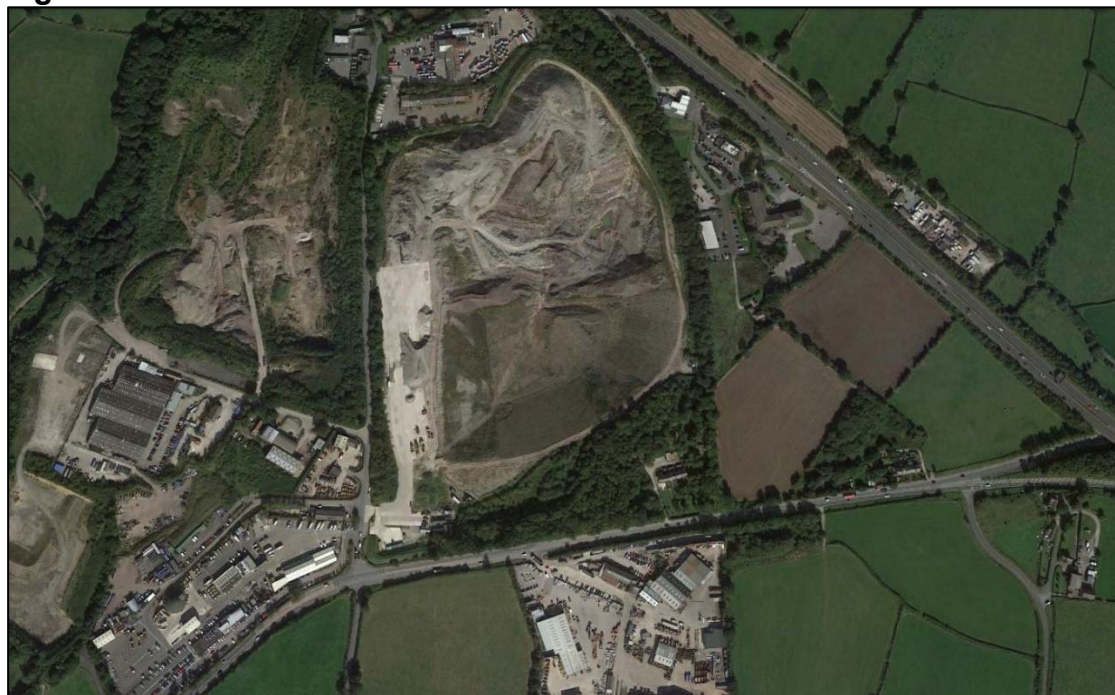
**Figure 2: Aerial view of site**

The proposed landfill operations will comprise the restoration of the quarry void using inert waste within a fully engineered contained cell. The landfill will be below ground and operated as a hydraulic containment landfill. Groundwater pumping will be carried out on a temporary basis until the infill development platform has reached groundwater rebound. The groundwater chamber will then be infilled and lined over

The local topography is undulating and formed from a series of ridges and valleys. The site is situated at an elevation of circa 105mAOD on the site of the valley with the land to the south west riding up towards New Brighton at circa 145mAOD and falling away towards the north east towards the Wepre Brook, which is at an elevation of approximately 55mAOD. The wider

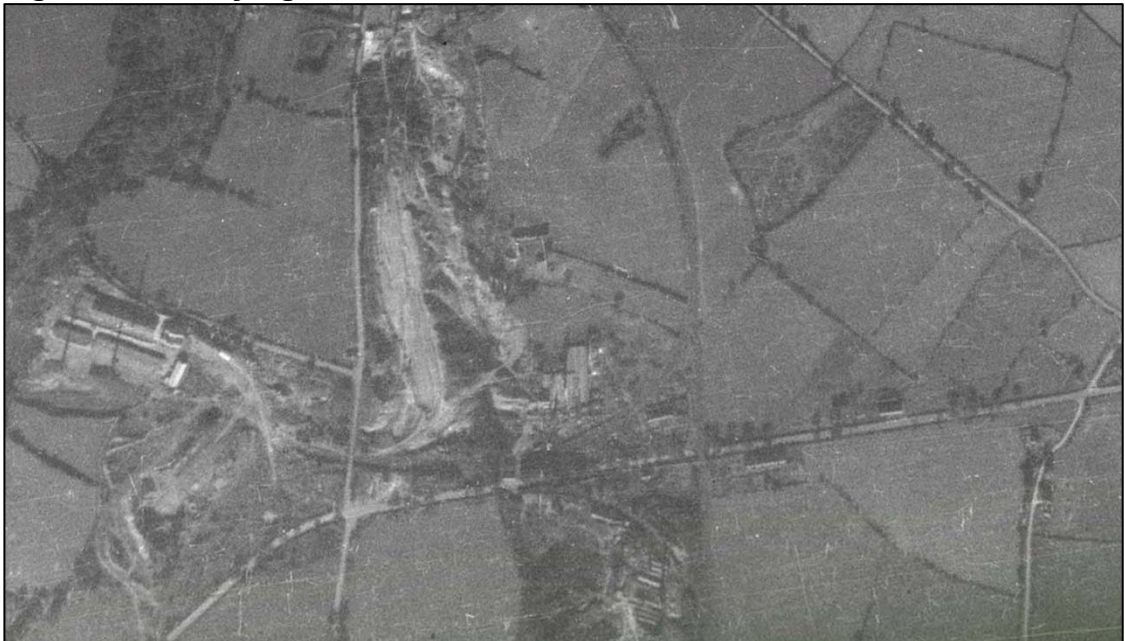
**Figure 3: Quarrying in 1945**

Historic Maps for the wider area, from 1900 onwards, show a number of brickworks having been developed to the south of the site with a small pit or pond shown immediately to the west of Pinfold Lane near the Castle Brickworks. The historic maps are presented at Appendix ESSD 1.

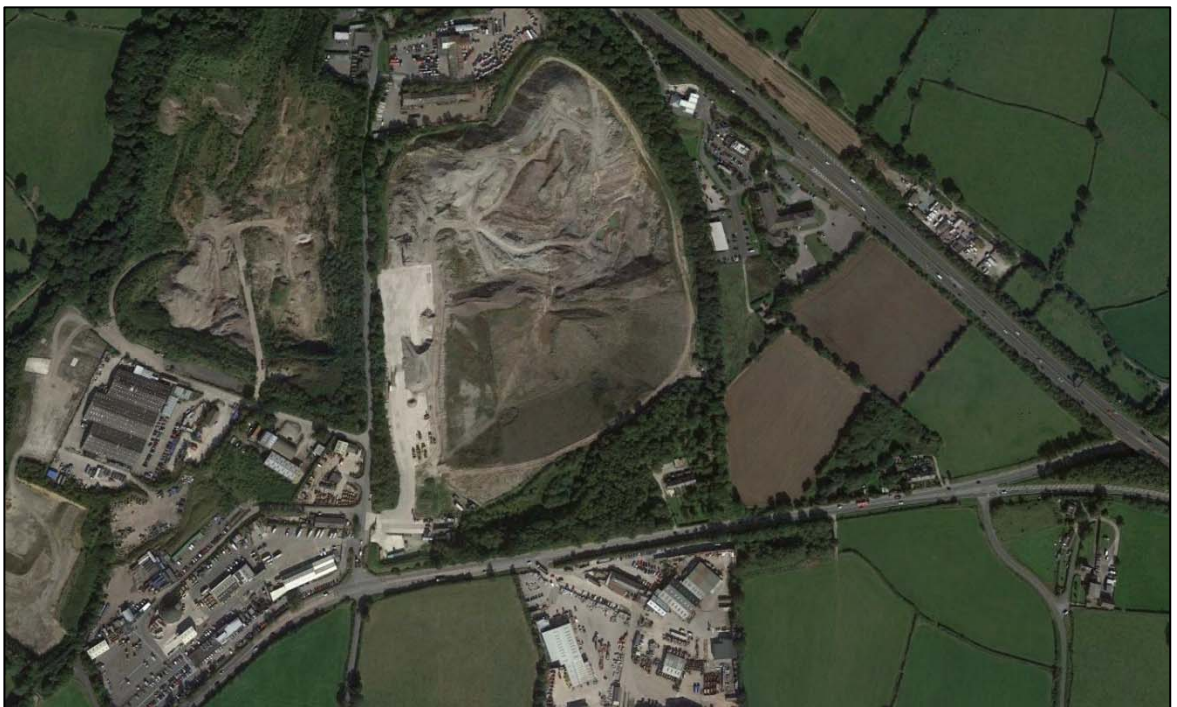
**Figure 6: Quarrying in 2020**

Remaining Etruria Marl deposits are clearly shown on the north, designated as Phase 2
