## Compliance Assessment Report

Report ID:  
CAR\_NRW0032081

| Site | Rhydymwyn CRT Recycling | Permit Ref | ZP3634CG | | | |
| Assessment type | Site Inspection | | | | | |

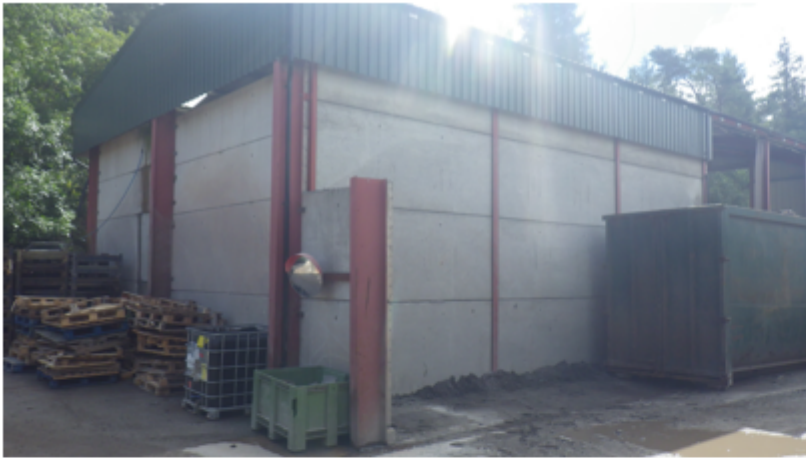
**Photograph 1**  
**Large stockpile of fines removed from side of CRT building**

There was a noticeable improvement on site today, it was explained to the regulatory officer that all fines previously stored outside are now stored inside to comply with relevant permit conditions. Two significant areas of improvement could be immediately noticed, this being the area behind the CRT (cathode ray tubes) building and the other alongside the CRT reception, these areas have now been cleared of fines.

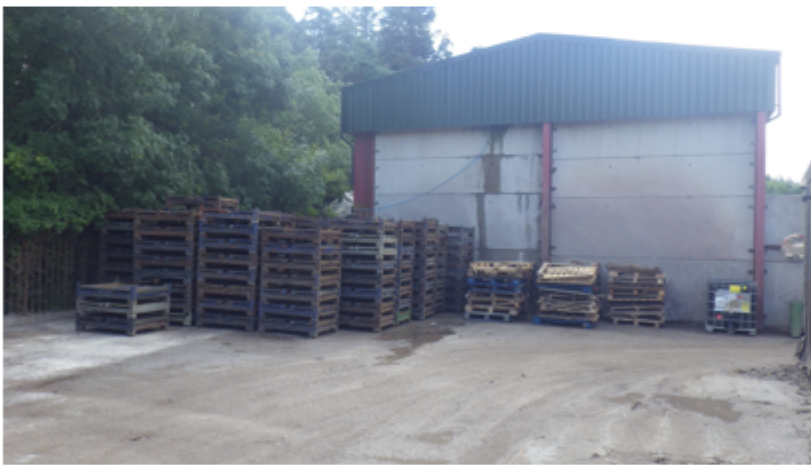
**Photograph 3**  
**Large stockpile of fines removed from back of CRT building**

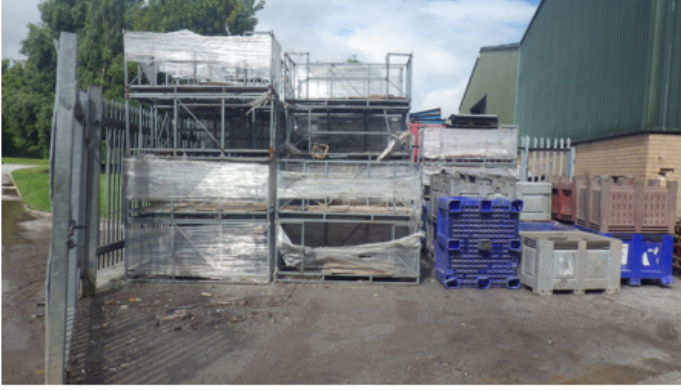
**Photograph 4.** Previous CRT stored in hessian bags have been removed and this area is now tidy and used for storage.

It was also encouraging to see today that no CRT were stored outside, and the CRT's that were previously stored in non-weatherproof open hessian bags had been removed as per last CAR form recommendations and actions.

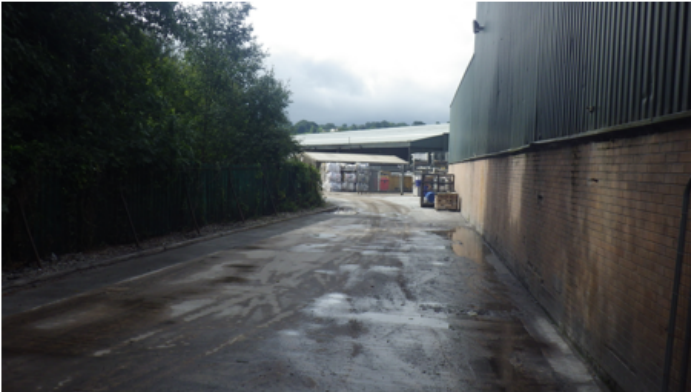
**Photograph 5.** Significant improvement in general housekeeping at the back of unit 6.

It was also noticed that the overall housekeeping on site had dramatically improved.

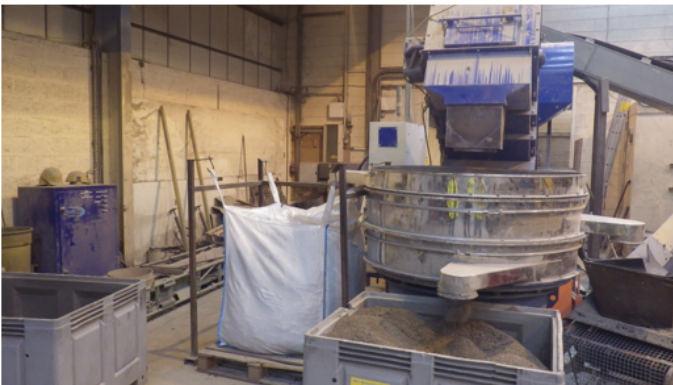
**Photograph 6.** Line 4 located further away from the wall.

The operator advised that they have spent considerable time and money in upgrading the processing equipment in order to be able to process more glass through the crushers and imploder. It was also explained that line 4 on site has been relocated slightly further away from the wall.

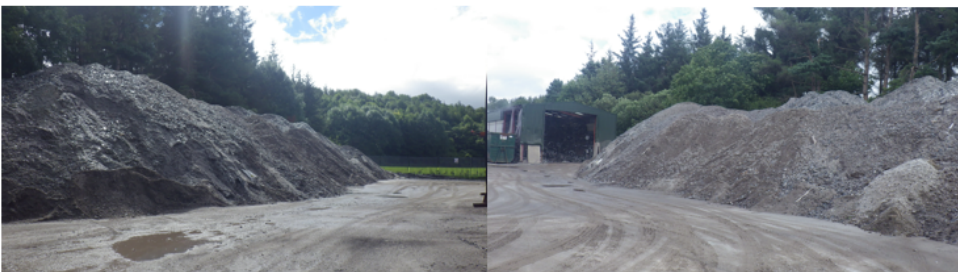
**Photograph 7**

The levels of oversized glass and funnel glass being stored on the yard area at Unit 8 are still high and are stored outside contrary to the permit. There is a risk of this material causing issues with dust and noise by the handling of waste materials around the facility.

As a result condition 2.1.1 has been breached and a score of 2 applied due to the quantity and the duration the waste material has now been stored outside and because the material is contributing to other issues on site such as limiting operational space, causing ponding of water contaminated with suspended solids, and has the potential of causing issues such as dust etc

Stockpile of oversized glass and funnel glass currently stored required to be removed by 11<sup>th</sup> November 2017.

**ACTION 1 :** Operator to treat and remove stockpiled waste stored outside by the 18th November 2017.

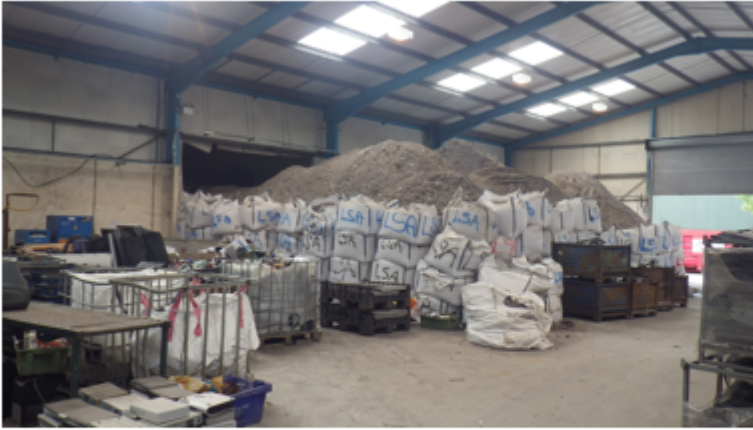
Photograph 9.

Stockpile of fines material required to be removed from Unit 6.

Options have been considered by the operator of how to become complaint, and the preferred option by the operator is to continue to focus and prioritise activities to clear external waste glass from the yard by the 18th November 2017, leaving the treatment of fines inside unit 6 until March 2018 which is under a weatherproof covering.
