## Compliance Assessment Report for: CAR\_NRW0037092

| <b>Permit number</b> | BL7108IM | <b>Operator name</b> | Tata Steel UK Ltd. |

| <b>Site name</b> | Port Talbot Steelworks |
| <b>Type of assessment</b> | Audit |

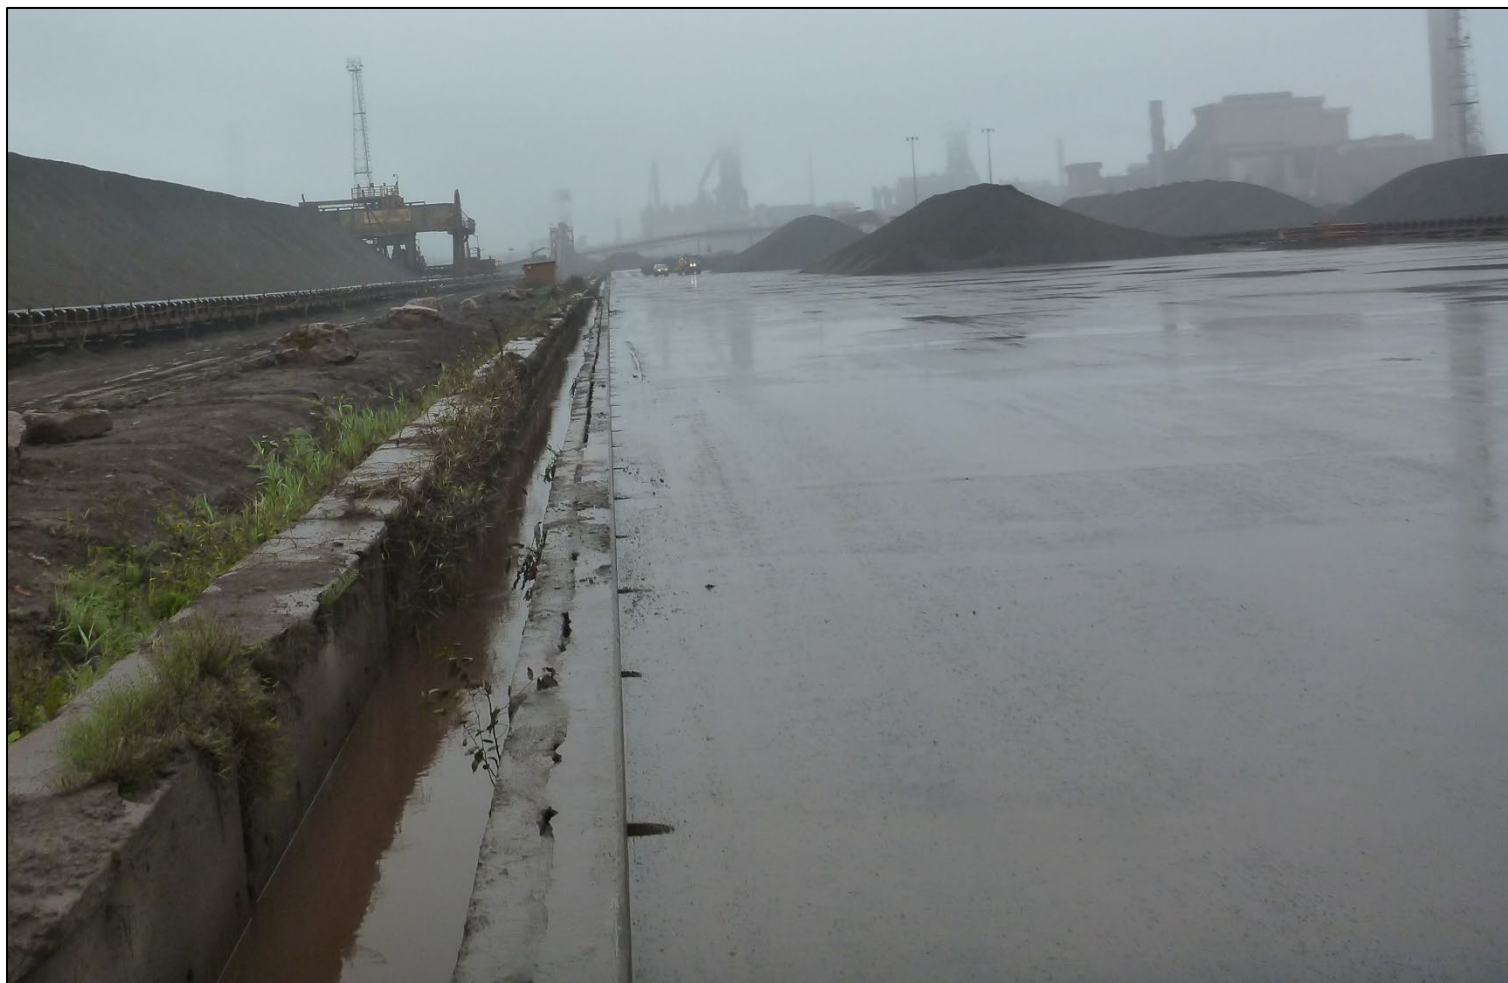
- We saw no evidence of dust lift-off from the any of the raw materials stockpiles we inspected.
- Road and yard sweeping units were active at the time of inspection. Even during wet weather this helps keep accumulated debris (which potentially generates dust when dry) to a minimum.
- Main haul road dissecting stockyards was visibly clear of debris and mud;
- Drainage system appeared to be working with no evidence of ponding water (see figure 1);

Figure 1. Photograph showing stockyard's surface. Despite heavy rain, the yard's drainage system appears to be functioning correctly with no evidence of significant waste ponding or surcharging drainage systems.

- During the visit to the stockyard area we observed several improvements and could clearly see flow in the central drain chamber.
- We noted that surface waste ponding (despite the rain) was largely absent from the areas inspected, indicating effective drainage (see figure 1).

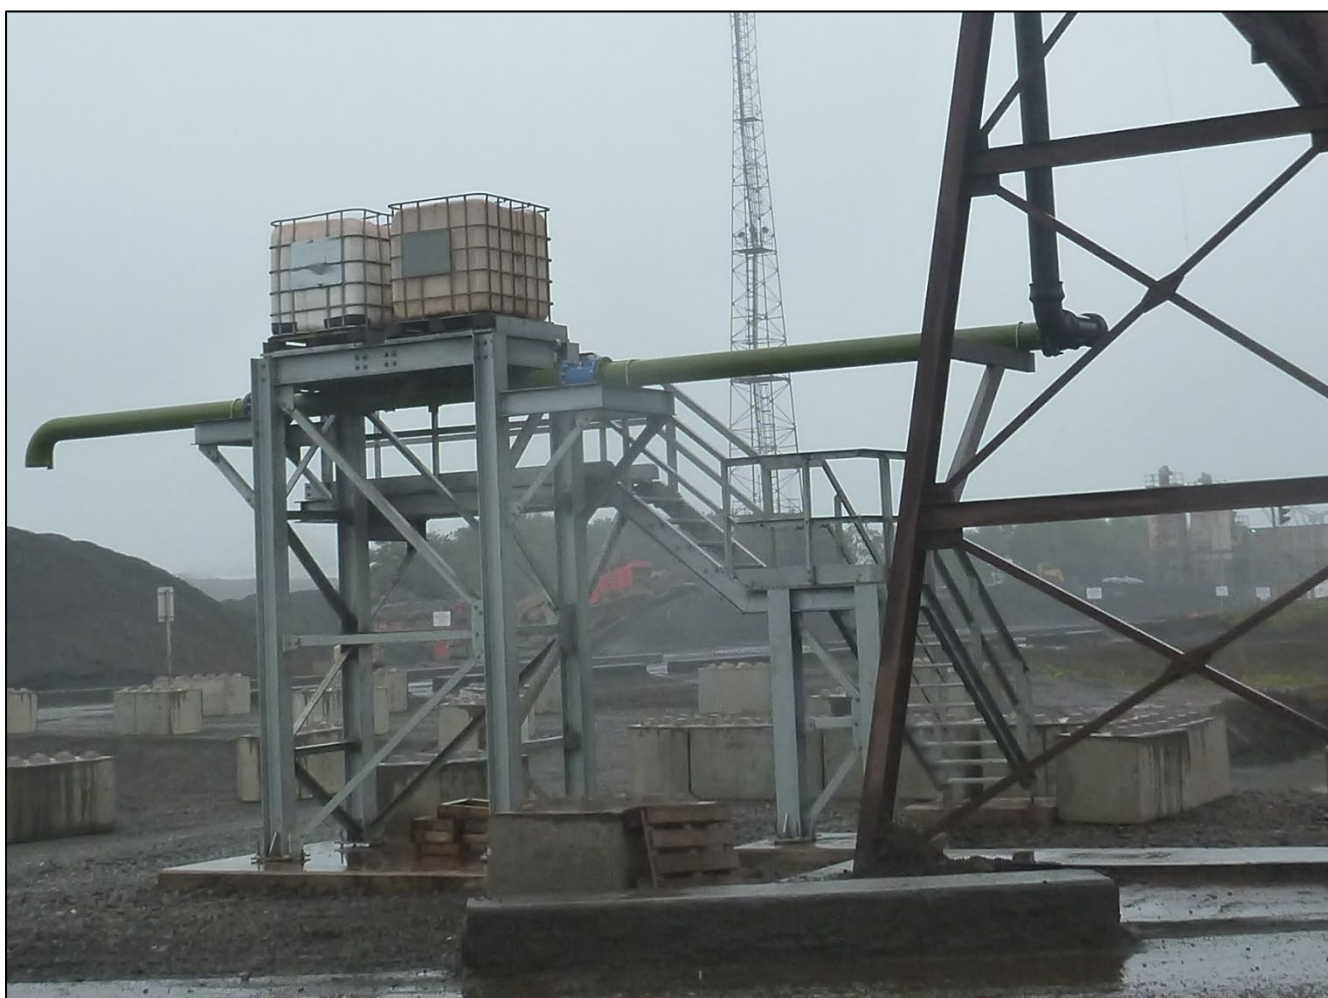
- The wheel washers we inspected appeared to be functioning correctly (NRW also inspected a random sample of the stockyards wheel washer maintenance schedule – which appeared satisfactory);
- Integrity of block enclosures for sinter blend additives/fluxes appeared satisfactory;
- Central water bowser filling point now available within rubble yards. This has a supply piped directly from the blast furnace area and a much faster filling capacity than all other points. Allows LW more flexibility and increases the capacity for latexing and water bowser deployment (see figure 2);

Figure 2. Photograph showing new water filling bowser point within the stockyard's rubble yards, significantly improving the operator's dust management capability.

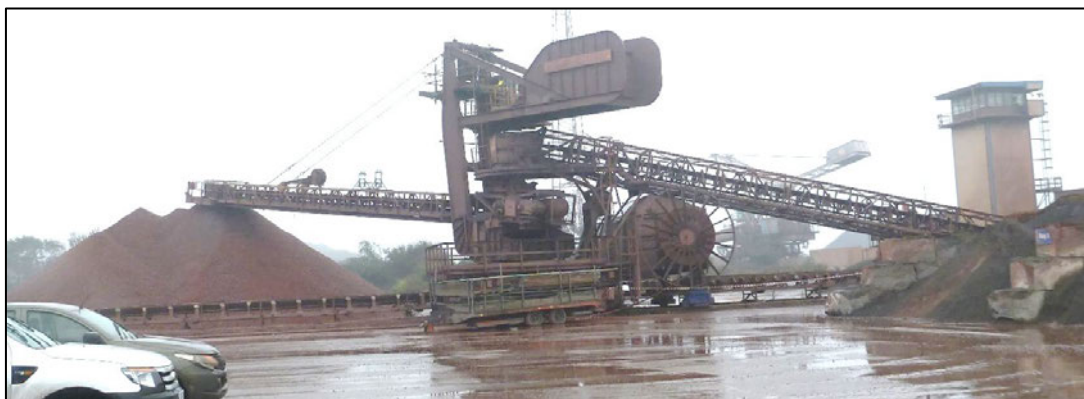
- Raw material stockpiles are worked from the sheltered (leeward) side where possible. However configuration of bucket wheel stacker reclaimers and conveyors within primary ore yards restricts ability to reclaim from leeward side in every circumstance (see figure 3);

Figure 3. Photograph showing boom stacker.

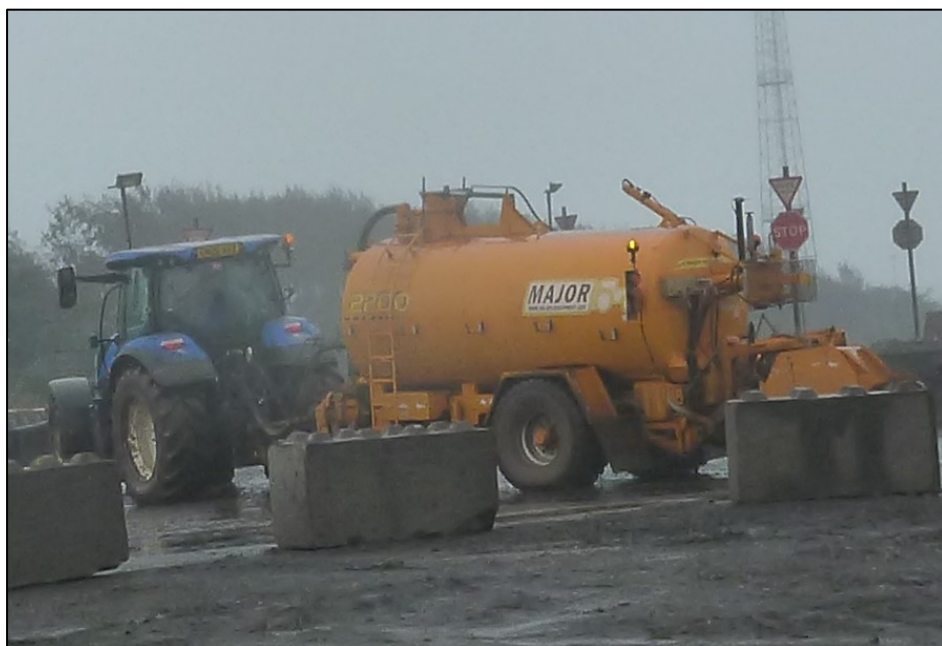
- New dust suppression tankers (fitted with water cannon and road cleaning equipment) have been acquired by the facility. We were informed that these provide an enhanced dust suppression capability. One of these new tankers was observed during course of our inspection (see figure 4).

Figure 4: New dust suppression tanker with enhanced capability
