## Compliance Assessment Report CAR\_NRW0037289

**Permit being assessed:** XB3393HM.

For: Project Red Recycling, held by Project Red Recycling Limited

**Type of assessment carried out:** Site Inspection, Reason: Routine.

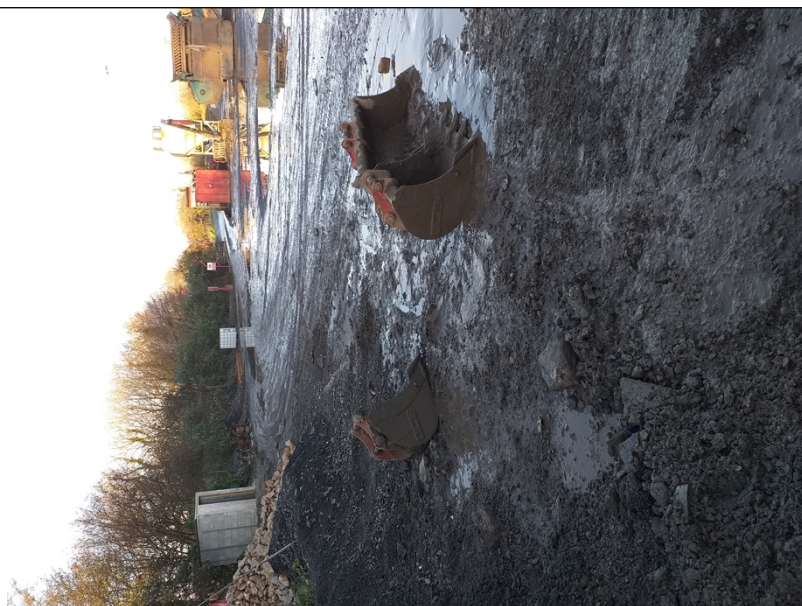
The area of the site used for inert storage and treatment was wet and muddy with pooling water across the area. There had been a breach of the bund with material leaving site and there is therefore the potential for pooling water from the area used for the treatment of the inert material to reach the watercourse. This area does not meet the definition of hardstanding as water is not able to permeate through. The root cause of this breach is detailed above under C2 – Management system.

Improvements to the hardstanding are required to ensure an effective drainage system in place in line with the permit condition. Please provide a response to this CAR in regards to the actions you will take in order to comply. The deadline for improvements to be made is 29<sup>th</sup> January 2021.

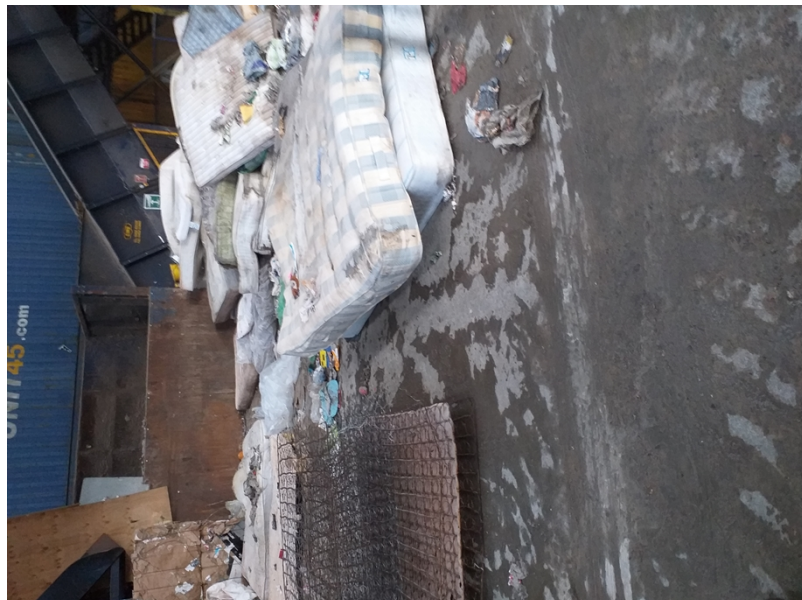
We witnessed mattresses being manually separated (treated) on site. This activity has not been identified in the EMS and is therefore a breach. We were advised this was a trial. Should you wish to proceed with treating mattresses please let us know.

Wastes were also being stored in shipping containers outside, this is a breach of the EMS which does not account for storage within the containers. The site have been breached for this in the past as it also leads to a breach of the FPMP as there are no separation distances between stacks, with containers in between stacks full of waste.

Action: Waste should be stored in line with the EMS.

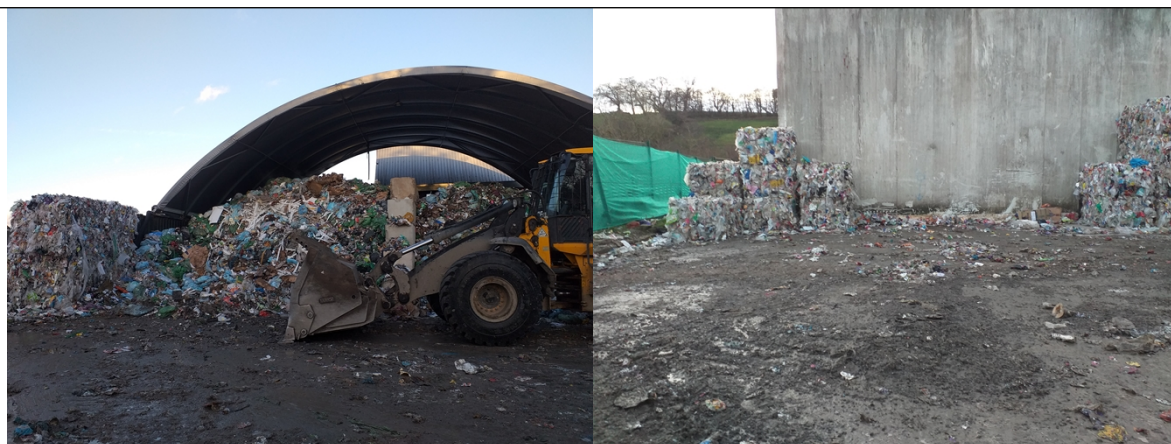
Waste was being stored outside as witnessed during the visit, namely bales of plastic waste.

Action: All waste must be stored and treated inside building in line with the permit conditions by the 22<sup>nd</sup> January 2021.

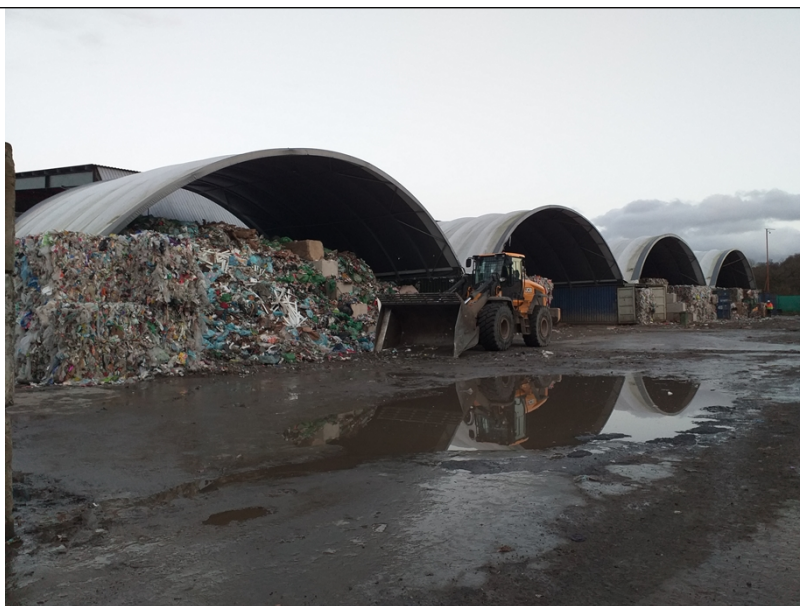
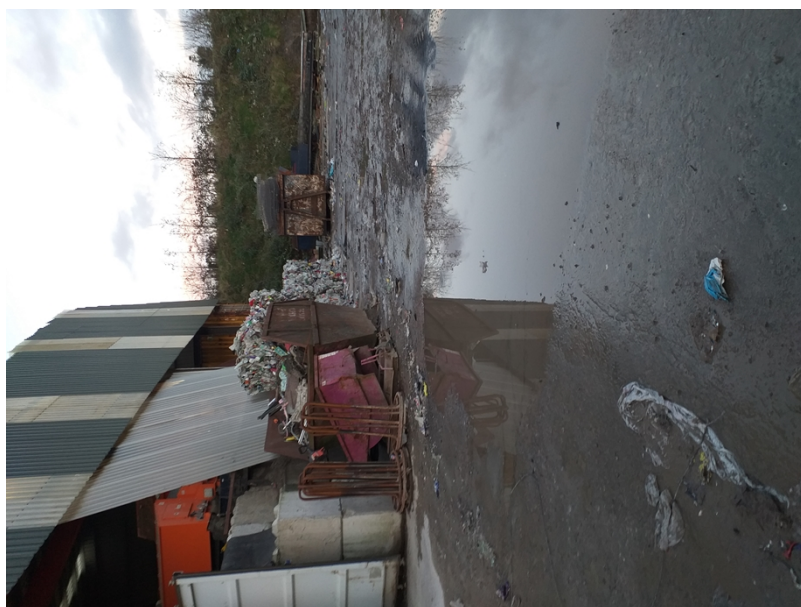
We also have concerns about what has been described as the building throughout the documentation which was submitted with the recent variation application. We are concerned as the building witnessed on site does not represent what has been applied for and this is therefore a breach. Please see non-compliances in the documentation/application:

Email sent on the 04/10/20 states: *'Although it is planned for the building to be updated, it is currently sealed on the northern edge, the southern edge (with the exception of the doors which would need to be opened anyway to allow for movement of material in and out of the facility) and the eastern side of the facility which is in the main concrete wall construction, reinforced with metal sheet cladding.'* – This is not the case, open sides to the Eastern side with only a low concrete wall and corrugated plastic which appeared to be loose and not providing a sealed edge. The walls are made of metal containers. Also, the hangar style storage areas (bunkers) at the front of the building have a completely open front and gaps at the back with potential to allow ingress of water and release emissions.

The EMS reference Oct 2020 states: *'As the reception area is fully enclosed on three sides the potential for the odour to escape the boundary is minimised significantly.'* The reception areas within the alcoves are only enclosed on two sides and this is therefore not being complied with.

Action: The building needs to be brought back in line with what was applied for and included in the accompanying documentation. Please provide a written response as to how you plan to come into compliance with this aspect of the permit.

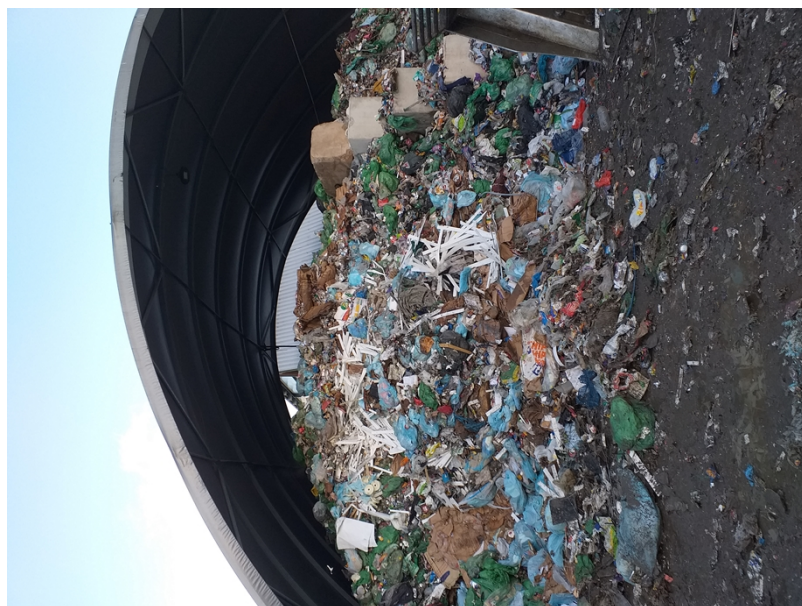
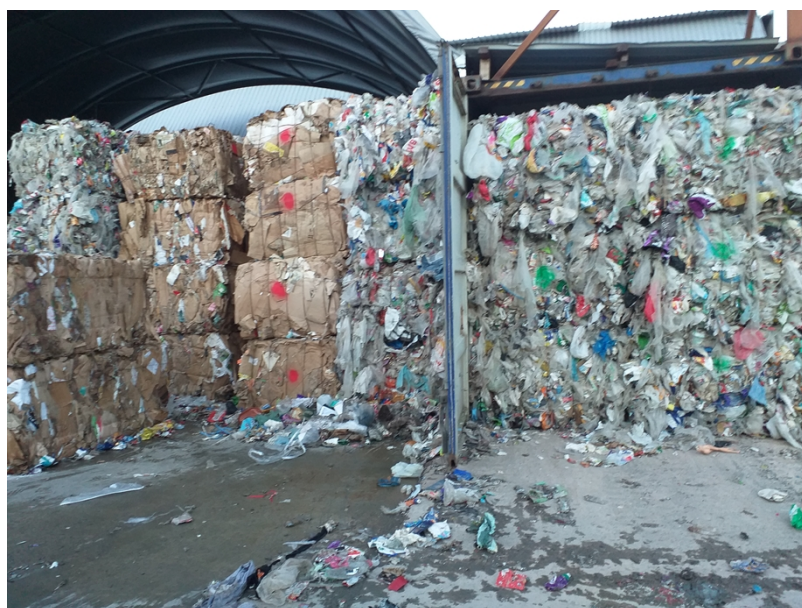
The waste piles are stored within the alcoves at the front of the building which can only be accessed from one side. As discussed on site the maximum width of stockpiles are limited to 10 metres if access is from one side only. Stockpiles must therefore be reduced to 10 metres width and the FPMP updated to reflect this.

The guidance and the FPMP stipulates that a 1 metre free board be left between the top of stockpiles and the top of bay walls. This ensures any walls used for separation distances are effective and reduces the chance of spread of fire between piles. This was not being complied with at the time of the visit.

The FPMP states, in line with the guidance that *'The concrete walls used for the construction of the waste storage bays will be made in accordance with the requirements of BS EN 771-3 and will conform with the specifications outlined under EN 13501-1:2007-A1:2009 where the material performs as a class A1 against fire resistance. The walls themselves would be made from solid concrete 'lego' block design where each block measures approximately 1.5m(l)x0.75m(w)x0.75m(h) and weighs circa 2.5T each'*. This is not an accurate reflection of the situation on site as some of the waste storage bays are metal and not concrete.

The FPMP states that *'There are 2x 100,000l water storage tanks held on site that are fed and topped up by the clean rainwater from the roof of the building and concrete surface'*. There are currently no water storage tanks on site. The guidance states that you must have sufficient water supplies available to your site for firefighting to take place and to manage a worst-case scenario incident (e.g. one (your largest stack) or more stacks on site are on fire). We were advised during the visit that the river would be used however, this is only something that can be considered to supplement the mains supply and should not be relied on as a primary source. It was then suggested that the 100,000 litre site drainage sump would be used, this would not be appropriate and would also rely on the tank being continually full to comply with your FPMP (which would lead to other non compliances).

FPMP states *'Baled wastes will be stored in rows that are only a single bale wide, therefore the stacking of the bales will generally only be 3 high (for safety reasons)'*. This was not the case whilst on site, with bales of plastic wastes filling the alcoves at the front of the building which we were advised were approximately 15 metres deep (width).

Action: Stack heights need to be reduced and/or bay walls increased to ensure that a 1 metre free board is in place by the 22<sup>nd</sup> January 2021.

Action: Water supplies need to be available on site in line with your FPMP. This should be remedied as a matter of urgency and by the 22<sup>nd</sup> January 2021.

Action: the FPMP needs to be updated in line with the guidance to reflect the on-site activities and/or stockpiles brought in line with the current FPMP by the 22<sup>nd</sup> January 2021.
